MINERALS PROGRAM INSPECTION REPORT
PHONE: (303) 866-3567

MINE NAME: Fountain Pit	MINE/PROSPECTING ID#: M-1982-155	MINERAL: Sand and gravel	COUNTY: El Paso
INSPECTION TYPE: Surety-Related Inspection	INSPECTOR(S): Timothy A. Cazier	INSP. DATE: October 27, 2017	INSP. TIME: 10:40
OPERATOR: Schmidt Construction Company	OPERATOR REPRESENTATIVE: Dan Chavez, Mark Heifner	TYPE OF OPERATION: 112c - Construction Regular Operation	
REASON FOR INSPECTION: Surety Related	BOND CALCULATION TYPE: None	BOND AMOUNT HELD: \$310,388.00	
DATE OF COMPLAINT: NA	POST INSP. CONTACTS: None	JOINT INSP. AGENCY: None	
WEATHER: Clear	INSPECTOR'S SIGNATURE:

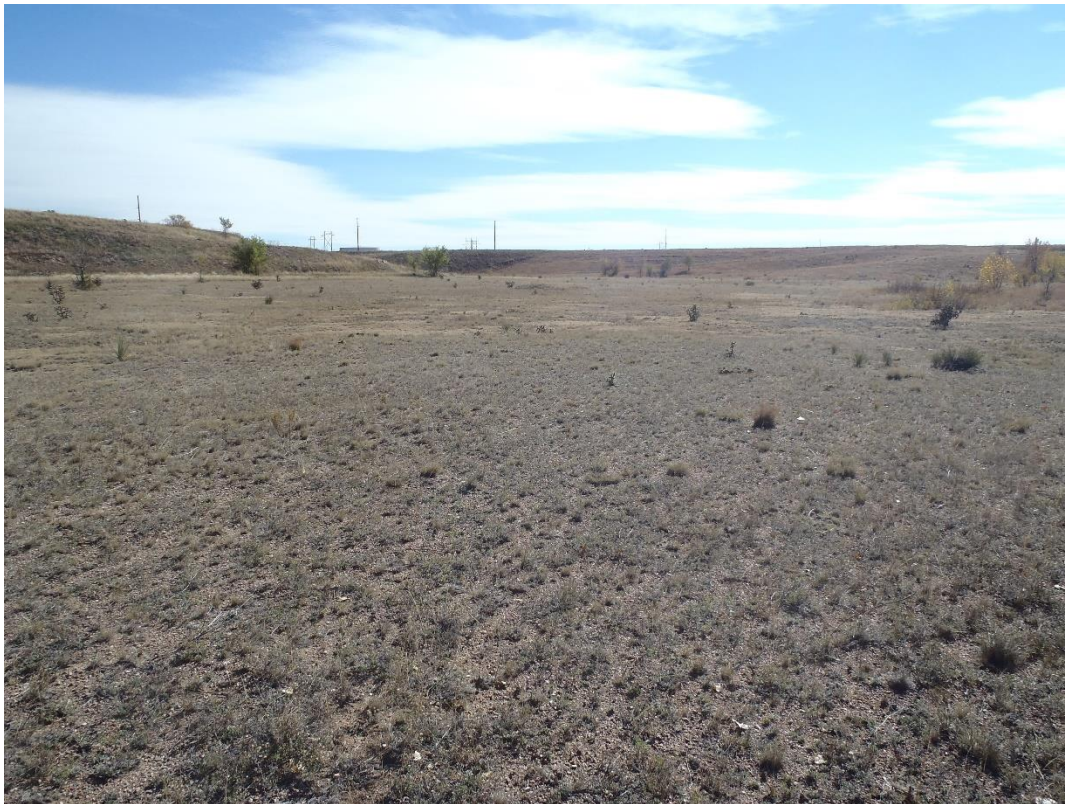
Backfilling and Grading: All grading required to achieve a stable slope appeared to have been completed (see **Photos 1 and 2**). No additional backfilling is required.

Photo 1. Pit floor reclamation (looking SE).

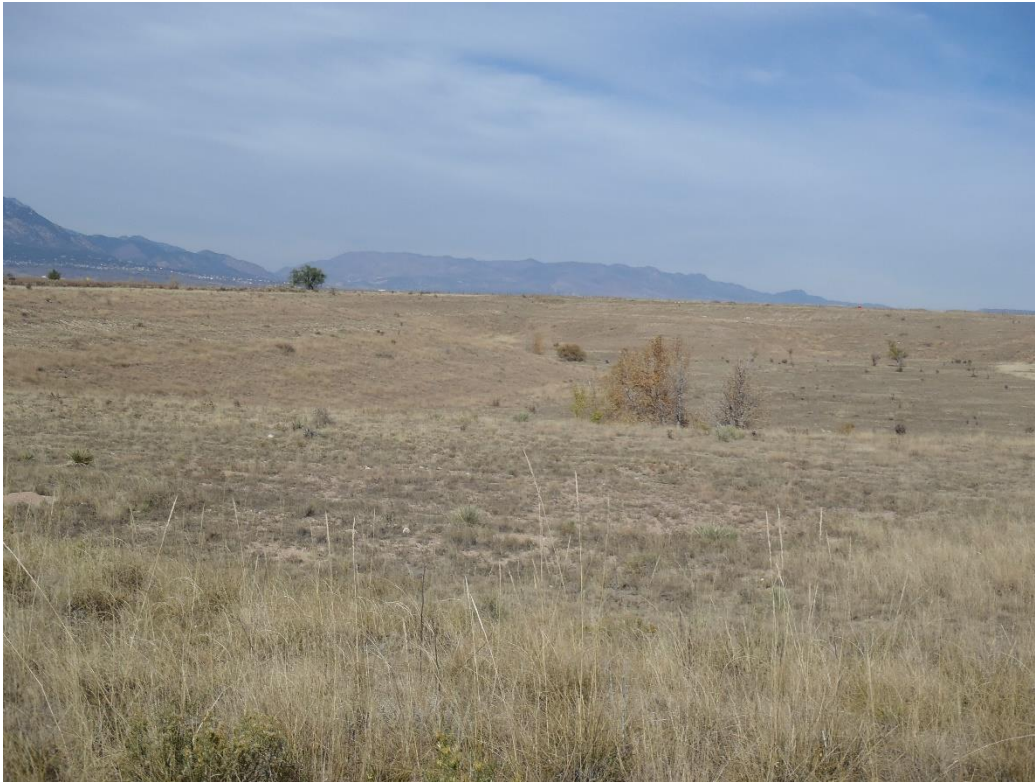
Photo 2. 3H:1V grading, west side slopes (looking NNW).

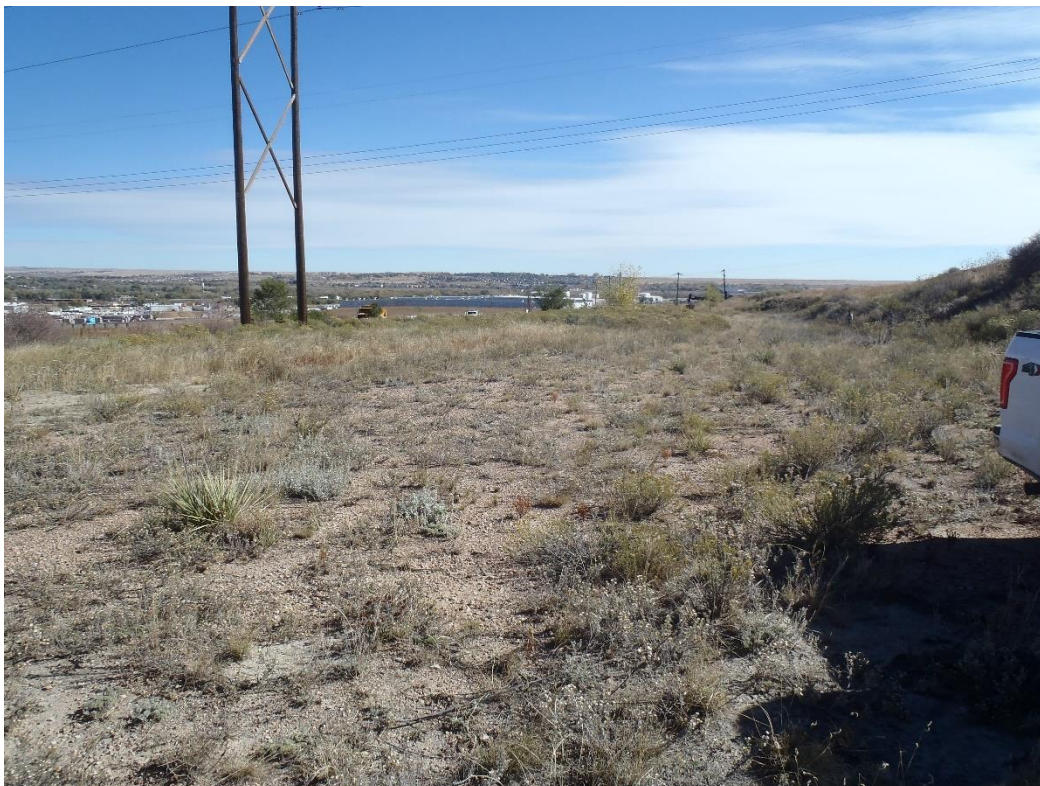
Roads: The original access road in the northeast corner of the permit boundary was abandoned and reclaimed (see **Photo 3**).

Photo 3. Reclaimed original access road (looking east near original entrance).

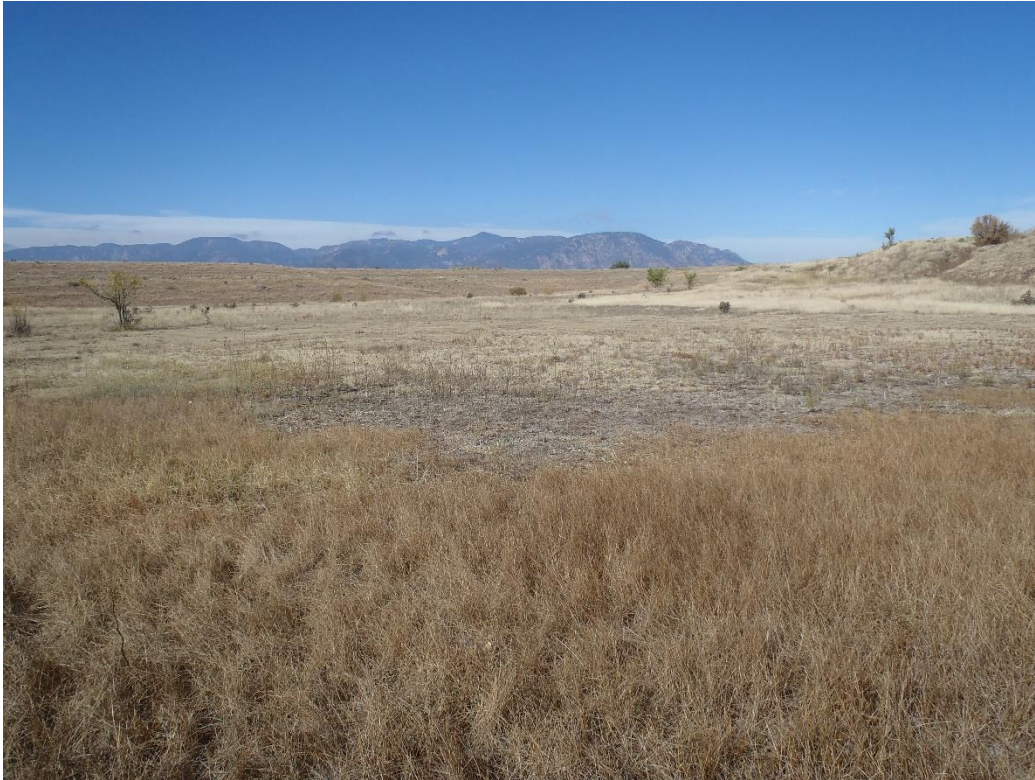
Revegetation: All the requested release area appeared to be adequately revegetated (see **Photos 4, 5 and 6**). The area does not appear to be a source from which noxious weeds might propagate.

Photo 4. Release area adequately revegetated (1 of 3, looking NW).

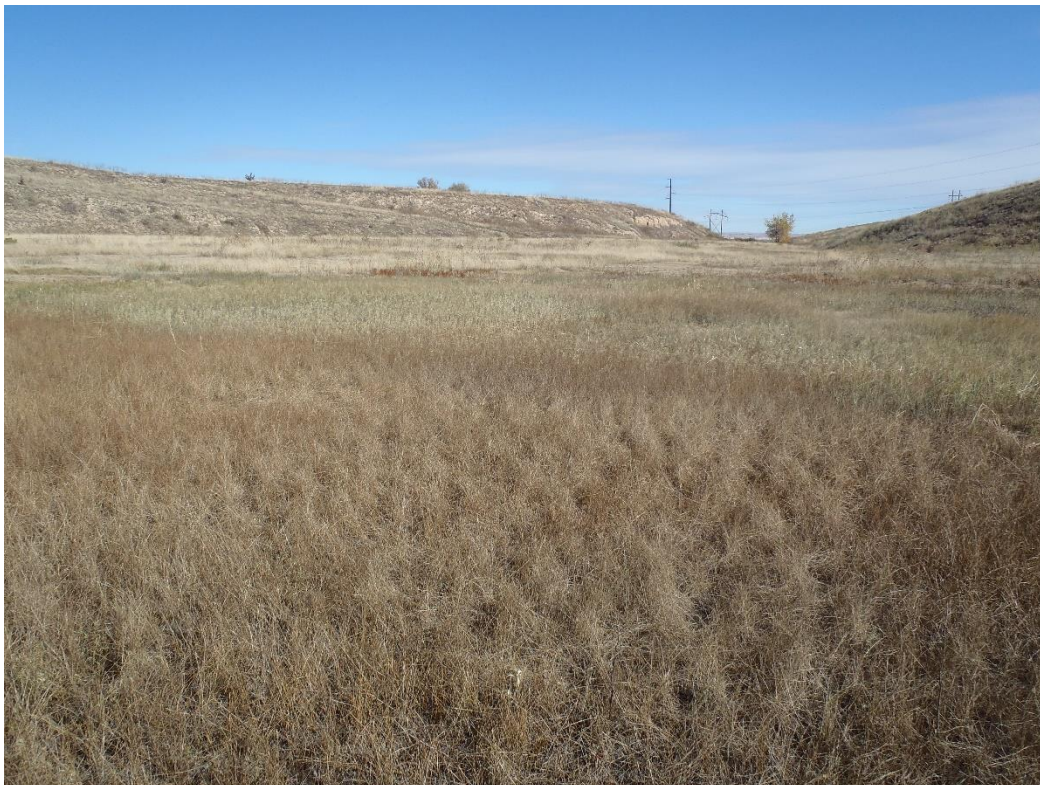
Photo 5. Release area adequately revegetated (2 of 3, looking NE).

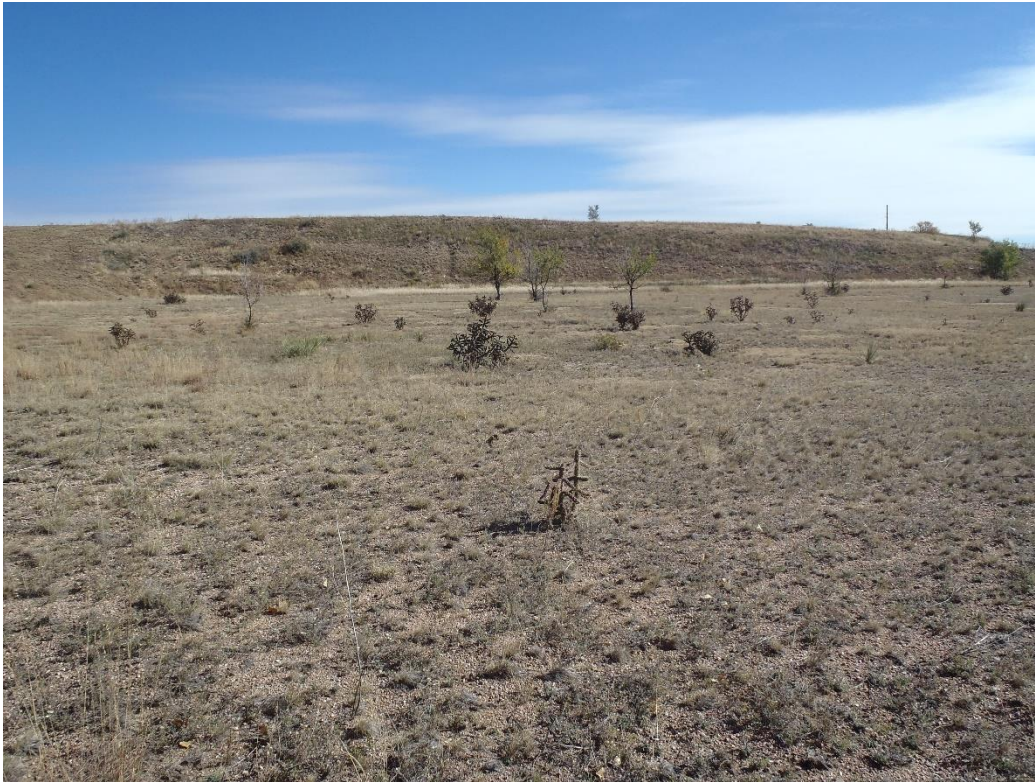
Photo 6. Release area adequately revegetated (3 of 3, looking east).

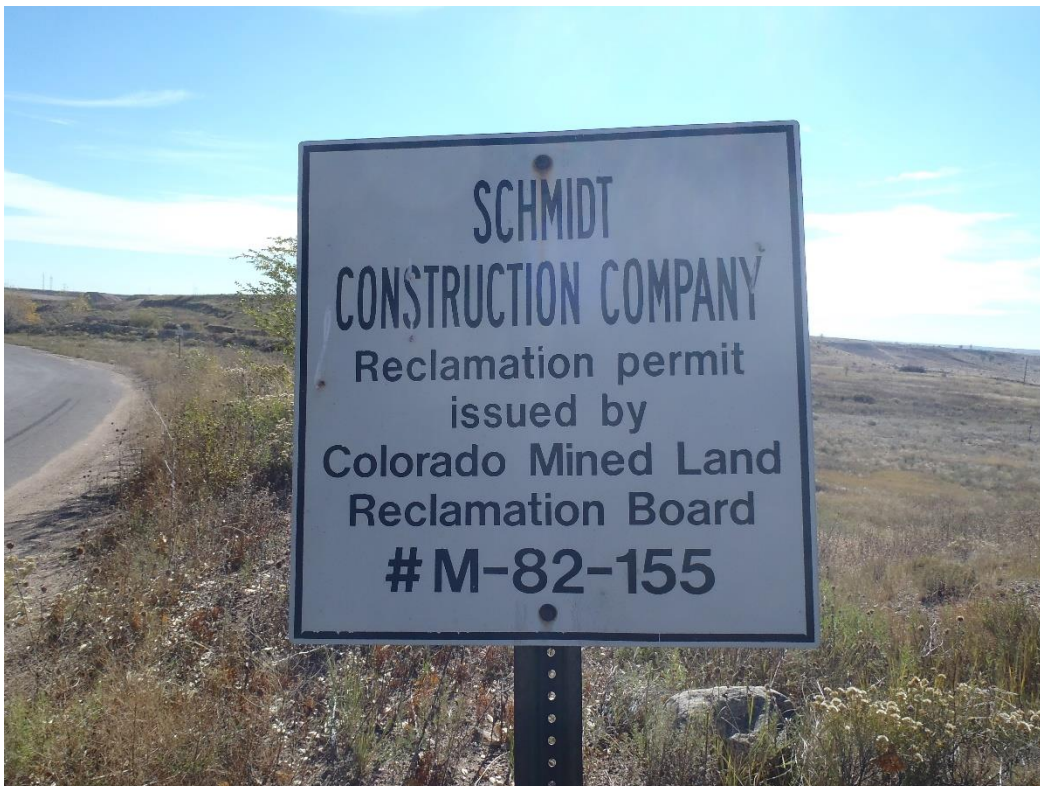
Signs and Markers: The permit sign was properly posted (see **Photo 7**).

Photo 7. Permit sign (at entrance).
