MINERALS PROGRAM INSPECTION REPORT
PHONE: (303) 866-3567

MINE NAME: Mid-Continent LST	MINE/PROSPECTING ID#: M-1982-121	MINERAL: Limestone (general)	COUNTY: Garfield
INSPECTION TYPE: Monitoring	INSPECTOR(S): Amy C. Yeldell	INSP. DATE: November 9, 2017	INSP. TIME: 10:00
OPERATOR: RMR Aggregates, Inc.	OPERATOR REPRESENTATIVE: Bobby Wagner	TYPE OF OPERATION: 112c - Construction Regular Operation	
REASON FOR INSPECTION: Normal I&E Program	BOND CALCULATION TYPE: None	BOND AMOUNT: \$196,181.00	
DATE OF COMPLAINT: NA	POST INSP. CONTACTS: None	JOINT INSP. AGENCY: None	
WEATHER: Clear	INSPECTOR'S SIGNATURE:

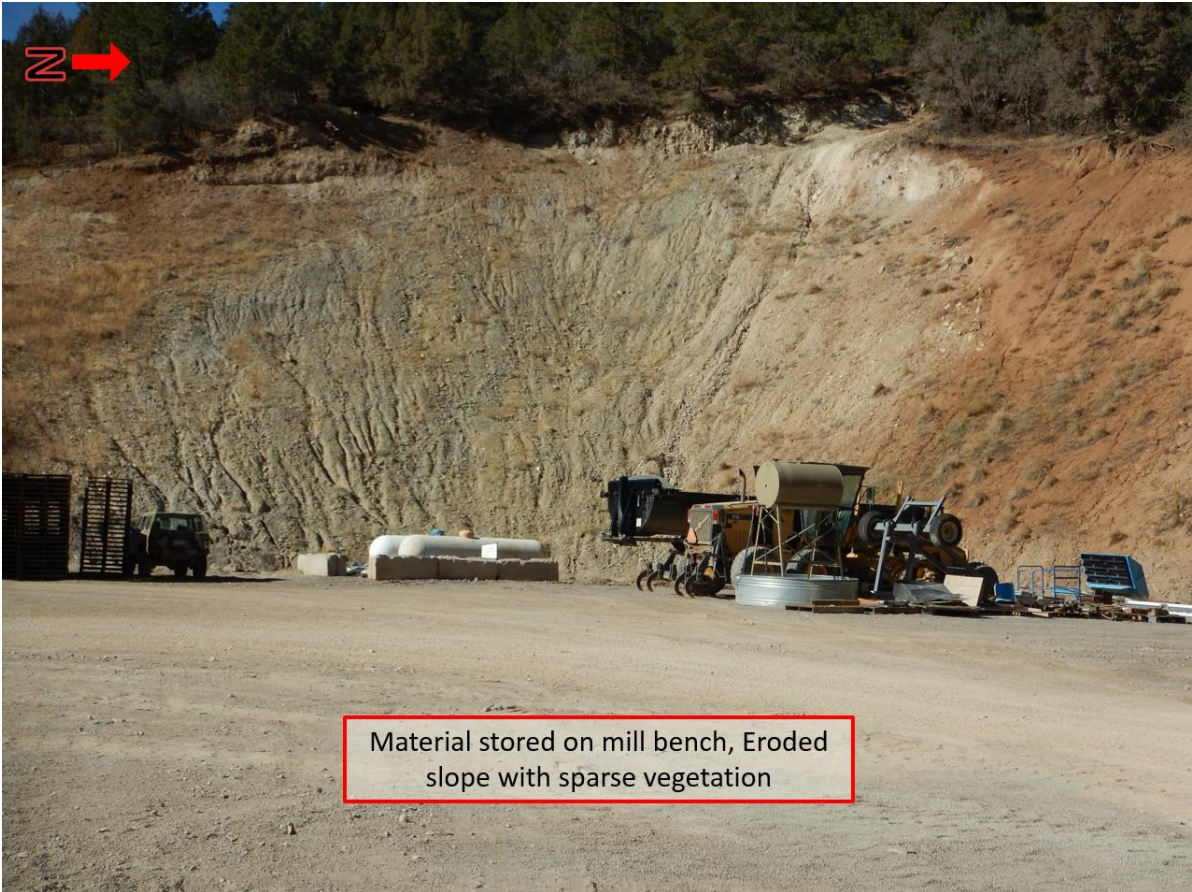
There is excessive riling on the cut slopes adjacent to the laydown yard. It appears that all the sediment stays on the pad however this should be monitored. The slope would benefit from establishing desirable vegetation.

Material stored on mill bench, Eroded slope with sparse vegetation

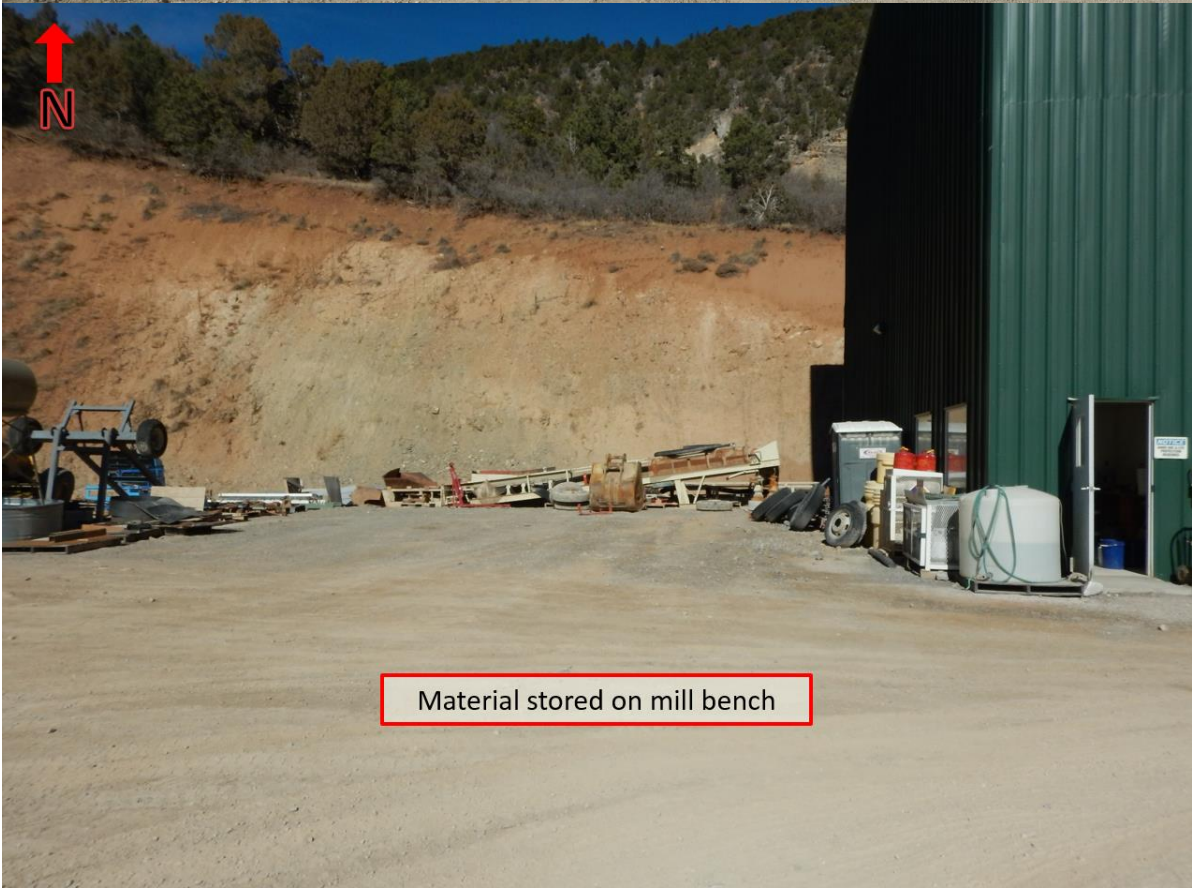
The remnants of the old scale and scale house have been removed. Likewise much of the scrap metal and other debris has been consolidated to the west side of the mill bench. The current scale being used is located adjacent to the office trailer on the mill bench. One fuel tank is located on the mill bench the other is on the production bench. Both of which are properly located within secondary containment. West of the mill building remains used as a laydown yard. Several pallets, a trailer, propane tanks and other debris are stored. This area should be kept orderly and all debris that will not be used for mining should be removed.

Material stored on mill bench

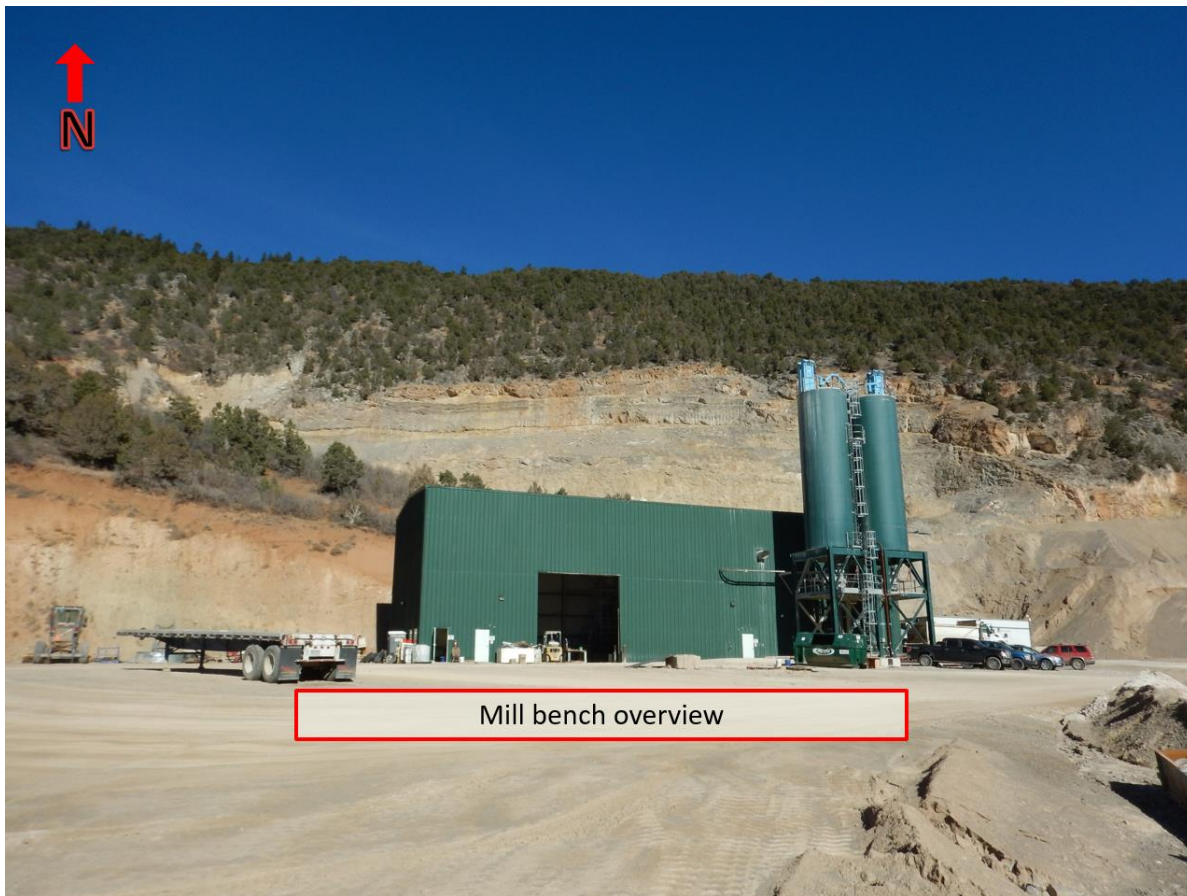
Mill bench overview

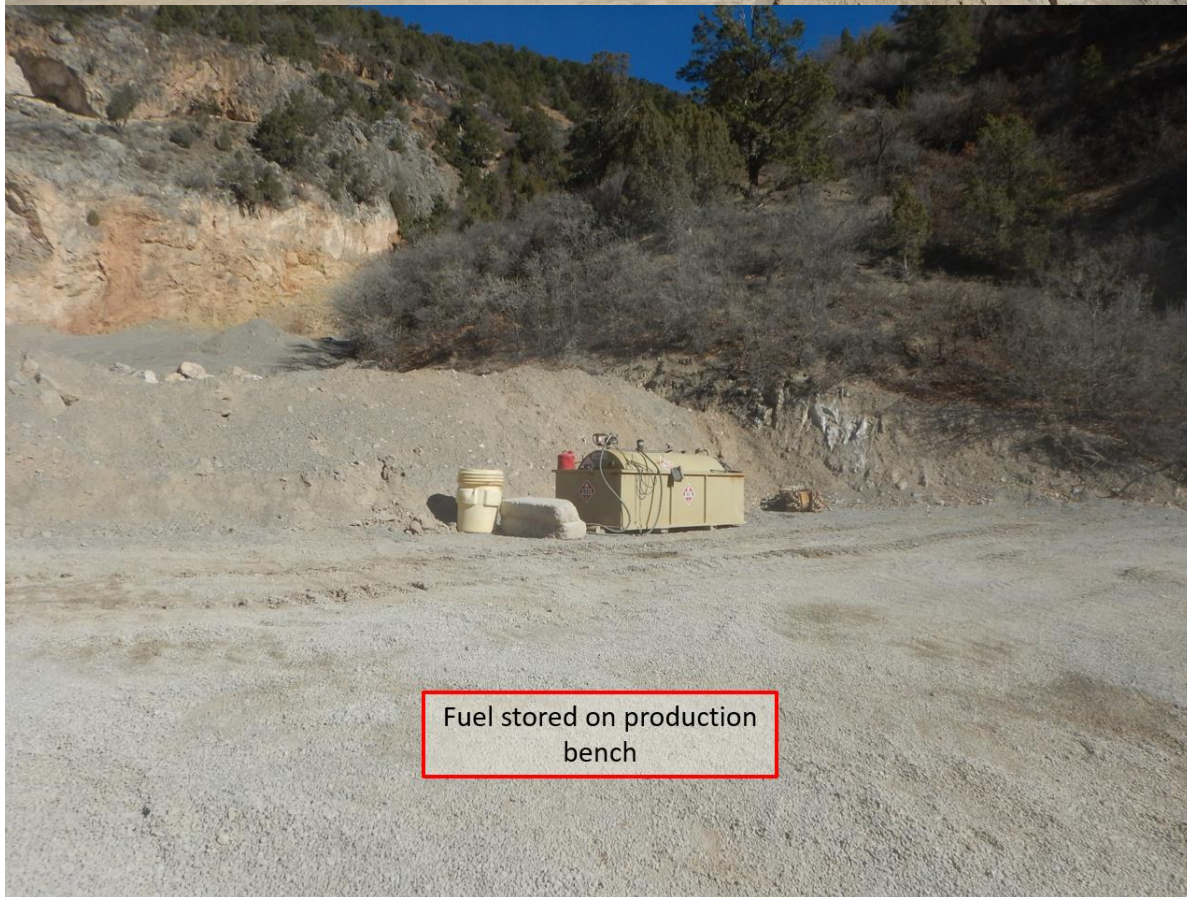
Fuel stored on production
bench

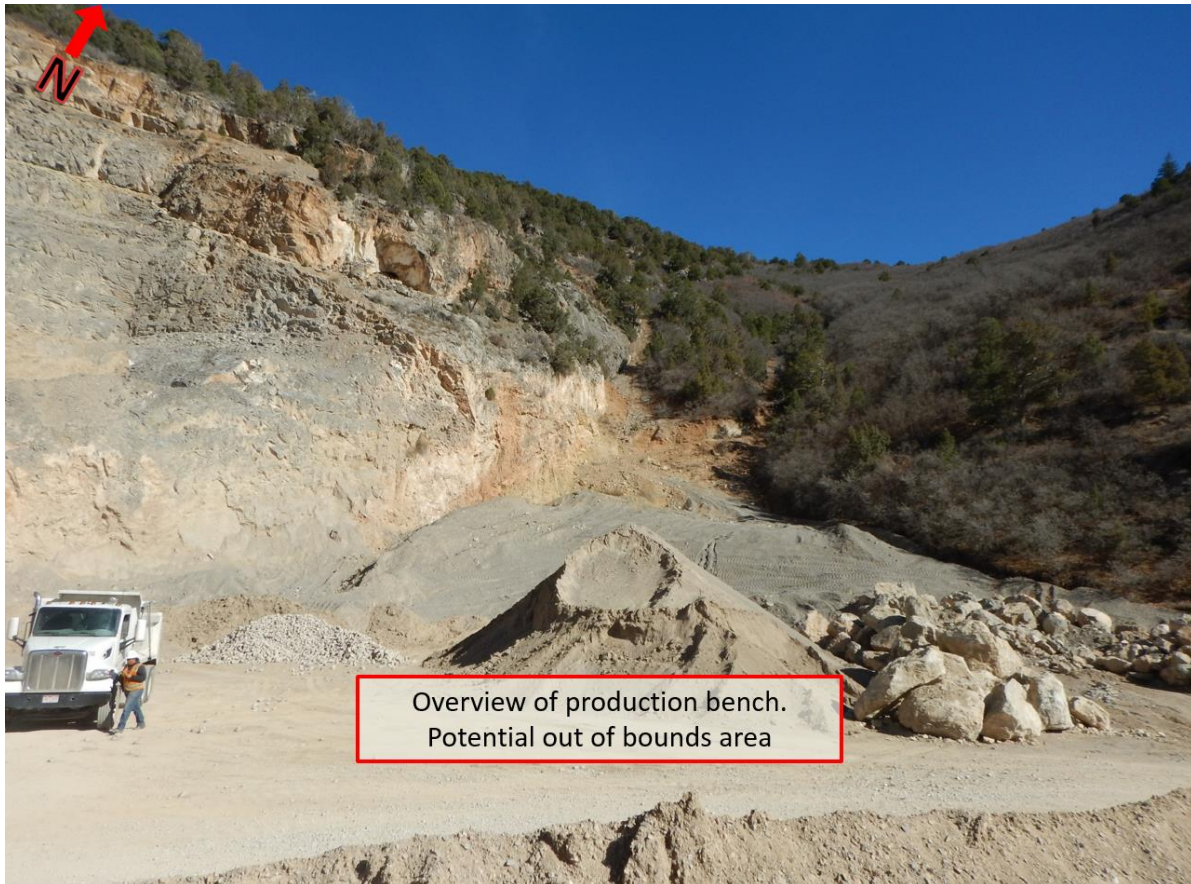
Overview of production bench.
Potential out of bounds area

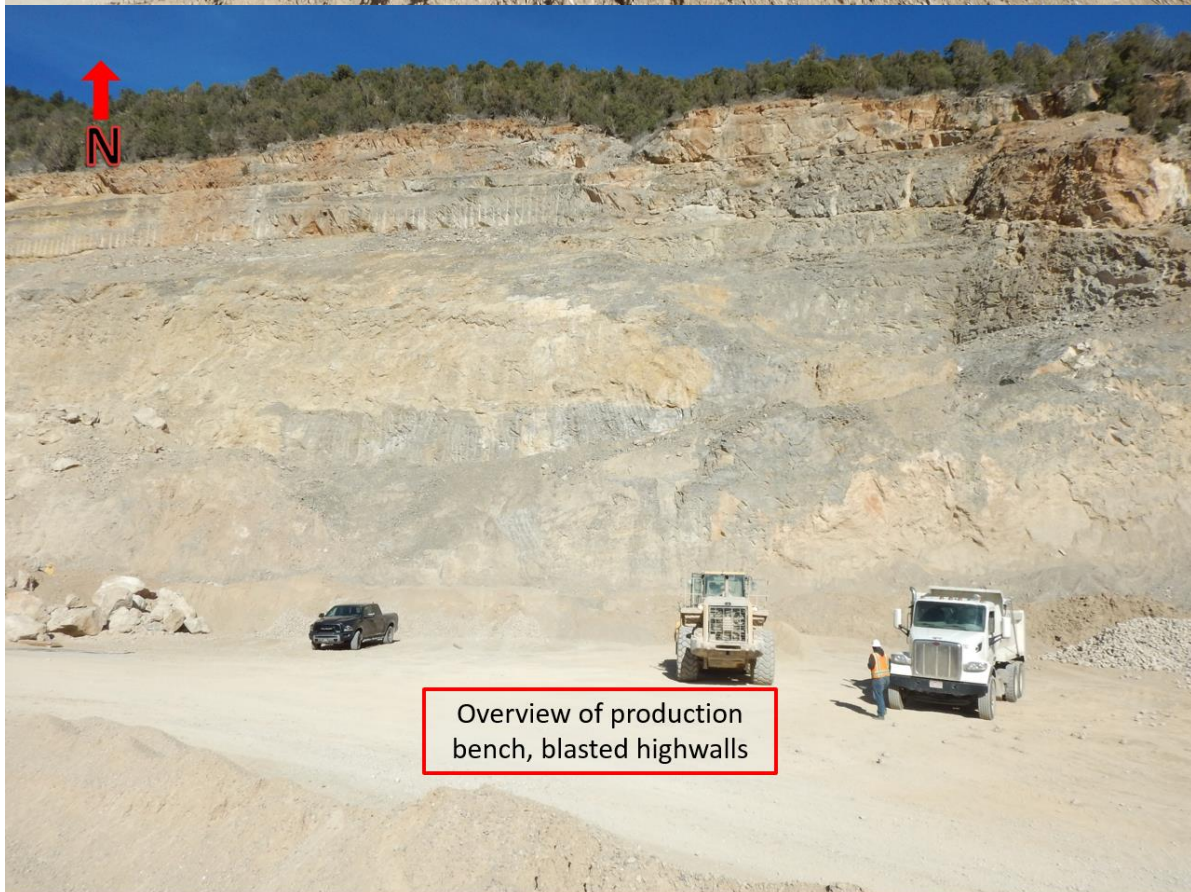
Overview of production
bench, blasted highwalls
