## MINERALS PROGRAM INSPECTION REPORT

<b>MINE NAME:</b> Winkler Light Aggregate Quarry	<b>MINE/PROSPECTING ID#:</b> M-1989-065	<b>MINERAL:</b> Crushed stone material	<b>COUNTY:</b> Douglas
<b>INSPECTION TYPE:</b> Monitoring	<b>INSPECTOR(S):</b> Peter S. Hays	<b>INSP. DATE:</b> November 9, 2017	<b>INSP. TIME:</b> 11:30
<b>OPERATOR:</b> Schmidt Construction Company	<b>OPERATOR REPRESENTATIVE:</b> Mark Heifner	<b>TYPE OF OPERATION:</b> 112c - Construction Regular Operation

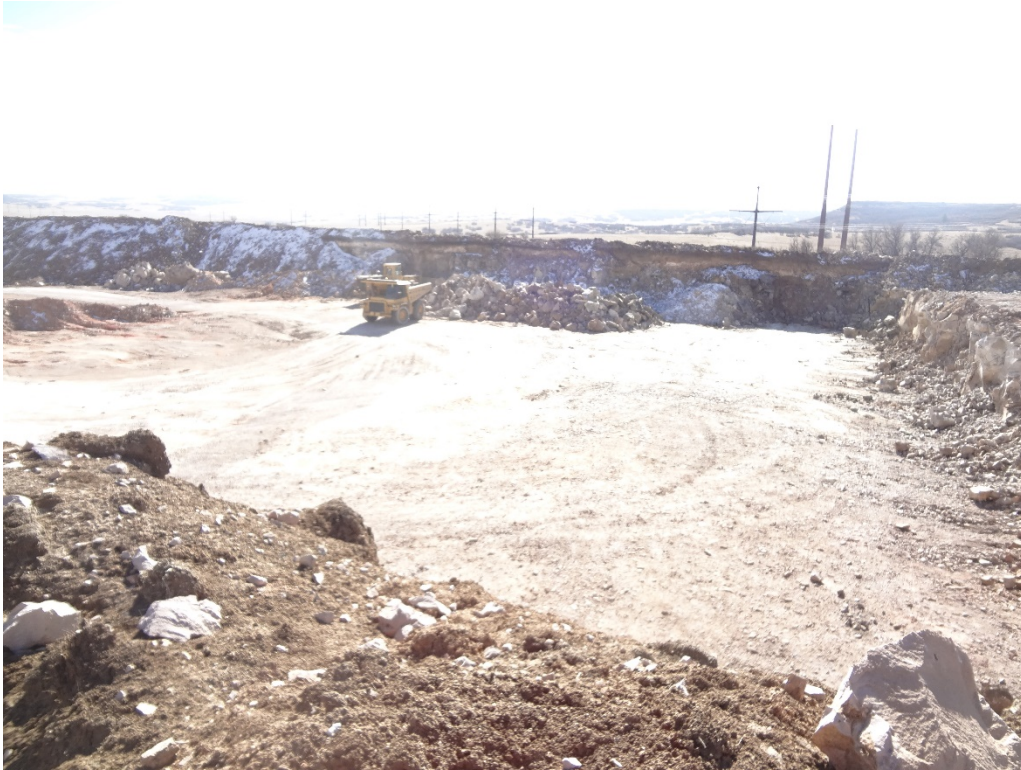
The site was active during the inspection. The 2017 Annual Report and Map submitted by the Operator accurately depicts the status of the site. The disturbance in the main quarry is contained within Phase 1 and Phase 2. The active highwall is progressing toward the southwest corner of Phase 2. Mining extraction will continue in Phase 2 until the 200 foot offset from the overhead powerlines centerline is reached. The Phase 2 south highwall is backfilled concurrently with mining activities for highwall stability.

View of the active excavation along the south boundary in the SW corner of Phase 2

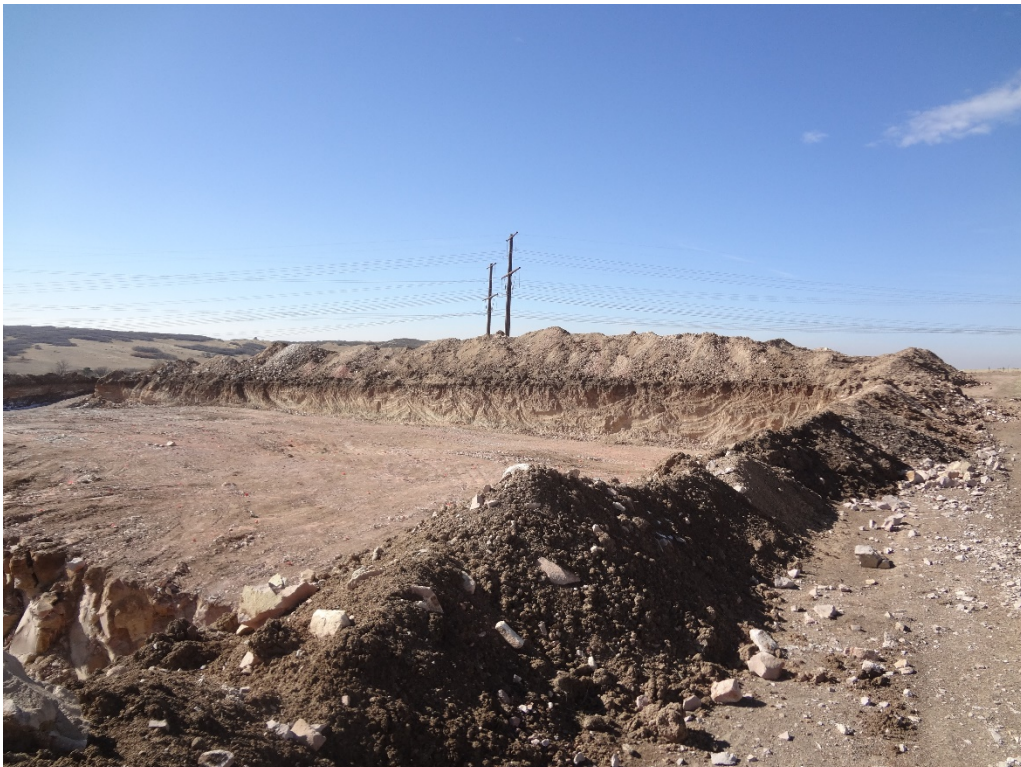
View of the area in Phase 2 prepared for blasting with stripped overburden to the west

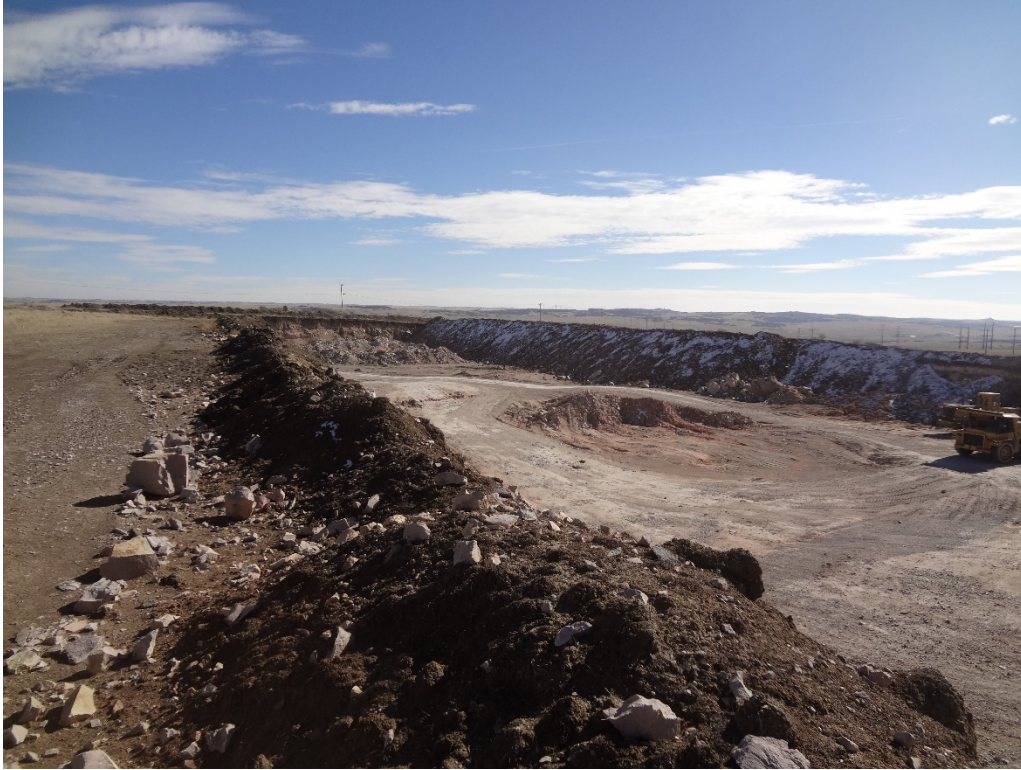
View of the backfilled south highwall in Phase 2

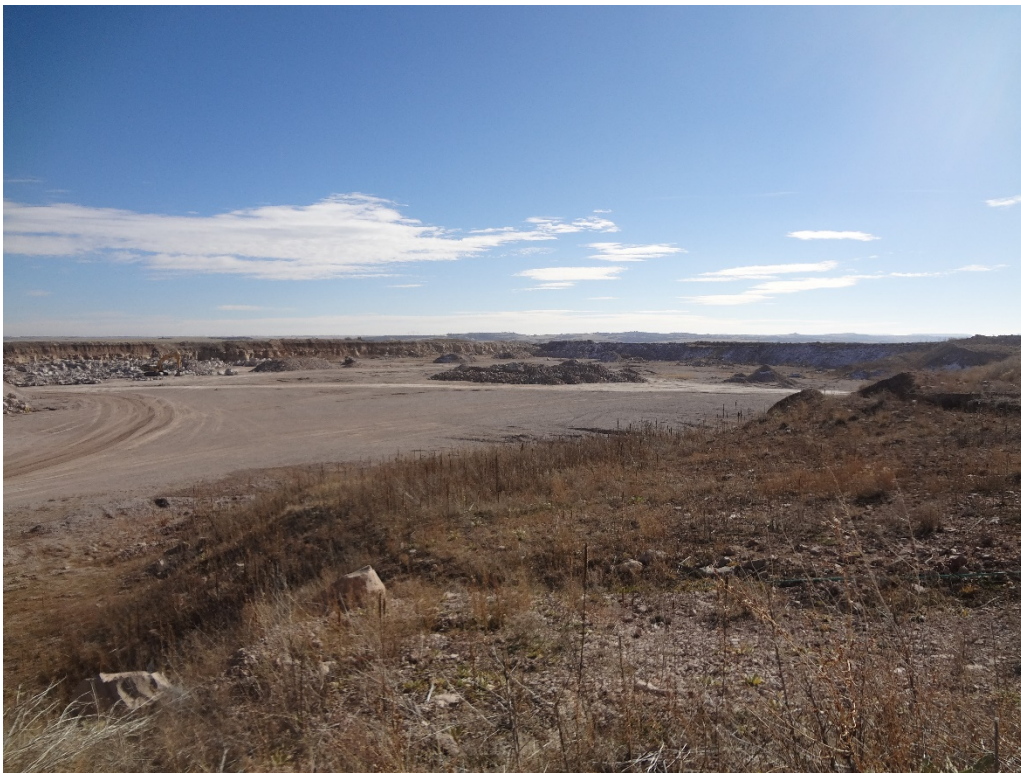
View of the south end of Phase 2 from the access road looking southeast

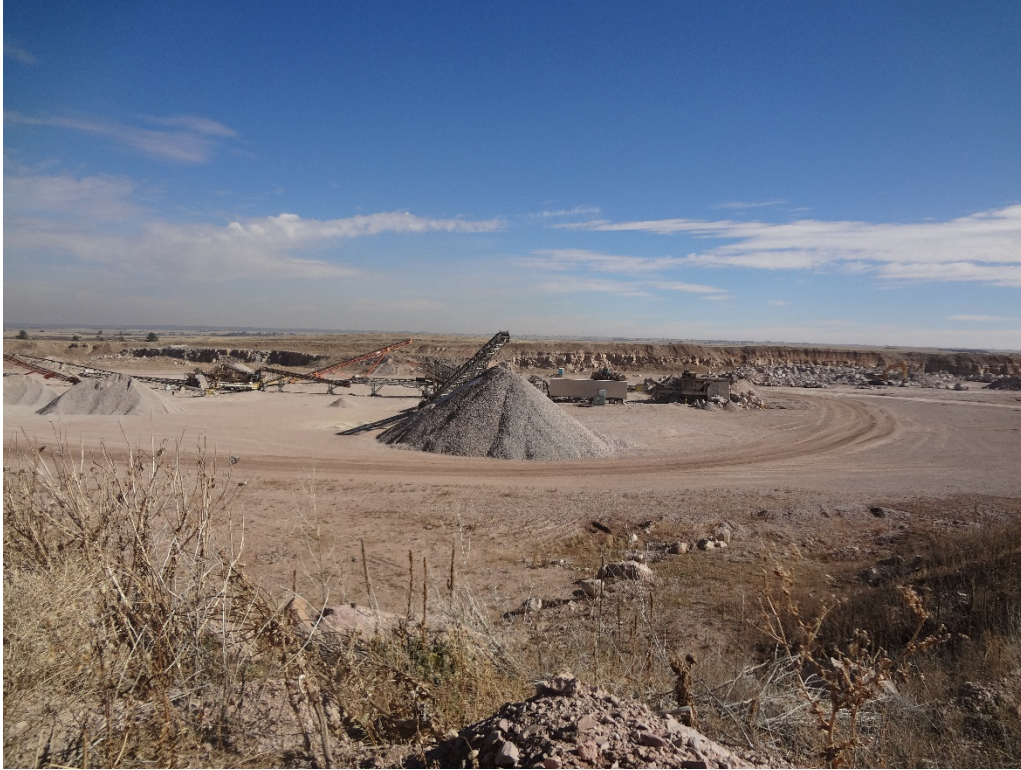
View of processing area in the main pit from the access road looking east

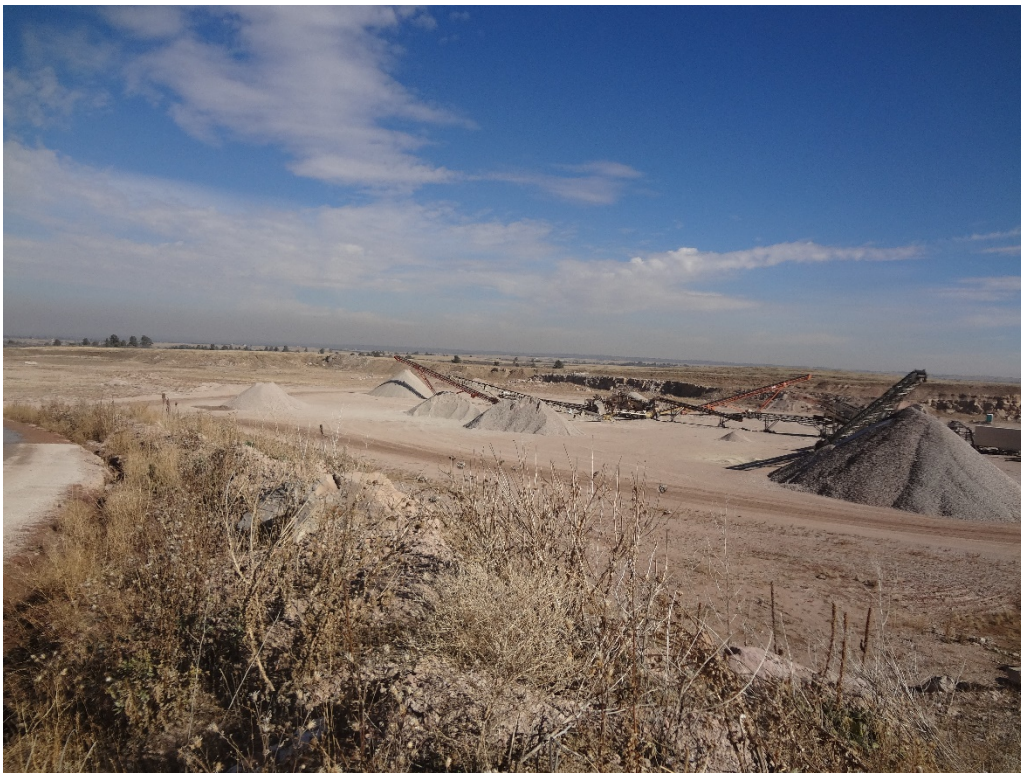
View of processing area in the main pit from the access road looking northeast

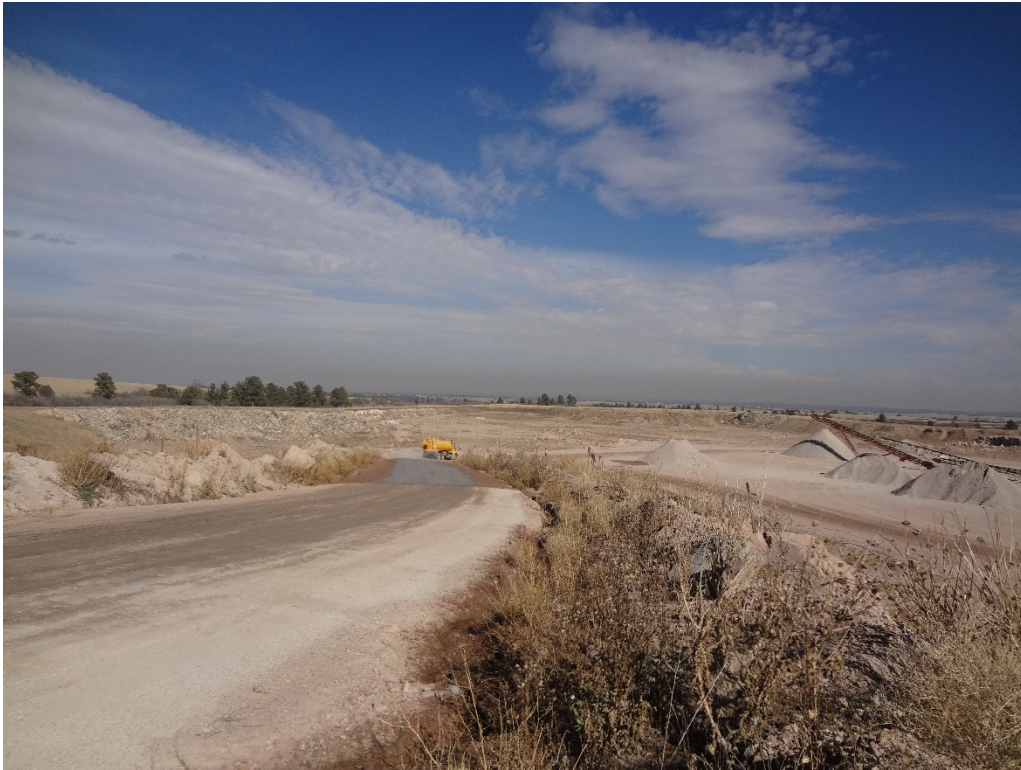
View of the north end of Phase 1 from the access road looking northeast

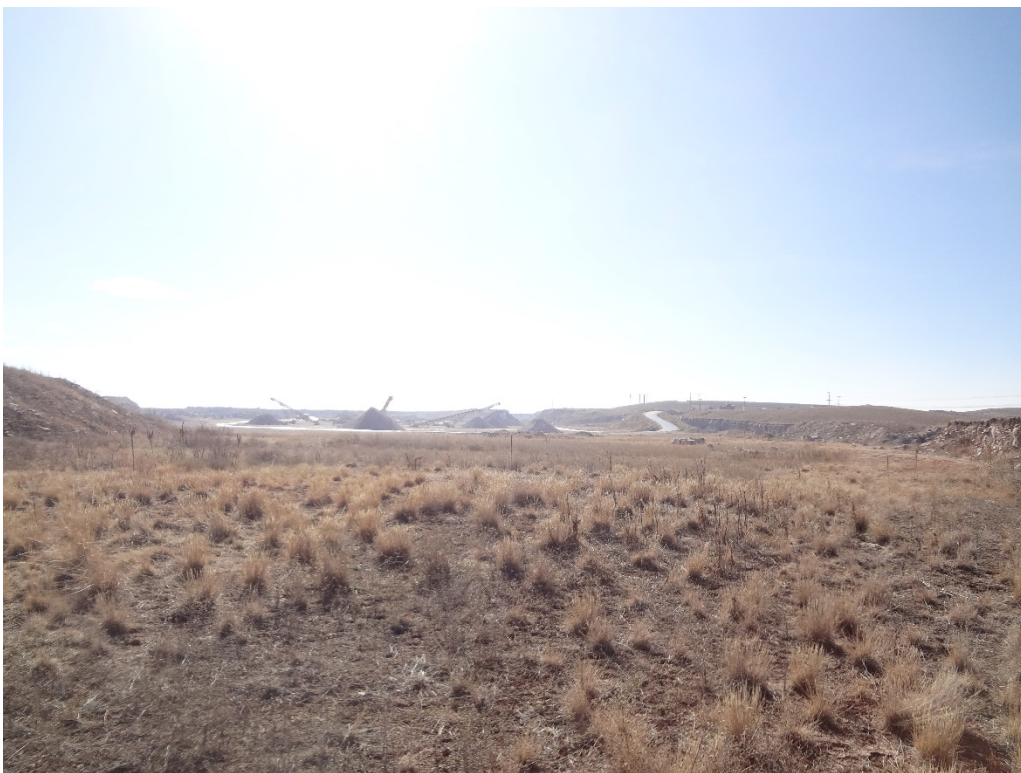
The approved post-mining land use is rangeland. The mining excavation is backfilled to original grade following the removal of the rhyolite. Backfill operations were observed in the southeast corner of Phase 2. The north portion of Phase 1 was released by the Division in 2013. The active reclamation area south of the release area was inspected to observe the current status of reclamation. The area appeared stable and the reclamation vegetation was establishing well with occasional areas lacking vegetation. Topsoil and overburden were stripped separately ahead of the active highwall in Phase 2. Well-vegetated stockpiles of topsoil were observed north and south of the office and on the east side of Phase 1 and 2 at the boundary with Phase 3.

View of the active reclamation area in the north end of Phase 1 looking south
