MINERALS PROGRAM INSPECTION REPORT
PHONE: (303) 866-3567

MINE NAME: Stevens Clay Lease	MINE/PROSPECTING ID#: M-1996-064	MINERAL: Clay (general)	COUNTY: Douglas
INSPECTION TYPE: Monitoring	INSPECTOR(S): Peter S. Hays	INSP. DATE: November 9, 2017	INSP. TIME: 10:00
OPERATOR: The Denver Brick Company	OPERATOR REPRESENTATIVE: Rob Tibbetts, Steve Helzer	TYPE OF OPERATION: 112c - Construction Regular Operation	
REASON FOR INSPECTION: Normal I&E Program	BOND CALCULATION TYPE: Partial Bond	BOND AMOUNT: \$148,000.00	
DATE OF COMPLAINT: NA	POST INSP. CONTACTS: None	JOINT INSP. AGENCY: None	
WEATHER: Clear	INSPECTOR'S SIGNATURE:

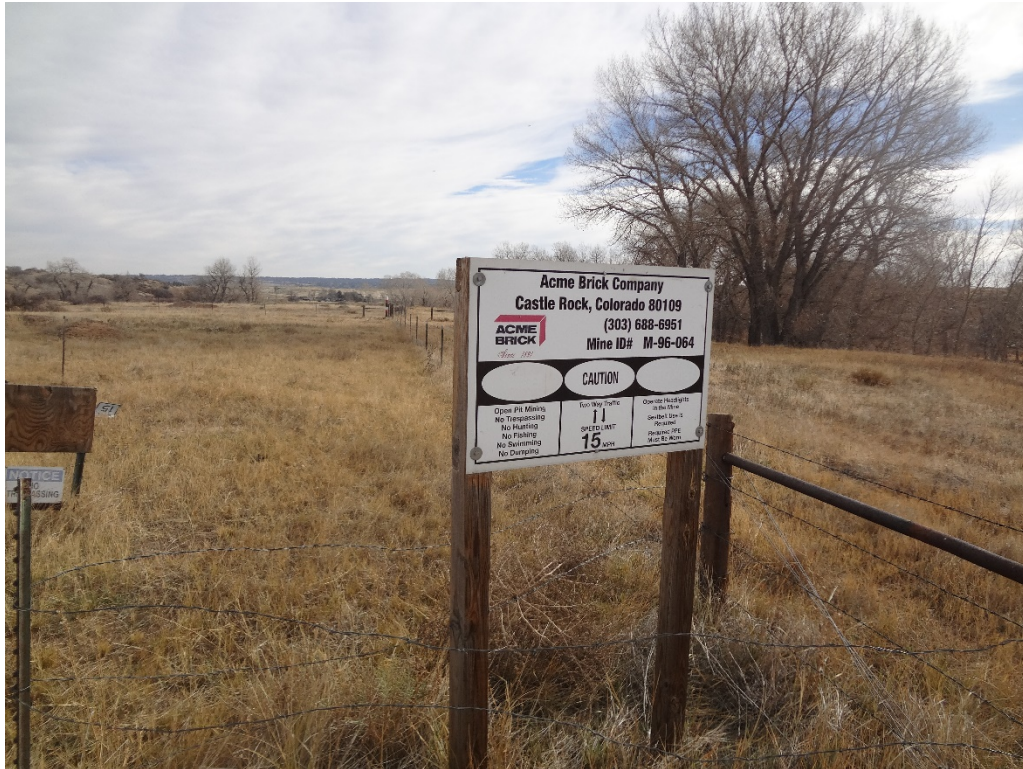
The site is an 112c Construction Materials permit for 40.20 total acres with 20.80 acres of disturbance. The Division currently holds a financial warranty in the amount of \$148,000.00, which appears adequate to reclaim the current site disturbance. A mine sign and boundary markers were observed as required by Rule 3.1.12. The mine sign was posted at the entrance to the mine site, instead of on the access gate off of Crowfoot Valley Road. A mine sign should be added or the current sign should be moved to the start of the access road off of Crowfoot Valley Road by the Operator.

Stevens Clay Lease mine sign at entrance to the pit

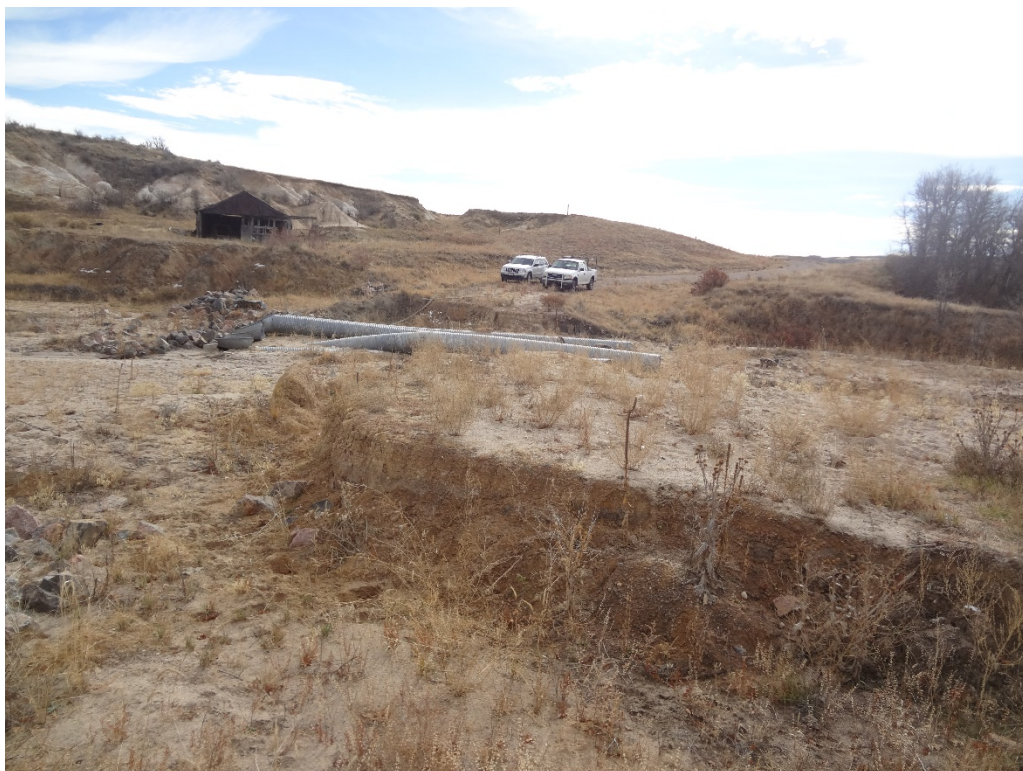
The site was inactive during the inspection. The access road to the site was damaged during a flood event at the Lemon Gulch crossing in 2015. The Operator plans to repair the crossing within the next year before the next mining activity at the site. The site was last mined in 2016 by utilizing an existing ranch road with the permission of the landowner.

View of flood damaged access road crossing at Lemon Gulch looking south

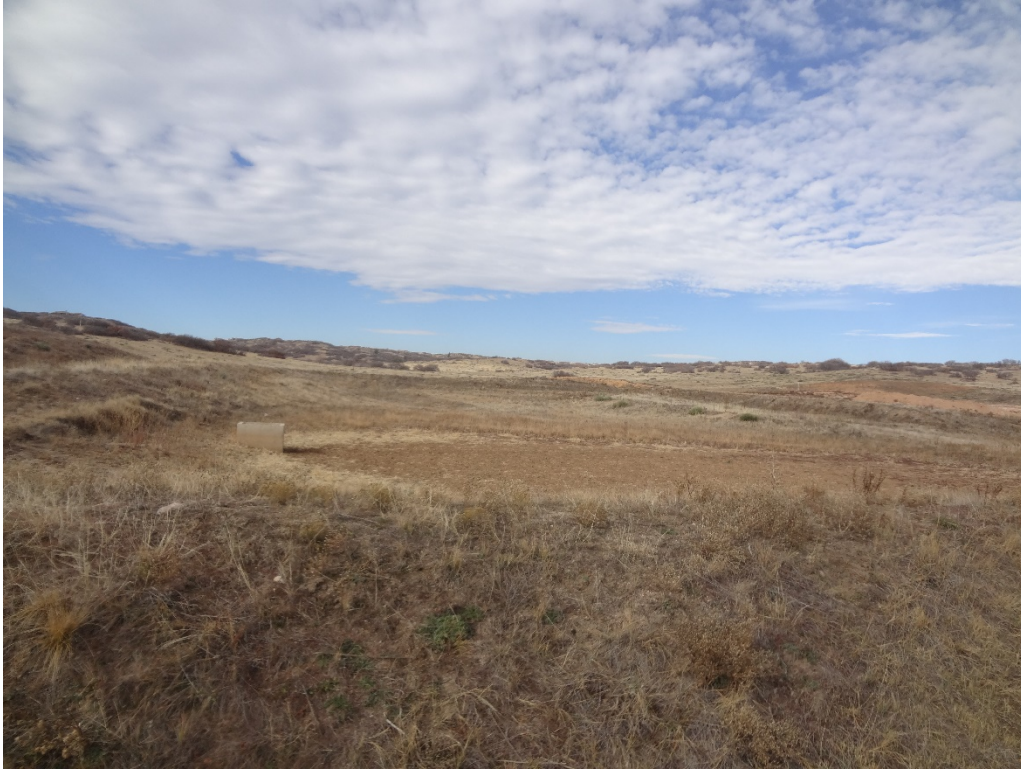
The mining activity is progressing from the east to west. The required 50 foot offset from the east boundary was confirmed during the inspection. The stormwater detention pond and outlet were observed in the southeast corner of the site. The detention pond was dry at the time of the inspection. The southeast corner of the pit contained stormwater during the inspection. The Operator stated the stormwater is pumped to the detention pond during mining operations. The eastern boundary highwall was partially backfilled at a 3H:1V slope. The Division estimated 325 feet of highwall from the southeast corner of the pit remain to be backfilled by the Operator. The highwall height was estimated at 10 feet. The approved Mine Plan states the maximum pit depth at 45 feet. The Operator stated the next mining activity will occur at an 80 foot offset from the eastern boundary. A stockpile area containing two small stockpiles was located in the southwest corner of the site. The pit floor contained numerous erosion rills and small gullies. The erosion features were contained within the permitted area and all of the features drained into the pit.

View of stormwater detention pond located in the SE corner of the site looking west

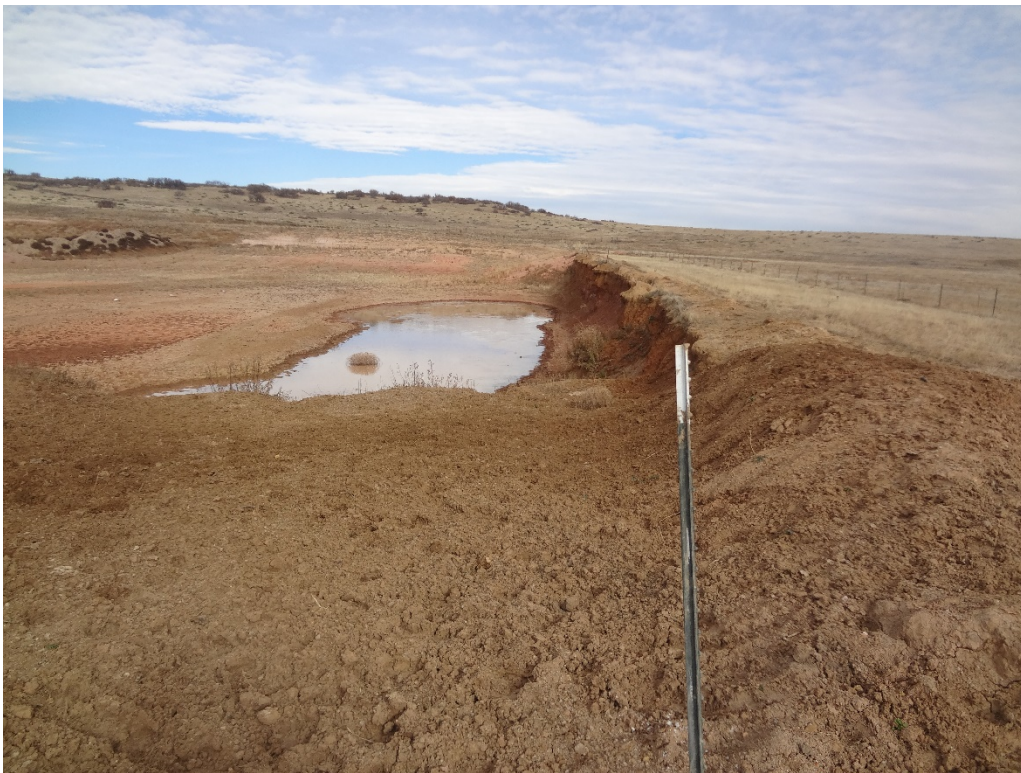
View of the eastern boundary highwall from the SE corner of the site looking north

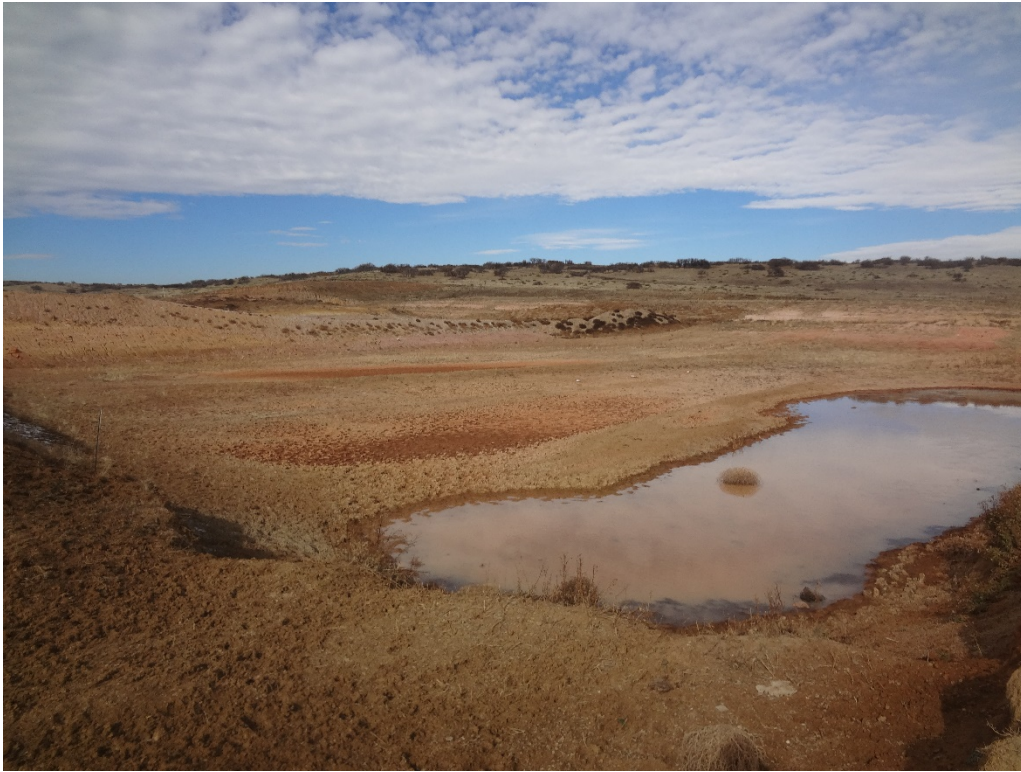
View of the eastern pit from the SE corner of the site looking NW

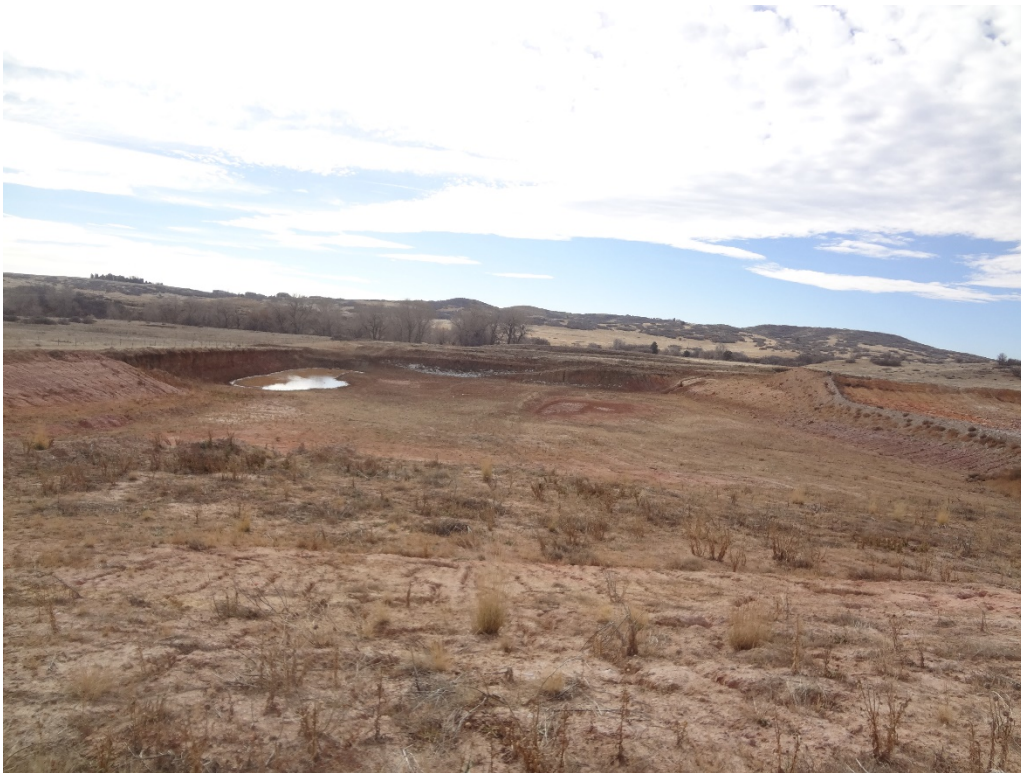
View of the eastern pit from the overburden stockpile looking south

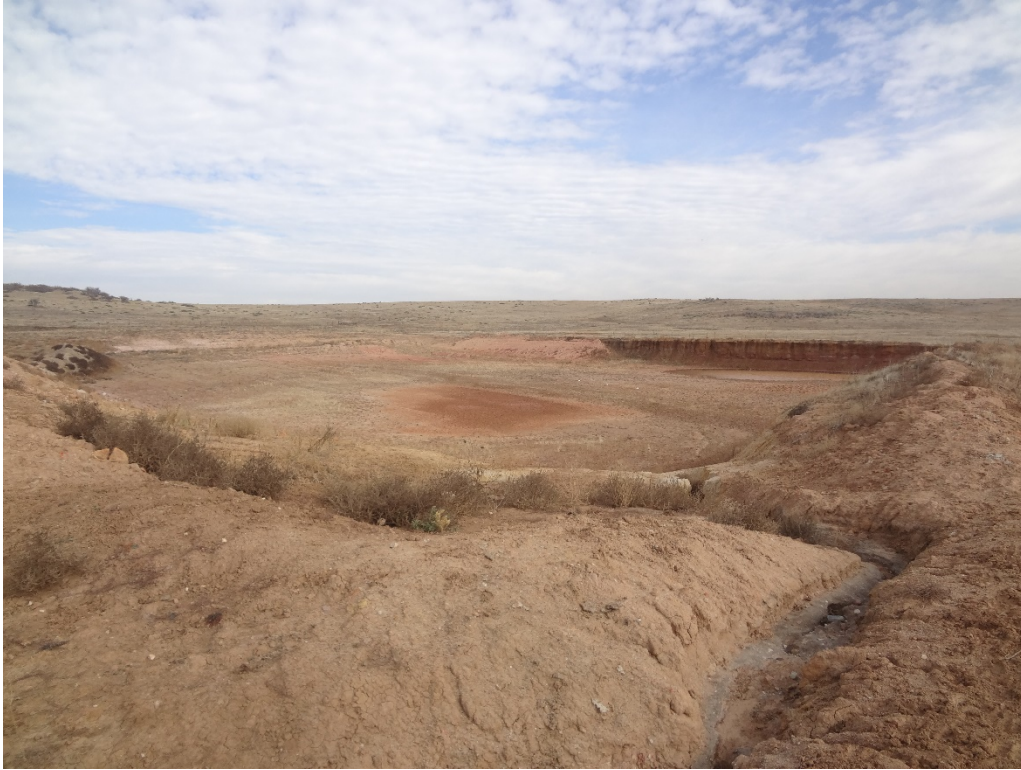
View of the eastern pit from the SW corner of the pit looking NE
