MINERALS PROGRAM INSPECTION REPORT
PHONE: (303) 866-3567

MINE NAME: Kiowa Clay Mine	MINE/PROSPECTING ID#: M-2007-009	MINERAL: Clay (general)	COUNTY: Elbert
INSPECTION TYPE: Monitoring	INSPECTOR(S): Peter S. Hays	INSP. DATE: November 15, 2017	INSP. TIME: 09:30
OPERATOR: The Denver Brick Company	OPERATOR REPRESENTATIVE: Rob Tibbetts, Steve Helzer	TYPE OF OPERATION: 112c - Construction Regular Operation	
REASON FOR INSPECTION: Normal I&E Program	BOND CALCULATION TYPE: Partial Bond	BOND AMOUNT: \$244,932.00	
DATE OF COMPLAINT: NA	POST INSP. CONTACTS: None	JOINT INSP. AGENCY: None	
WEATHER: Clear	INSPECTOR'S SIGNATURE:

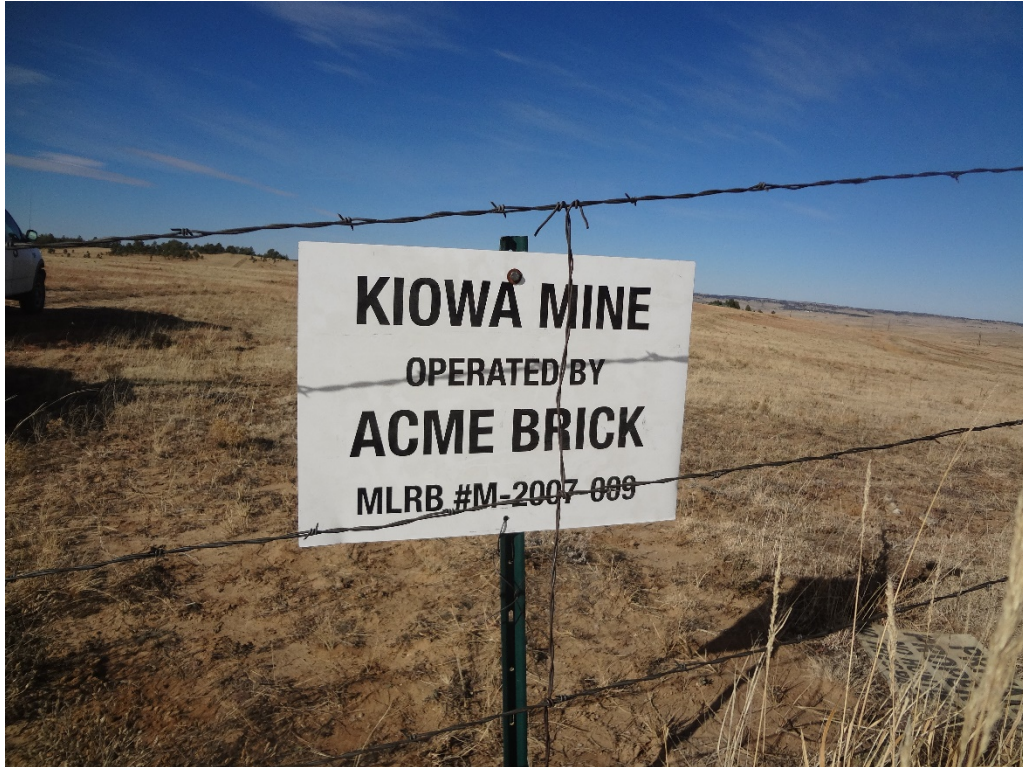
The site is an 112c Construction Materials permit for 400 total acres with 92 acres of planned mining and processing/stockpile area disturbance. The Division currently holds a financial warranty in the amount of \$244,932.00. A mine sign and boundary markers were observed as required by Rule 3.1.12.

Kiowa Mine sign

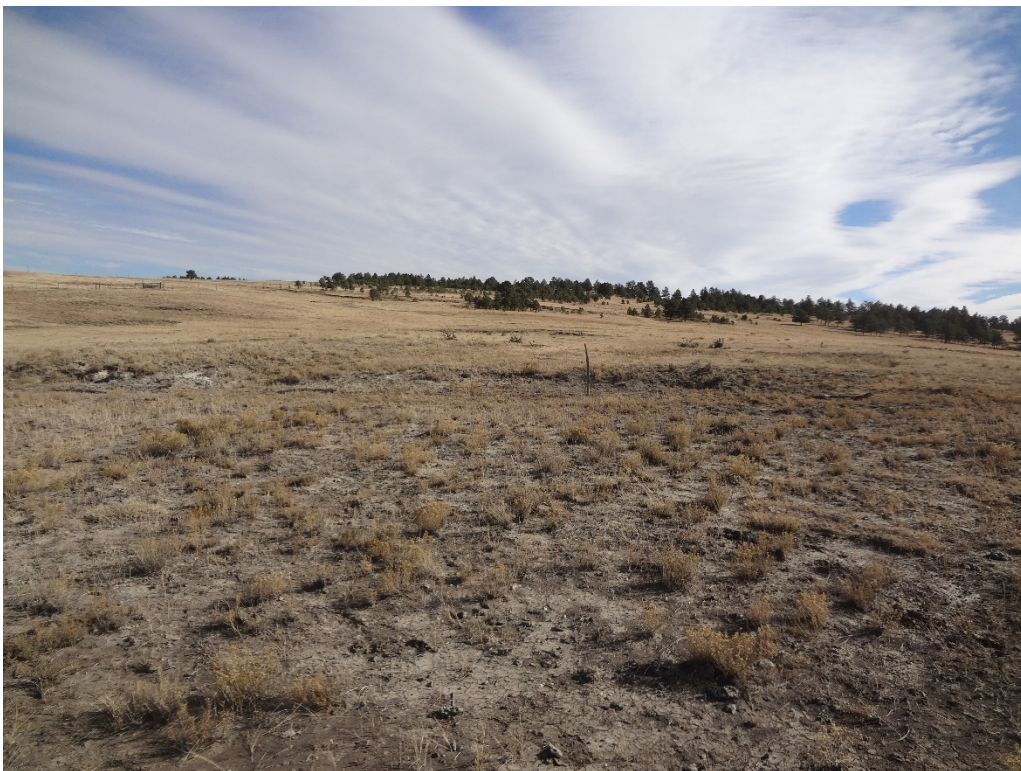
View of the site from the northwest corner looking southeast

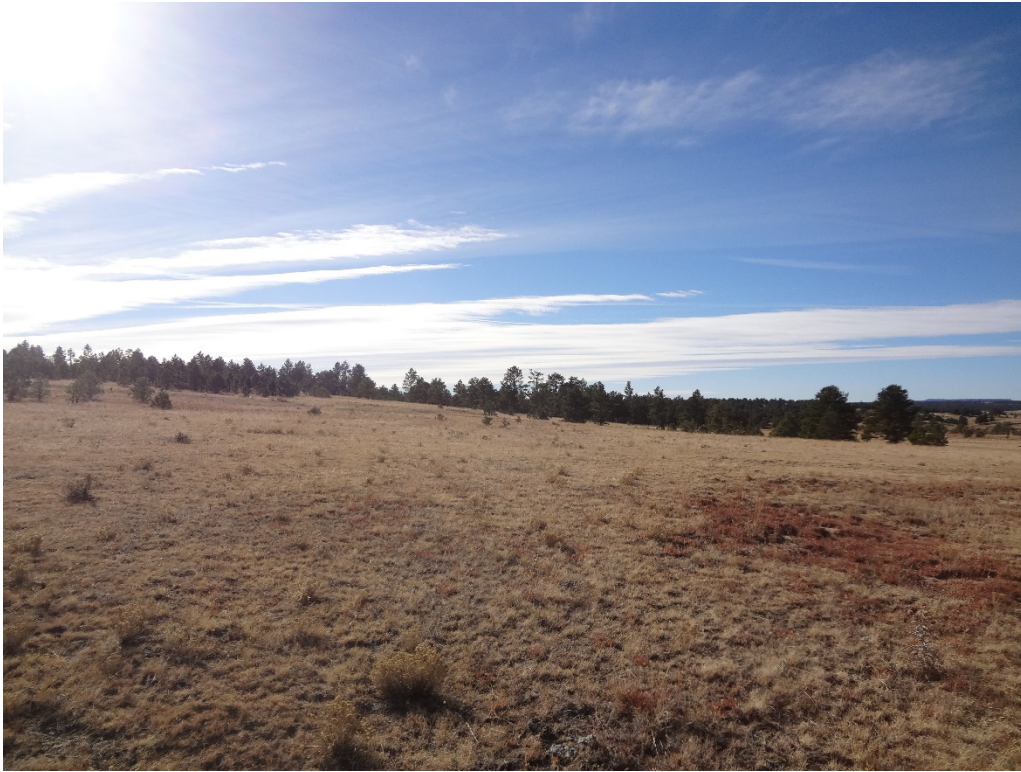
View of the site from the northeast corner looking south

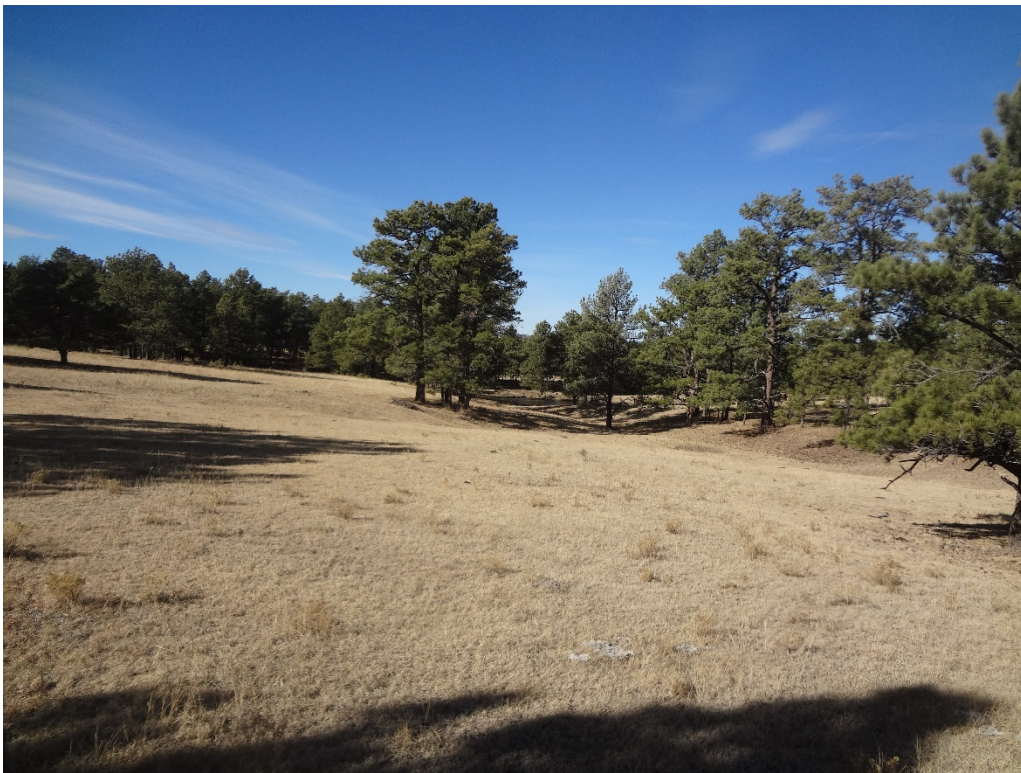
View of the site from the southeast corner looking northwest
