COLORADO
Division of Reclamation,
Mining and Safety
Department of Natural Resources

Permit Number: C-1981-035 Mine Name: King Coal Mine Operator: GCC Energy, LLC Operator Address: Mr. Tom Bird 6473 County Road 120 Hesperus, CO 81326	County: La Plata Operation Type: Underground Permit Status: Active Ownership: Federal
	Operator Representative Present: None
Operator Representative Signature: (Field Issuance Only)

Inspection Start Date: November 27, 2017 Inspection Start Time: 15:00 Inspection End Date: Inspection End Time:	Inspection Type: Aerial Inspection Inspection Reason: Normal I&E Program Weather: Clear
Joint Inspection Agency: None	Joint Inspection Contacts:
Post Inspection Agency: None	Post Inspection Contacts:
Inspector(s): Harry B. Ranney	Inspector's Signature:

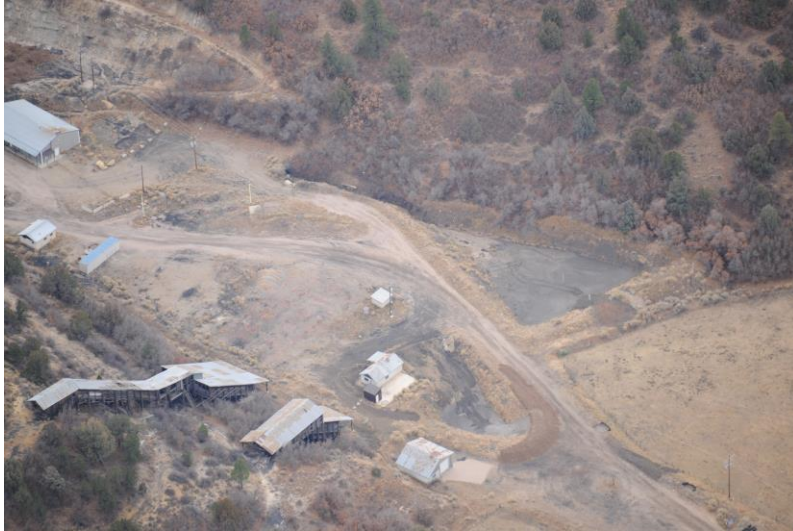
At the King I Mine, the West Pond and East Pond were dry. The pasture below the pond spillways showed no sign of discharges from the ponds in recent weeks. The photographs show that work has been done on both King I ponds, and GCC has confirmed that primary spillways were replaced at both ponds (per Tom Bird email). Also, material has been added to the embankment of the East Pond. All of this work has been performed to make the ponds meet the specifications in the PAP designs.

King I – lower area with improvements of ponds

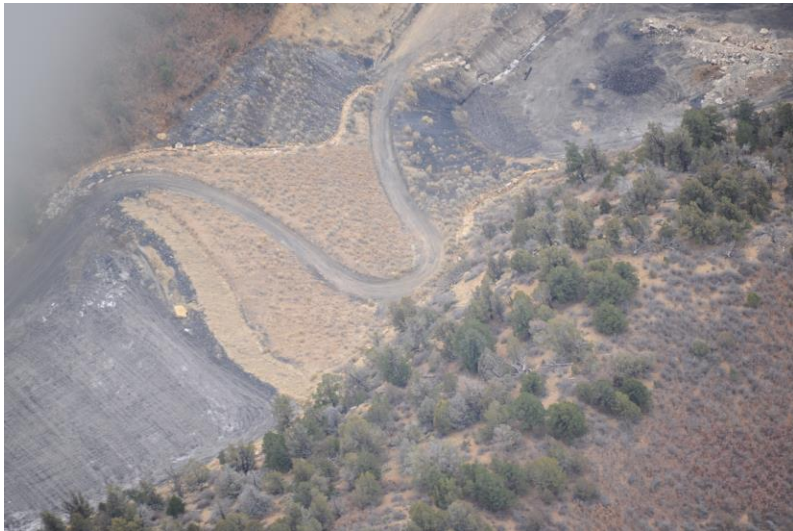
The Refuse Pile was inspected, and no slumps, erosion, or other problems were seen. It appears that the project to add material to the toe of the Refuse Pile has not progressed, presumably because GCC is awaiting lab results for the material that they will use.

Refuse Pile at King I

Piles of soil and waste on the King I facilities area need to be placed on the Refuse Pile, either on the upper portion (active portion of the Refuse Pile) or the lower portion where GCC needs to lessen the slope of the pile.

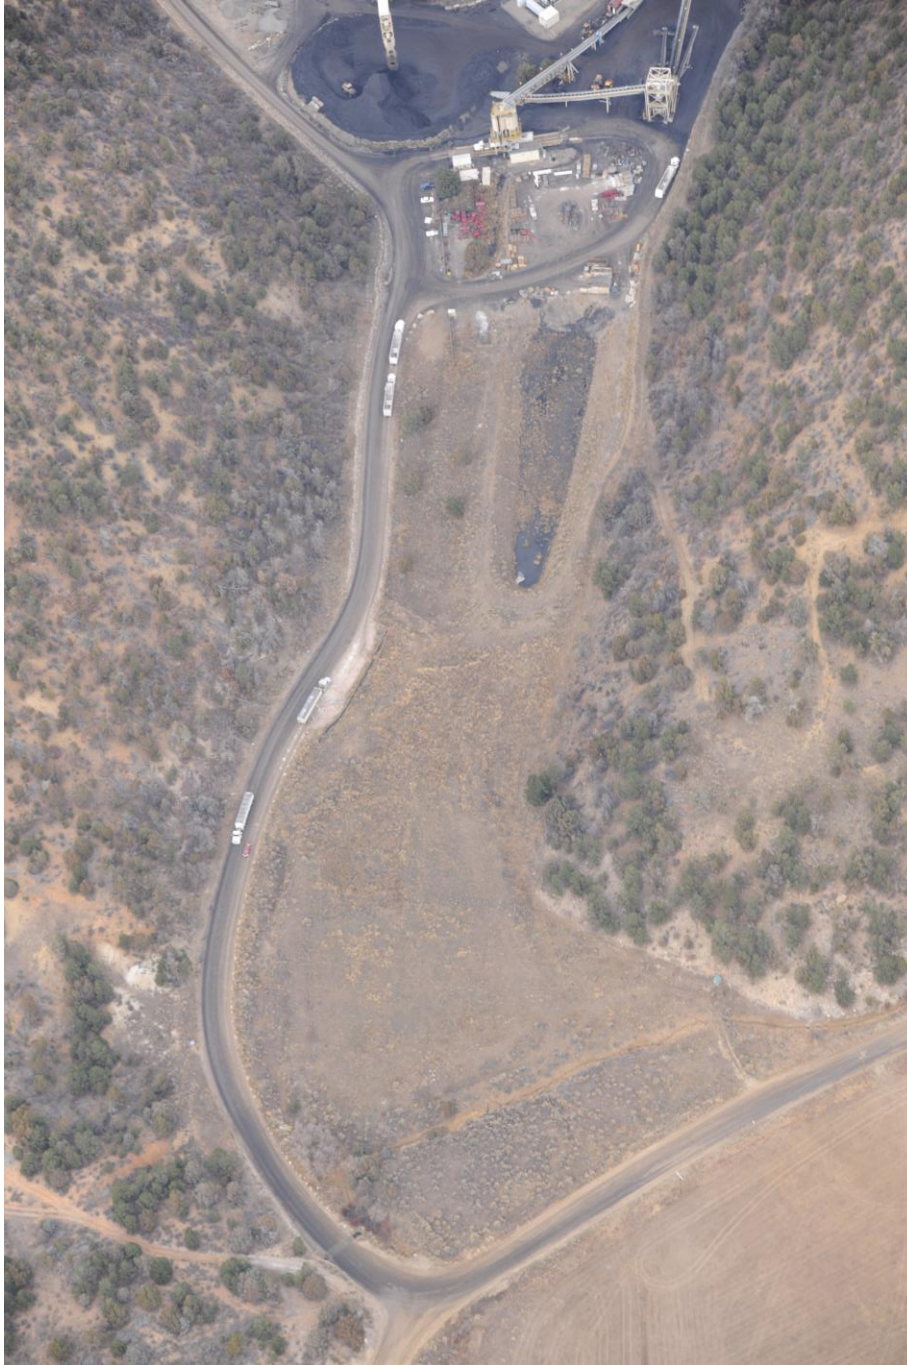
The King II pond was holding no water. No issues were found with the embankment.

The silt fence southwest of the King II pond appears to be functioning well since there are no signs of sediment loading below this BMP.

King II – lower portion

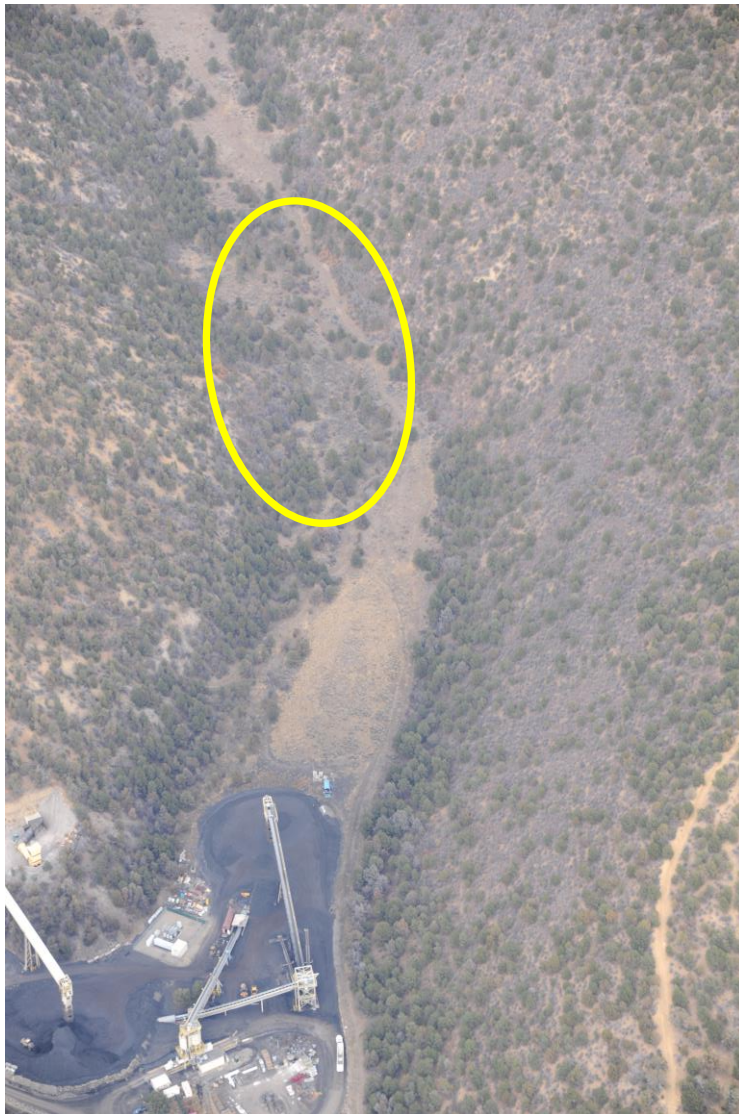
No issues were seen with the vegetation reference area northeast of the King II facilities area.

No problems were seen with the Topsoil Stockpiles at King II. They appear to be well vegetated, and there are no signs that the soil has been transported off the piles by runoff.

**King II – facilities, topsoil pile, and vegetation reference area
(reference area is within yellow oval)**
