**MINERALS PROGRAM INSPECTION REPORT**  
**PHONE: (303) 866-3567**

<b>MINE NAME:</b> Worthing Pit	<b>MINE/PROSPECTING ID#:</b> M-1977-526	<b>MINERAL:</b> Sand and gravel	<b>COUNTY:</b> Adams
<b>INSPECTION TYPE:</b> Monitoring	<b>INSPECTOR(S):</b> Jared L. Ebert	<b>INSP. DATE:</b> November 9, 2017	<b>INSP. TIME:</b> 09:30
<b>OPERATOR:</b> Albert Frei & Sons Inc.	<b>OPERATOR REPRESENTATIVE:</b> Ben Frei and Steve O'Brian	<b>TYPE OF OPERATION:</b> 112c - Construction Regular Operation	
<b>REASON FOR INSPECTION:</b> Normal I&E Program	<b>BOND CALCULATION TYPE:</b> None	<b>BOND AMOUNT:</b> \$230,800.00	
<b>DATE OF COMPLAINT:</b> NA	<b>POST INSP. CONTACTS:</b> None	<b>JOINT INSP. AGENCY:</b> None	
<b>WEATHER:</b> Clear	<b>INSPECTOR'S SIGNATURE:</b>

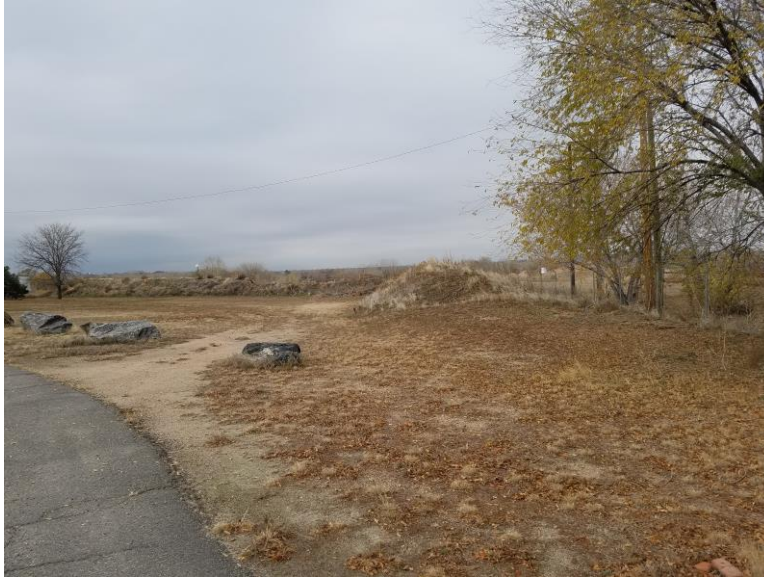
1.) By a verbal agreement between the Operator and Mrs. Russell, a berm was constructed on Mrs. Russell's property between their home and the processing facilities/mining operation to the west and between their home and the mine entrance to the north. According to Mr. Russell, it was agreed the Operator would remove the berm once the crusher was removed from the mine's property. Mr. Russell indicated the Operator now refuses to remove the berm.

Since the complaint was received by the Office, it appears Mr. Russell and Mr. Frei have agreed the berm will be removed. According to Mr. Russell, they signed a statement indicating they wished the berm was removed and sent it to the Operator. After speaking with Ben Frei, he indicated once he gets the signed statement requesting the berm's removal, they would remove the berm. At the time of the inspection, it appears part of the berm had been removed by the Operator. The berm is about 15 feet in height with steep side slopes and partially vegetated with annual weeds. The majority of the berm was located on the Russell's property with the remainder within the Worthing Pit's permit area.

**Figure 1. Northeast corner of Russell property looking west at the berm.**

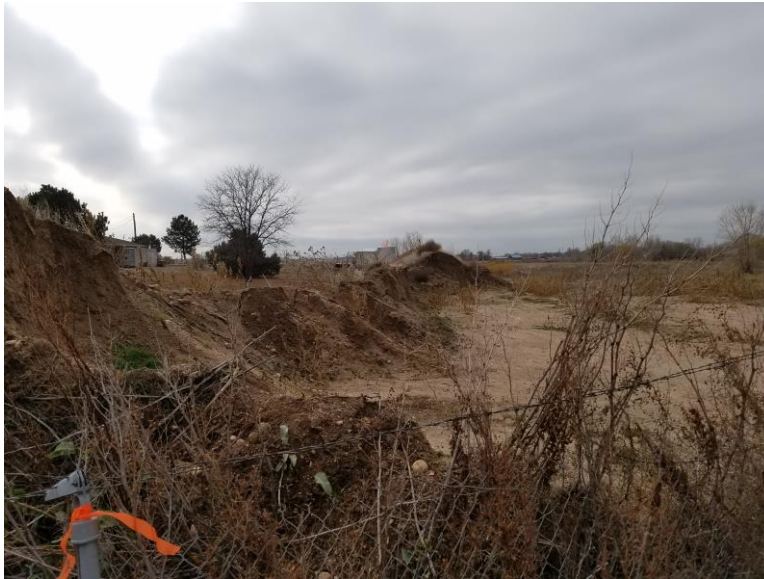
**Figure 2. Northwest corner of the berm partially removed.**

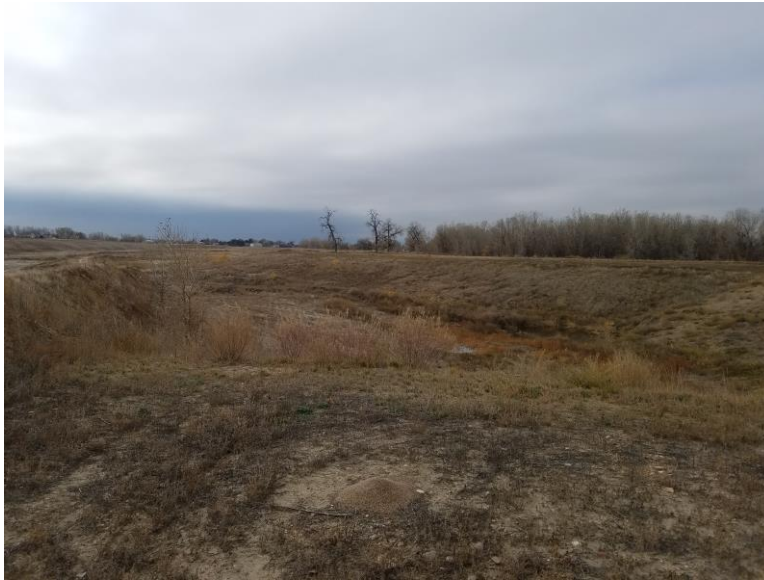
Figure 3. South Expansion Area reservoir from the north end looking southwest.

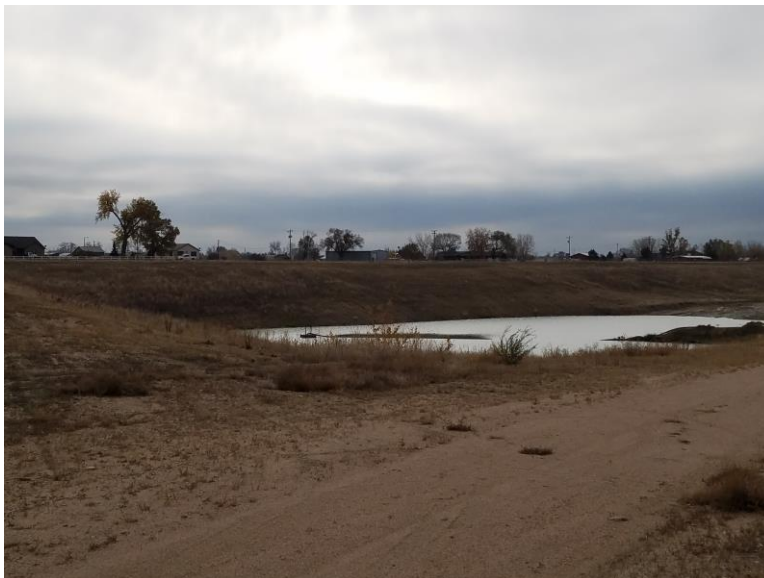
Figure 4. South Expansion Area reservoir from the north end looking southeast.

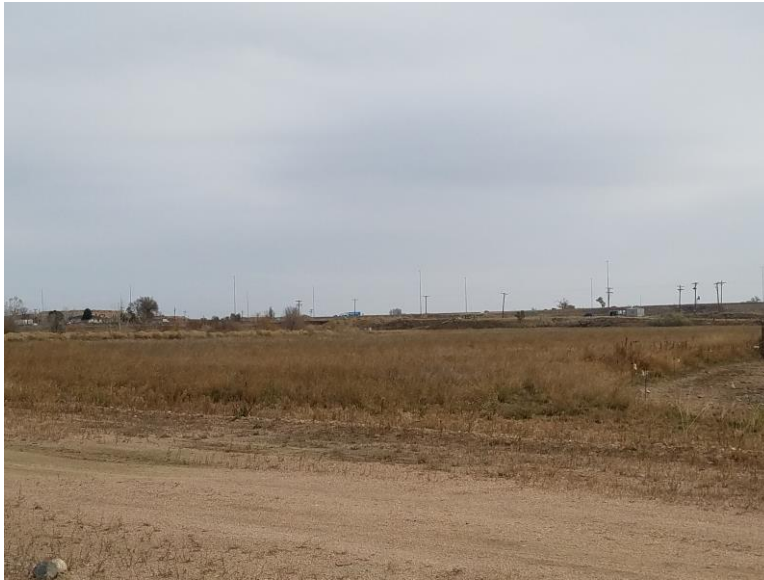
Portions of both the North and South Expansion Area have been backfilled, graded and revegetated with a mixture of grasses and Alfalfa. These areas are depicted on the 2017 Annual Report Map. These area appear stable and well vegetated.

Figure 5. North end of South Expansion Area, reclaimed.

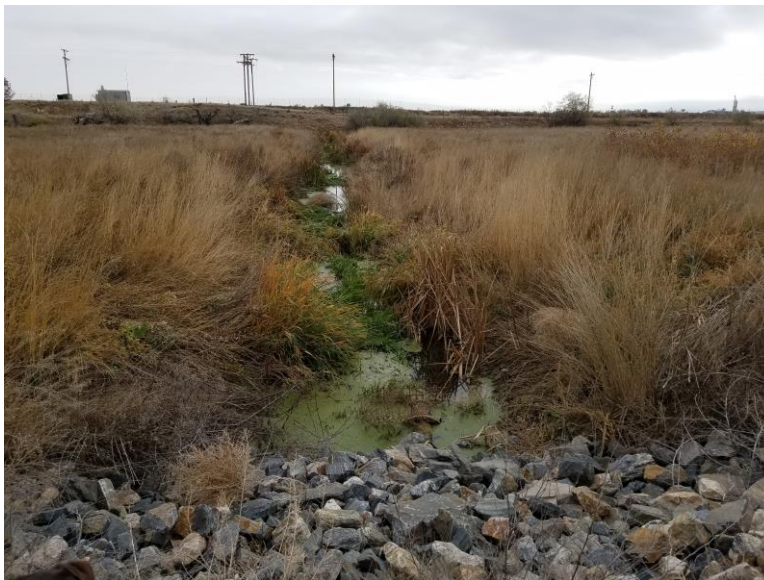
The groundwater drain installed in the South Expansion Area was observed. This drain appears to be functioning and water was flowing and discharging into the South Platte River.

Figure 6. Groundwater drain.

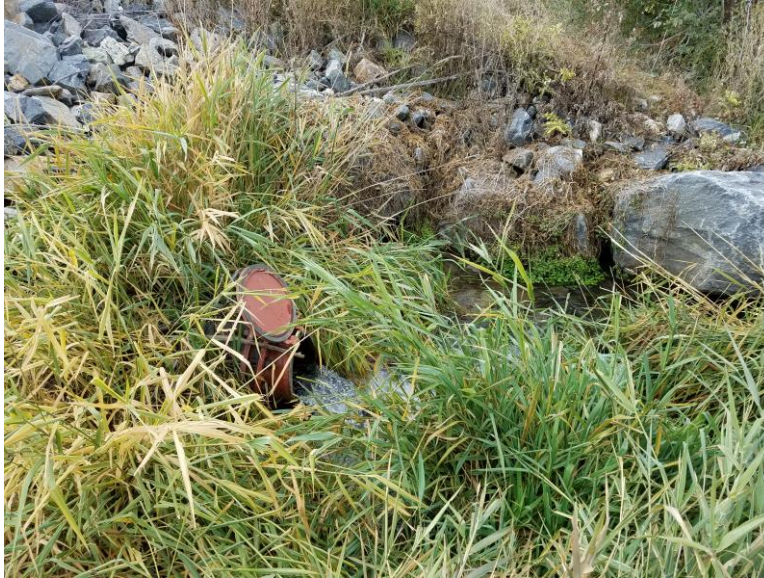
**Figure 7. Groundwater drain discharge.**

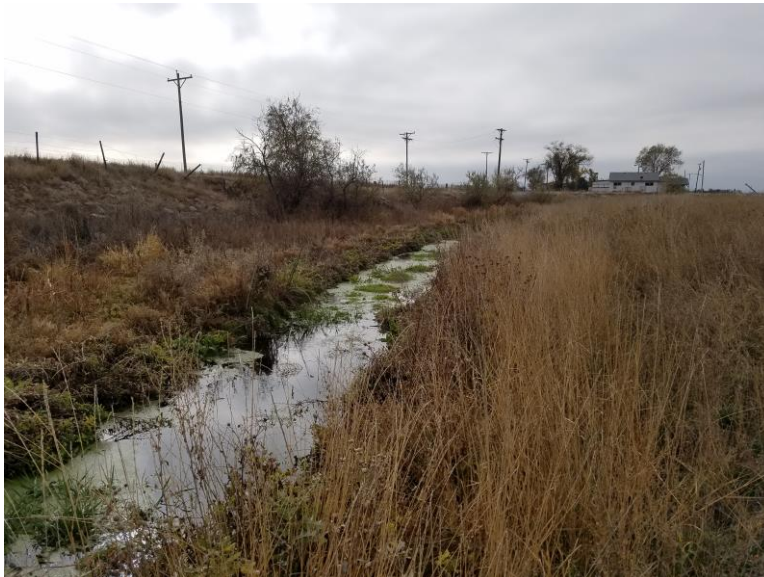
**Figure 8. Groundwater drain.**

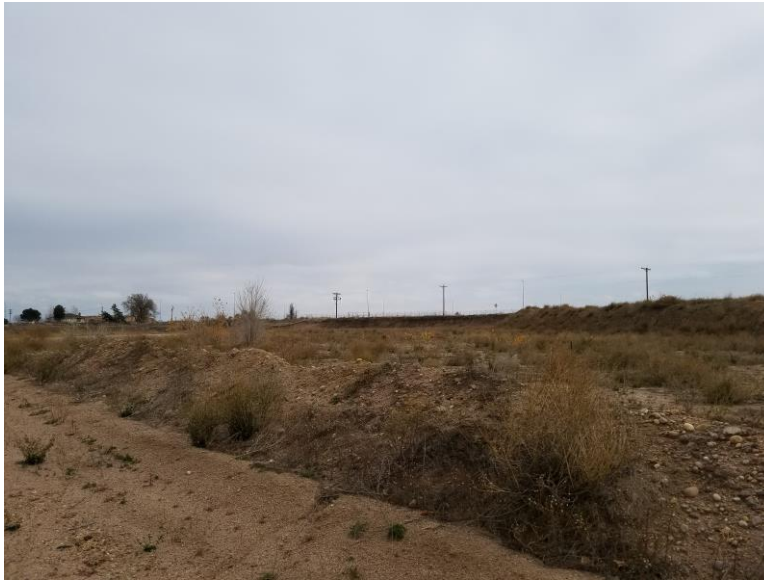
Figure 9. From the south end of the North Expansion Area looking northeast.

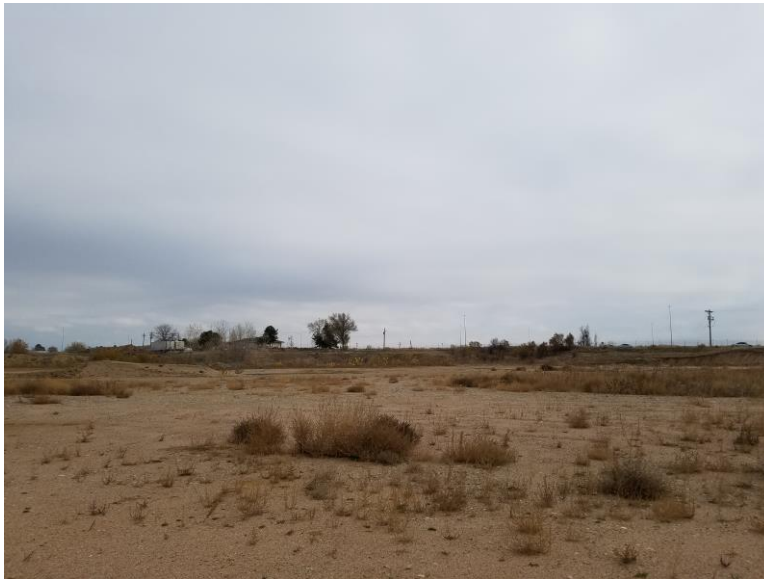
Figure 10. From the middle of the North Expansion Area looking northeast.

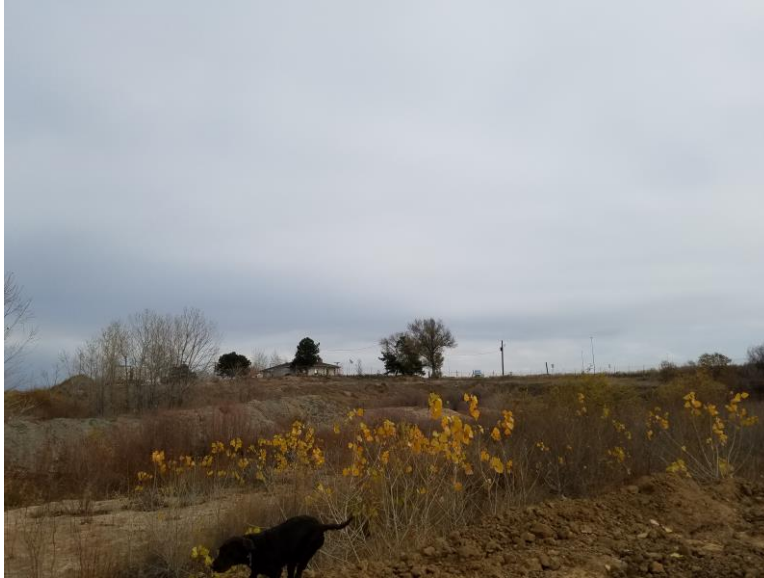
Figure 11. Northeast corner of North Expansion Area.

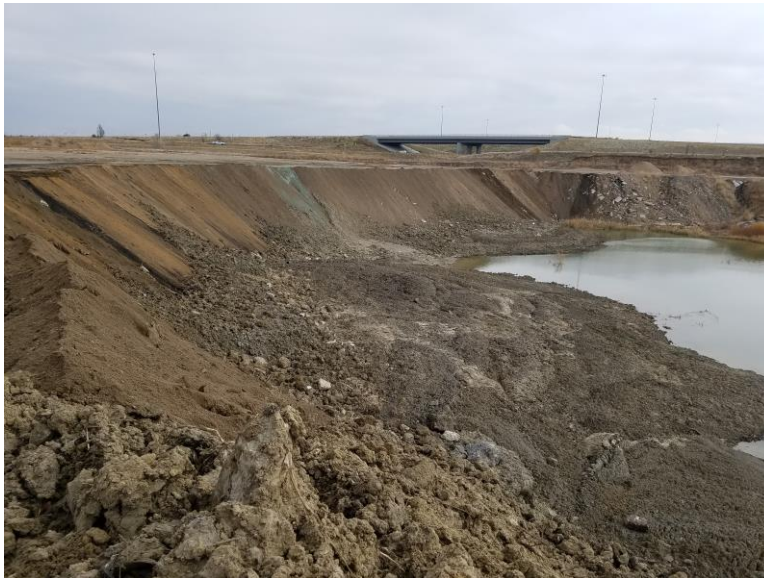
Pit 2 is being filled with inert fill. A small pit remains to be filled. The area surrounding the pit is graded fairly level and a French drain has been installed on the east side of the pit. The French drain drains to a channel and a pipe that flows west into Pit 1 north of the residential area within the site.

Figure 12. Inert fill in Pit 2.

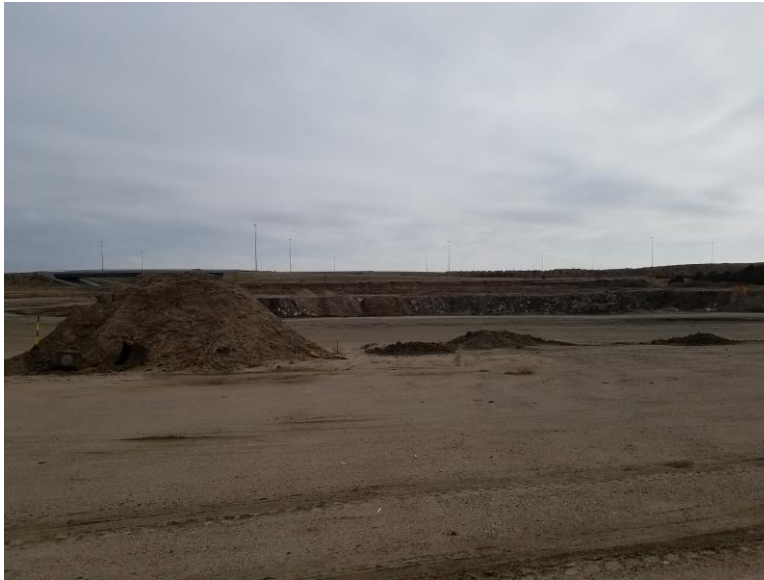
Figure 13. Pit 2 from west side looking east.

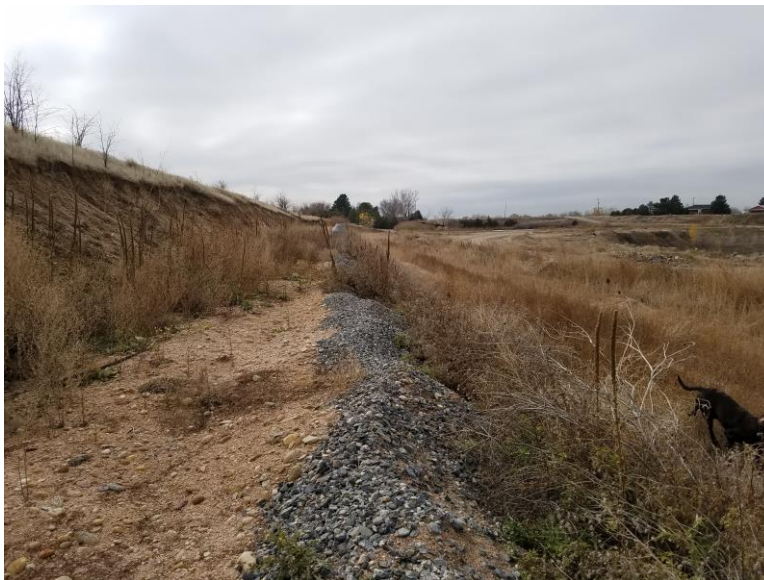
Figure 14. French drain installed on the east side of Pit 2.
