**MINERALS PROGRAM INSPECTION REPORT**  
**PHONE: (303) 866-3567**

<b>MINE NAME:</b> Knox Pit	<b>MINE/PROSPECTING ID#:</b> M-2017-036	<b>MINERAL:</b> Sand and gravel	<b>COUNTY:</b> Larimer
<b>INSPECTION TYPE:</b> Preoperation Inspection	<b>INSPECTOR(S):</b> Jared L. Ebert	<b>INSP. DATE:</b> November 22, 2017	<b>INSP. TIME:</b> 09:50
<b>OPERATOR:</b> Loveland Ready-Mix Concrete, Inc.	<b>OPERATOR REPRESENTATIVE:</b> Stephanie Fancher-English	<b>TYPE OF OPERATION:</b> 112c - Construction Regular Operation	
<b>REASON FOR INSPECTION:</b> Normal I&E Program	<b>BOND CALCULATION TYPE:</b> None	<b>BOND AMOUNT:</b> No Bond Held	
<b>DATE OF COMPLAINT:</b> NA	<b>POST INSP. CONTACTS:</b> None	<b>JOINT INSP. AGENCY:</b> None	
<b>WEATHER:</b> Clear	<b>INSPECTOR'S SIGNATURE:</b>

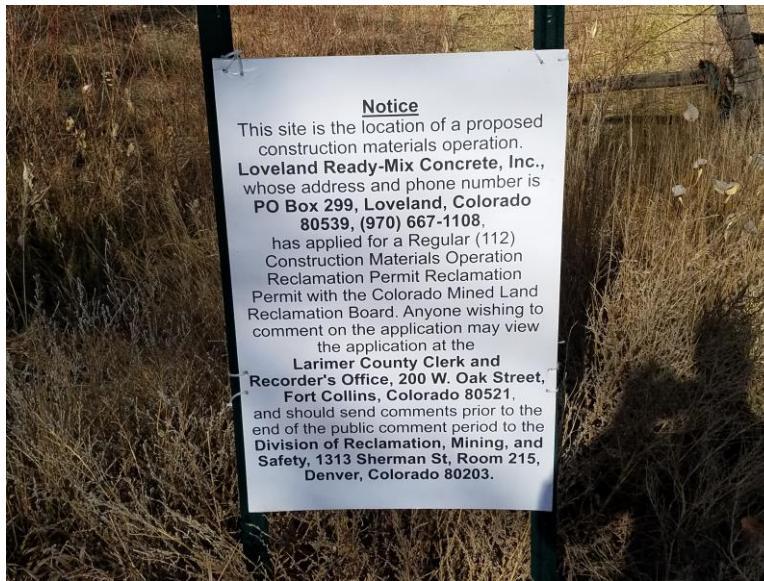
Two public notice signs were posted at the two entrances to the proposed permit area in accordance with Rule 1.6.2(1)(b).

Figure 2. Notice sign located at the southeast entrance to the site.

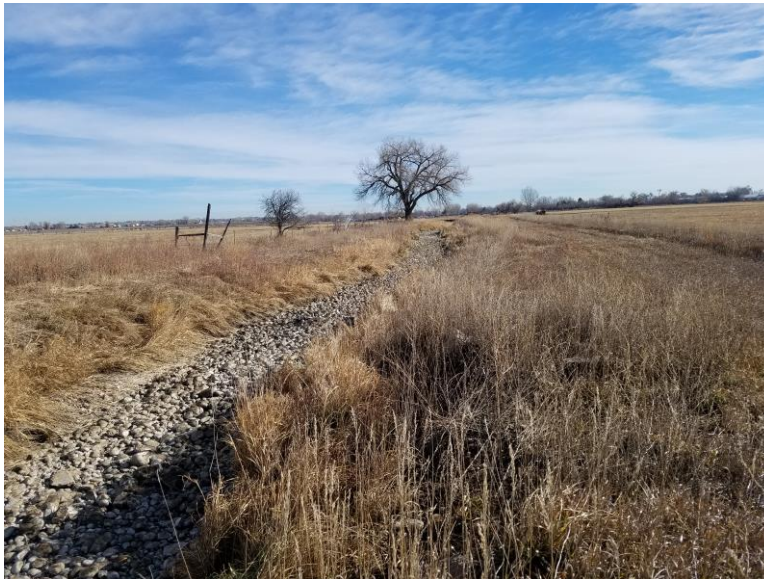
The Little Cache La Poudre ditch nearly bisects the entire 127 acre site. This is an unlined ditch that runs from west to east. Within the permit area there are four bridges over the ditch and a box culvert located within the ditch.

**Figure 10. Little Cache La Poudre Ditch.**
