**MINERALS PROGRAM INSPECTION REPORT**  
**PHONE: (303) 866-3567**

<b>MINE NAME:</b> Bijou Clay Mine	<b>MINE/PROSPECTING ID#:</b> M-1997-007	<b>MINERAL:</b> Clay (general)	<b>COUNTY:</b> Elbert
<b>INSPECTION TYPE:</b> Monitoring	<b>INSPECTOR(S):</b> Peter S. Hays	<b>INSP. DATE:</b> November 15, 2017	<b>INSP. TIME:</b> 12:00
<b>OPERATOR:</b> The Denver Brick Company	<b>OPERATOR REPRESENTATIVE:</b> Rob Tibbetts, Steve Helzer	<b>TYPE OF OPERATION:</b> 112c - Construction Regular Operation	
<b>REASON FOR INSPECTION:</b> Normal I&E Program	<b>BOND CALCULATION TYPE:</b> Partial Bond	<b>BOND AMOUNT:</b> \$196,124.37	
<b>DATE OF COMPLAINT:</b> NA	<b>POST INSP. CONTACTS:</b> None	<b>JOINT INSP. AGENCY:</b> None	
<b>WEATHER:</b> Clear	<b>INSPECTOR'S SIGNATURE:</b>

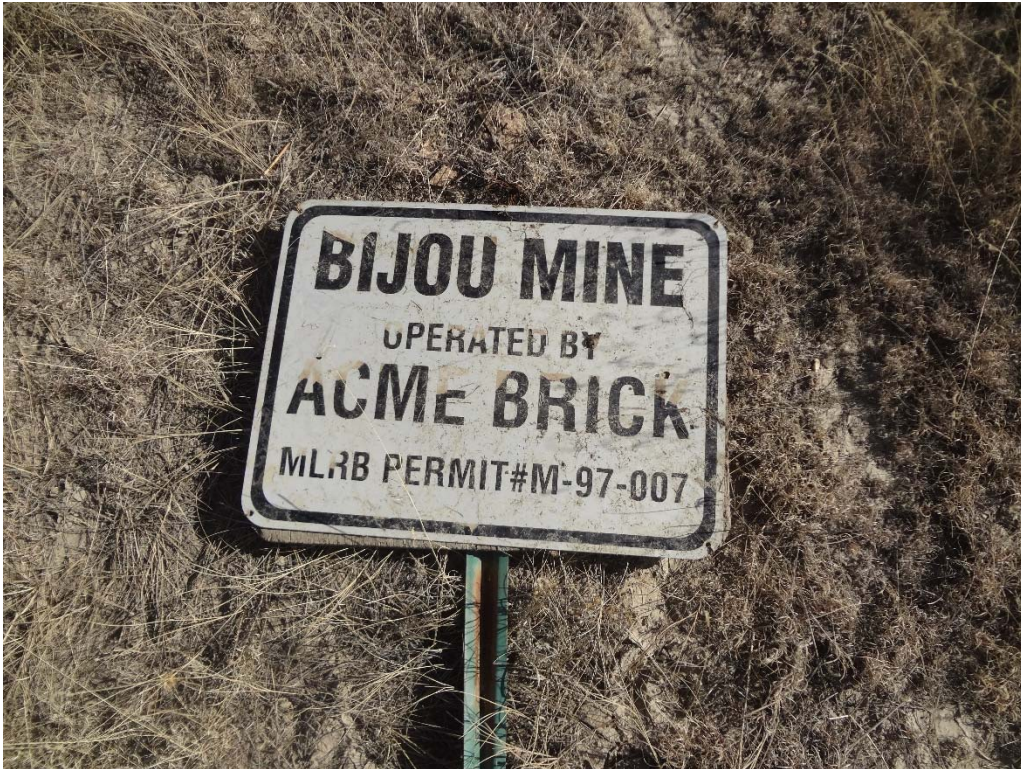
The site is a 33.75 acre 112c Construction Materials permit for the mining of clay. The Division currently holds a financial warranty in the amount of \$196,124.37, which appears adequate based on the current site disturbance level. A mine sign and boundary markers were observed as required by Rule 3.1.12.

Bijou Clay Mine sign

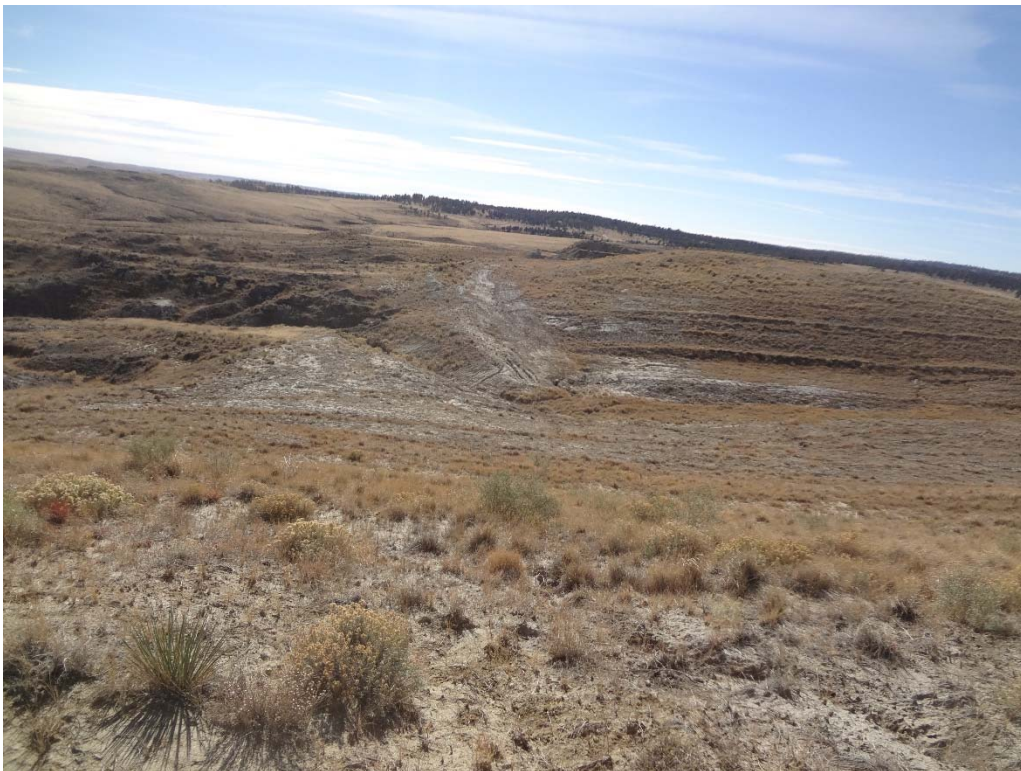
The north mining area appears unchanged since the last inspection. The area consists of a basin with 3H:1V graded slopes on the north, south and west sides. The slopes were partially vegetated and contained numerous erosion rills and gullies. The slopes lacked the required topsoil placement as noted in the last inspection report. The east side of the basin consists of a berm with a stormwater outfall at the low part of the berm. The erosion control structures installed at the outfall are damaged and need to be repaired by the Operator to prevent offsite damage from occurring. The stockpile area contained several clay stockpiles. The south mining area was mined this year in the southwest corner of the area according to the Operator. The west and south slopes of the mined area were graded at the approved 3H:1V slope, however topsoil has not been replaced on the slopes. The Operator stated additional grading and contouring will be done in the area prior to placement of topsoil. The east side of the mined area was benched by clay type (red and buff) with topsoil and overburden above the highwall. The south mining area contained two areas of standing water in the pit floor. As stated in the last inspection report, the Division recommends the Operator construct a diversion ditch around the northern side of the area to divert stormwater around the pit.

View of the north mining area from the northeast corner looking south

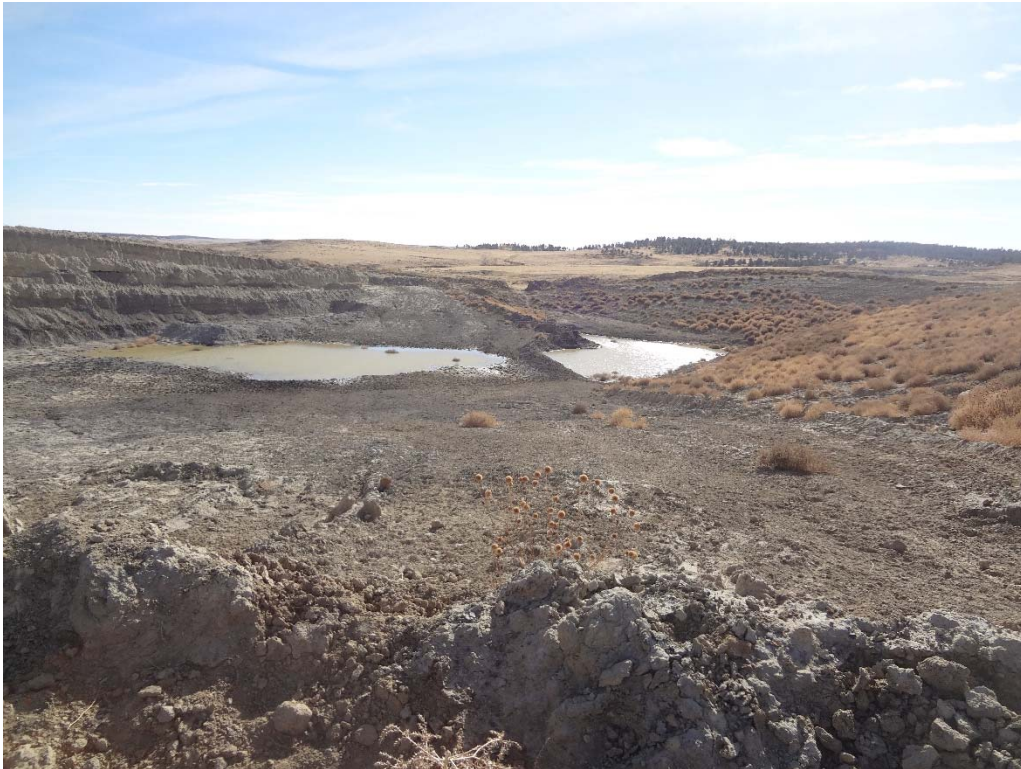
View of the south mining area from the northwest corner looking southeast

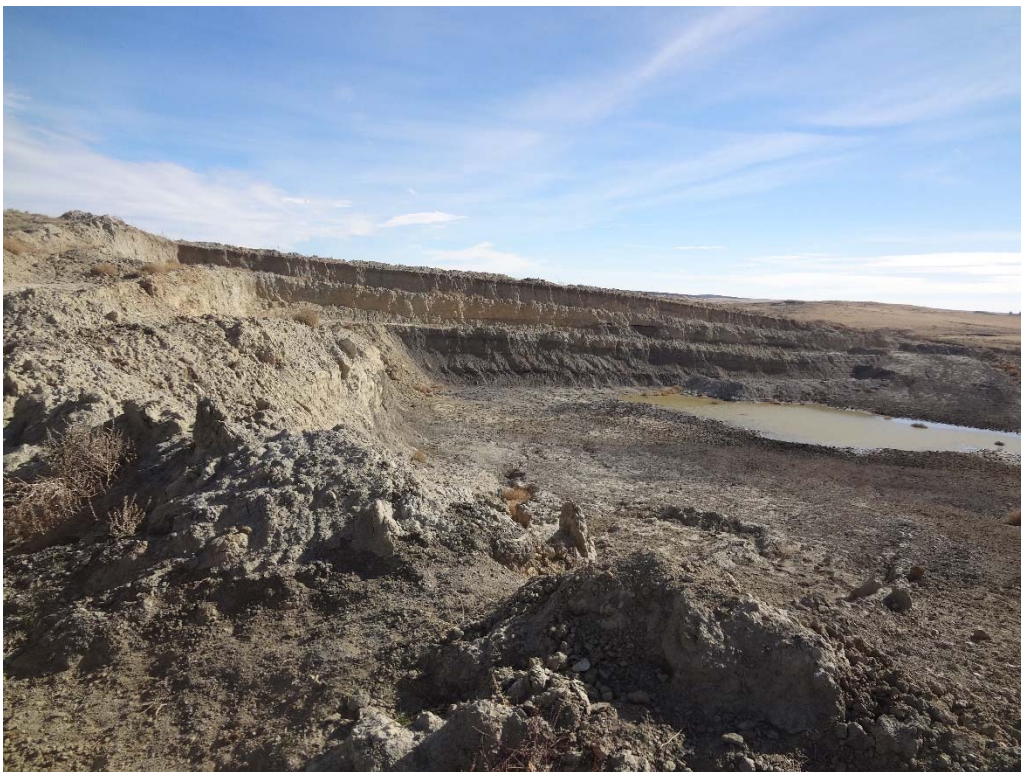
View of the south mining area from the northwest corner looking southeast

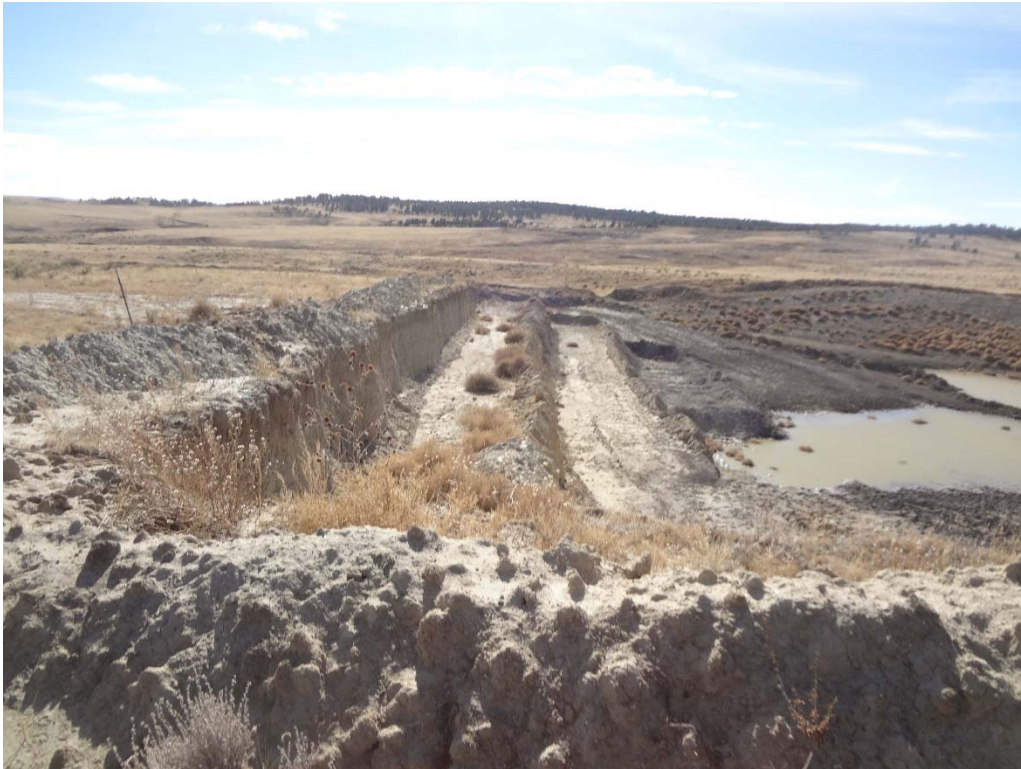
View of the south mining area from the northeast corner looking south

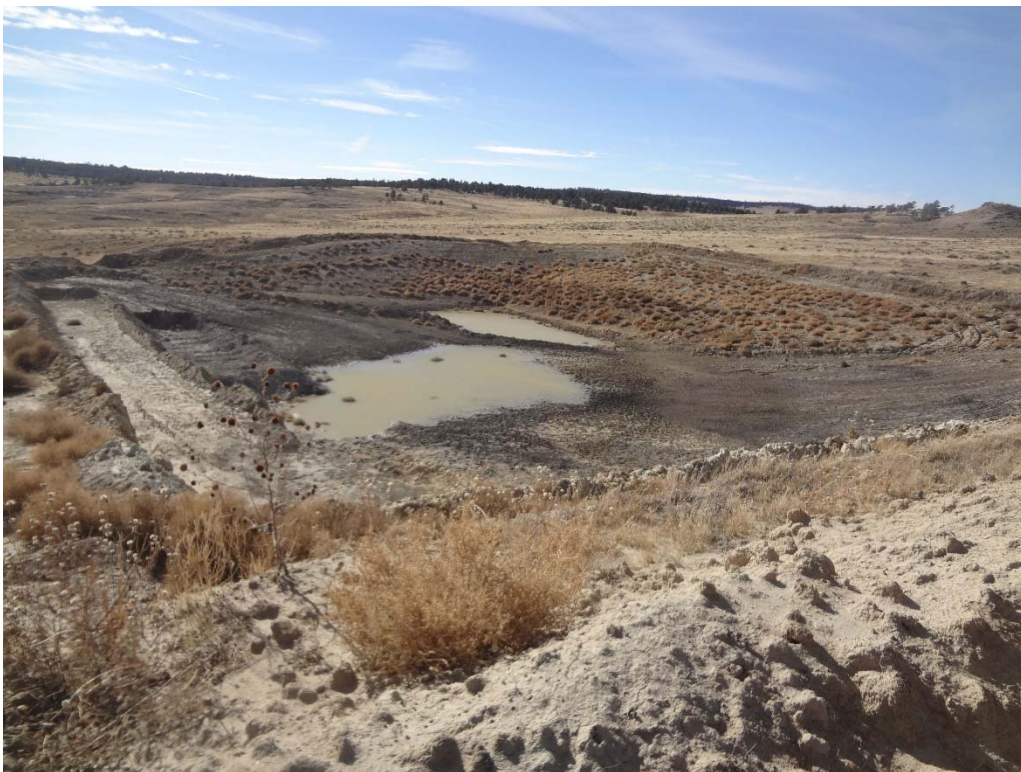
View of the south mining area from the northeast corner looking southwest
