MINERALS PROGRAM INSPECTION REPORT
PHONE: (303) 866-3567

MINE NAME: Dawson Mine	MINE/PROSPECTING ID#: M-1977-392	MINERAL: Clay (general)	COUNTY: Elbert
INSPECTION TYPE: Monitoring	INSPECTOR(S): Peter S. Hays	INSP. DATE: November 15, 2017	INSP. TIME: 11:00
OPERATOR: The Denver Brick Company	OPERATOR REPRESENTATIVE: Rob Tibbetts, Steve Helzer	TYPE OF OPERATION: 112c - Construction Regular Operation	
REASON FOR INSPECTION: Normal I&E Program	BOND CALCULATION TYPE: Partial Bond	BOND AMOUNT: \$80,358.00	
DATE OF COMPLAINT: NA	POST INSP. CONTACTS: None	JOINT INSP. AGENCY: None	
WEATHER: Clear	INSPECTOR'S SIGNATURE:

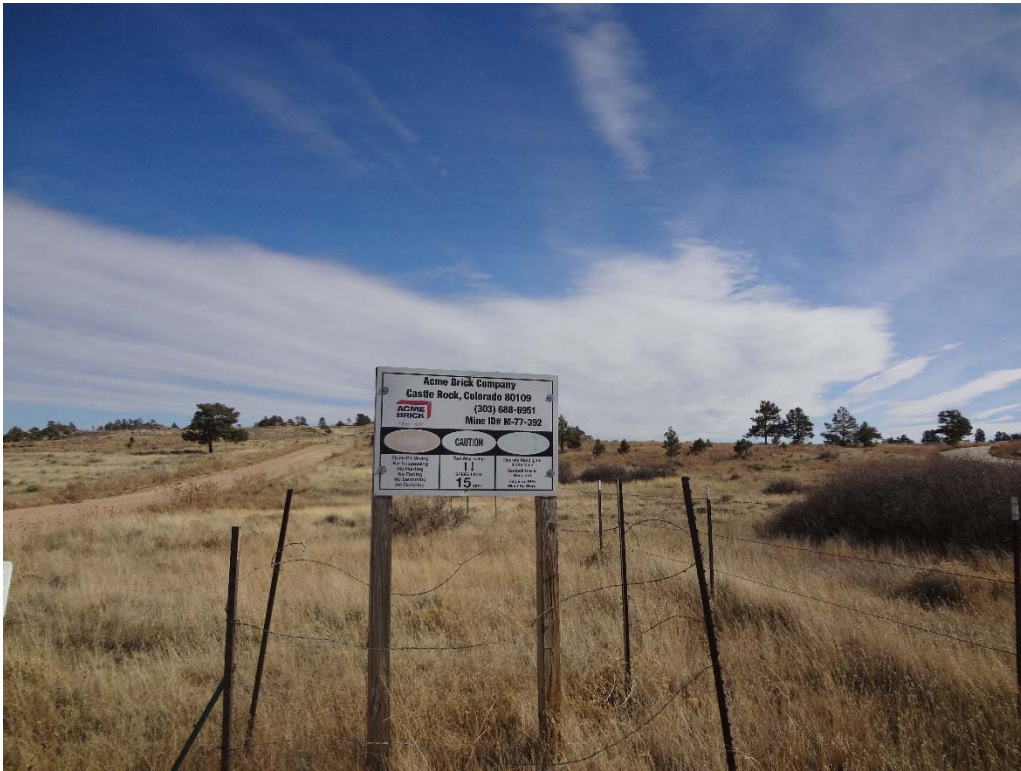
The site is a 28.85 acre 112c Construction Materials permit for the mining of clay. The Division currently holds a financial warranty in the amount of \$80,358.00, which appears adequate based on the current site disturbance level. A mine sign and boundary markers were observed as required by Rule 3.1.12.

Dawson Mine sign

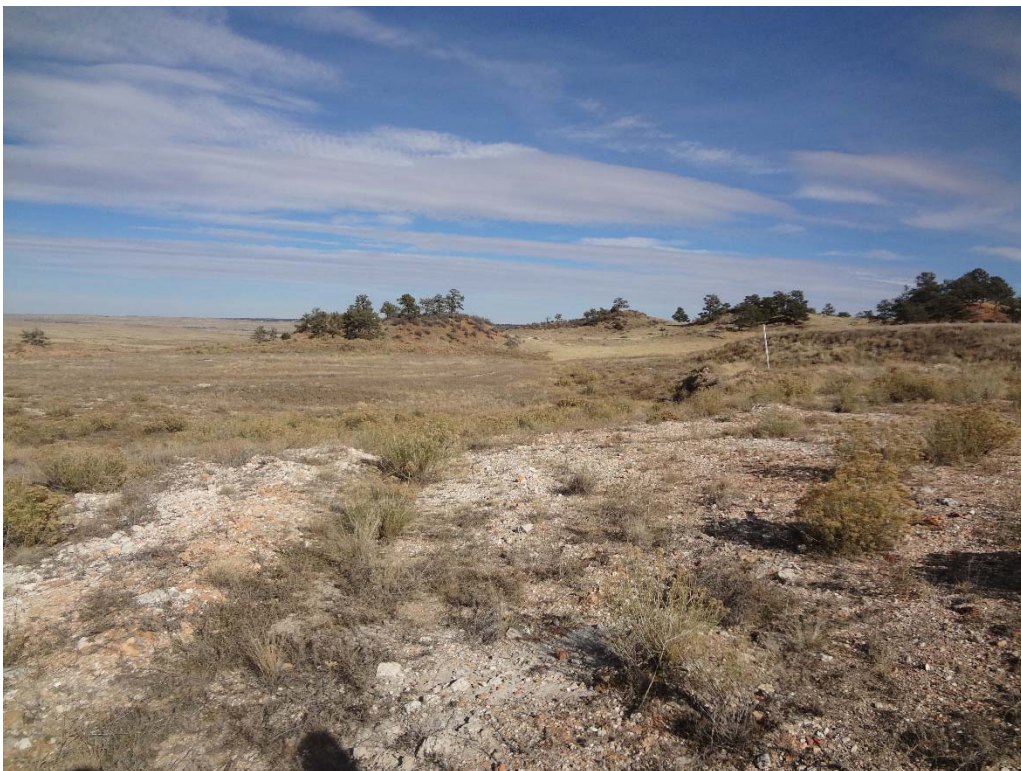
View of the site from the southwest corner of the site looking north east

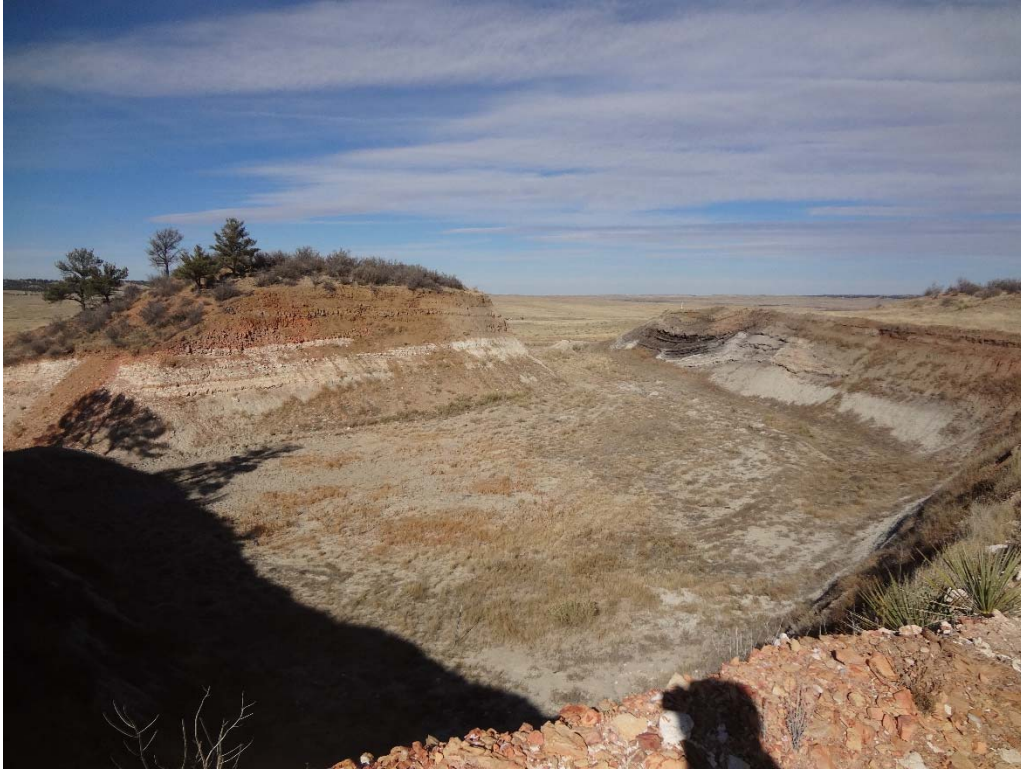
Area 2 contains the current mining disturbance with near vertical highwalls of 15 to 20 feet in height. Mining activities will continue in this area and progress to the southwest and will eventually mine through the three hills within the permit area.

View of the eastern mining area from the southwest corner looking northeast
