Knox Pit, M-2017-036, Pre-operation Inspection Report

MINERALS PROGRAM INSPECTION REPORT
PHONE: (303) 866-3567

MINE NAME: Knox Pit	MINE/PROSPECTING ID#: M-2017-036	MINERAL: Sand and gravel	COUNTY: Larimer
INSPECTION TYPE: Preoperation Inspection	INSPECTOR(S): Jared L. Ebert	INSP. DATE: November 22, 2017	INSP. TIME: 09:50
OPERATOR: Loveland Ready-Mix Concrete, Inc.	OPERATOR REPRESENTATIVE: Stephanie Fancher-English	TYPE OF OPERATION: 112c - Construction Regular Operation	
REASON FOR INSPECTION: Normal I&E Program	BOND CALCULATION TYPE: None	BOND AMOUNT: No Bond Held	
DATE OF COMPLAINT: NA	POST INSP. CONTACTS: None	JOINT INSP. AGENCY: None	
WEATHER: Clear	INSPECTOR'S SIGNATURE:

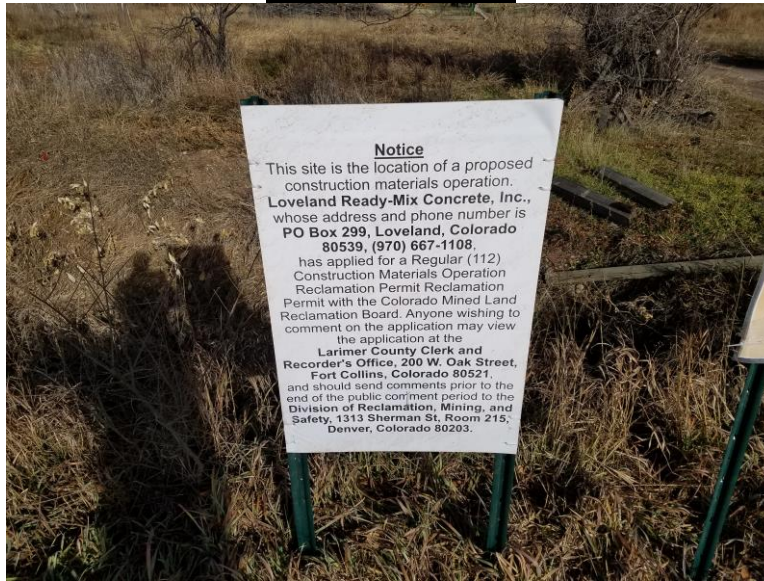
Two public notice signs were posted at the two entrances to the proposed permit area in accordance with Rule 1.6.2(1)(b).

Figure 1. Notice Sign located at the southwest entrance to the site.

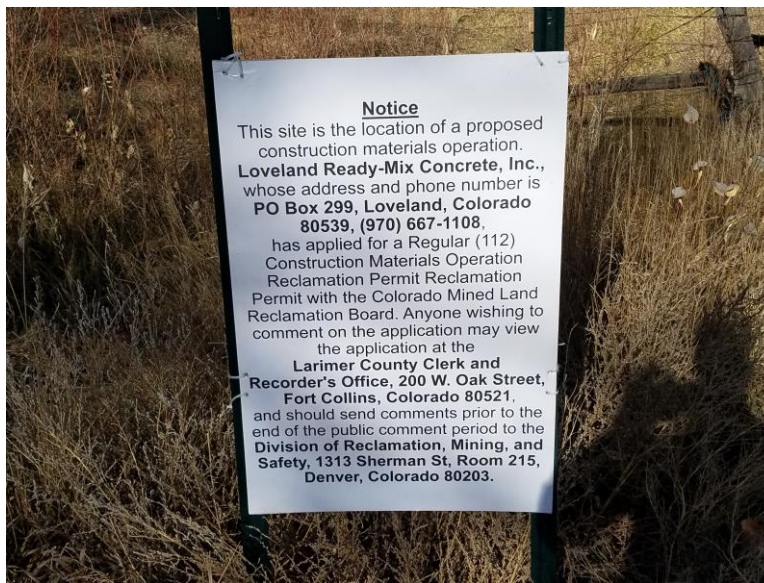
Figure 2. Notice sign located at the southeast entrance to the site.

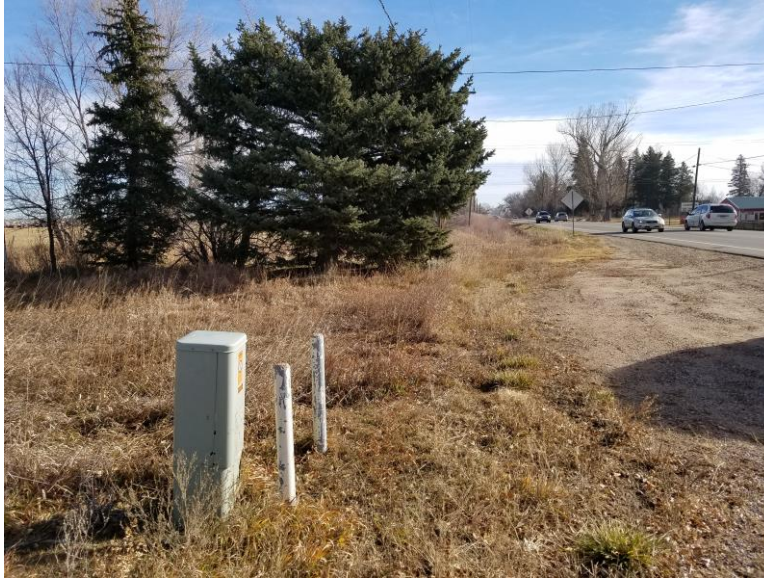
Figure 3. From the southwest entrance looking east.

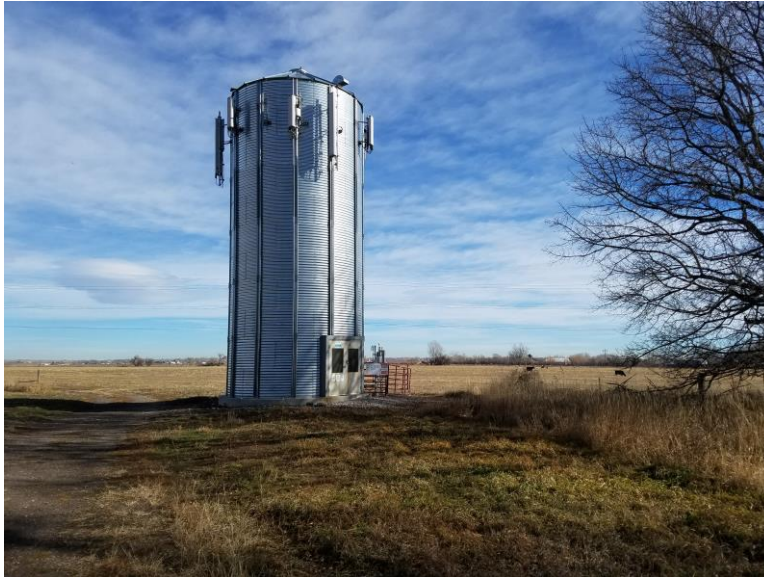
The southwest corner of the site consists of an access road that leads to a silo used as a cell tower. A small grove of trees are established in this area and amongst the trees there appears to be a corral and several pieces of agricultural equipment.

Figure 4. Silo/Cell Tower located in the southwest corner of the site.

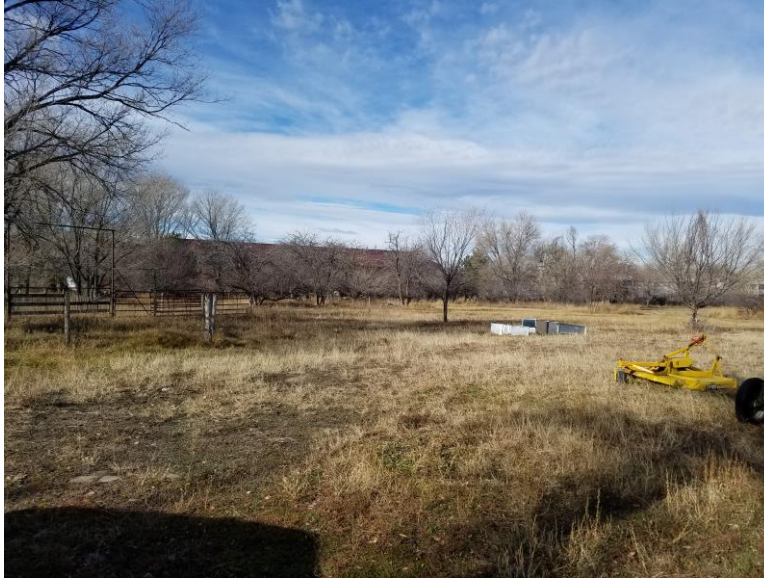
Figure 5. Grove of trees in the southwest corner of the site.

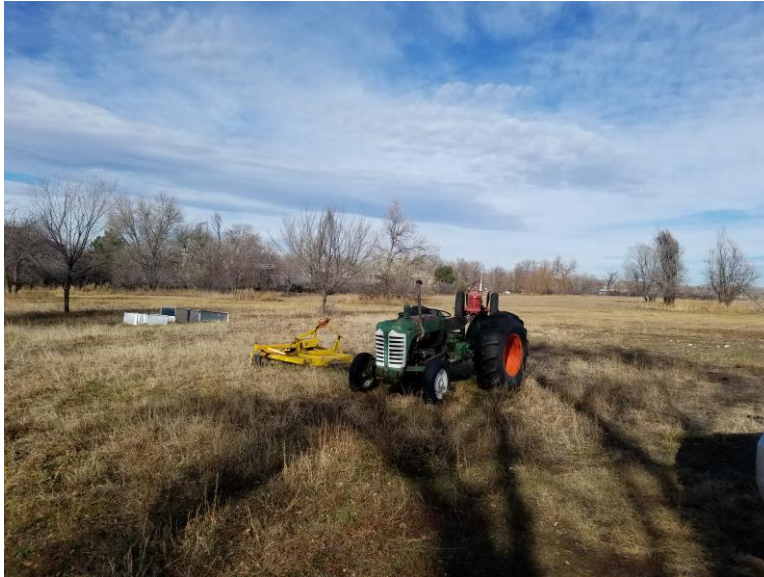
Figure 6. Agricultural equipment located in the southwest corner of the site.

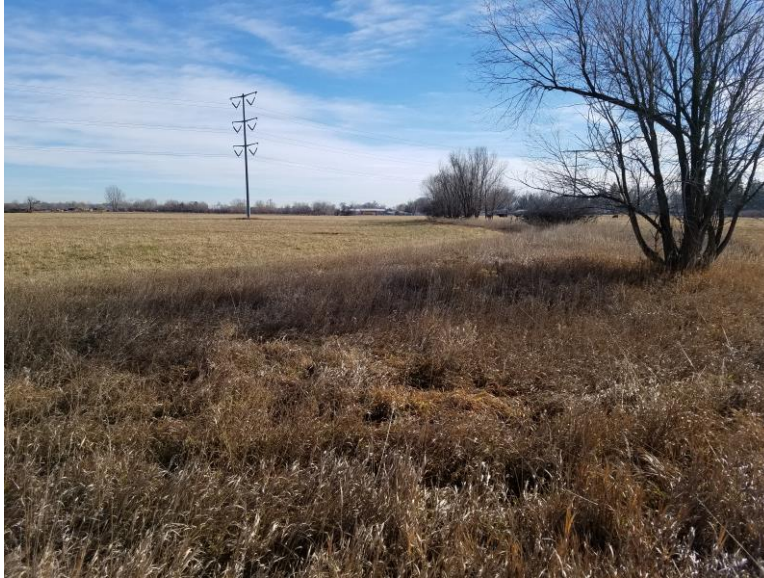
There are no laterals from the Taylor and Gill onto our property. The lateral in photo 7 is also off the Little Cache la Poudre Ditch.

Figure 7. Lateral ditch from the Cache La Poudre Ditch bending east in the permit area.

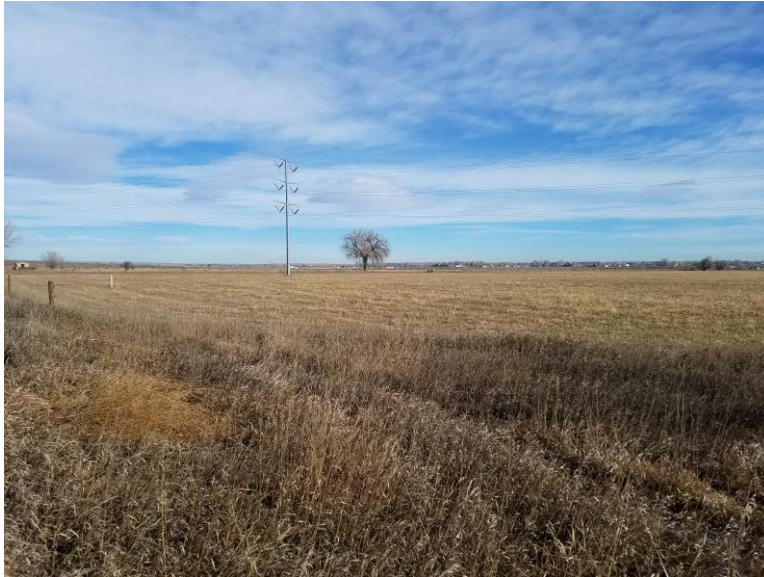
Figure 8. Pasture located in the southwest corner of the site.

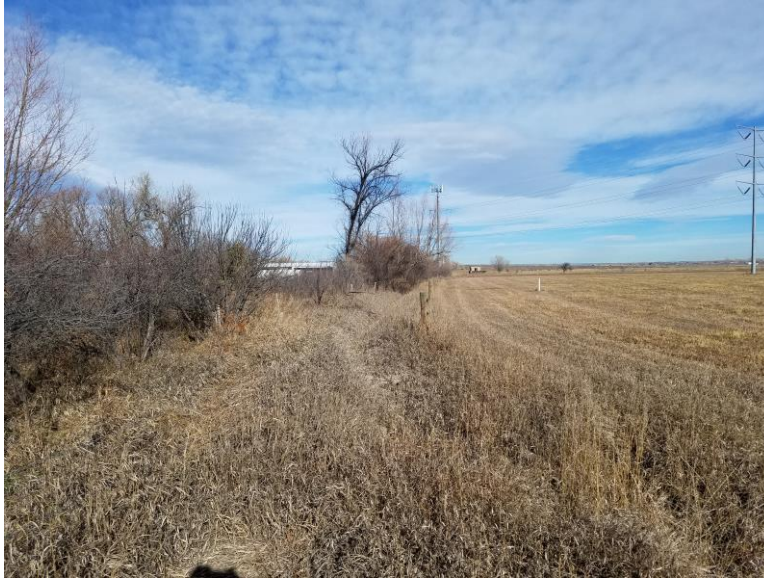
In case you can still edit this report, for clarification, the photo in 9 is actually a lateral off of the Little Cache la Poudre Ditch. It is fed from the headgate that is on the Tilley's property. The Taylor and Gill runs parallel to this lateral west of the wild plum trees that are on our property line.

Figure 9. Lateral ditch from the Cache La Poudre Ditch next to the Taylor and Gill Ditch on the west side of the site in the SW quarter of the site.

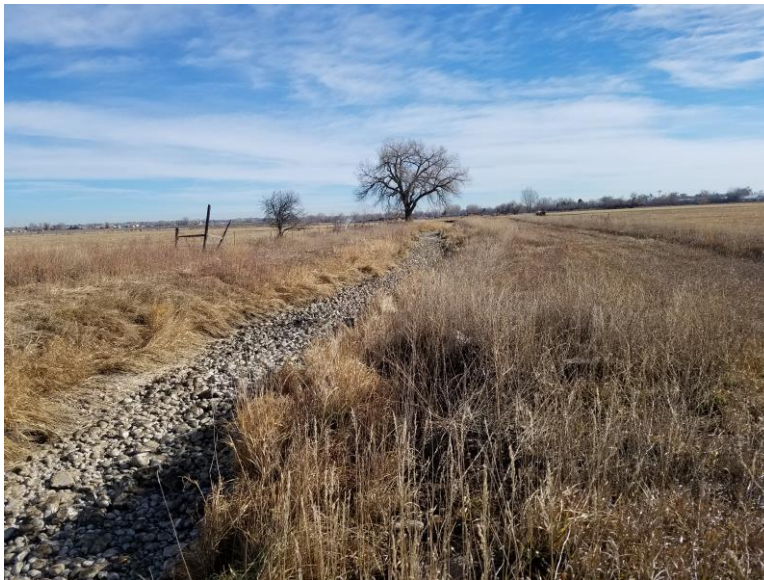
The Little Cache La Poudre ditch nearly bisects the entire 127 acre site. This is an unlined ditch that runs from west to east. Within the permit area there are four bridges over the ditch and a box culvert located within the ditch.

Figure 10. Little Cache La Poudre Ditch.

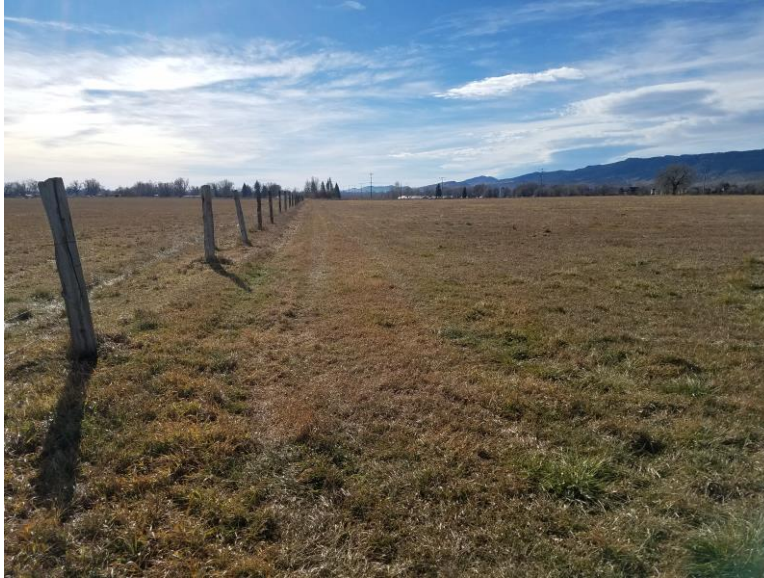
Figure 11. Pasture located in the northwest quarter of the site.

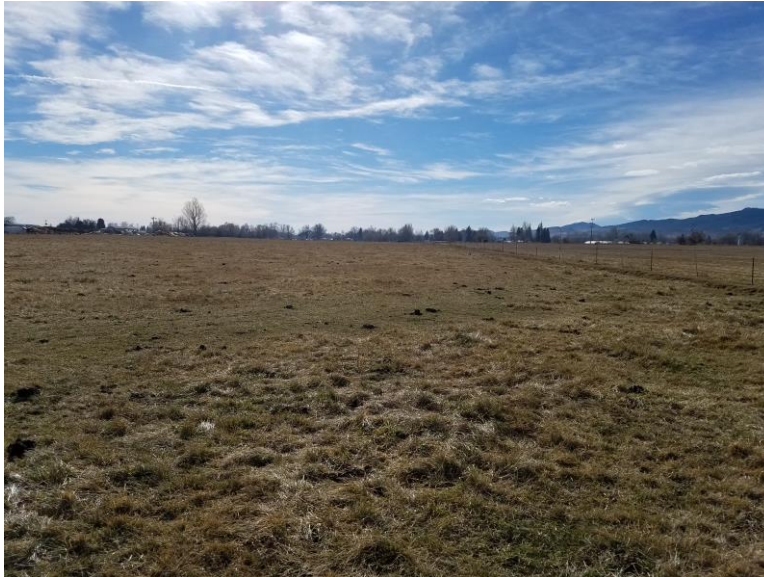
Figure 12. Pasture located in the northeast quarter of the site.

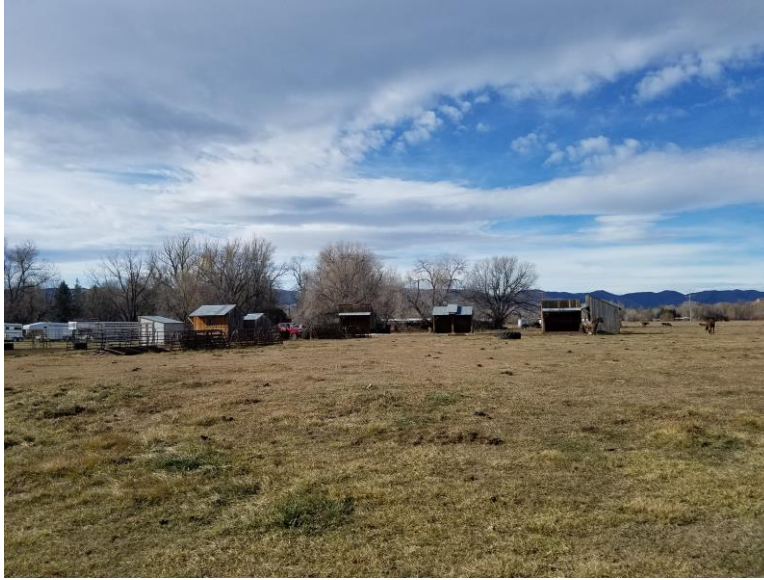
The southeast quarter of the site consists of several homes and many outbuildings/garages/barn type structures that are owned by LRM. Portions of this area is used as a horse pasture. The northern part of the eastern half of this quarter appears to have been utilized as a storage area for various types of garbage, trash and various types of debris. LRM has contracted with a neighbor to remove this debris.

Figure 13. LRM property located within the southeast quarter of the site.
