**COLORADO**  
Division of Reclamation,  
Mining and Safety  
Department of Natural Resources

<b>Permit Number:</b> C-1981-008 <b>Mine Name:</b> New Horizon Mine <b>Operator:</b> Elk Ridge Mining and Reclamation, LLC <b>Operator Address:</b> Mr. Tony Tennyson 5731 State Highway 13 Meeker, CO 81641	<b>County:</b> Montrose <b>Operation Type:</b> Surface <b>Permit Status:</b> Active <b>Ownership:</b> Private
	<b>Operator Representative Present:</b>  None
<b>Operator Representative Signature: (Field Issuance Only)</b>

<b>Inspection Start Date:</b> November 27, 2017 <b>Inspection Start Time:</b> 14:17 <b>Inspection End Date:</b> November 27, 2017 <b>Inspection End Time:</b> 14:18		<b>Inspection Type:</b> Aerial Inspection <b>Inspection Reason:</b> Normal I&E Program <b>Weather:</b> Cloudy	
<b>Joint Inspection Agency:</b>  None		<b>Joint Inspection Contacts:</b>  	
<b>Post Inspection Agency:</b>  None		<b>Post Inspection Contacts:</b>  	
<b>Inspector(s):</b>  Brock F. Bowles  Harry B. Ranney		<b>Inspector's Signature:</b>

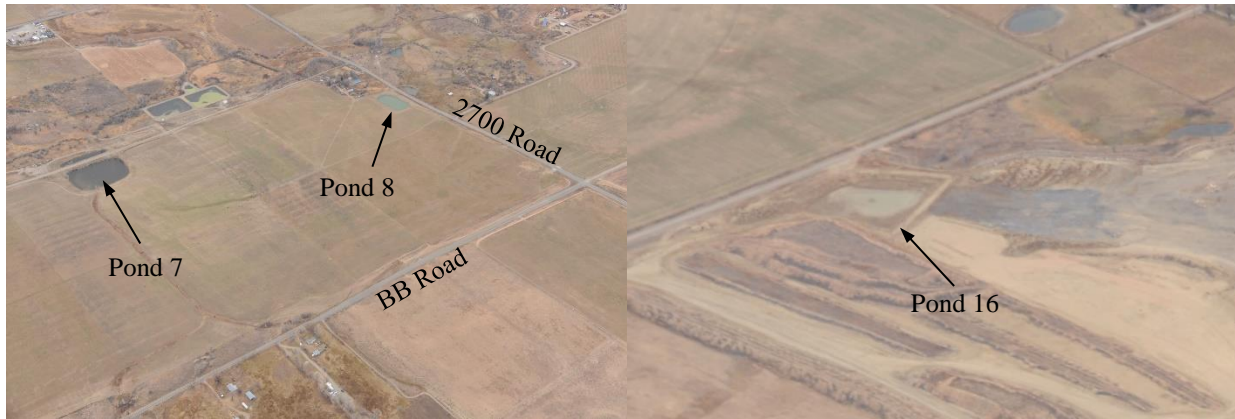
Ponds 7, 8 (photo 1) and 13 contained water.

Pond 16 appears to have some water in the bottom of the pond, although, the bottom of the pond is not completely covered with water (photo 2).

Photo 1 – Ponds 7 and 8 Containing Water

Photo 2 – Pond 16 Contained Water.

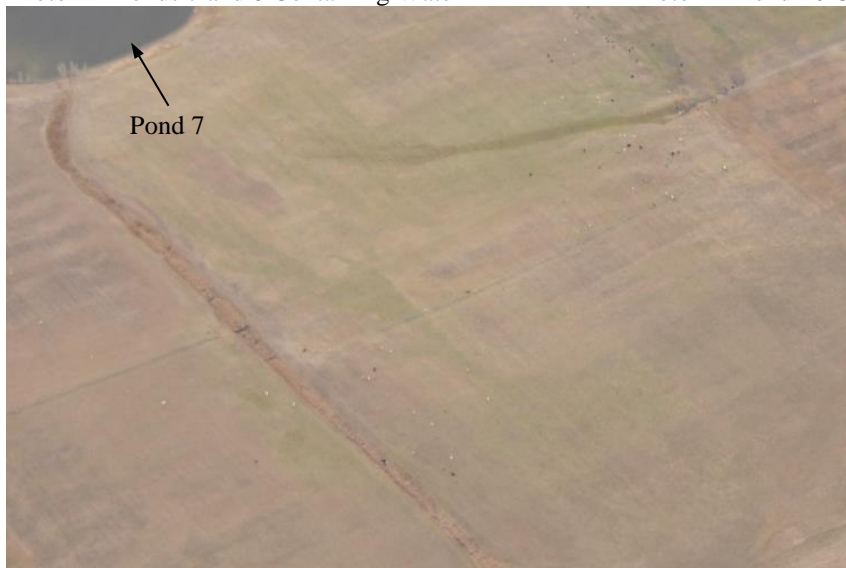
Cattle were grazing on the irrigated pasture areas between BB Road and 5th Street (photo 3).

Photo 3 – Cattle Grazing on Irrigated Pasture
