MINERALS PROGRAM INSPECTION REPORT**PHONE: (303) 866-3567**

MINE NAME: McCoy Gulch	MINE/PROSPECTING ID#: M-2017-017	MINERAL: Granite, granite gneiss	COUNTY: Fremont
INSPECTION TYPE: Preoperation Inspection	INSPECTOR(S): Timothy A. Cazier	INSP. DATE: May 2, 2017	INSP. TIME: 14:45
OPERATOR: Bureau of Land Management	OPERATOR REPRESENTATIVE: Ken Klco	TYPE OF OPERATION: NP - Needs Permit

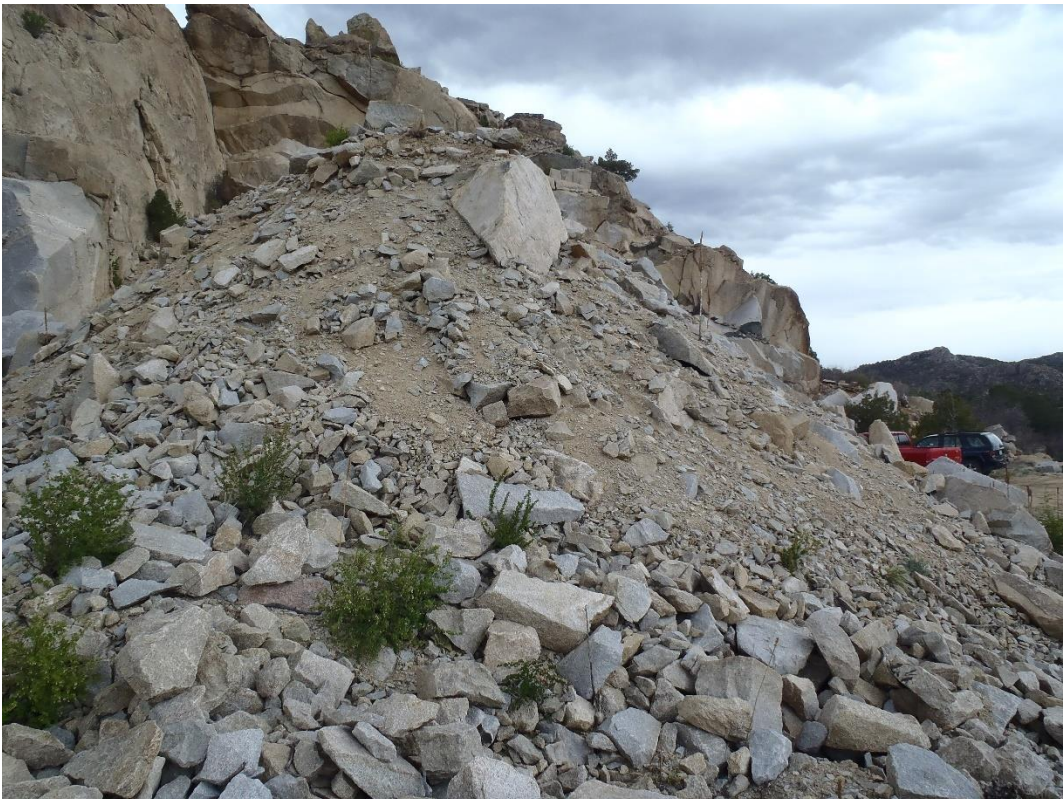
Backfilling and Grading: As the disturbance is pre-law, no backfilling is proposed by Mr. Klco's client. The plan is to pick rock generally greater than three inches, leaving smaller material for growth media (see **Photos 1 and 2**).

Photo 1. Example of fines supporting vegetation (West side, looking SE).

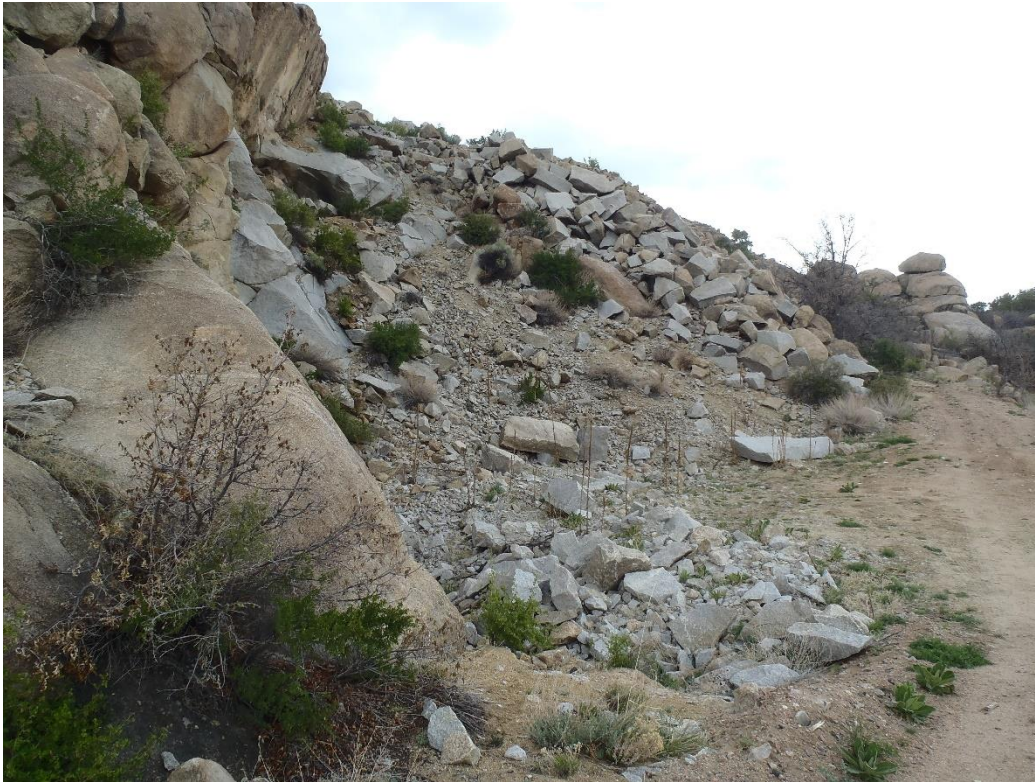
Photo 2. Example of fines supporting vegetation (East side, looking north).

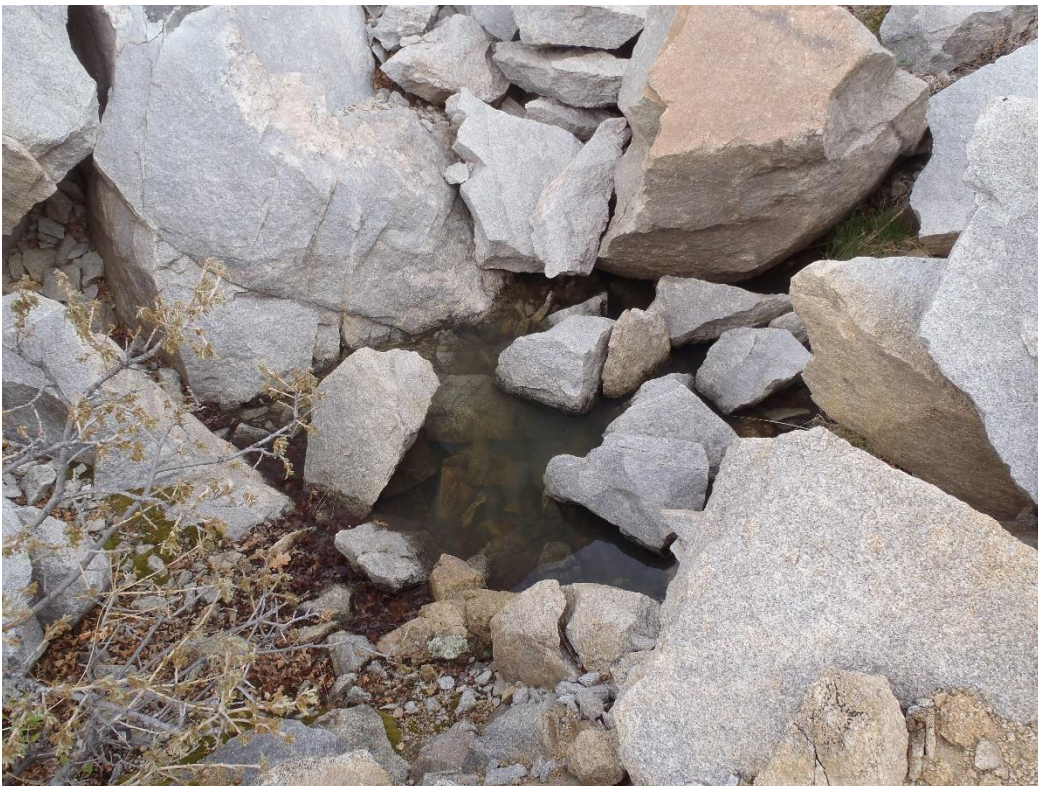
Hydrologic Balance: A small amount of standing water was observed in the east working area pit (see **Photo 3**). Mr. Klco indicated this was from snowmelt. No exposed groundwater was observed.

Photo 3. Standing water observed in the east working area (south side).

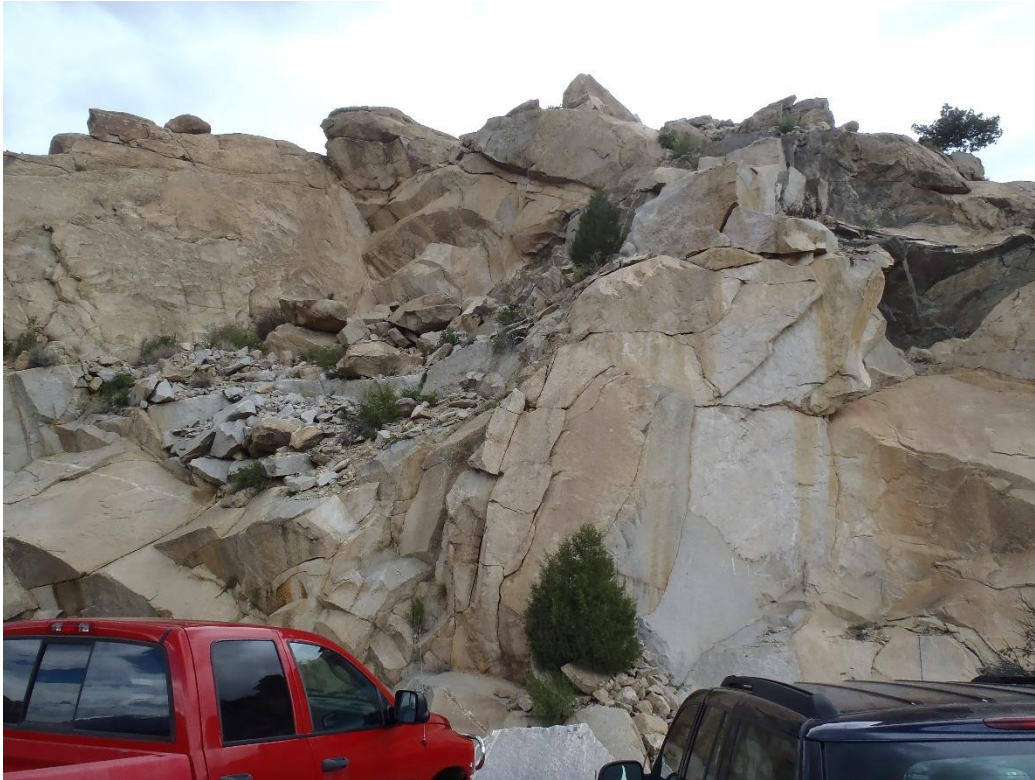
Gen. Compliance with Mine Plan: The site is unpermitted, therefore no mine plan has been submitted to the Division. The current disturbance appears to be pre-law. However, blasted rock is apparently collected periodically with the knowledge of the BLM. Google Earth was used to measure the disturbed area, which was estimated to be approximately 1.24 acres on the west side and 0.99 additional acres on the east side for a total disturbance of 2.23 acres. High walls were estimated to vary between 10 and 50 feet in height and appeared stable (see **Photo 4**).

Photo 4. High walls estimated between 10 and 50 feet in height (West side, looking NE).

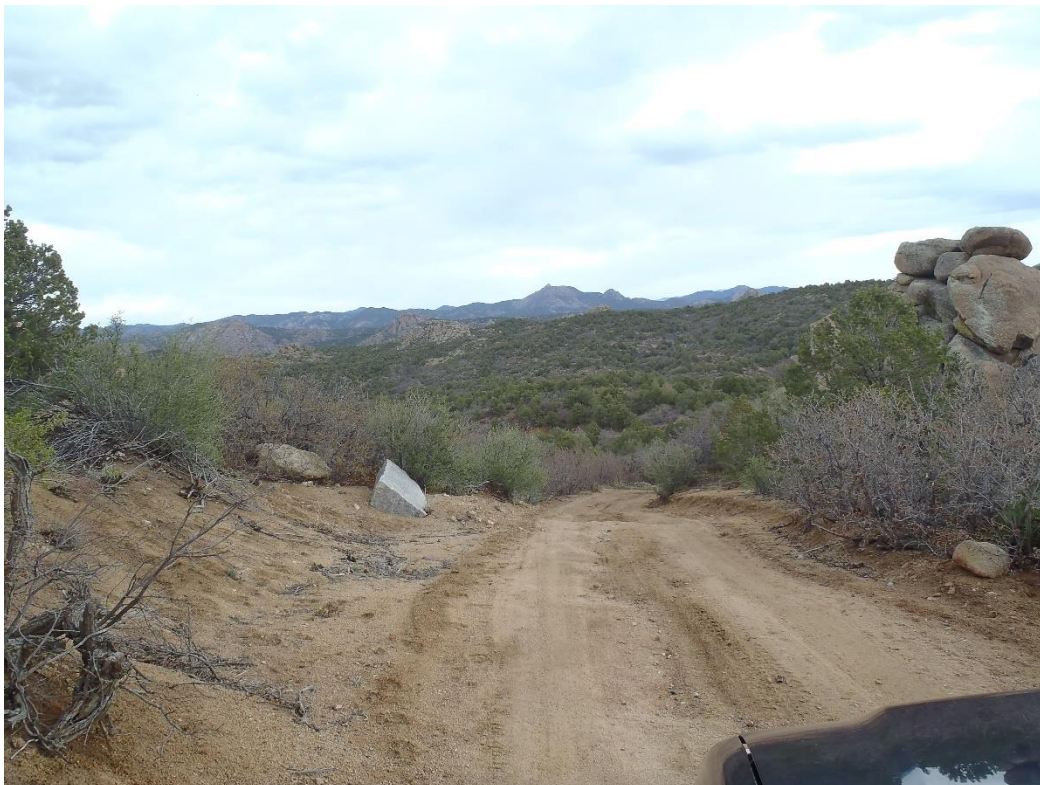
Roads: County Rd 37 links the east and west sides. The access road from CR 37 to the west side (see **Photo 5**) is approximately 0.2 miles long. The access road to the east side is considerably shorter (see **Photo 6**). Given all roads in the vicinity are unpaved, it is unlikely access roads are a source of sediment that could be tracked offsite.

Photo 5. West side access road from CR 37 (looking SE towards CR 37).

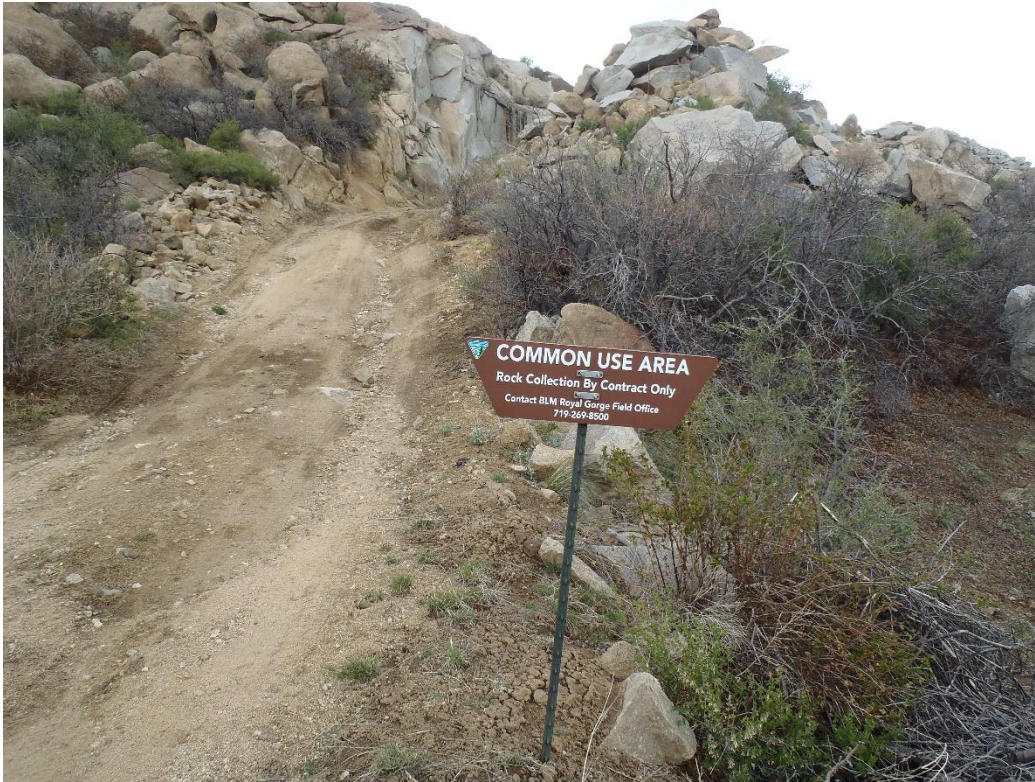
Signs and Markers: As this is an unpermitted site, no permit sign was posted. There was a BLM sign (see **Photo 6**) identifying the site as a common use area. Mr. Klco had previously flagged his client's proposed permit boundaries (separate east and west areas) with survey lathe (see **Photos 9 and 10**).

Photo 6. East side access road from CR 37 (looking north, note Common Use Area sign)

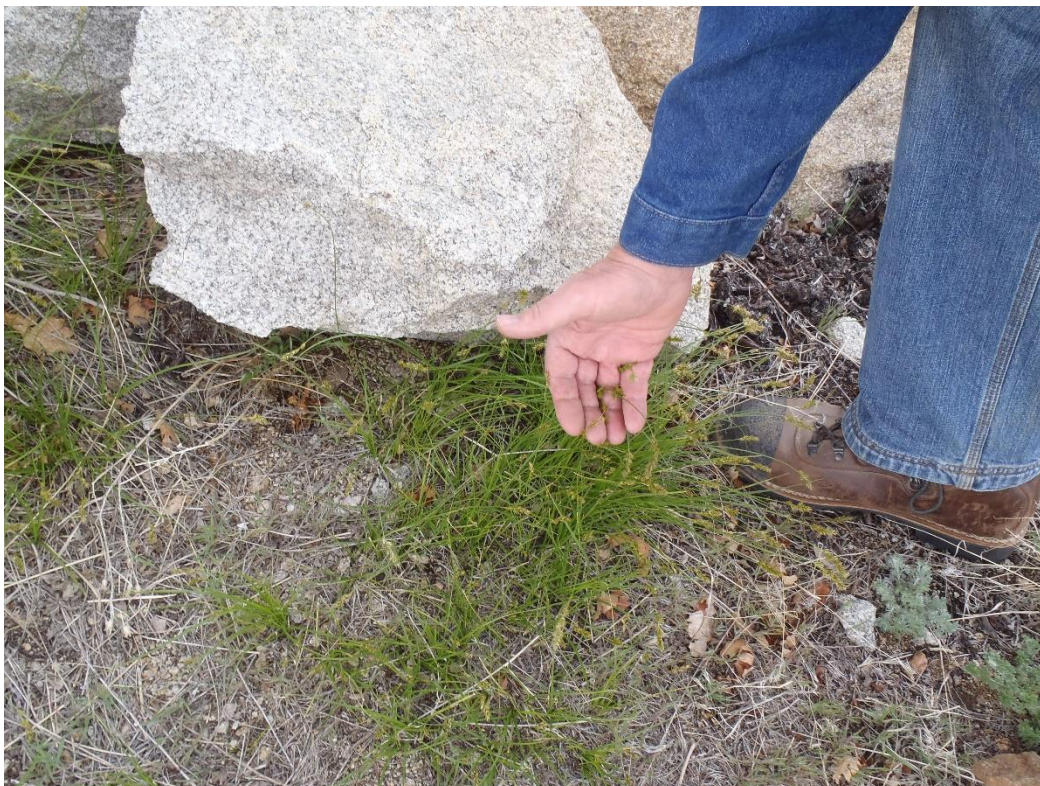
Revegetation: Mr. Klco indicated most of the revegetation would be brush similar to what was observed in the stockpiles with higher fines content. However, some grasses were observed (see **Photo 7**). No noxious weeds were observed.

Photo 7. Grasses observed on East side.

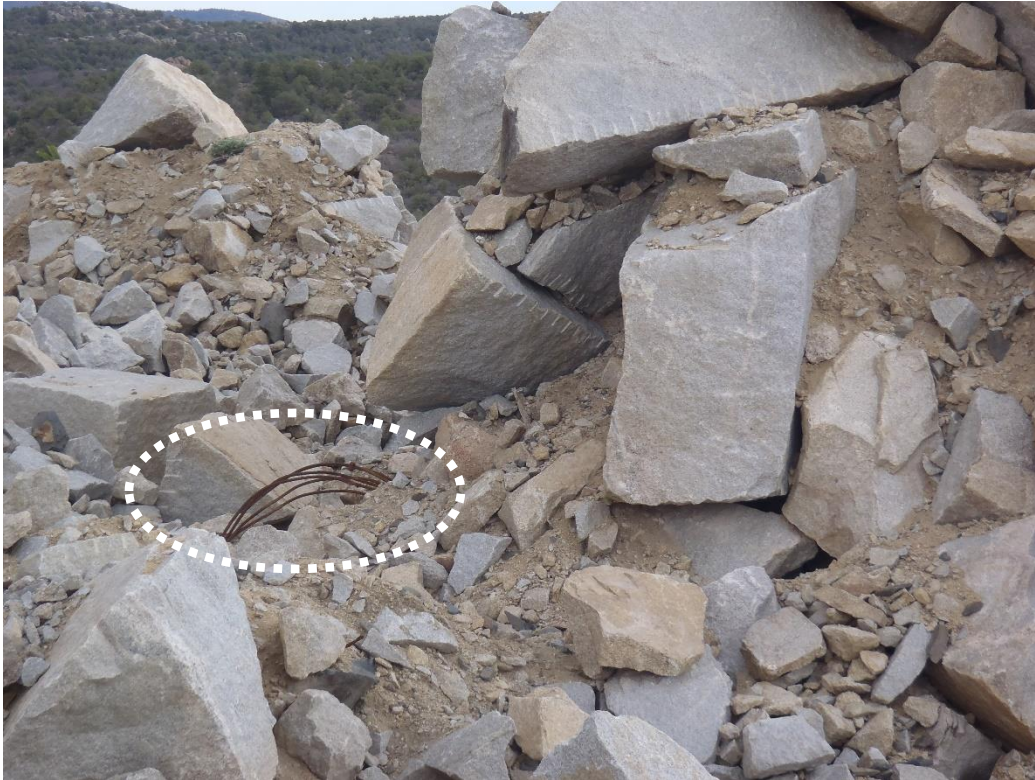
Support Facilities On-site: Heavy rusted cables (see **Photo 8**) from the pre-law mining operations were observed, but no other support equipment was present at the time of the inspection.

Photo 8. Typical heavy rusted cables from the pre-law mining operations (West side).

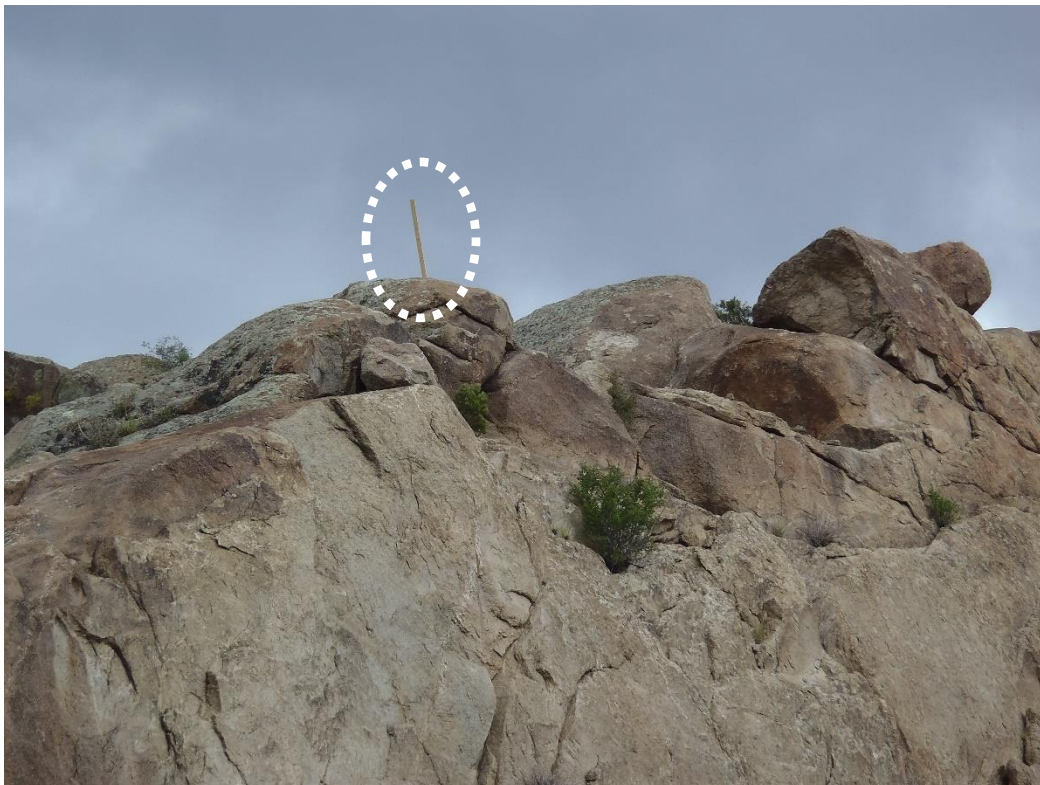
Photo 9. Typical survey lathe marking proposed boundary (West side, top of highwall).

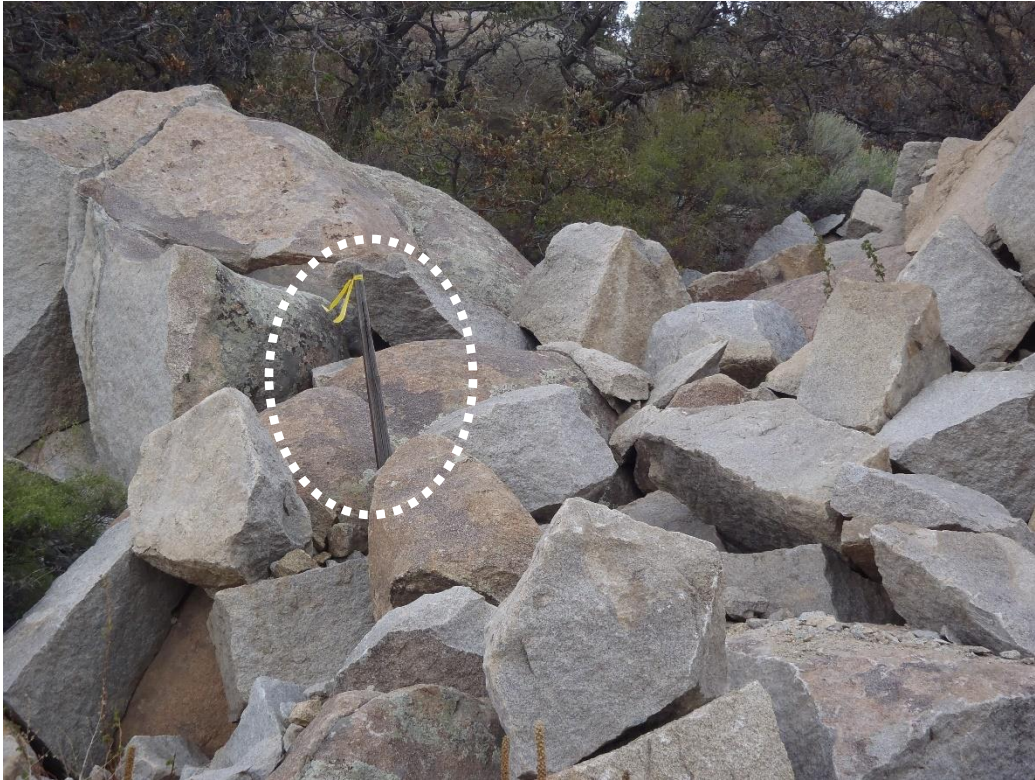
Photo 10. Typical survey lathe marking proposed boundary (East side).

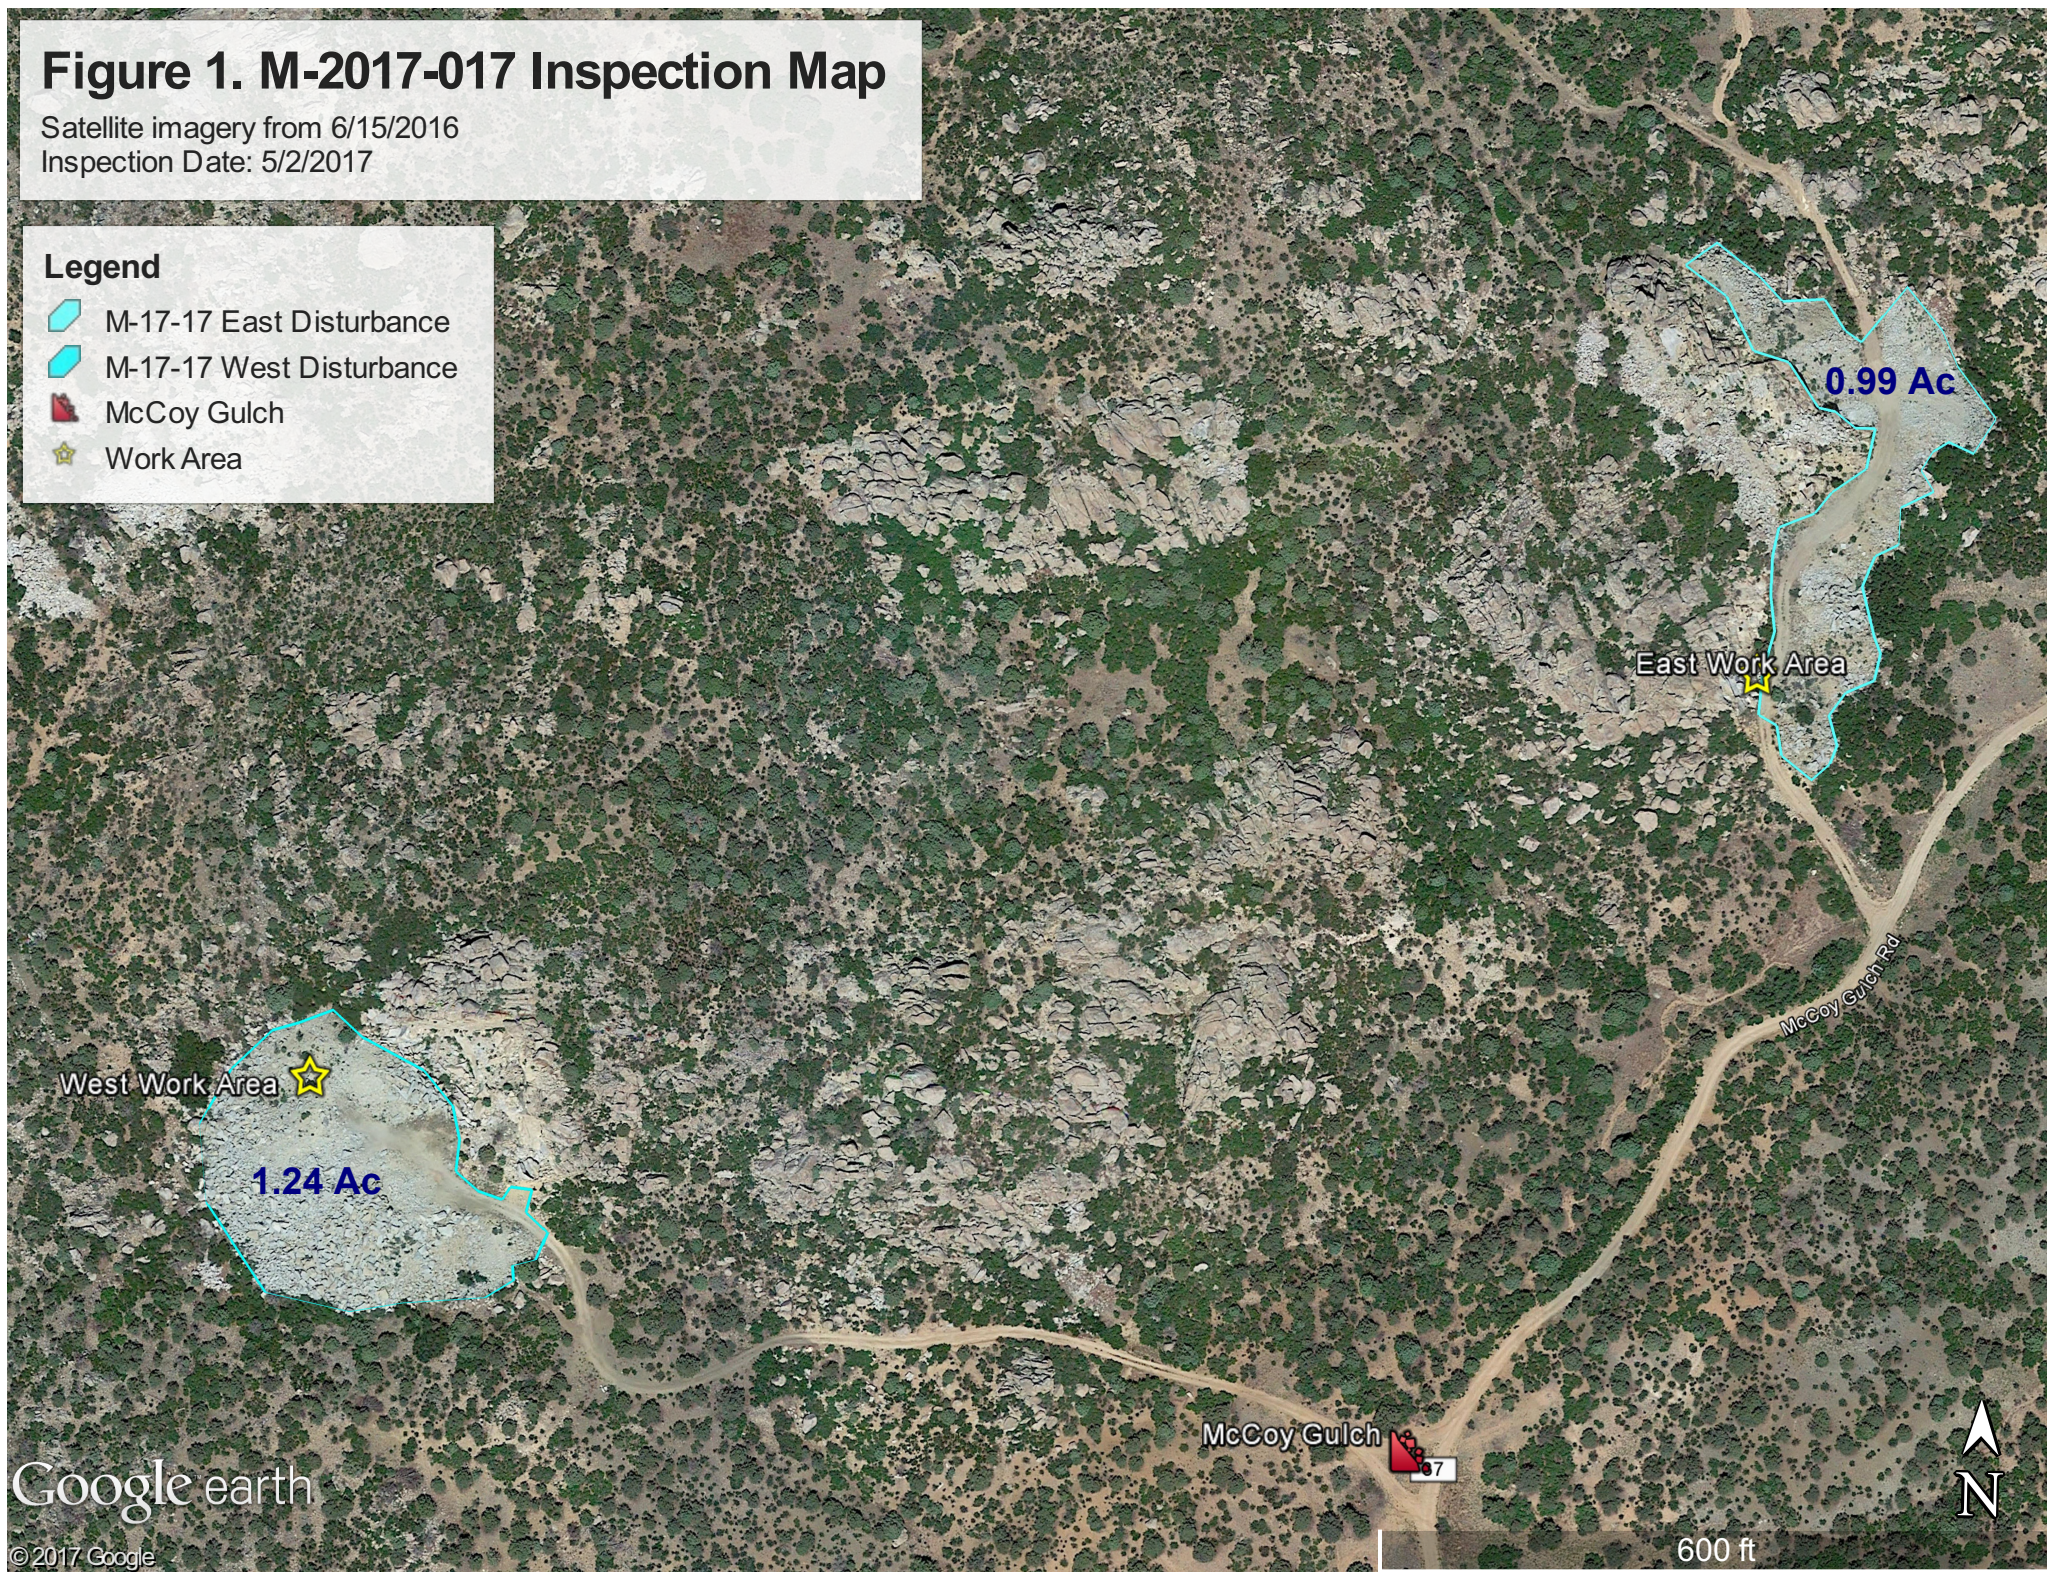
Figure 1. M-2017-017 Inspection Map

The purpose of the inspection was for Mr. Klco to brief the Division on the proposed mine and reclamation plans his client has for the site. Two small areas were historically worked. Both were blasted and a system of cables were used to move large rocks to the valley below where apparently wagons were used to transport the material offsite. The area proposed for the permit is small and the intent is to only collect rock already loose as a result of the pre-law blasting operation. Size of the available rock varies from very large boulders to 3-inch minus material. There are two working areas, referred herein as "East" and "West" (see **Figure 1**).
