MINERALS PROGRAM INSPECTION REPORT

MINE NAME: Lamar West Pit	MINE/PROSPECTING ID#: M-1981-132	MINERAL: Sand and gravel	COUNTY: Prowers
INSPECTION TYPE: Monitoring	INSPECTOR(S): Amy Eschberger	INSP. DATE: November 27, 2017	INSP. TIME: 11:00
OPERATOR: Valco, Inc.	OPERATOR REPRESENTATIVE: Tom Brubaker	TYPE OF OPERATION: 112c - Construction Regular Operation

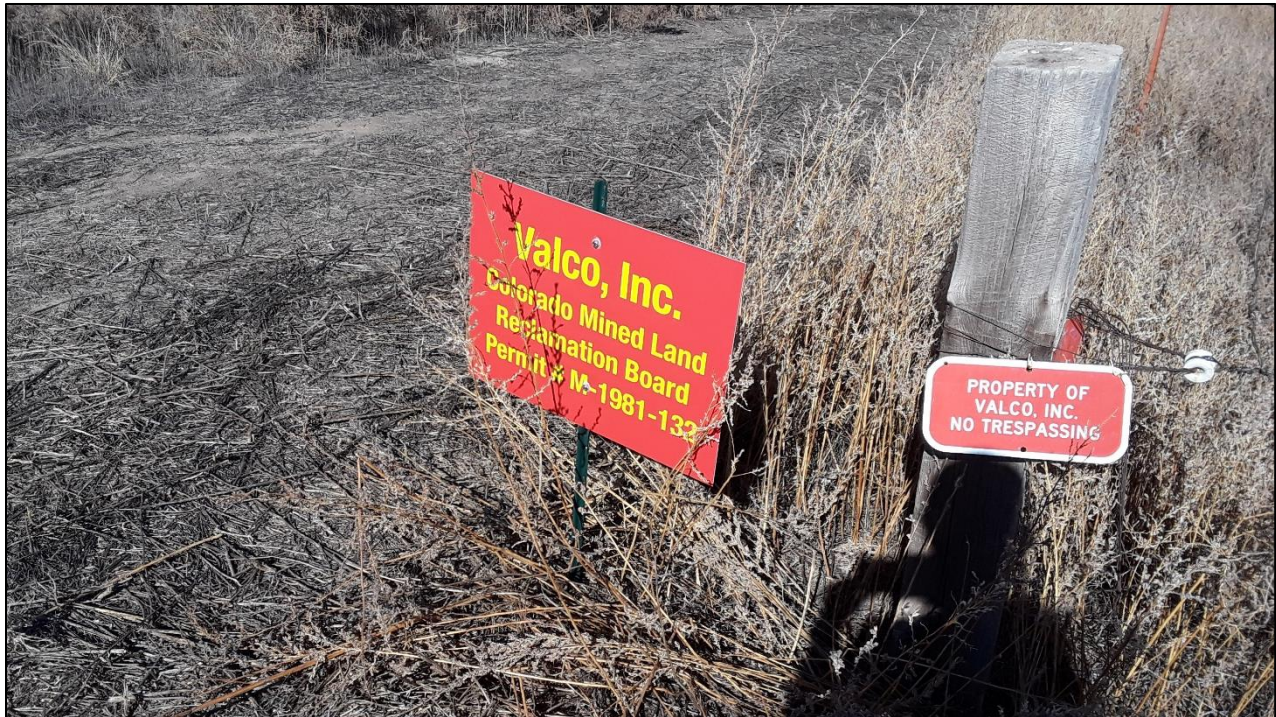
Photo 1. View of permit sign posted at main site entrance off of Holly Street.

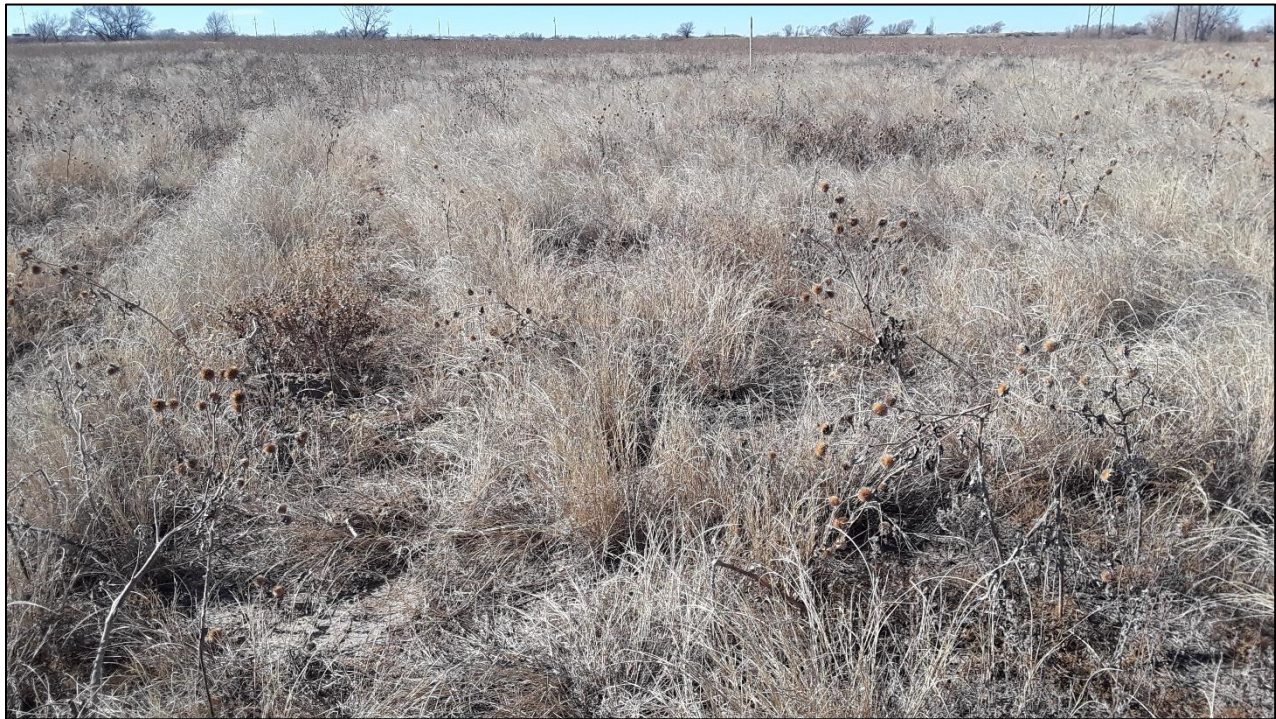
Photo 2. View looking west across northern portion of mining phase 1 area, which was undisturbed by the operation.

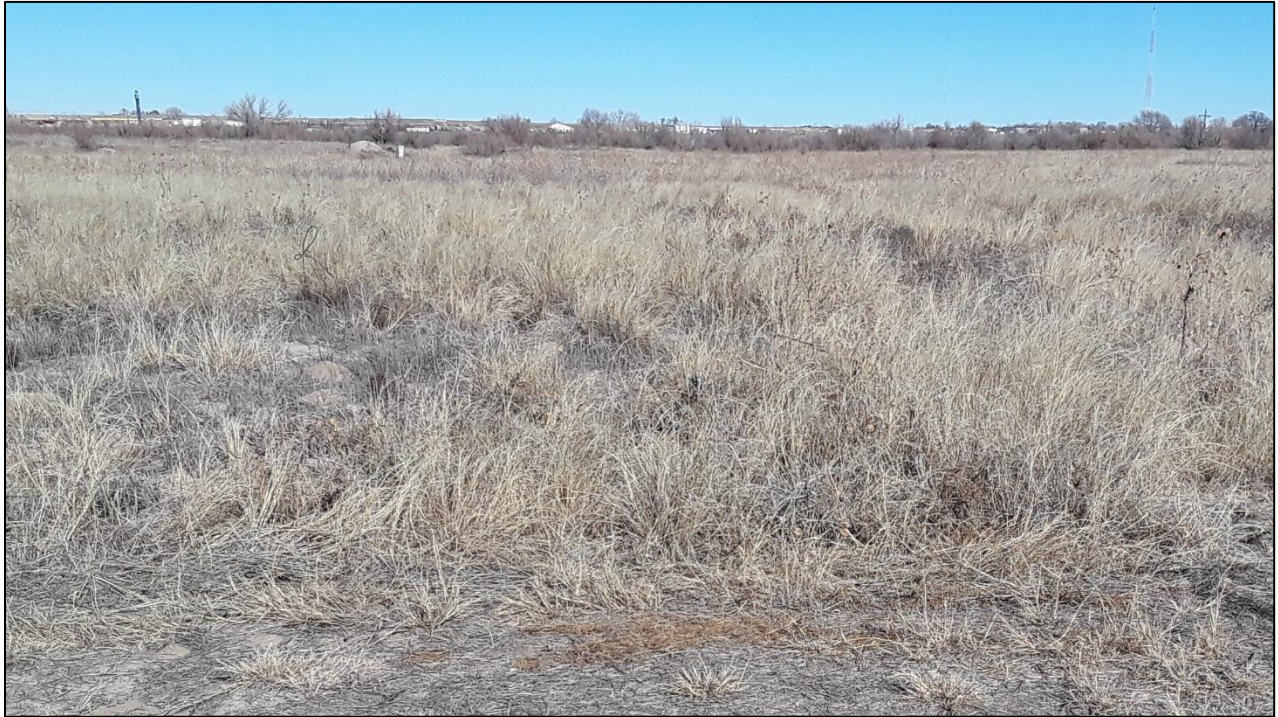
Photo 3. View looking north across area of mining phases 2 and 3, which were undisturbed by the operation.

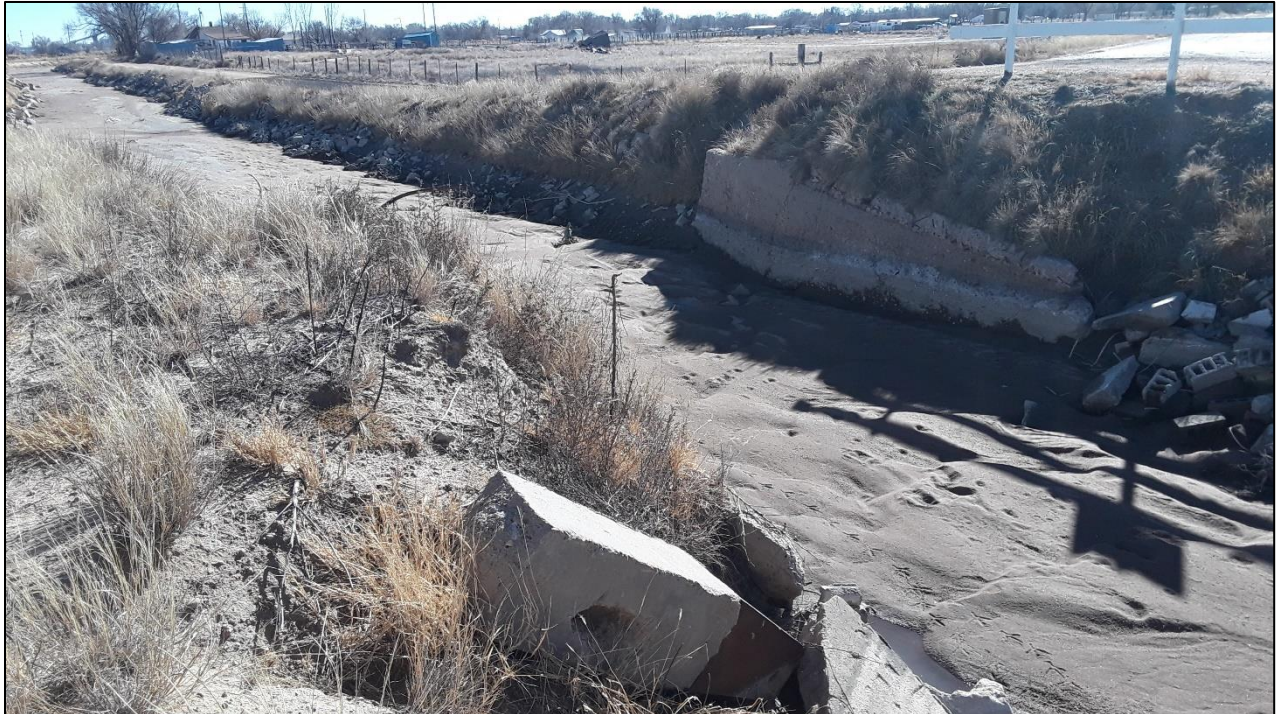
Photo 4. View looking southeast from southwestern corner of permit area, showing Lamar Canal present along southern permit boundary. Note canal was dry at the time of the inspection.

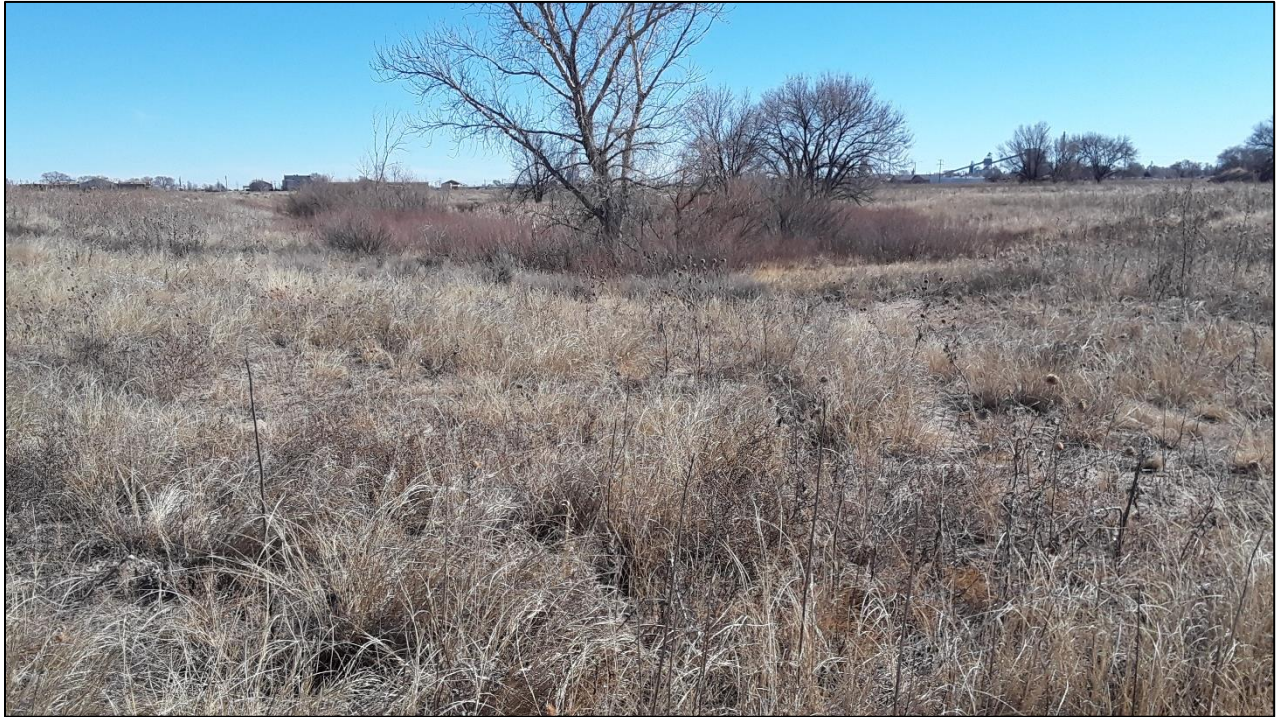
Photo 5. View looking east across reclaimed excavation area located in southern portion of permit area. This disturbance is 2.75 acres in size and approximately 15 feet deep, with slopes that are flatter than 3H:1V.

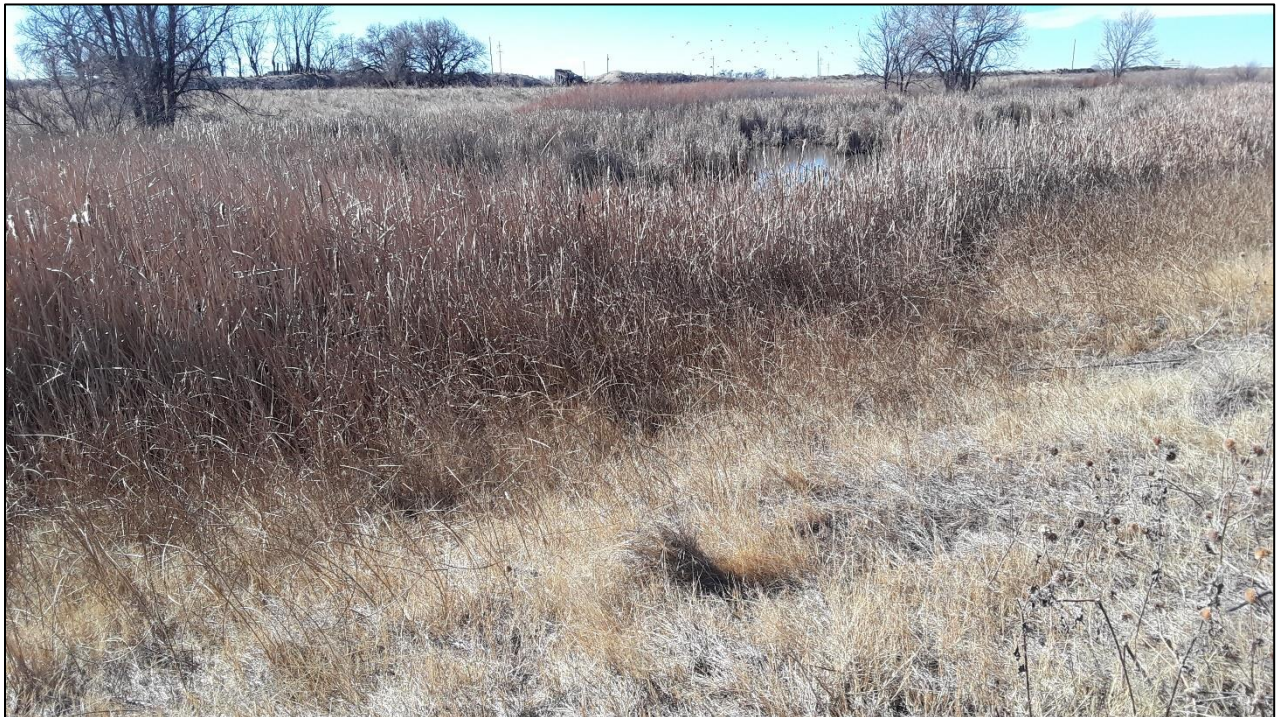
was observed to be dry. However, in review of historic imagery of the site in Google Earth, it appears the excavation has held water at times, at least as far back as 1988. Based on this information, the lack of precipitation in the region in recent weeks, and the presence of wetland vegetation on the pit floor, the Division believes the water is exposed groundwater.

Photo 6. View looking west across reclaimed excavation area located in southern portion of permit area. Note presence of wetland vegetation across bottom of excavation.

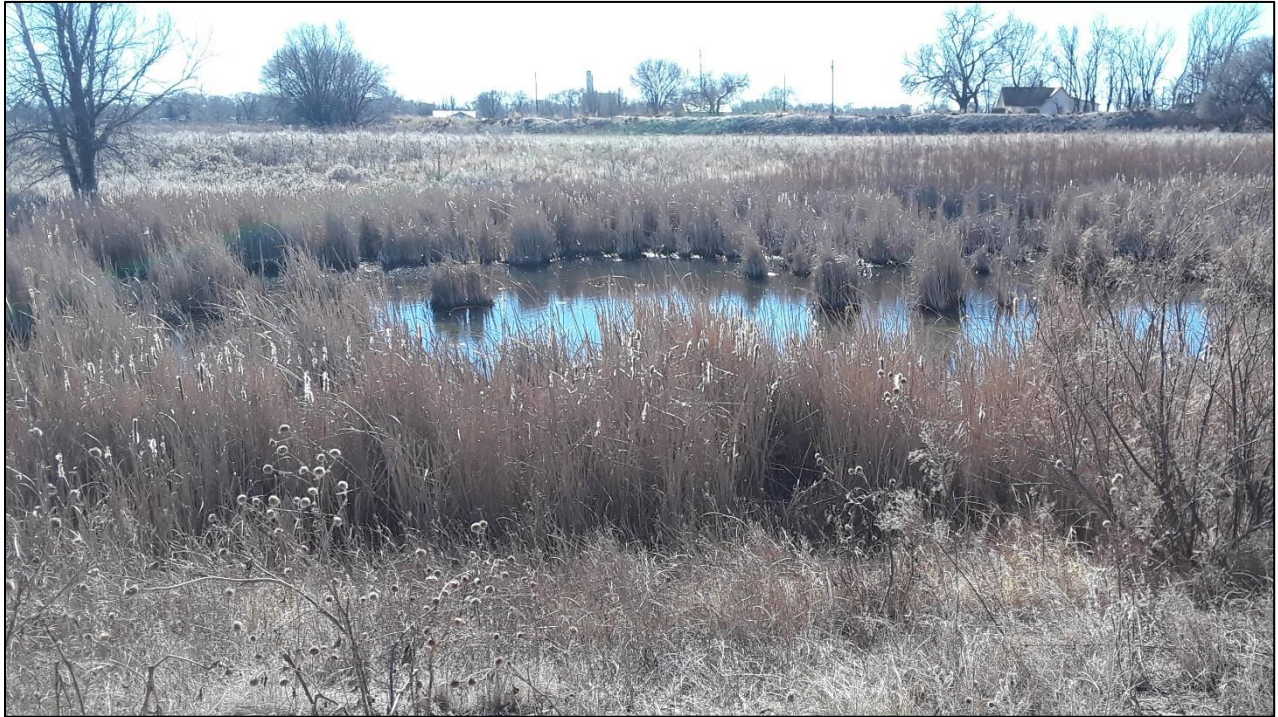
PROBLEM: The Division has no evidence that the operator has a valid well permit, substitute water supply plan, or approved water augmentation plan for the exposed groundwater at the site. This is a problem related to 34-32.5-116(4)(h) of the Colorado Revised Statutes and 3.1.6(1)(a) of the Construction Materials Rules and Regulations governing injury to existing water rights.

The Division would recommend the operator submit a full release request for the site, except that a problem was identified which will require corrective action before the site could be released. The Division observed the pit to be holding some water during the inspection. The Division estimated the water to be approximately one foot in depth and its surface area to be no more than one acre in size. During the past few inspections of the site, the pit

Photo 7. View looking south across reclaimed excavation area located in southern portion of permit area. Note presence of water and wetland vegetation at bottom of excavation.

CORRECTIVE ACTIONS: The operator shall demonstrate that the operation is in compliance with the Office of the State Engineer (SEO), show evidence that the operator is taking measures to bring the site into compliance with the SEO, or backfill the pits to at least two feet above the groundwater surface by the corrective action date specified.

Mr. Brubaker indicated that, if necessary, material could be removed from the outer edges of the pit to place approximately 3 feet of fill in the pit to cover exposed groundwater. Based on the Division's calculations, the operator would need approximately 4,840 cubic yards of material to cover the exposed groundwater to 2 feet above the water level (1 acre pit floor x 1 foot deep). If the operator removes material from the site to backfill the pit, the newly disturbed areas will need to be revegetated in accordance with the approved reclamation plan. Another option would be for the operator to submit a Technical Revision to import inert backfill material to the site for reclamation. Although this option may be more costly, it would minimize disturbance of currently reclaimed areas around the pond so that the site could be released sooner.

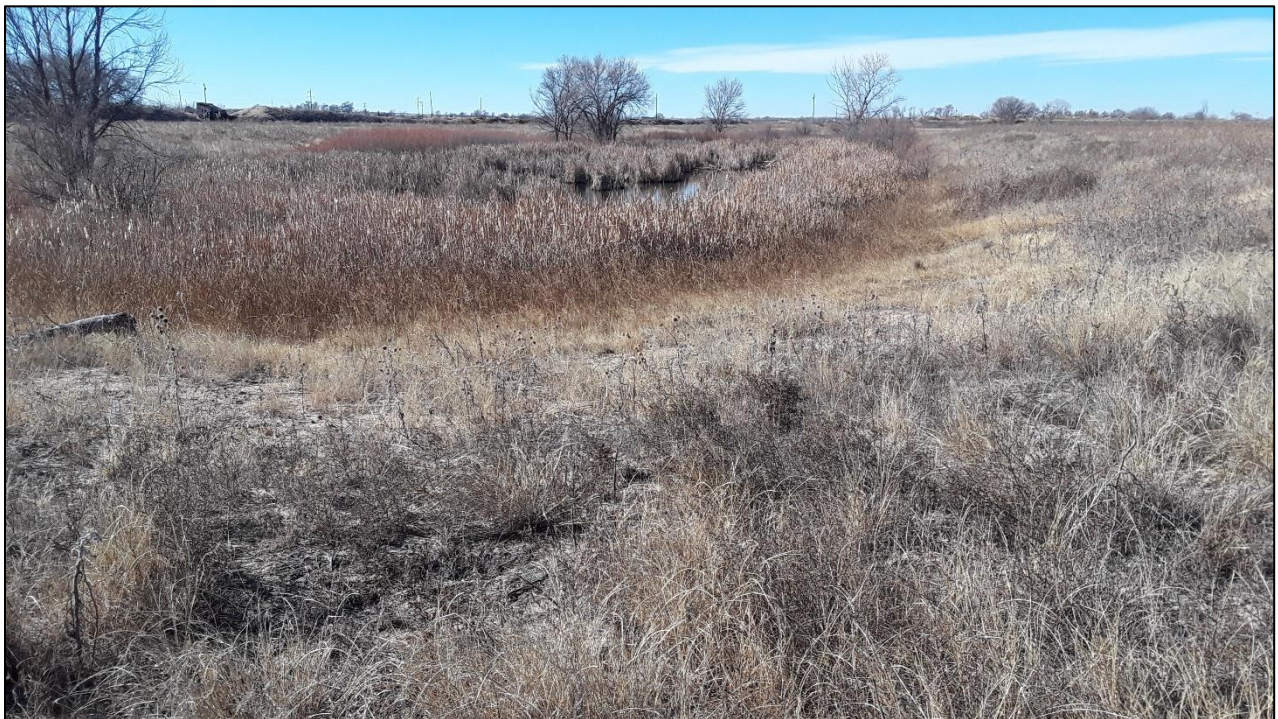
The Division observed some weeds (mainly annual) present on site, especially in the disturbance area. The weeds did not appear to be hindering the growth of desired vegetation. However, the Division recommends the operator continue to monitor the growth and spread of weeds particularly in the disturbed area, and implement the approved weed control plan as needed.

Photo 8. View looking west across reclaimed excavation area located in southern portion of permit area. Note slopes of excavation graded flatter than 3H:1V and fairly well vegetated with native grasses, forbs, and some annual weeds.

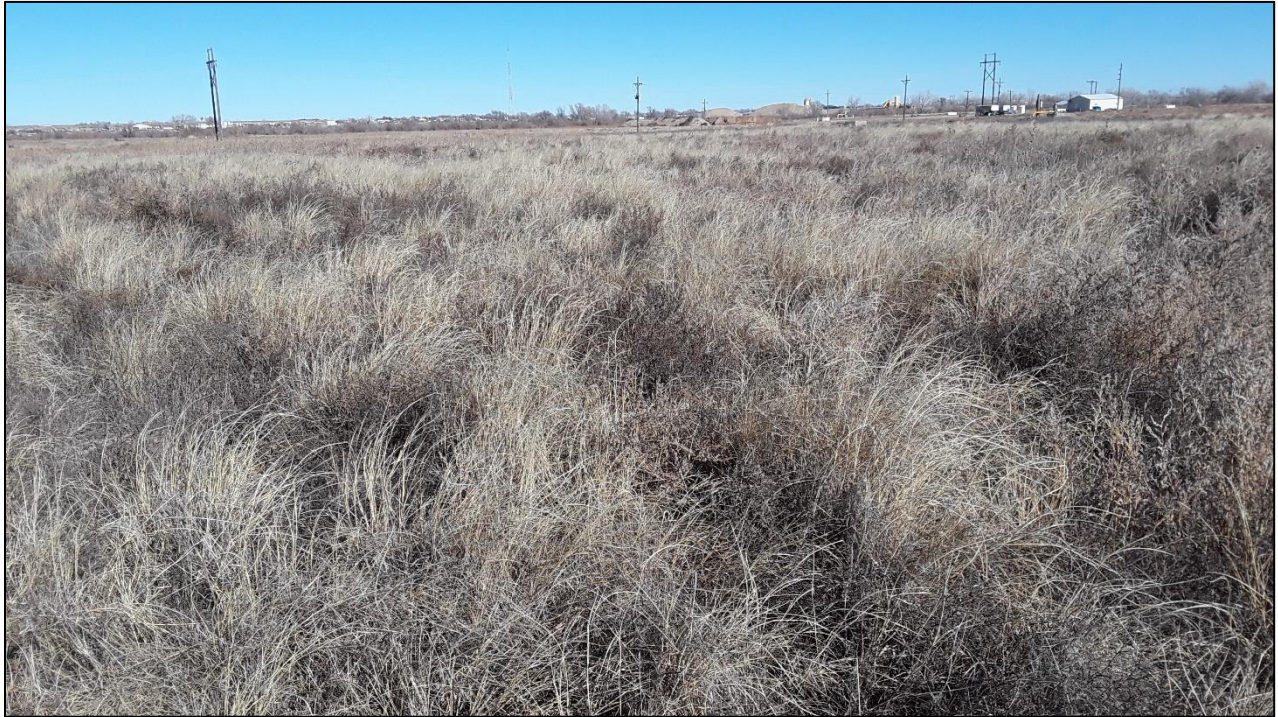
Photo 9. View looking east across land east of excavation, which was undisturbed by the operation.

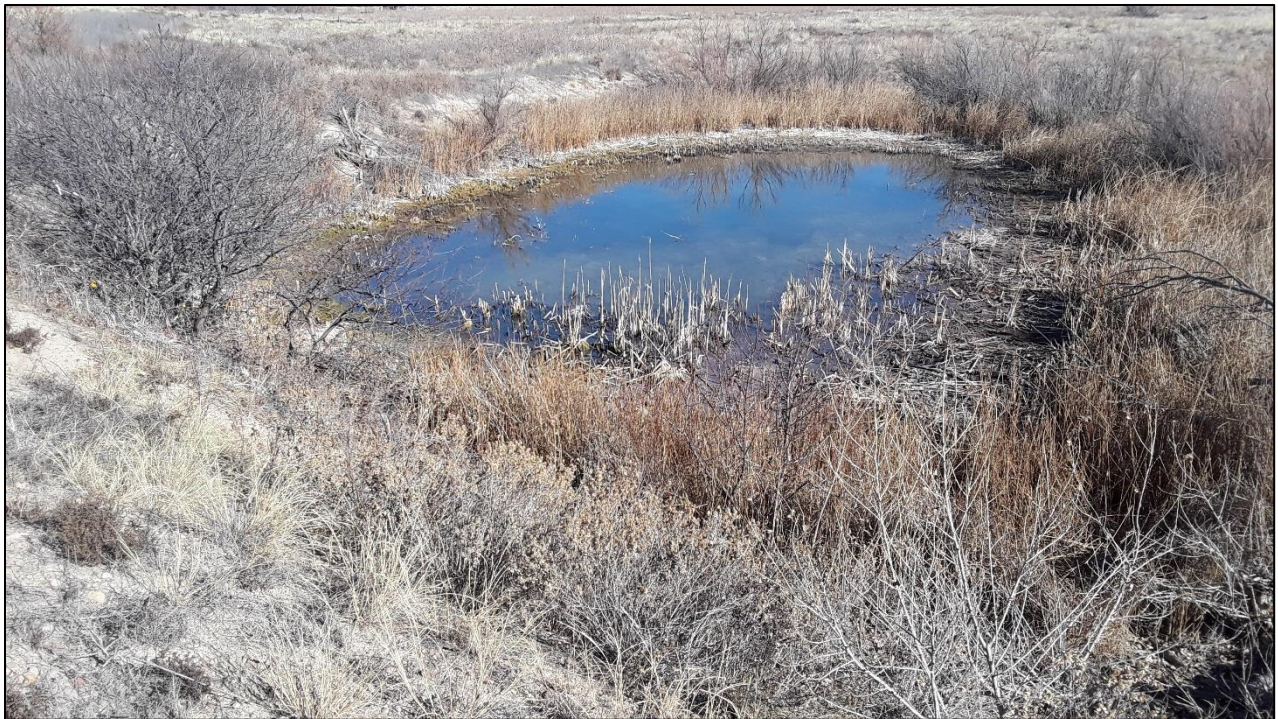
It should be noted that a smaller excavation, approximately 0.35 acre in size, is present in the southwestern corner of the permit area, near the intersection of the flood levee and the Lamar Canal. According to Mr. Brubaker, this excavation was not created by the operation. This area is not described in past annual reports submitted by the operator or in inspection reports written by the Division. In review of historical imagery of the site available in Google Earth, this small excavation appears to have been present at least as early as October of 1988. This excavation was holding some water during the inspection. The slopes of the excavation appeared to be stable with vegetative cover. It is possible the excavation was created by the company that constructed the flood levee, canal and other water control structures in the area.

Photo 10. View of small excavation located in southwestern corner of permit area, near the intersection of the flood levee and the Lamar Canal. The operator indicates this excavation was not done by the operation and may have been created by the company that constructed the nearby water control structures.
