MINERALS PROGRAM INSPECTION REPORT PHONE: (303) 866-3567

MINE NAME:		MINE/PROSPECTING ID#:	MINERAL:	COUNTY:	
Navajo Clay Pit		M-1993-004	Clay (general)	Elbert	
INSPECTION TYPE:		INSPECTOR(S):	INSP. DATE:	INSP. TIME:	
Monitoring		Peter S. Hays	November 30, 2017	11:00	
OPERATOR:		OPERATOR REPRESENTATIVE:	TYPE OF OPERATION:		
General Shale Brick, Inc.		Jason McGraw	112c - Construction	Regular Operation	
REASON FOR INSPECTION:		BOND CALCULATION TYPE:	BOND AMOUNT:		
Normal I&E Program		Partial Bond	\$48,297.00		
DATE OF COMPLAINT:		POST INSP. CONTACTS:	JOINT INSP. AGENCY:		
NA		None	None		
WEATHER:	INSPECTOR'S SIGNATURE:		SIGNATURE DATE:		
Clear	f Agres		December 12, 2017		
	1	Il/ry

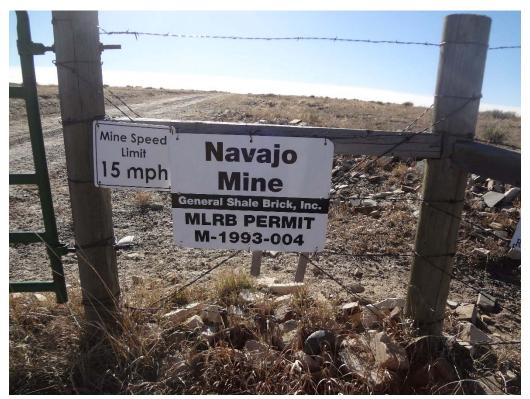
The Division currently holds a financial warranty in the amount of \$48,297.00, which appears adequate to reclaim the site based on this inspection. The mine sign and boundary markers were observed as required by Rule 3.1.12. All mining disturbance was contained within the permit boundary.

Navajo Mine sign

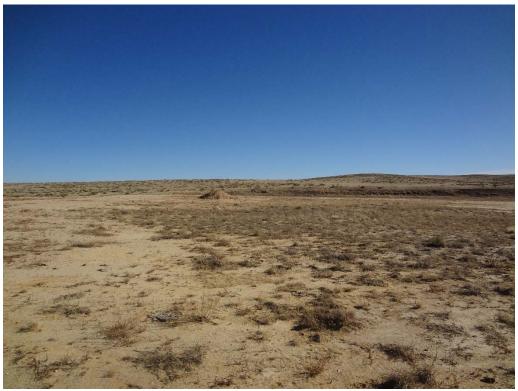
Stockpile area containing a small material stockpile looking east from the west side of the area

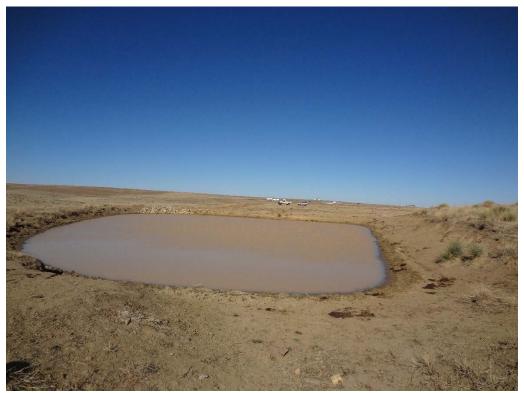
The site status was accurately depicted by the Operator in the 2017 Annual Report. The site consists the mine pit in the northwest corner of the site, a stockpile area located southeast of the pit with a stormwater detention pond in the southwest corner of the stockpile area and an access road from the northeast corner of the site to the stockpile area. The mine pit was approximately 35 feet deep and contained groundwater. The Operator has a valid well permit (65324-F) and water rights (Colorado Groundwater Commission Determination No. 1029-D) according to the Division's records. The pit slopes were estimated at 1.5H:1V with numerous erosion gullies. The erosion features were contained to the pit area and did not pose a threat to effect off-site areas. The pit will be mined to the west when mining operations commence. The stockpile area contained a small stockpile of clay. The Operator stated the site would be mined soon to produce material stockpiles. The stormwater detention pond contained water and appeared to be function as designed with no evidence of erosion at the inlet or outlet of the pond.

View of the stormwater detention pond from the south side looking north

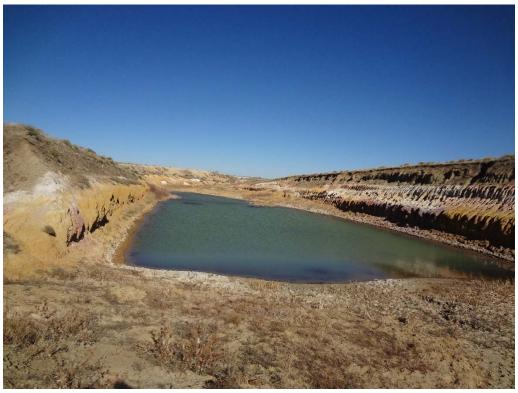
View of the mine pit from the south side looking north
