MINERALS PROGRAM INSPECTION REPORT
PHONE: (303) 866-3567

MINE NAME: Buffalo No 1	MINE/PROSPECTING ID#: M-1978-011	MINERAL: Clay (general)	COUNTY: Elbert
INSPECTION TYPE: Monitoring	INSPECTOR(S): Peter S. Hays	INSP. DATE: November 30, 2017	INSP. TIME: 13:00
OPERATOR: General Shale Brick, Inc.	OPERATOR REPRESENTATIVE: Jason McGraw	TYPE OF OPERATION: 112c - Construction Regular Operation	
REASON FOR INSPECTION: Normal I&E Program	BOND CALCULATION TYPE: Partial Bond	BOND AMOUNT: \$42,491.00	
DATE OF COMPLAINT: NA	POST INSP. CONTACTS: None	JOINT INSP. AGENCY: None	
WEATHER: Clear	INSPECTOR'S SIGNATURE:

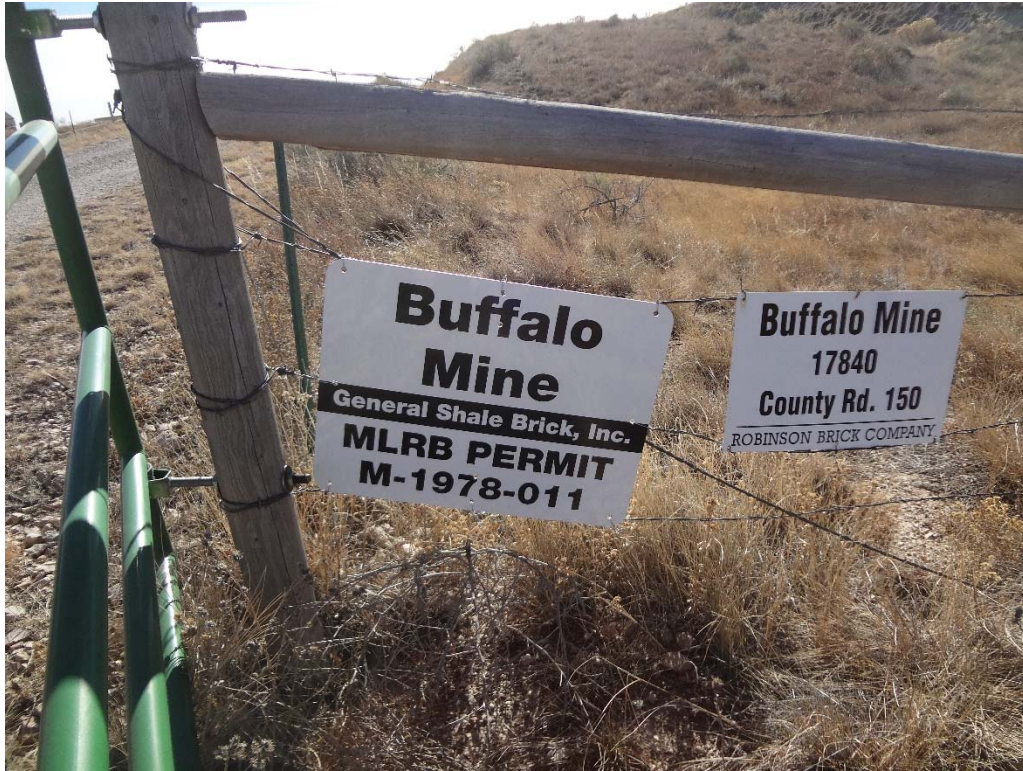
The Division currently holds a financial warranty in the amount of \$42,491.00, which appears adequate to reclaim the site based on this inspection. The mine sign and boundary markers were observed as required by Rule 3.1.12. All mining disturbance was contained within the permit boundary.

Buffalo No. 1 Area III mine sign

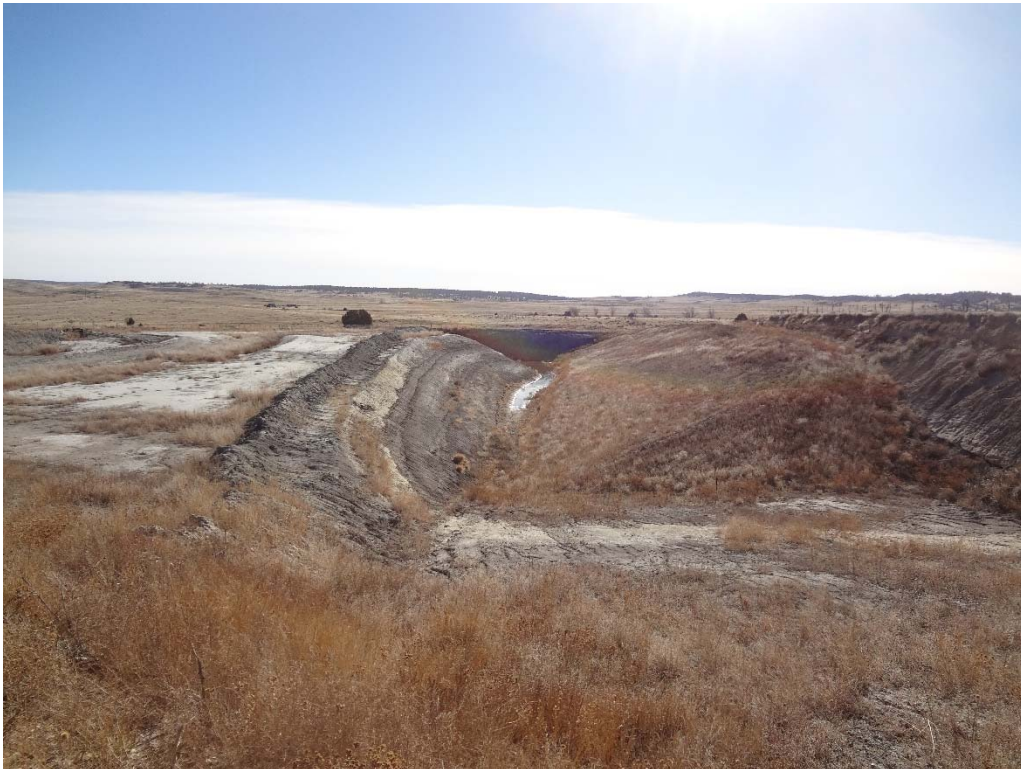
View of the southern portion of the site from the stockpile area looking south

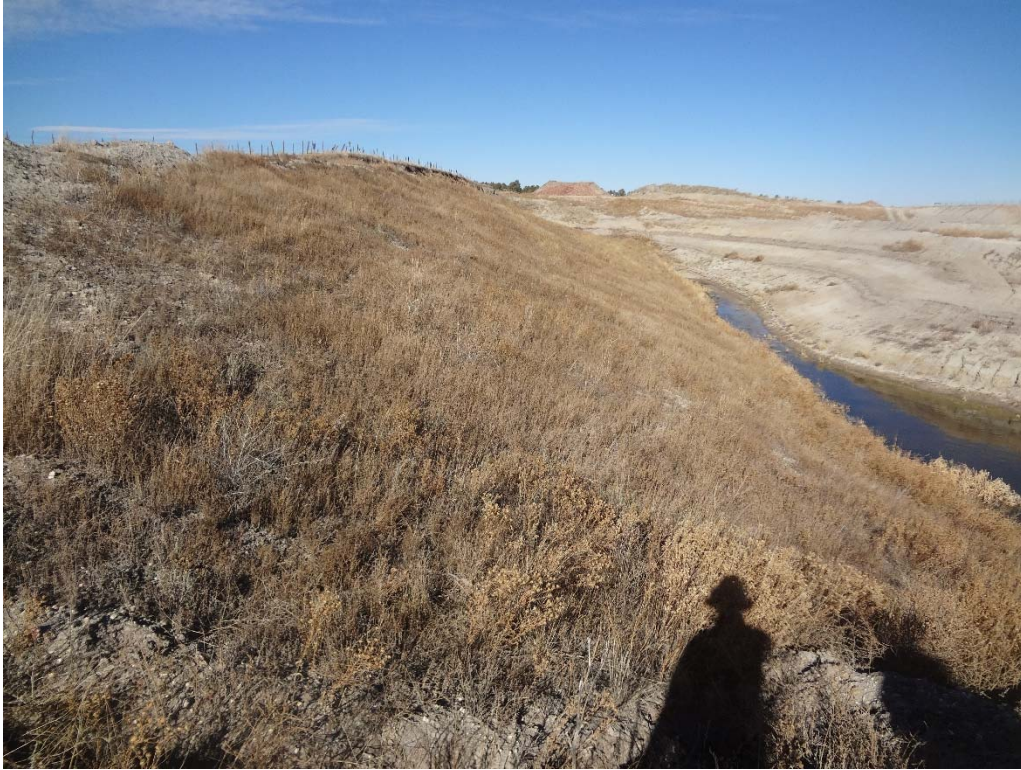
The approved post mining land use for the site is rangeland. No reclamation besides the highwall backfill has been conducted at the site. Photographs taken during the inspection are attached.

View of the pit and backfilled western highwall with volunteered vegetation looking north

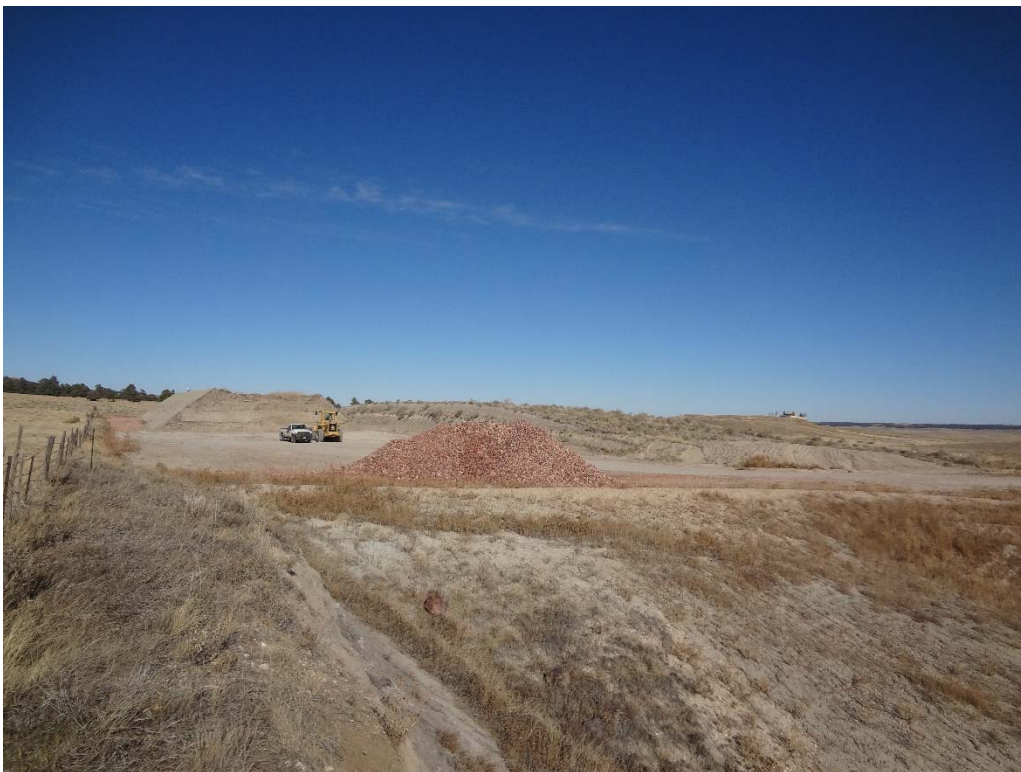
The site status was accurately depicted by the Operator in the 2017 Annual Report. The north portion of the site is used for stockpile storage. The stockpile area contained a clay stockpile, well-vegetated topsoil and overburden stockpiles and a small stockpile of waste brick (grog). The importation of the waste brick for inert fill was approved by the Division in 2015 under TR-01. The southern portion of the site contains the mining excavation in the western half of the area and a stormwater detention pond and an unmined area in the eastern half of the area. The mine pit contained stormwater which should be pumped out by the Operator to comply with the CDPHE 72-hour release requirement for captured stormwater. The stormwater detention pond was dry at the time of the inspection. The mining highwall has been backfilled along the western boundary. The backfill was estimated at a 3H:1V slope and was vegetated with volunteered vegetation consisting of annual weeds. The Operator stated the backfill area had not been topsoiled or reseeded as part of the reclamation activities. The mine excavation will continue to the east and then to the north during the life of the mine.

View of the stockpile area from the NW corner of the pit looking north
