**MINERALS PROGRAM INSPECTION REPORT****PHONE: (303) 866-3567**

<b>MINE NAME:</b> Valley's Edge Resource	<b>MINE/PROSPECTING ID#:</b> M-2016-030	<b>MINERAL:</b> Gravel and Sand	<b>COUNTY:</b> Weld
<b>INSPECTION TYPE:</b> Monitoring	<b>INSPECTOR(S):</b> Peter S. Hays	<b>INSP. DATE:</b> December 1, 2017	<b>INSP. TIME:</b> 14:00
<b>OPERATOR:</b> Brannan Sand and Gravel Company, L.L.C.	<b>OPERATOR REPRESENTATIVE:</b> Alex Schatz	<b>TYPE OF OPERATION:</b> 112c - Construction Regular Operation

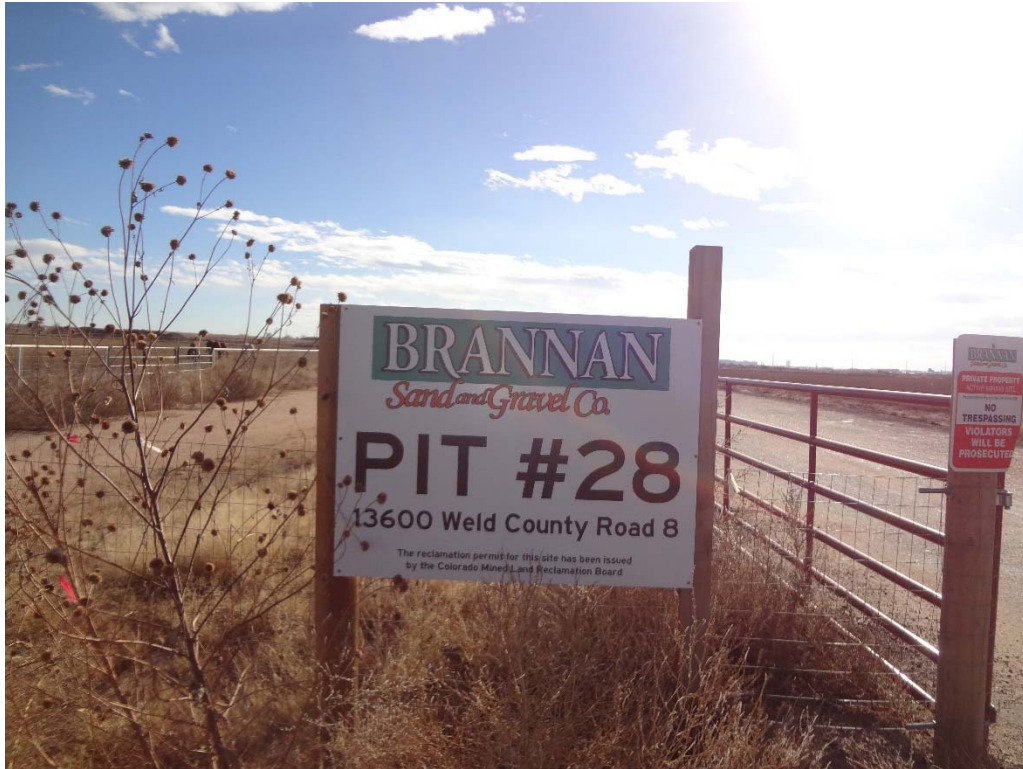
**PROBLEM/POSSIBLE VIOLATION:** Problem: The mine identification sign posted at the entrance of the mine site did not include the permit number for the site. This is a problem for failure to post a mine identification sign as required by Rule 3.1.12(1).

The mine sign located at the site entrance did not indicate the DRMS permit number assigned to the site as required by Rule 3.1.12(1). As cited as a problem above, the Division will require the Operator update the mine sign with the permit number. The Operator shall submit photo documentation sign is updated by the corrective action date. The affected boundary markers were installed as required by Rule 3.1.12(2).

Valley's Edge Resource mine sign without a permit number

**CORRECTIVE ACTIONS:** The Operator shall, at the entrance of the mine site, post a sign which shall be clearly visible from the access road with the following: the name of the operator, a statement that a reclamation permit for the operation has been issued by the Colorado Mined Land Reclamation Board; and the permit number. The Operator shall submit photo documentation a proper sign has been posted by the corrective action date.

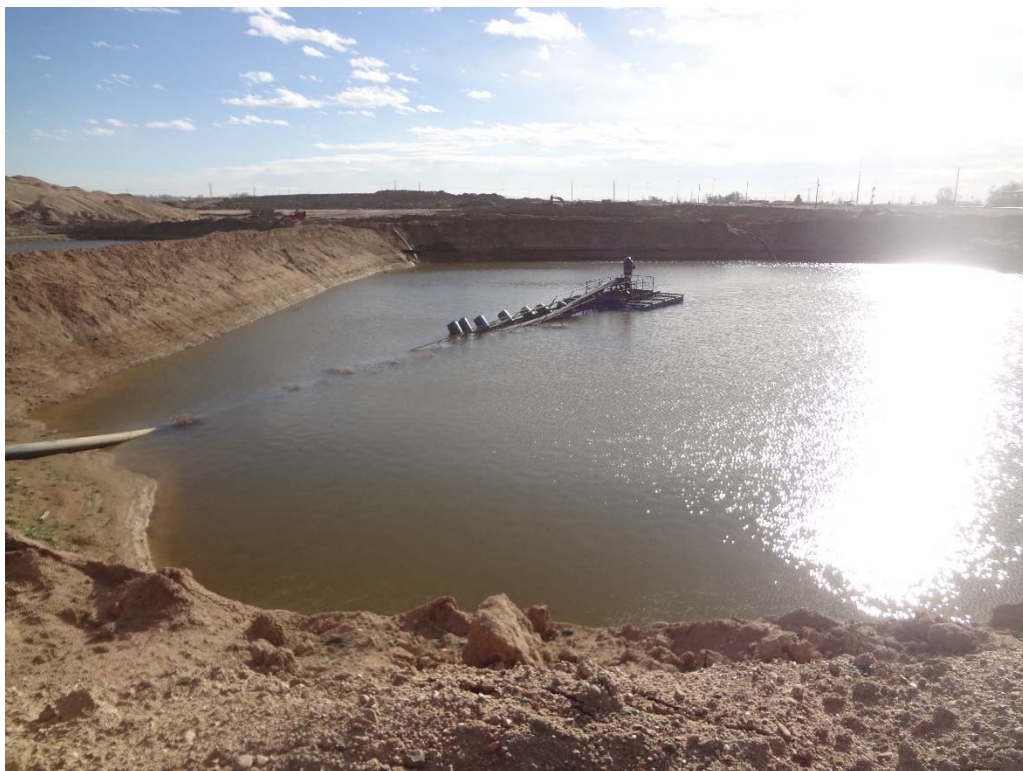
View of the process water pond located in the northwest corner of the site

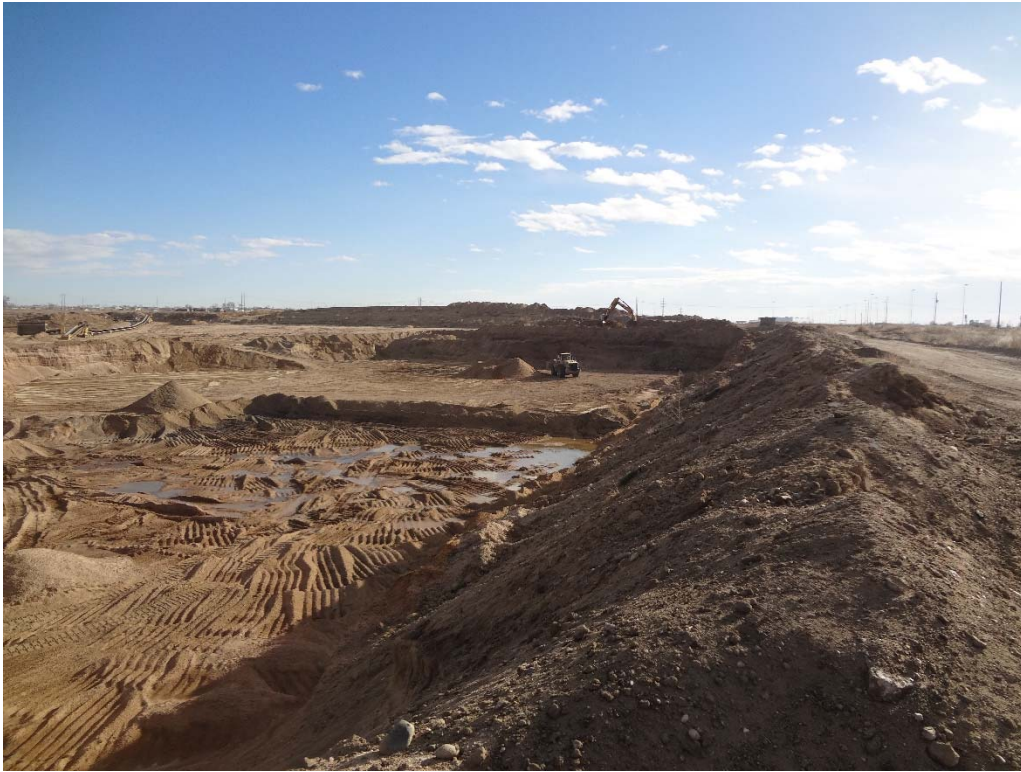
View of the mining activity from the NW corner of Phase 1A looking south at the western portion of Phases 1A and 1B

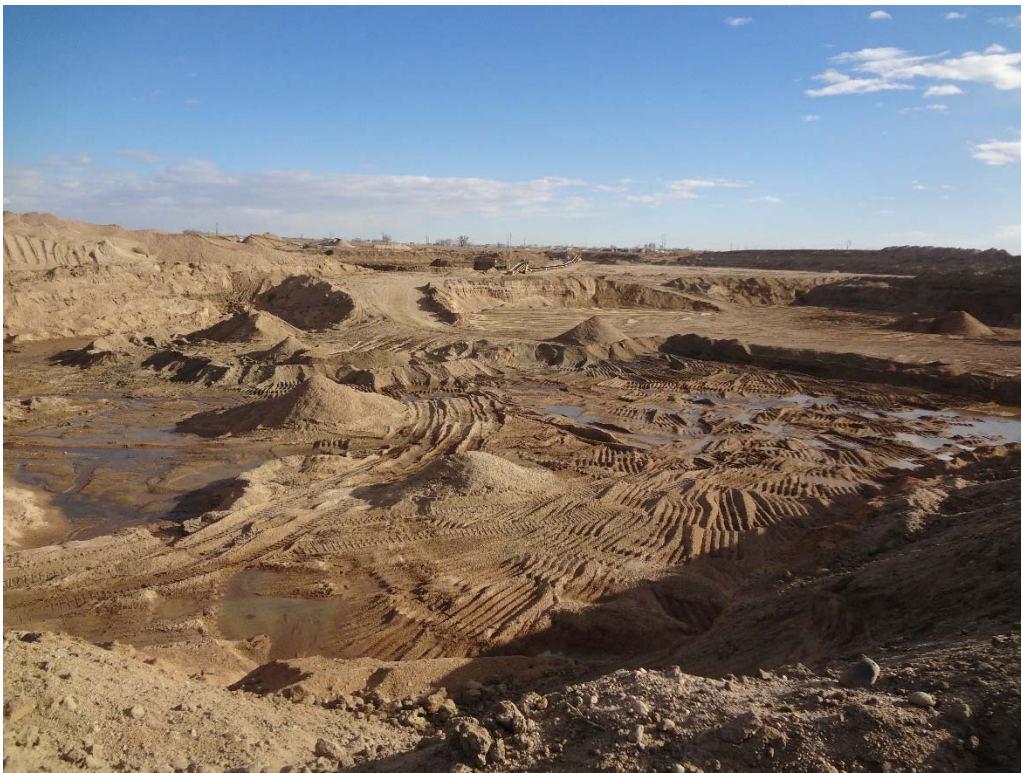
View of the mining activity from the NW corner of Phase 1A looking southeast at the western portion of Phases 1A and 1B

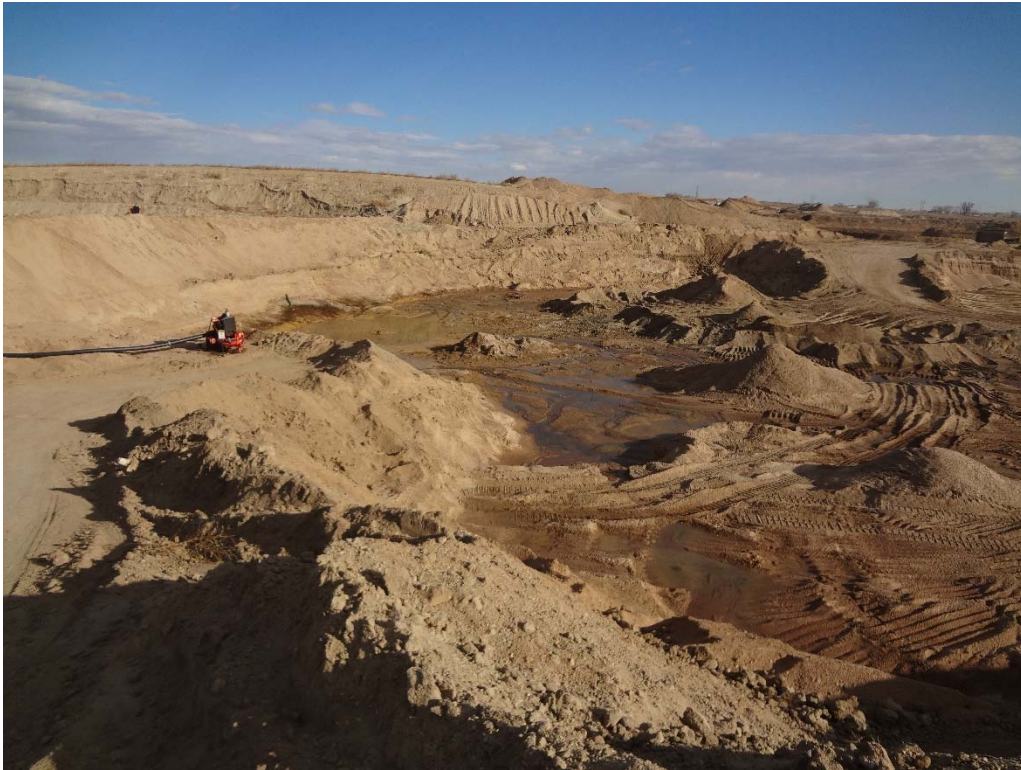
View of the mining activity from the NW corner of Phase 1A looking east at the western portion of Phases 1A and 1B

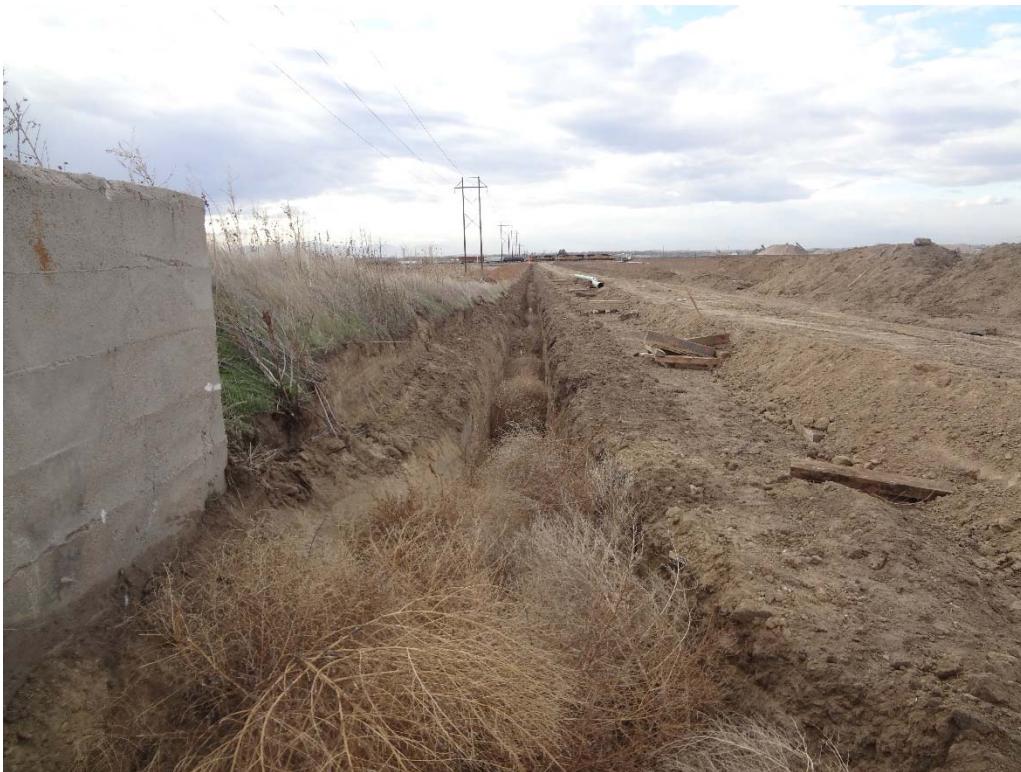
View of the installation of the DJ Services gas pipeline along the southern permit boundary
