MINERALS PROGRAM INSPECTION REPORT

MINE NAME: C-JD-5	MINE/PROSPECTING ID#: M-1977-248	MINERAL: Uranium and vanadium	COUNTY: Montrose
INSPECTION TYPE: Monitoring	INSPECTOR(S): Dustin M. Czaplá	INSP. DATE: December 12, 2017	INSP. TIME: 10:30
OPERATOR: Gold Eagle Mining, Inc.	OPERATOR REPRESENTATIVE: None	TYPE OF OPERATION: 112d-1 - Designated Mining Operation	
REASON FOR INSPECTION: Normal I&E Program	BOND CALCULATION TYPE: None	BOND AMOUNT: \$100.00	
DATE OF COMPLAINT: NA	POST INSP. CONTACTS: None	JOINT INSP. AGENCY: None	
WEATHER: Clear	INSPECTOR'S SIGNATURE:

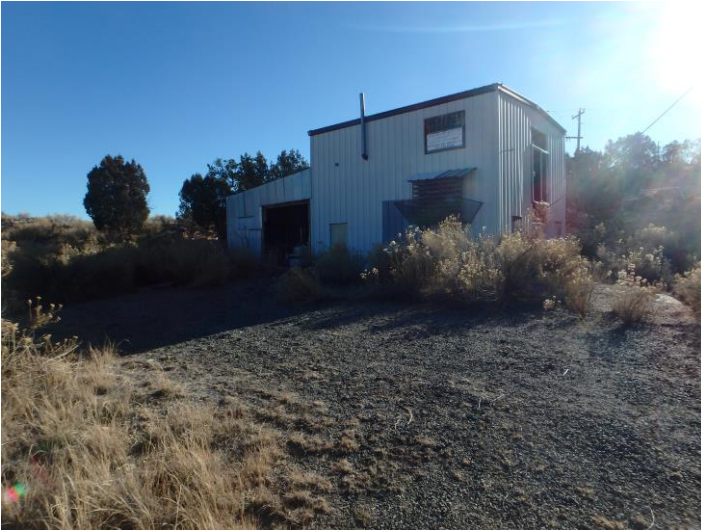
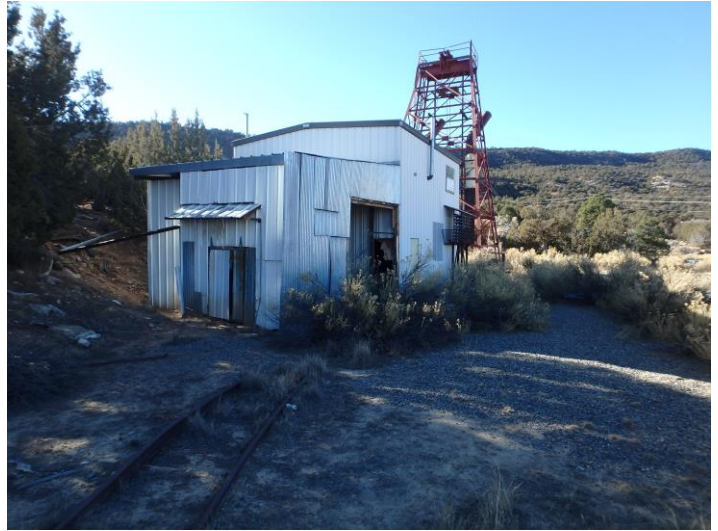
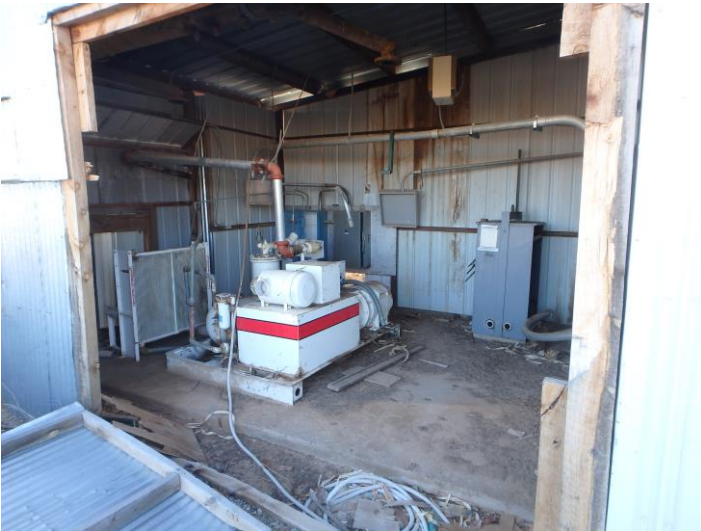
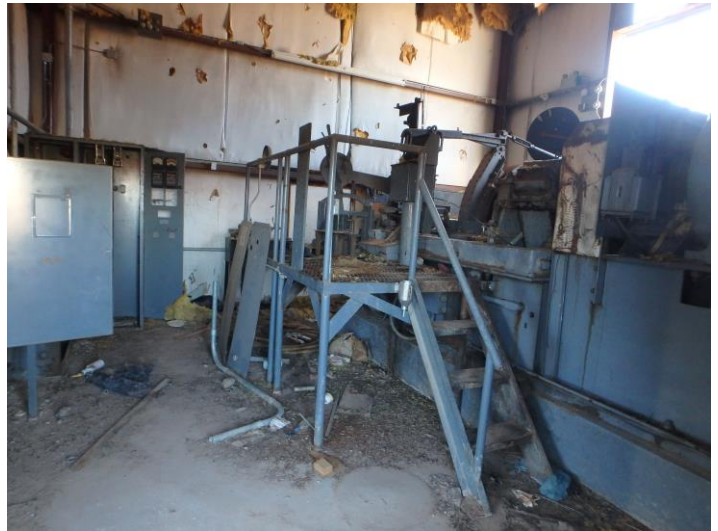
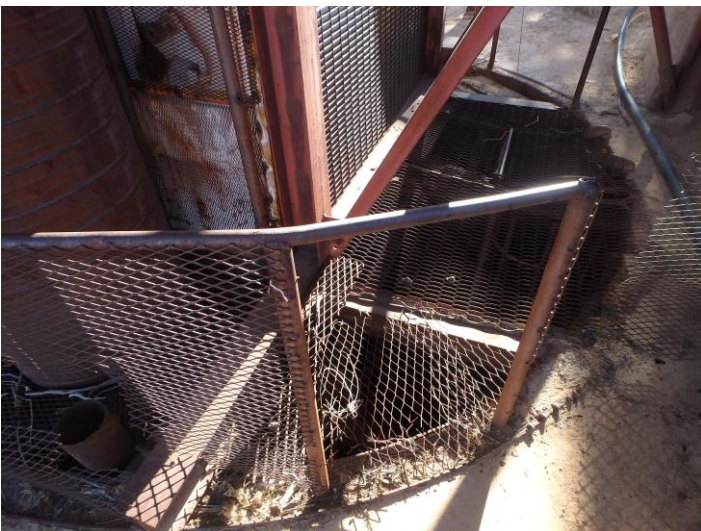
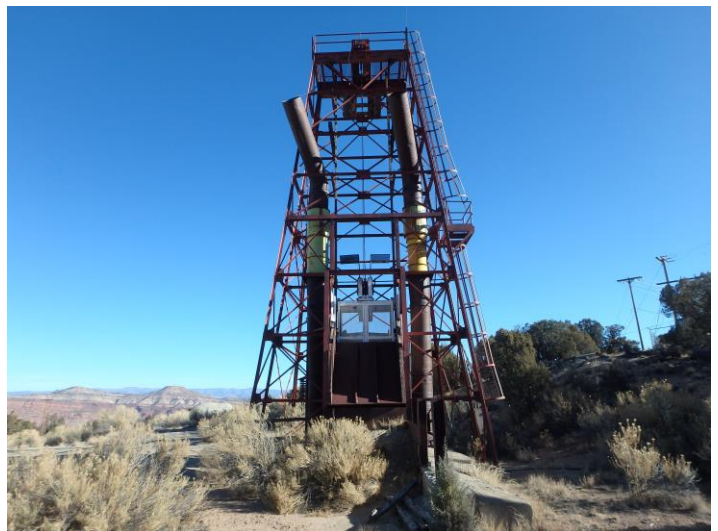
Adequate mine identification signage was posted on the hoist house visible from the entrance to the mine site.

The mine building and hoist assembly have been damaged by vandalism.
