COLORADO
Division of Reclamation,
Mining and Safety
Department of Natural Resources

Permit Number: C-1981-012 Mine Name: New Elk Mine Operator: New Elk Coal Company, LLC Operator Address: Mr. Louis Head 12250 Highway 12 Weston, CO 81091	County: Las Animas Operation Type: Underground Permit Status: Active Ownership: Private
	Operator Representative Present: None
Operator Representative Signature: (Field Issuance Only)

Inspection Start Date: December 11, 2017 Inspection Start Time: 16:12 Inspection End Date: Inspection End Time:	Inspection Type: Aerial Inspection Inspection Reason: Normal I&E Program Weather: Clear
Joint Inspection Agency: None	Joint Inspection Contacts:
Post Inspection Agency: None	Post Inspection Contacts:
Inspector(s): Harry B. Ranney	Inspector's Signature: <i>Rhet D. Zh</i> Signature Date: 12/15/2017

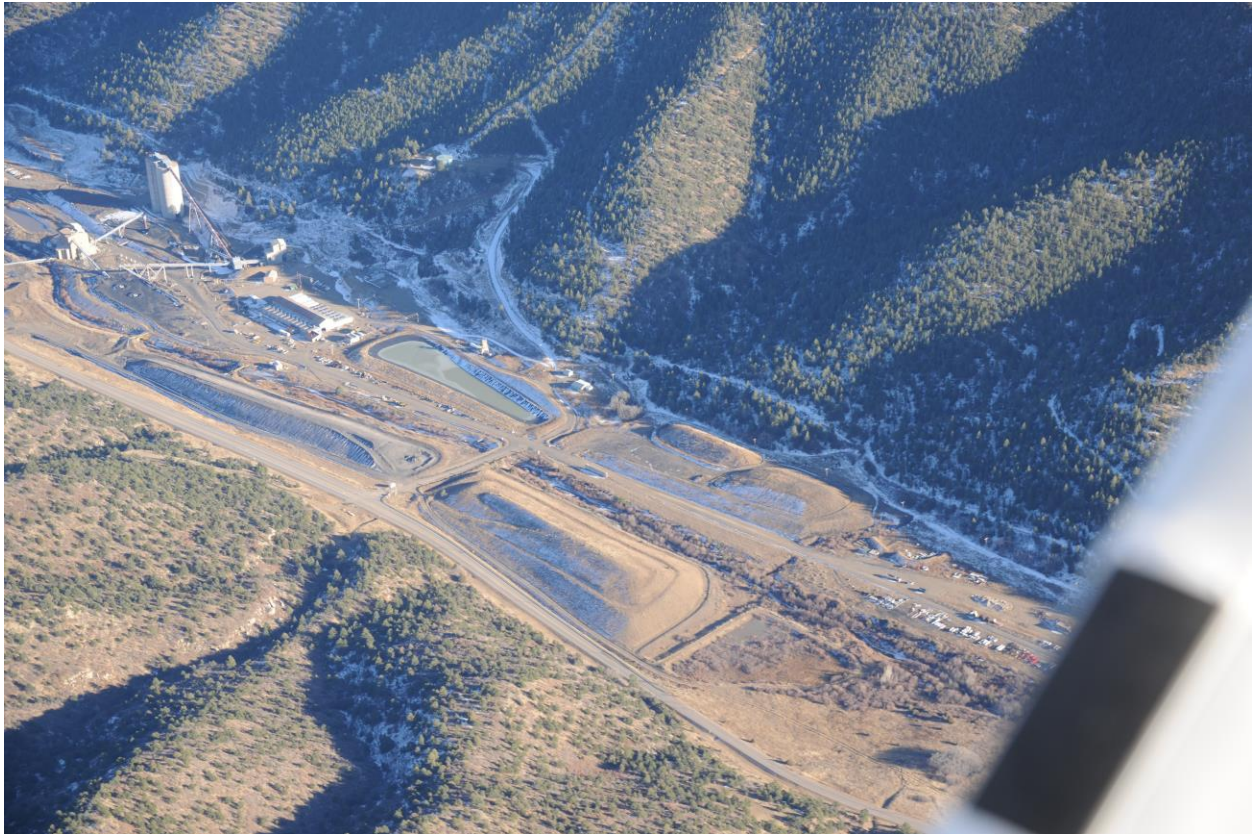
Central portion of mine site

The following ponds were inspected: Pond 001A, Pond 004A, Pond 006A, Pond 007A, and Pond 08. All of the ponds were holding water (relatively small amount in Pond 004A). No issues were identified with any embankments or spillways.

- **Note Pond 004A holding water to left of airplane strut**

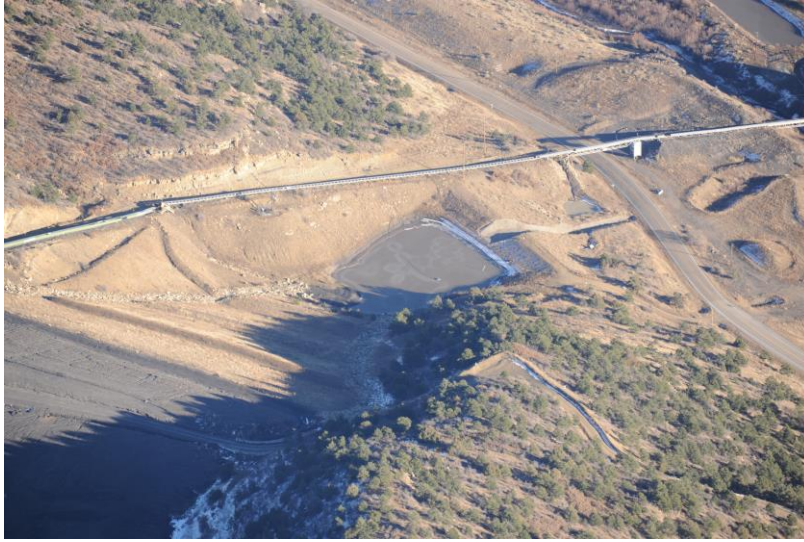
RDA and Pond 08

No erosion was seen on the face of the lower RDA (reclaimed portion). The ditch and other surface water control structures (namely sumps) between the upper RDA and lower RDA appears to be functioning well. No problems were seen with the upper (un-reclaimed) portion of the RDA.
