COLORADO
Division of Reclamation,
Mining and Safety
Department of Natural Resources

Permit Number: C-1996-084 Mine Name: Lorencito Canyon Mine Operator: New Elk Coal Company, LLC Operator Address: Mr. Louis Head 12250 Highway 12 Weston, CO 81091	County: Las Animas Operation Type: Surface Permit Status: Permanent Cessation Ownership: Private
	Operator Representative Present: None
Operator Representative Signature: (Field Issuance Only)

Inspection Start Date: December 11, 2017 Inspection Start Time: 16:15 Inspection End Date: Inspection End Time:	Inspection Type: Aerial Inspection Inspection Reason: Normal I&E Program Weather: Clear
Joint Inspection Agency: None	Joint Inspection Contacts:
Post Inspection Agency: None	Post Inspection Contacts:
Inspector(s): Harry B. Ranney	Inspector's Signature: <i>Phet D. Zh</i> Signature Date: 12/14/2017

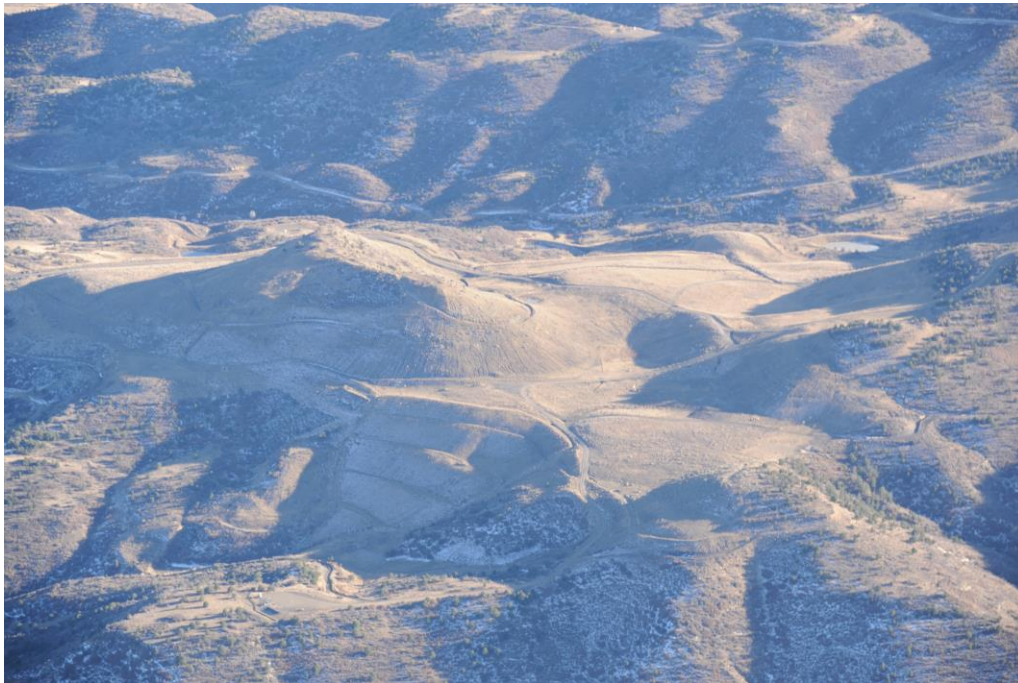
Fills 7, 8, and 9 were generally in good condition.

The northwest portion of the large hill (aka “the knob”) still appears to have many rills requiring maintenance.

Fill 8, “the knob” and other portions of the mine site

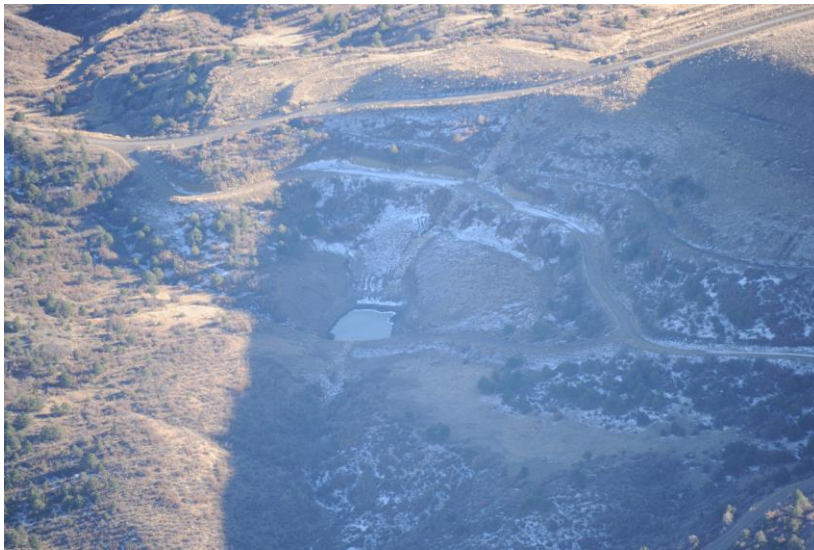
Ponds 6, 7, 8, 9, and 9A were inspected, and all contained water. No issues were identified with embankments or spillways. As in the past, the bank opposite the Pond 9 embankment (inlet side) is highly eroded.
