1313 Sherman Street, Room 215, Denver, CO 80203 P 303.866.3567 F 303.832.8106 http://mining.state.co.us

Permit Number: C-1981-012 Mine Name: New Elk Mine Operator: New Elk Coal Company, LLC Operator Address: Mr. Louis Head 12250 Highway 12 Weston, CO 81091 County: Las Animas Operation Type: Underground Permit Status: Active Ownership: Private

Inspection Start Date: December 13, 2017 Inspection Start Time: 12:00 Inspection End Date: Inspection End Time:			<b>Inspection Type:</b> Coal Partial Inspection <b>Inspection Reason:</b> Normal I&E Program <b>Weather:</b> Clear		
Joint Inspection Agency:		Joint Inspection Contacts:			
None					
Post Inspection Agency:		Post Inspection Contacts:			
None					
Inspector(s):	Inspecto	r's Sig	nature:	Signature Date:	
Robert D. Zuber, P.E.	Phot	D.	21-		
				12/15/2017

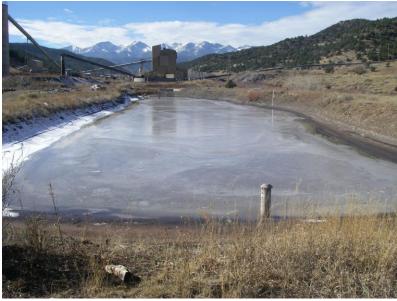
Ponds 006A, 007A, and 08 were inspected. None of them were discharging. Water levels in Ponds 007A and 08 were relatively low compared to recent months. This is due to pumping out of Pond 08 and dry weather conditions. Significant flow into Pond 007A was seen from the pipe coming from Pond 08. No significant issues were seen with the pond spillways or embankments of any ponds.

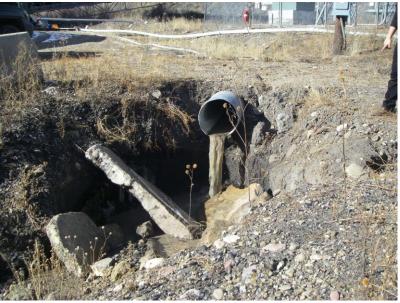
Flow into ditch that flows to Pond 007A

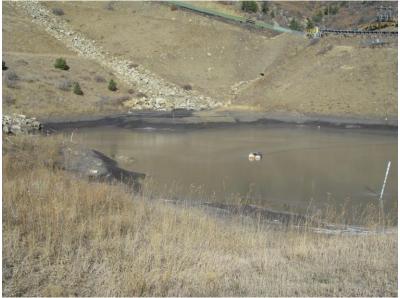
Pond 08 (note large amount of sediment)

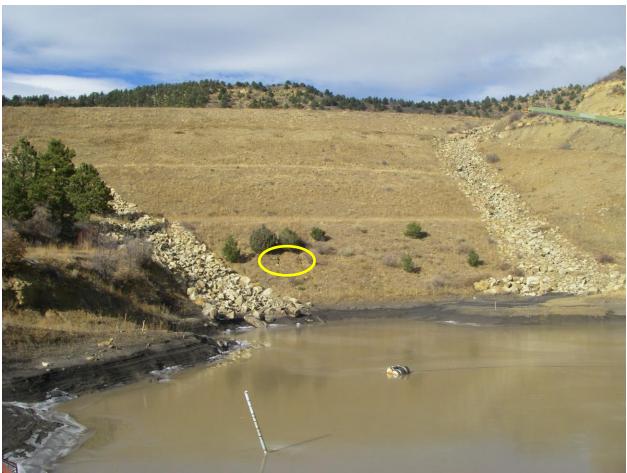
There is good vegetation cover on the reclaimed portion of the RDA. Small rills were seen on the face, near the bottom below some trees, and these should be repaired or at least monitored closely.

RDA and portion of Pond 08 Rills are circled
