Permit Number: C-1981-035 Mine Name: King Coal Mine Operator: GCC Energy, LLC Operator Address: Mr. Tom Bird 6473 County Road 120 Hesperus, CO 81326	County: La Plata Operation Type: Underground Permit Status: Active Ownership: Federal
	Operator Representative Present: Michael McFarland
Operator Representative Signature: (Field Issuance Only)

Inspection Start Date: December 12, 2017 Inspection Start Time: 08:00 Inspection End Date: Inspection End Time:	Inspection Type: Coal Partial Inspection Inspection Reason: Normal I&E Program Weather: Clear
Joint Inspection Agency: None	Joint Inspection Contacts:
Post Inspection Agency: None	Post Inspection Contacts:
Inspector(s): Robert D. Zuber, P.E.	Inspector's Signature:

A partial inspection was conducted by Rob Zuber of DRMS on December 12, 2017. Michael McFarland of GCC accompanied Rob in the field. The weather was clear and the ground was dry.

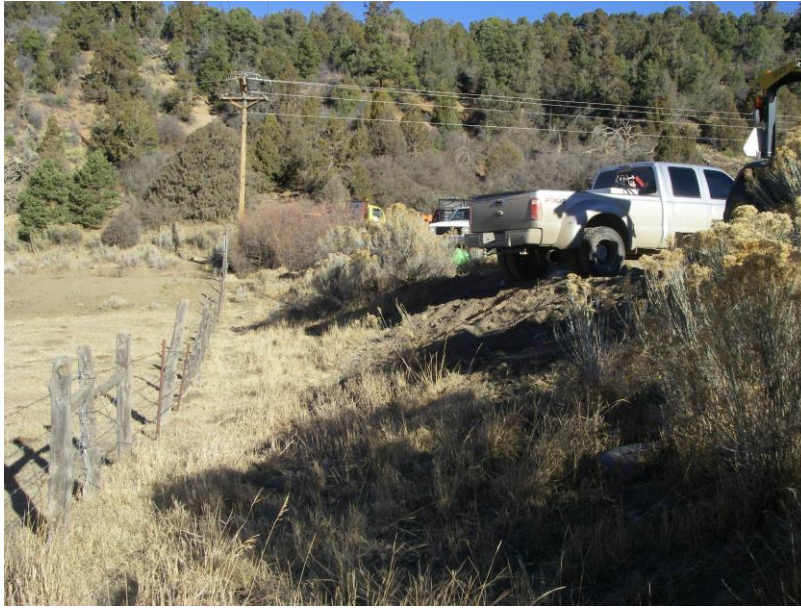
Near the King I entrance, activities by the road contractor (Four Corners) have created a source of sediment that could be transported off site. A representative of the contractor was on site, and he indicated that he would have

Near King I entrance – area that needs erosion and sediment control

his staff fix the problem in near future. The solution should entail a berm to direct runoff to the silt fence sumps that are shown on Map King I-007, and wattles and seed should be added to the slope from the road to the adjacent pasture.

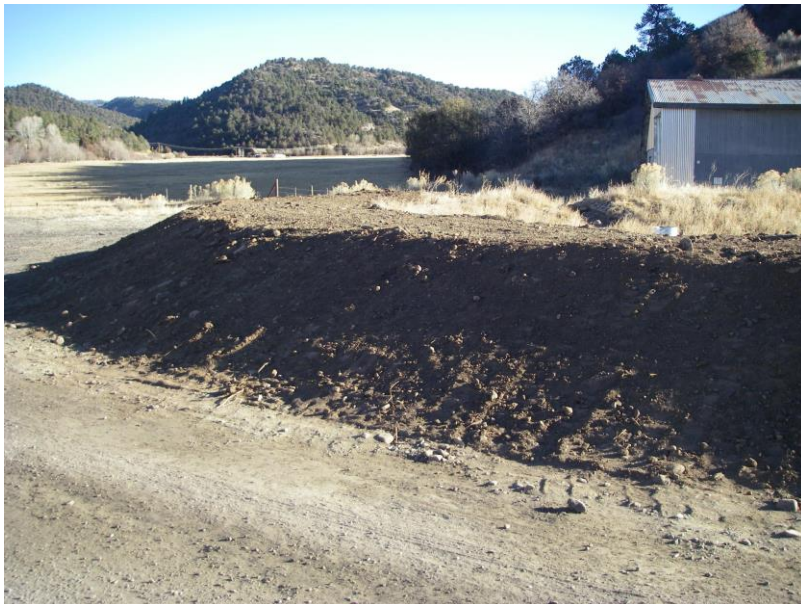
At the King I Mine, the West and East Ponds were dry. A large amount of work has been done on these ponds to make them meet the design specifications in the Permit Application Package (PAP). The embankment of the East Pond was reconstructed, and primary spillways were replaced for both ponds. Some elevations for the new pond features were estimated with a range finder, and the following observations were made (comparison to PAP specifications are in parentheses):

East Pond (King I) - embankment improvement

In summary, it appears that the new pond dimensions that were measured match the PAP specifications very closely. Sediment control (e.g., erosion blankets, seed) is needed on the areas where loose soil is present from the work on the King I ponds.

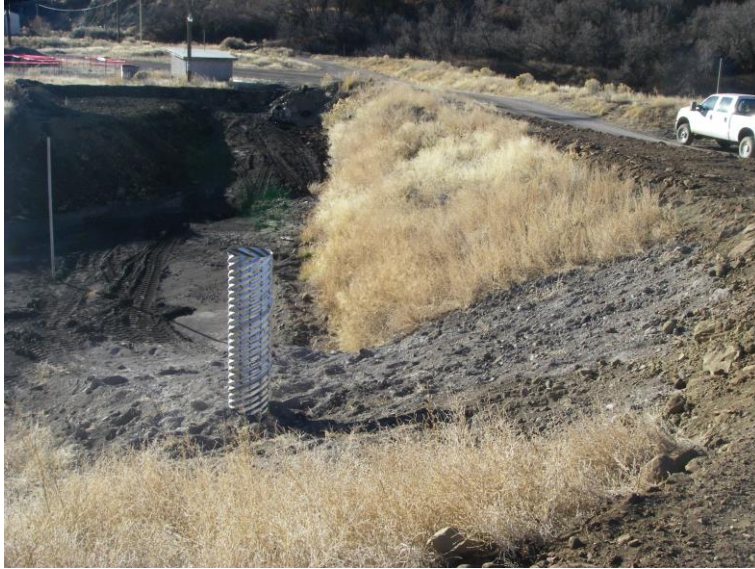
- The East Pond dam elevation is approximately two feet above the emergency spillway elevation. (This indicates that the existing freeboard meets the one-foot requirement).
- Also for the East Pond, the low-level outlet of the primary spillway was estimated to be four to five feet below the emergency spillway elevation. (This matches the specification in the PAP, which says that the elevation difference should be five feet.)
- The West Pond dam elevation is approximately one foot above the emergency spillway elevation. (This indicates that the existing freeboard meets the one-foot requirement).
- Also for the West Pond, the low-level outlet of the primary spillway was estimated to be 5.5 feet below the emergency spillway elevation. (This matches the specification in the PAP, which says that the elevation difference should be 5.5 feet.)

East Pond (King I) – new primary spillway

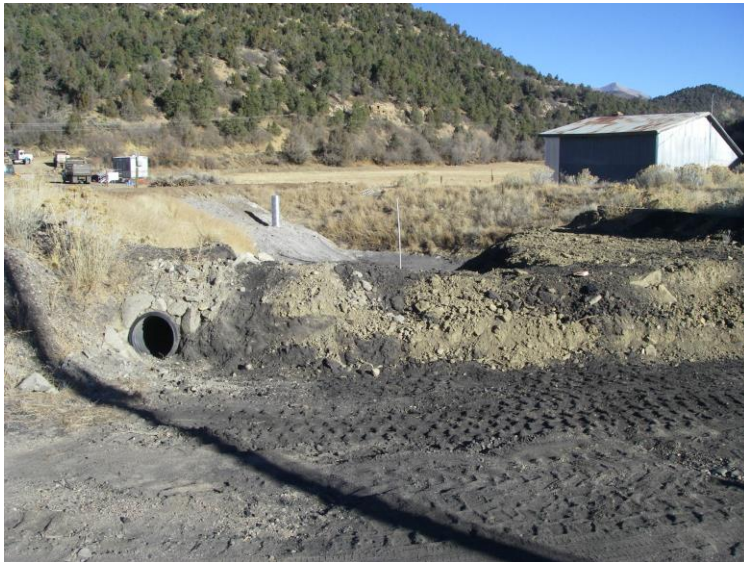
East Pond (King I) – inlet pipe in foreground

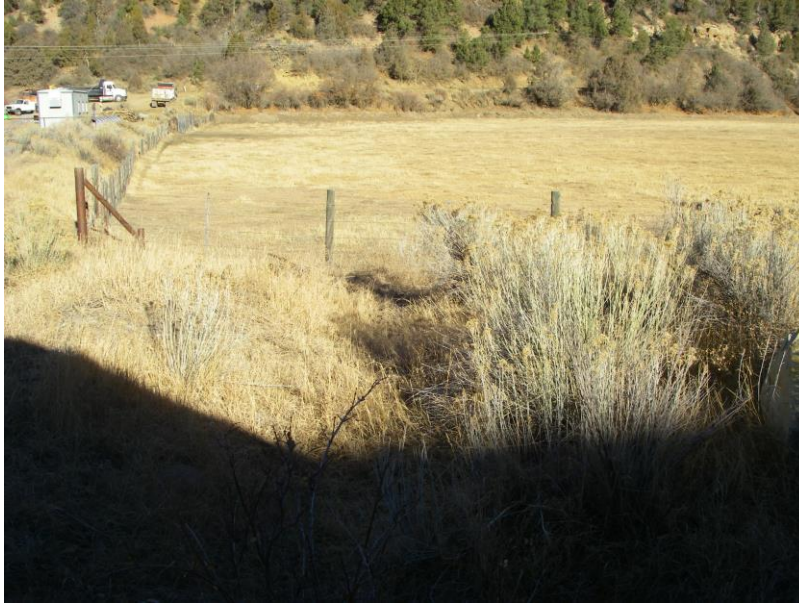
The lower portion of Reach 5 has recently been improved, and a sump was added a few feet above the building east of the East Pond (owned by Jack Wiltse). No problems were identified.

Bottom of Reach 5 where it enters field (King I)

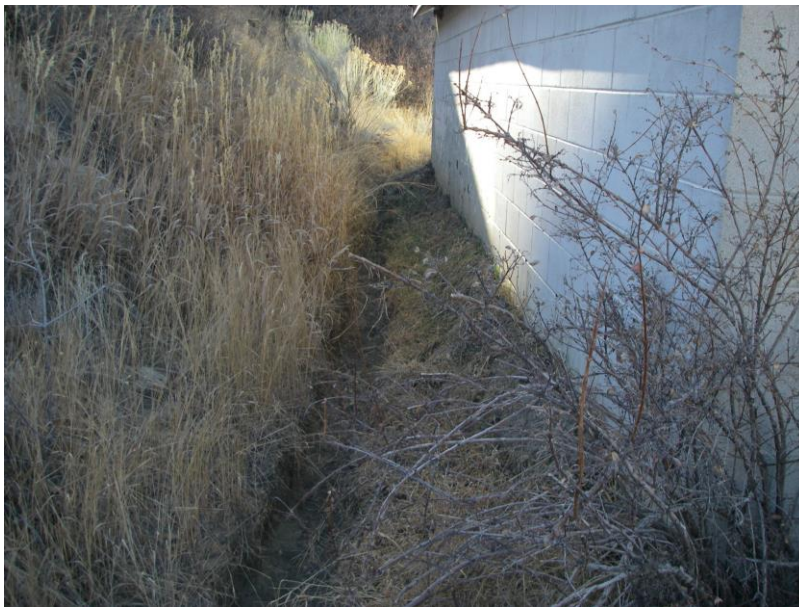
Reach 5 beside Wiltse structure (King I)

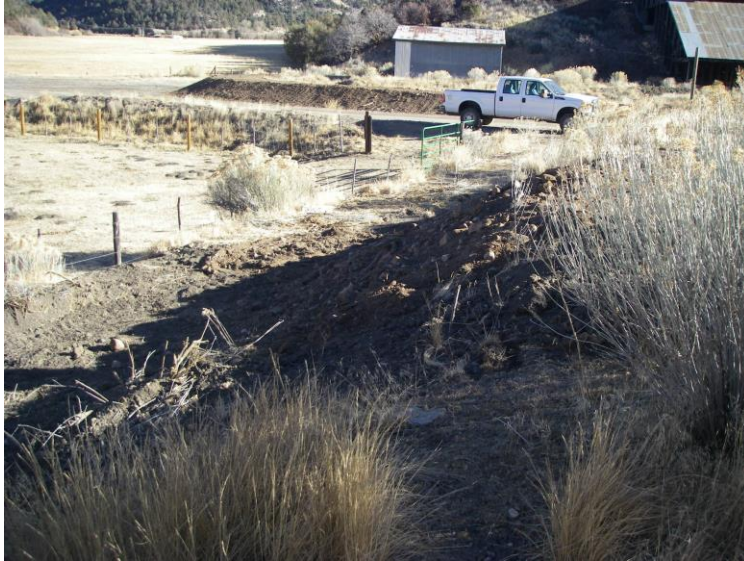
King I ponds – West Pond embankment in foreground and East Pond embankment in back (by truck)

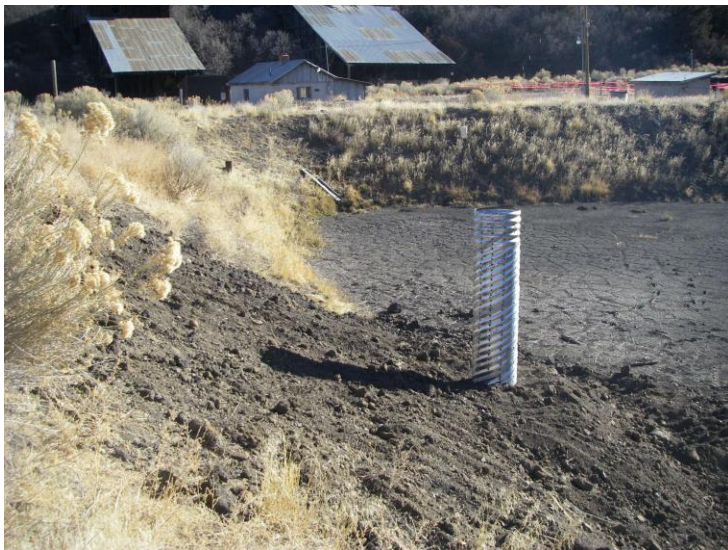
King I West Pond – new primary spillway

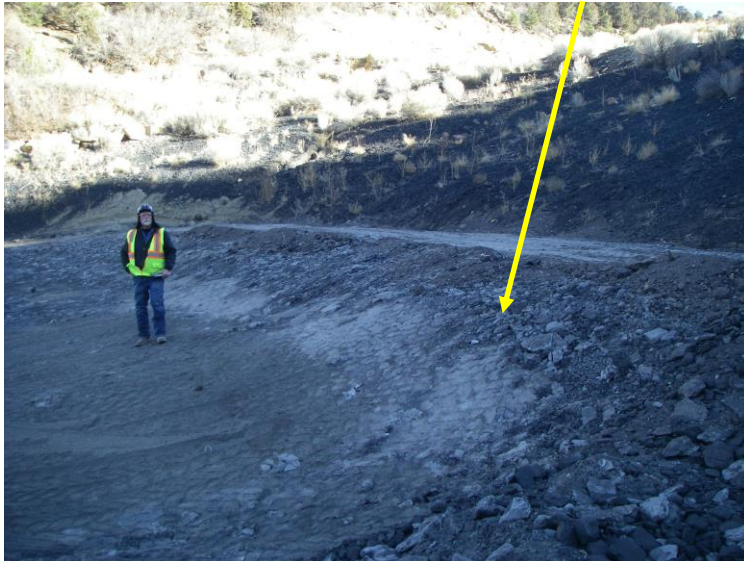
Refuse Pile

At the toe of the Refuse Pile, new material (waste rock) has been added for a new bench to make the lower portion of the pile less steep. It appears to be well compacted.

Recently added material

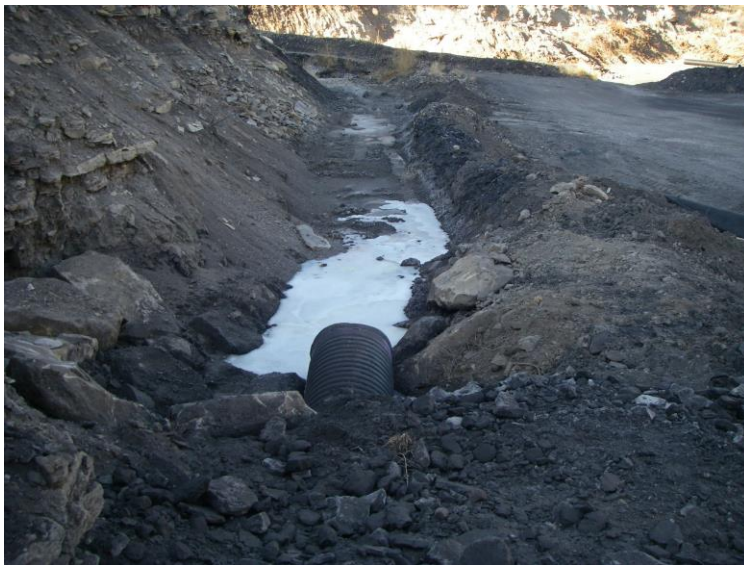
Water in the form of ice was seen in the channel below the rock underdrain of the Refuse Pile, but no stains were seen. It appears that the underdrain allows water from above the refuse to seep under the Refuse Pile, but there is no sign that water is infiltrating through the pile and causing dissolution of metals that end up in the discharge below the pile.

Underdrain below Refuse Pile

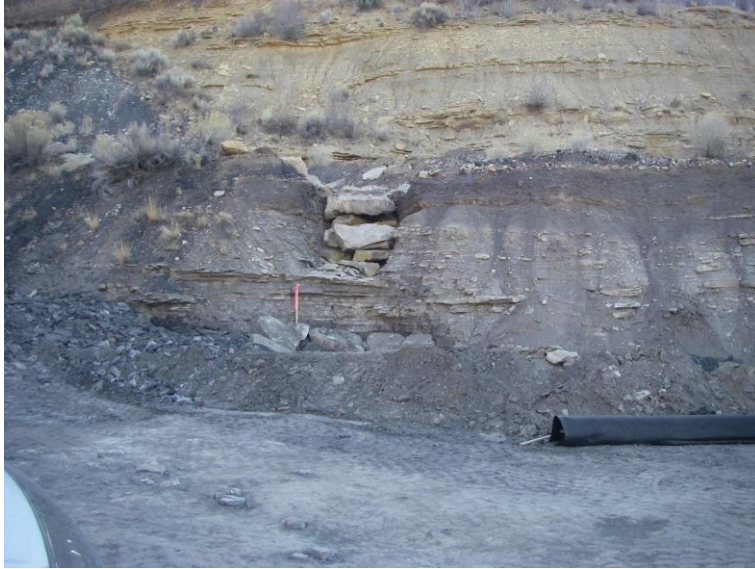
The step portion of Reach 10 (near the toe of the Refuse Pile) appeared stable. The upper portion of this ditch (where the road ends on the un-reclaimed Refuse Pile) has been improved, and this riprap looks like it has been placed well and will keep the reach stable.

Steep portion of Reach 10 (King I)

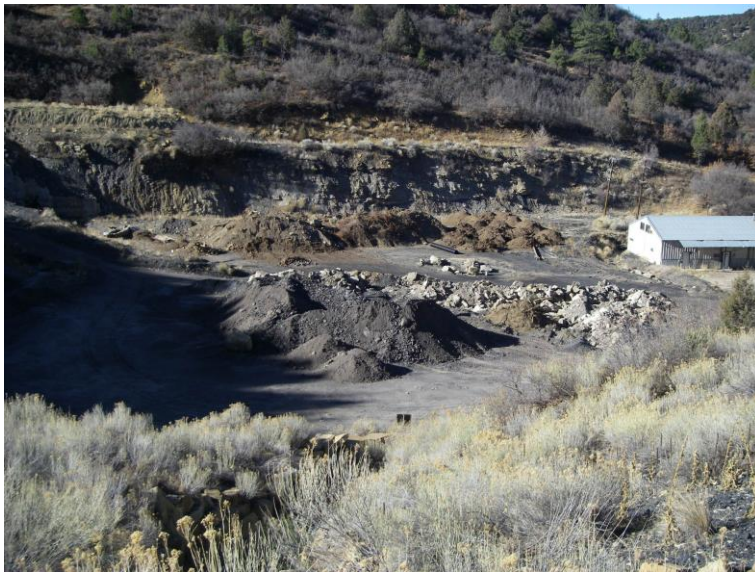
The primary cut slopes at the mine appear to be stable. This includes the King I facilities area (where portals were located) and the King II portal areas.

Facility area at King I

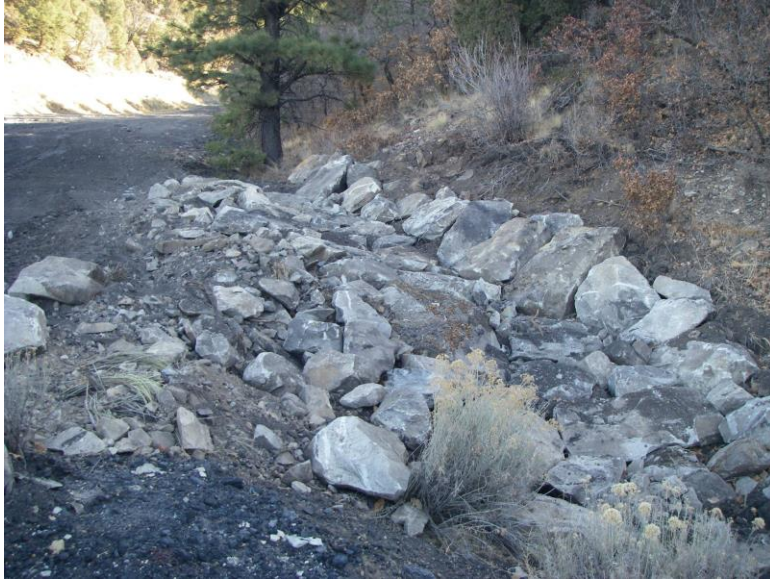
Improved portion of Reach 10 near Refuse Pile (King I)

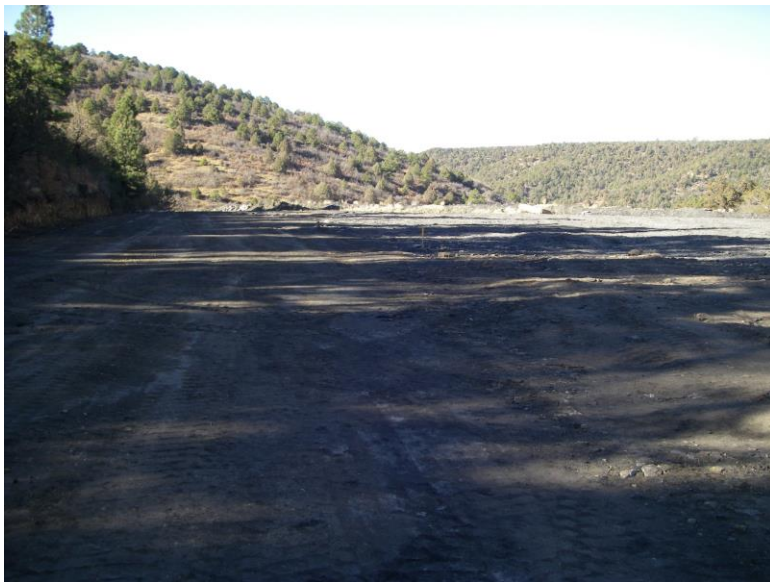
The un-reclaimed portion of the Refuse Pile (upper portion) has been graded, and the piles of waste rock (noted in past inspection reports) are no longer present. No rills or puddles were seen on the upper portion of the Refuse Pile.

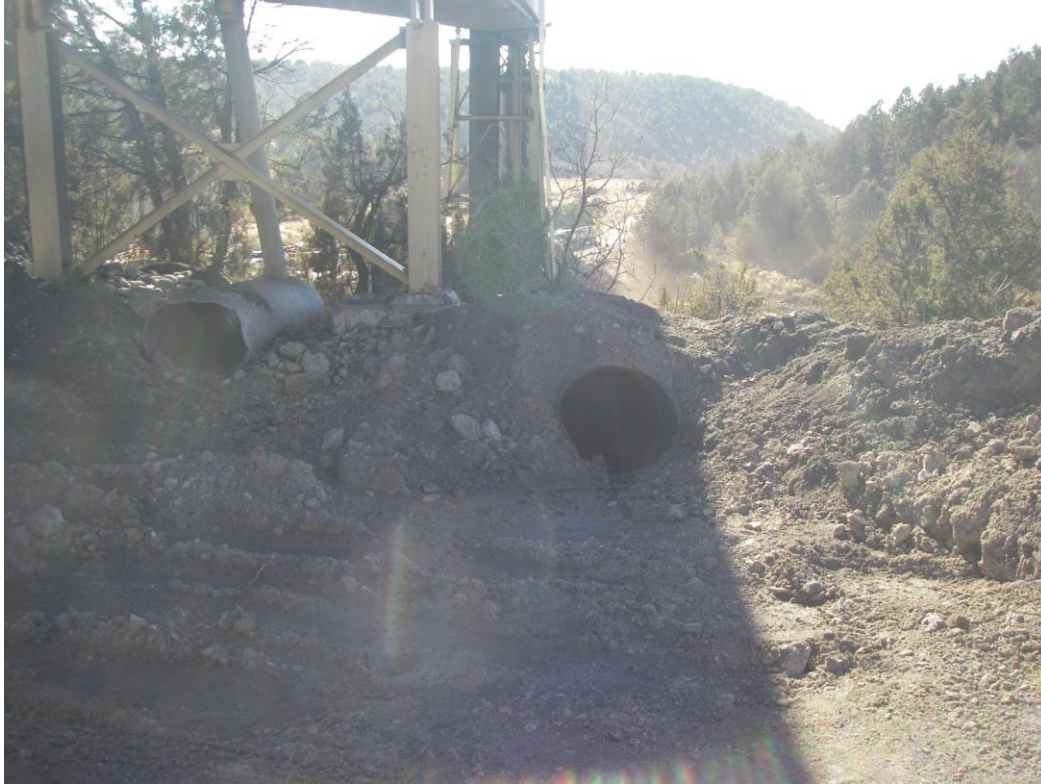
No major problems were seen with erosion or sediment loading onto the hill below the new King II fan. Under the conveyor near the culverts, however, a sump is recommended.

Area near new fan where sump is needed (King II)
