COLORADO
Division of Reclamation,
Mining and Safety
Department of Natural Resources

Permit Number: C-1981-012 Mine Name: New Elk Mine Operator: New Elk Coal Company, LLC Operator Address: Mr. Louis Head 12250 Highway 12 Weston, CO 81091	County: Las Animas Operation Type: Underground Permit Status: Active Ownership: Private
	Operator Representative Present: Nick Mason
Operator Representative Signature: (Field Issuance Only)

Inspection Start Date: November 8, 2017 Inspection Start Time: 13:00 Inspection End Date: November 9, 2017 Inspection End Time: 13:30		Inspection Type: Coal Complete Inspection Inspection Reason: Normal I&E Program Weather: Clear	
Joint Inspection Agency: None		Joint Inspection Contacts: 	
Post Inspection Agency: None		Post Inspection Contacts: 	
Inspector(s): Robert D. Zuber, P.E.	Inspector's Signature:

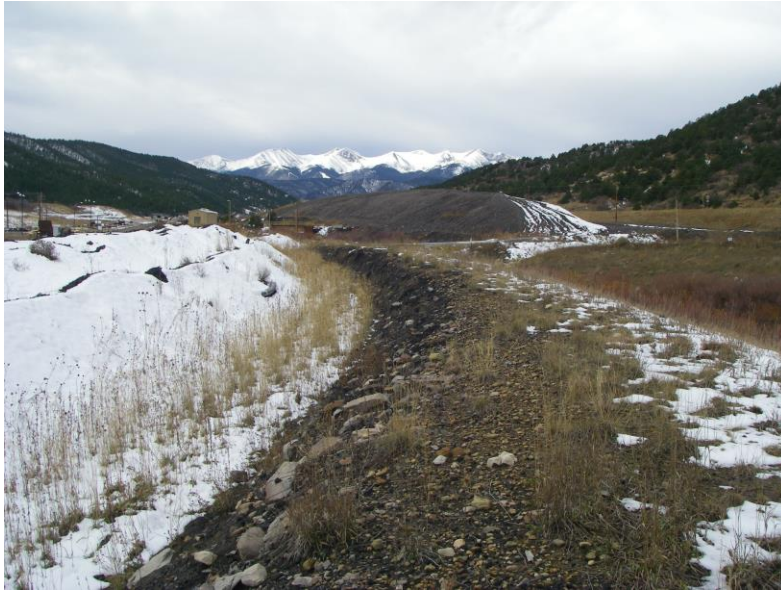
Ditch D32

The following ditches and culverts were inspected and no problems were identified: D2, D3, D4, D10, D10A, D11, D14, D32, C13, and C30.

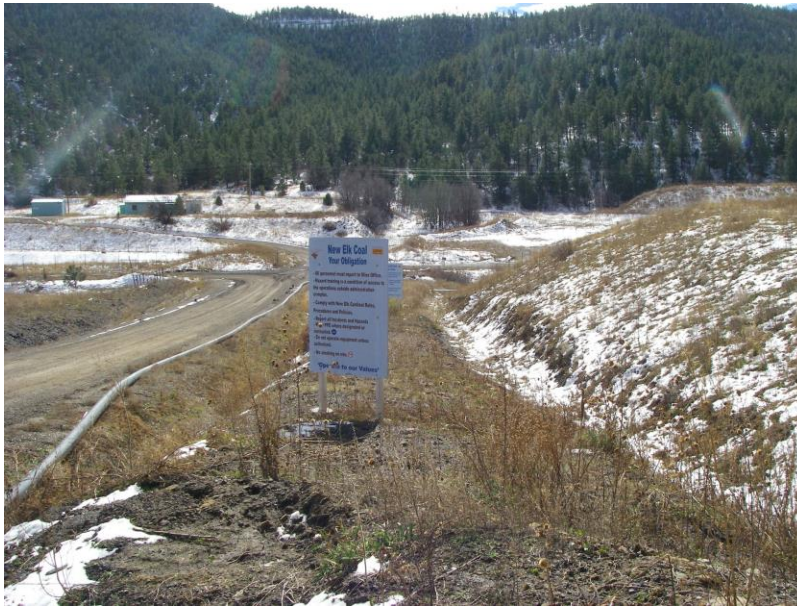
Entrance sign, Ditches D10 and D10A

The entrance sign has the required information.

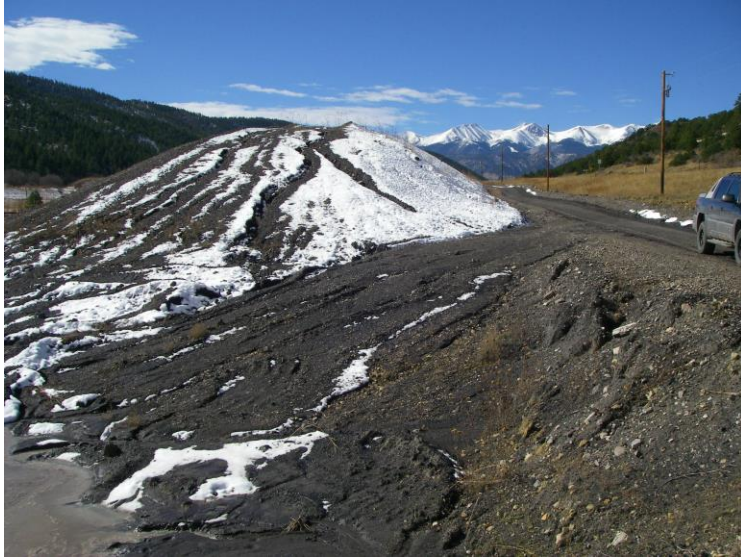
Erosion on DWDA#2 may have gotten worse in 2017, with some rills close to two feet deep. The sump below DWDA#2 did not appear to need immediate maintenance. Stockpiled material at the west end of this pile should be moved to the RDA as soon as it dries.

Rills on east end of DWDA#2

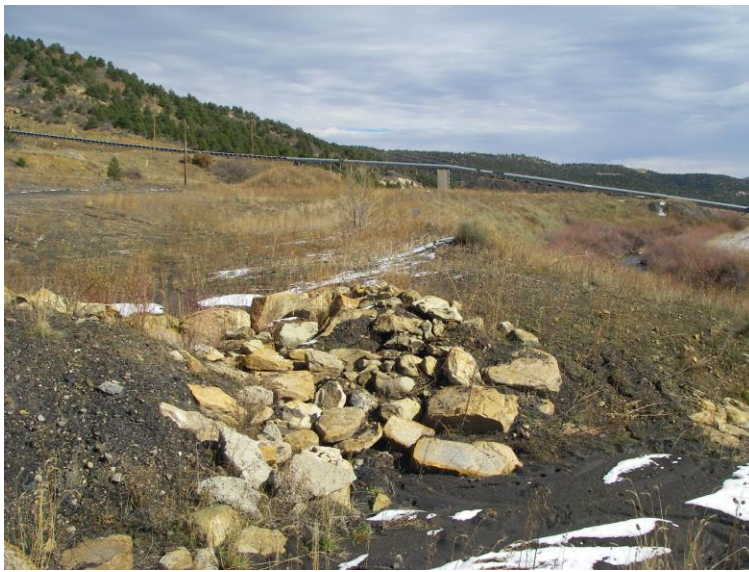
The two rows of silt fence below the SAE by Pond 007A appear to be functioning well. No significant problems were seen with the SAE by Topsoil Stockpile #2, although some sediment has accumulated in Ditch D11. This area should be watched closely for erosion problems.

**Riprap below SAE near Topsoil Stockpile #2
(note sediment in lower right portion of photograph)**

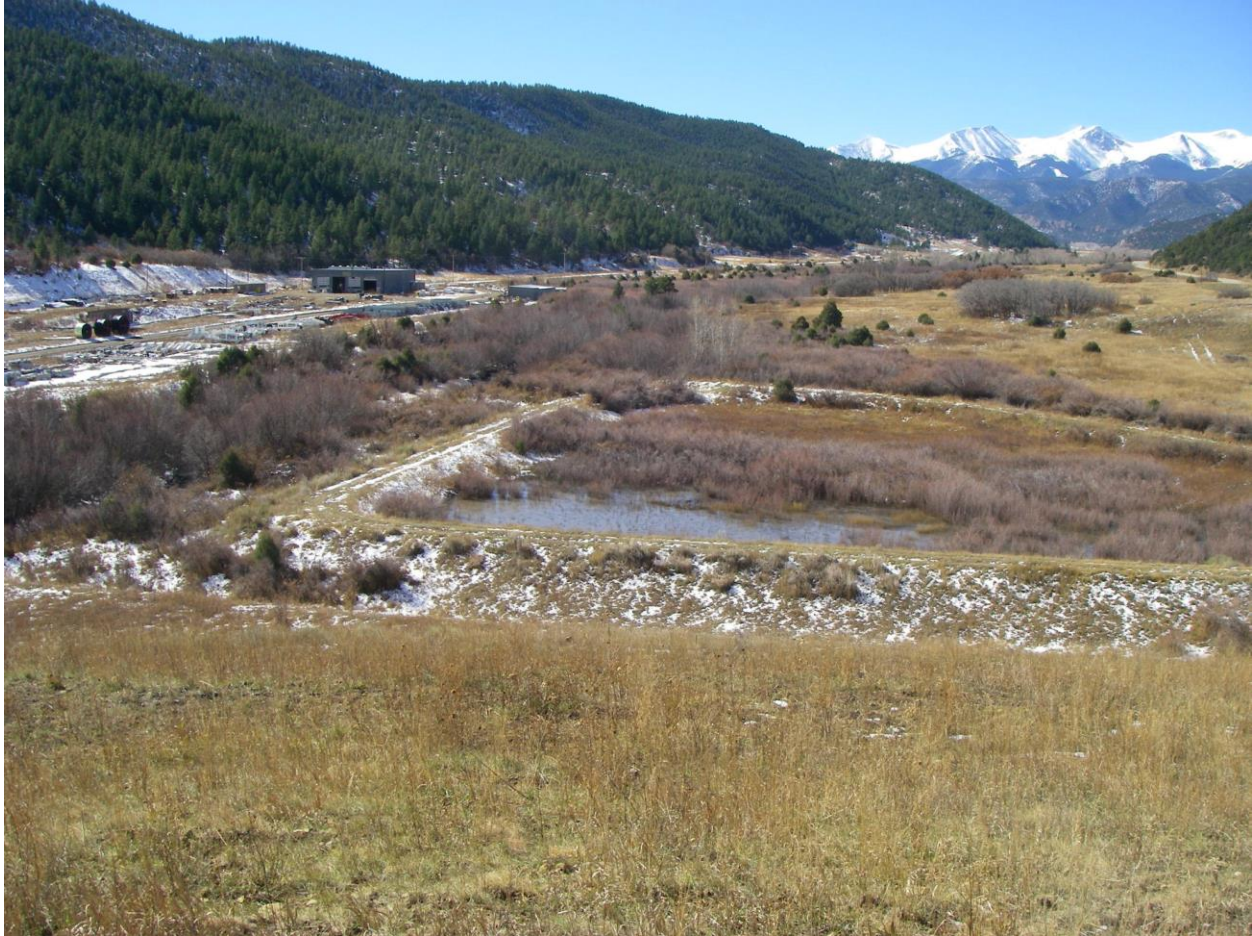
Ponds 004A, 006A, 007A, and 08 were inspected. None of them were discharging, but all held water from recent snow melt (all but Pond 004A were very full). No flow into Pond 006A was seen. The impounded water in Pond 007A was below five rows of holes in the primary spillway, and signs of recent flow through the emergency spillway could not be seen. The water in Pond 004A appeared lower than in past months. Water was in the discharge pipe from Pond 08; NECC staff confirmed that a recent discharge occurred, and they said that CDPHE was notified. No significant issues were seen with the pond spillways or embankments of any ponds.
