**PERMIT INFORMATION**

<b>Permit Number:</b> C-1996-084 <b>Mine Name:</b> Lorencito Canyon Mine <b>Operator:</b> New Elk Coal Company, LLC <b>Operator Address:</b> Mr. Louis Head 12250 Highway 12 Weston, CO 81091	<b>County:</b> Las Animas <b>Operation Type:</b> Surface <b>Permit Status:</b> Permanent Cessation <b>Ownership:</b> Private
	<b>Operator Representative Present:</b>  Nick Mason
<b>Operator Representative Signature: (Field Issuance Only)</b>

**INSPECTION INFORMATION**

<b>Inspection Start Date:</b> November 9, 2017 <b>Inspection Start Time:</b> 07:00 <b>Inspection End Date:</b> <b>Inspection End Time:</b>	<b>Inspection Type:</b> Coal Partial Inspection <b>Inspection Reason:</b> Normal I&E Program <b>Weather:</b> Clear
<b>Joint Inspection Agency:</b>  None	<b>Joint Inspection Contacts:</b>
<b>Post Inspection Agency:</b>  None	<b>Post Inspection Contacts:</b>
<b>Inspector(s):</b>  Robert D. Zuber, P.E.	<b>Inspector's Signature:</b>  <i>Robert D. Zuber</i>  <b>Signature Date:</b>  11/14/2017

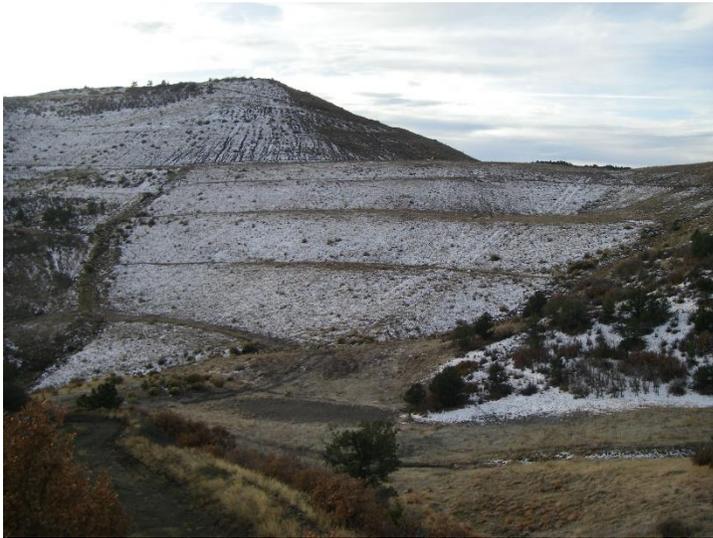
**Fill 8**

Fills 7, 8, and 9 were inspected. All were generally in good condition with good vegetation cover. At the low end of the east channel of Fill 9, the bare bank looks stable, and rock has been configured by NECC staff to route the ditch flow away from this bank. This spot should be watched closely for erosion problems in the future.

The ditch below Fill 8 appears to be stable, and NECC staff indicated (after the inspection via email) that Vince Massarotti has performed additional rock work with an excavator to keep this steep ditch stable.

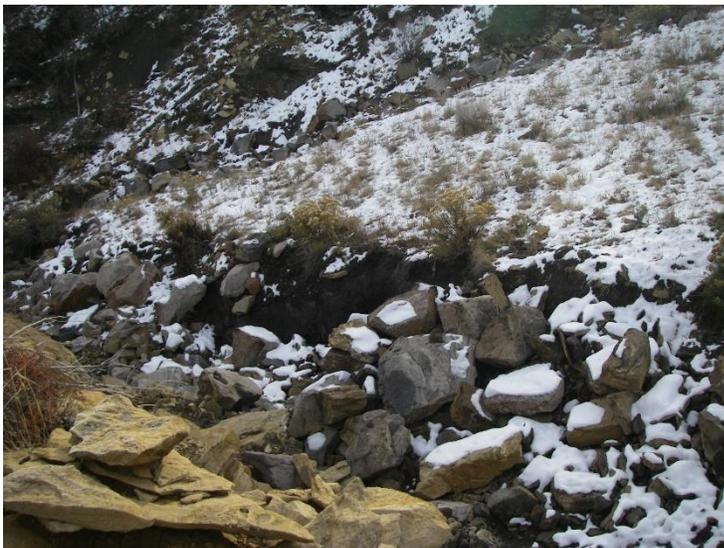
**Area vulnerable to erosion in Ditch D84**

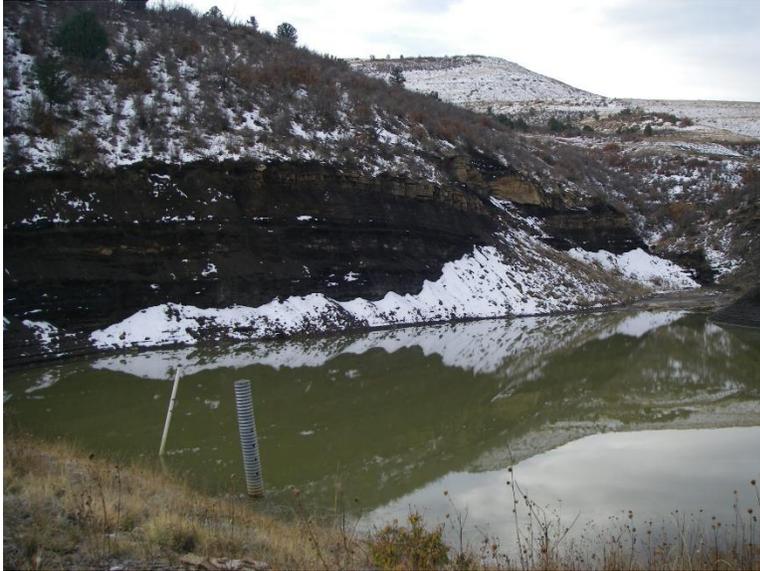
**Pond 8**

Three ponds were inspected: 8, 9, and 9A. All three were holding water but not discharging. At Pond 8, the water appeared to be below all of the holes on the riser (primary spillway); four rows were visible.

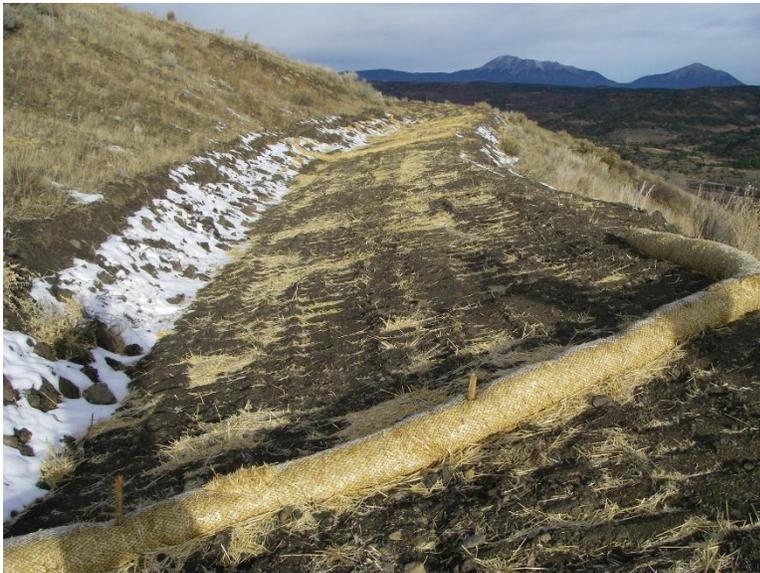
Recent work has been performed by Vince Massarotti on Ditch D86 to route it to Culvert 9. This ditch had been routed to Culvert 10, and this was causing erosion on the steep hillside. The re-constructed ditch is three to four feet deep and approximately 15 feet wide. This is in compliance with the design requirement in the Pond 8 SEDCAD model (Exhibit 15 of the PAP): depth of 1.75 feet and width of 10.47 feet. The requirement is for a vegetated channel. Vince Massarotti seeded and mulched the re-constructed channel. The sump above Culvert 9 looked to be functioning well, and no immediate maintenance was needed.

**Re-constructed Ditch D86**

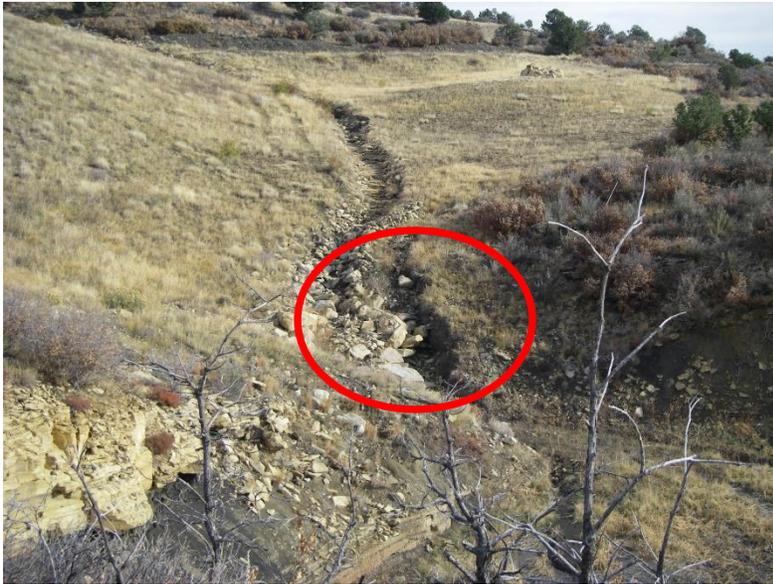
**East ditch at Fill 9  
(spot to watch closely in circle)**
