MINERALS PROGRAM INSPECTION REPORT
PHONE: (303) 866-3567

MINE NAME: Henderson Development	MINE/PROSPECTING ID#: M-1980-110	MINERAL: Sand and gravel	COUNTY: Adams
INSPECTION TYPE: Monitoring	INSPECTOR(S): Jared L. Ebert	INSP. DATE: December 21, 2017	INSP. TIME: 10:30
OPERATOR: E-470 Public Highway Authority	OPERATOR REPRESENTATIVE: Derek Slack, E-470	TYPE OF OPERATION: 112c - Construction Regular Operation	
REASON FOR INSPECTION: Normal I&E Program	BOND CALCULATION TYPE: NA	BOND AMOUNT: \$0.00	
DATE OF COMPLAINT: NA	POST INSP. CONTACTS: None	JOINT INSP. AGENCY: None	
WEATHER: Clear	INSPECTOR'S SIGNATURE:

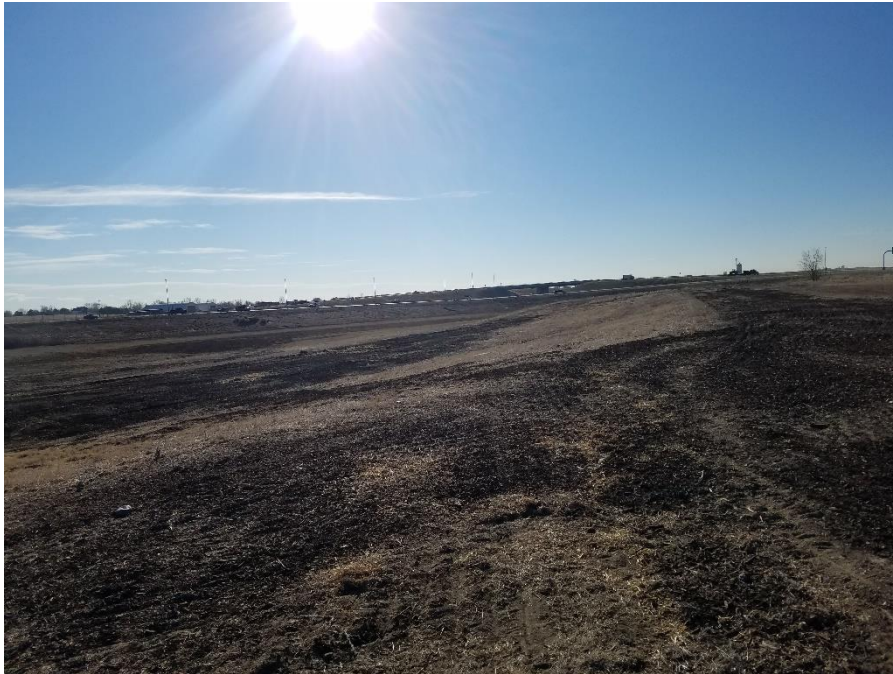
Figure 3. From the entrance of the mine site looking south.

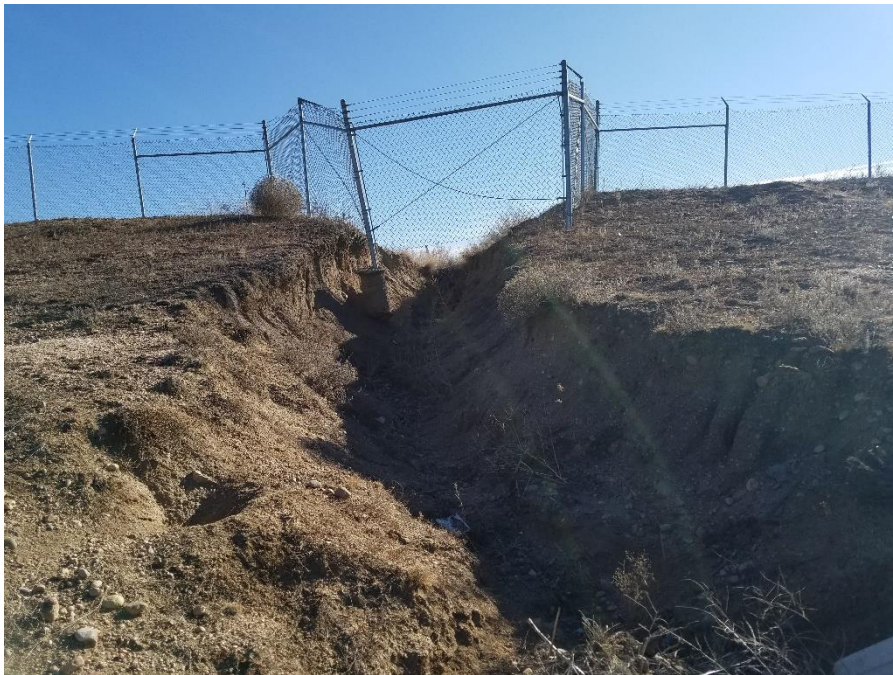
Mining is complete at the site and the pit used to be an open groundwater lake. The reclamation plan for the site called for backfilling the former lake area with inert material. The backfilling operation is complete and the exposed groundwater at the site has been covered up. The area now consists of a graded basin with gentle side slopes that appear to be set at a 3H:1V ratio or less. The majority of the pit slopes appear stable with the exception of a few erosion rills and gullies. One erosion gully on the east-central side of the former pit area near Highway 85 is fairly large, about 4 to 5 feet deep. At the top of this gully a culvert under the highway was observed allowing stormwater discharge into the pit. Mr. Slack indicated they intend to repair the gully and stabilize the area, likely with rip-rap. A few other erosion gullies were observed that will also need to be stabilized.

Figure 4. Large erosion gully on the east-central pit slope.

As indicated above, the Operator will need to stabilize several erosion gullies observed along the pit slopes.
