MINERALS PROGRAM INSPECTION REPORT PHONE: (303) 866-3567

| MINE NAME: | MINE/PROSPECTING ID#: | MINERAL: | COUNTY: | |
|---|---|---|---|--|
| Fisher Pit | M-1977-163-SG | Sand and gravel | Lincoln | |
| Surety Release Inspection | Timothy A. Cazier | December 19, 2017 | 9:55 | |

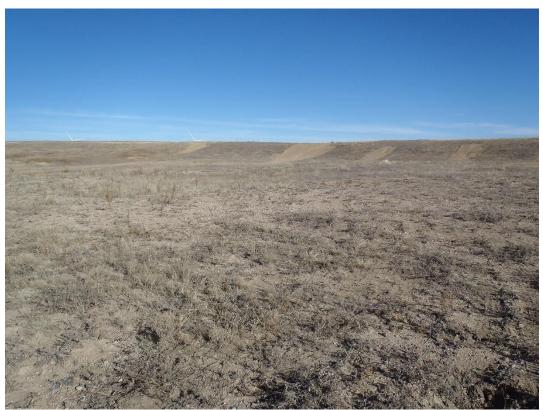
<u>Backfilling and Grading</u>: The previously observed erosion gullies had been adequately repaired with regards to earthwork (see **Photos 1** through **5** and **8**), and relatively recently with respect to this 2017 inspection. However, the repairs to the largest of the gullies exhibited some severely compacted soils (see **Photo 6**) due to the multiple passes made by the equipment to fill it. The Division strongly recommends disking/roughening the soil prior to seeding.

Photo 1. Four gully repair areas (looking NE).

<u>Sediment Control</u>: No erosion problems were observed. However, the Division encourages the Permittee to implement BMPs (such as straw wattles or silt fence at the crest of the gully repair areas until vegetation is established.

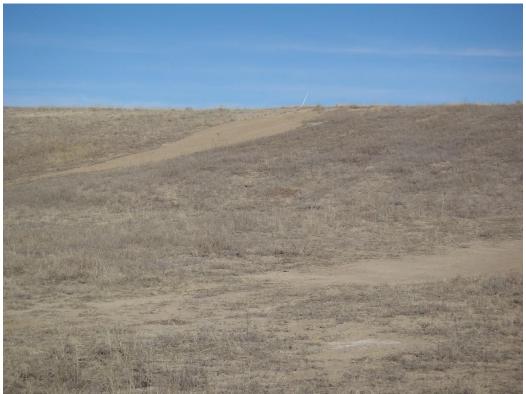
Photo 2. Western most gully repair (looking north).

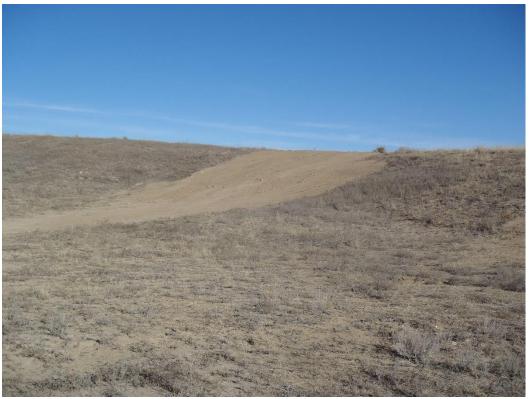
Photo 3. Gully repair – second from west to east (looking north).

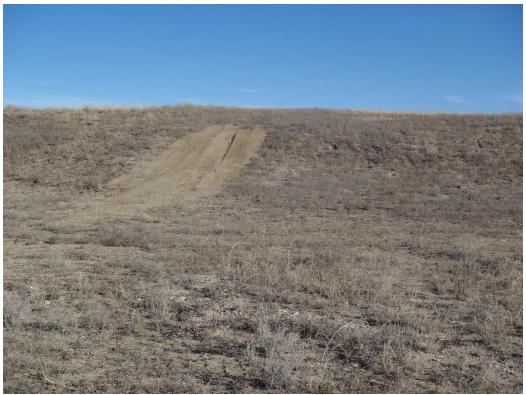
Photo 4. Gully repair – third from west to east (looking north).

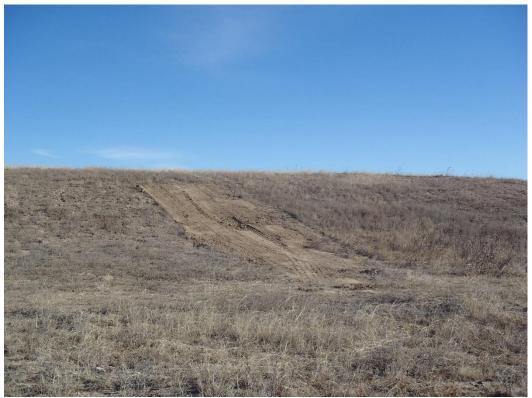
Photo 5. Gully repair – fourth from west to east (looking NE).

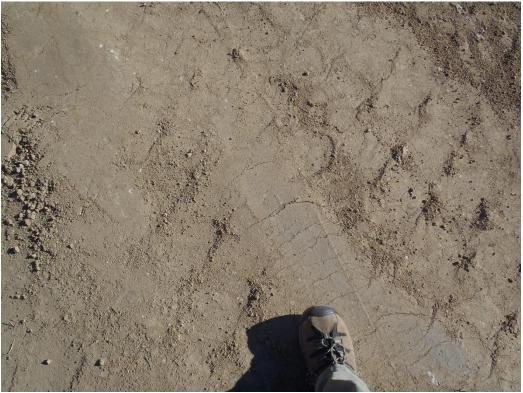
Photo 6. Heavily compacted soil in second from west gully repair.

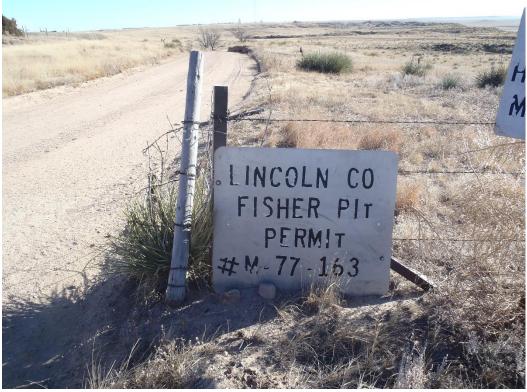
Signs and Markers: The permit sign was properly posted (see Photo 7) and boundary markers were observed

Photo 7. Permit sign at entrance.

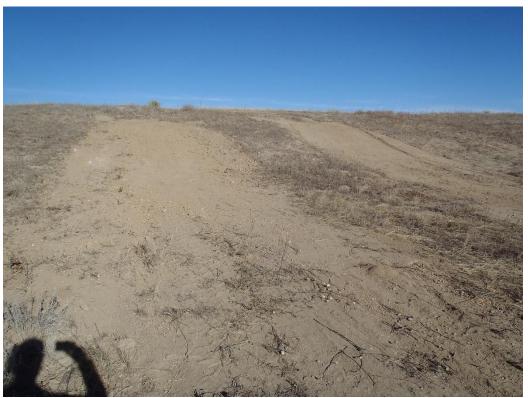
Photo 8. Two eastern most gully repairs (looking NW).
