**MINERALS PROGRAM INSPECTION REPORT****PHONE: (303) 866-3567**

| <b>MINE NAME:</b><br>DDD | <b>MINE/PROSPECTING ID#:</b><br>M-1984-076 | <b>MINERAL:</b><br>Clay (general) | <b>COUNTY:</b><br>Elbert |
| <b>INSPECTION TYPE:</b><br>Monitoring | <b>INSPECTOR(S):</b><br>Peter S. Hays | <b>INSP. DATE:</b><br>November 30, 2017 | <b>INSP. TIME:</b><br>10:00 |
| <b>OPERATOR:</b><br>General Shale Brick, Inc. | <b>OPERATOR REPRESENTATIVE:</b><br>Jason McGraw | <b>TYPE OF OPERATION:</b><br>112c - Construction Regular Operation | |

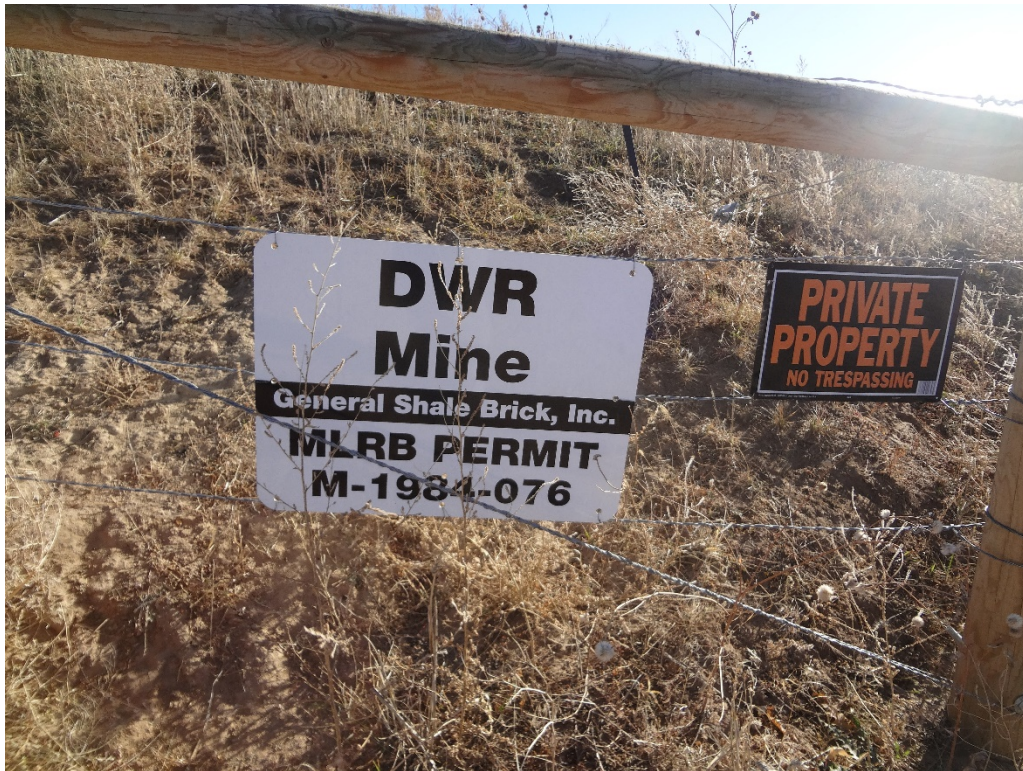
DWR (west pit) mine sign

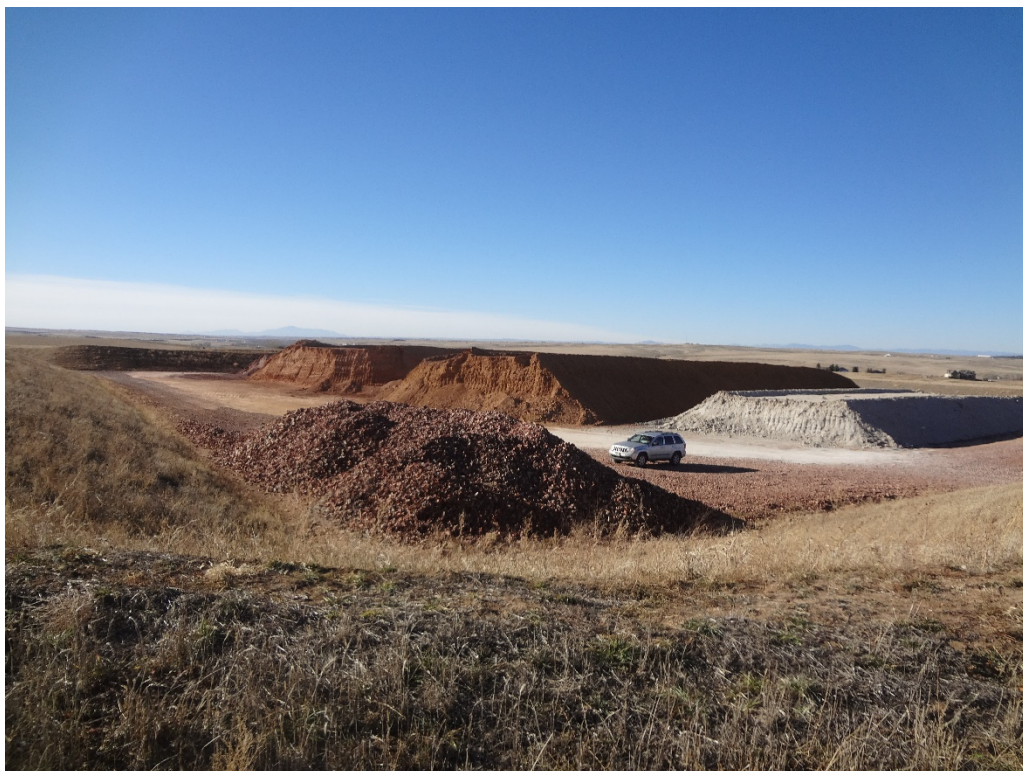
The Operator negotiated a surface only lease with the landowner of the middle portion of the site. The middle area is used as a stockpile area and contained four product stockpiles. The stockpile area was surrounded by well-vegetated topsoil stockpiles on all four sides. Hauling activities from the product stockpiles was observed during the inspection.

View of the DWR middle area from the northeast corner looking southwest

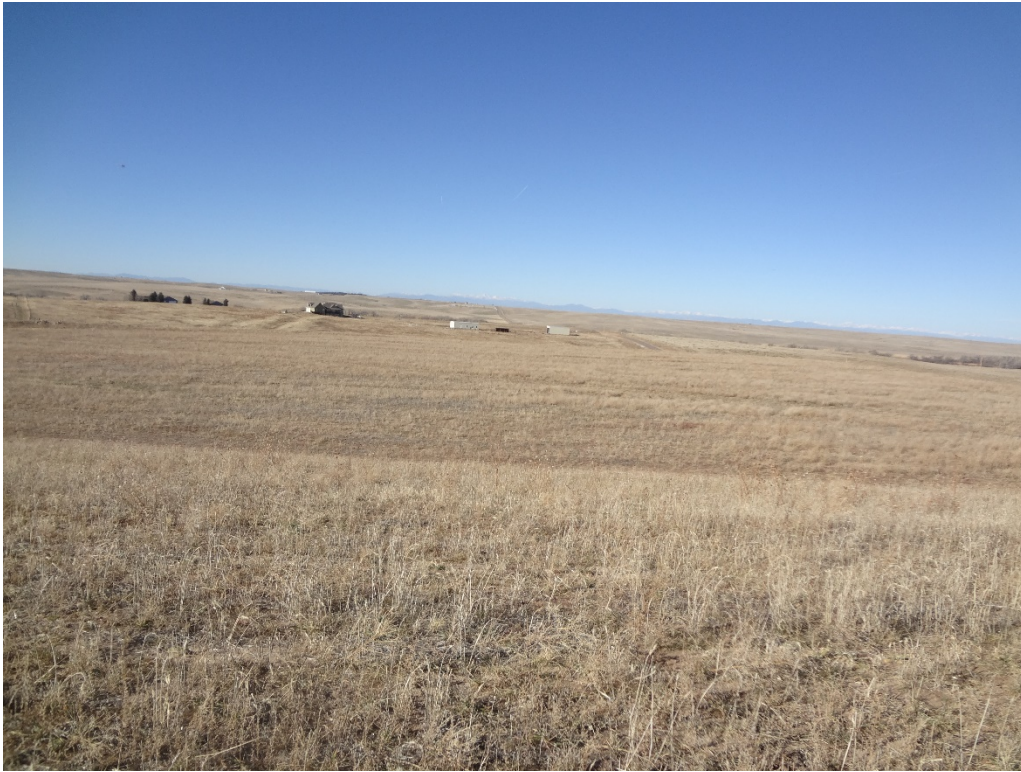
View of the reclaimed DWR west area from the east side looking west

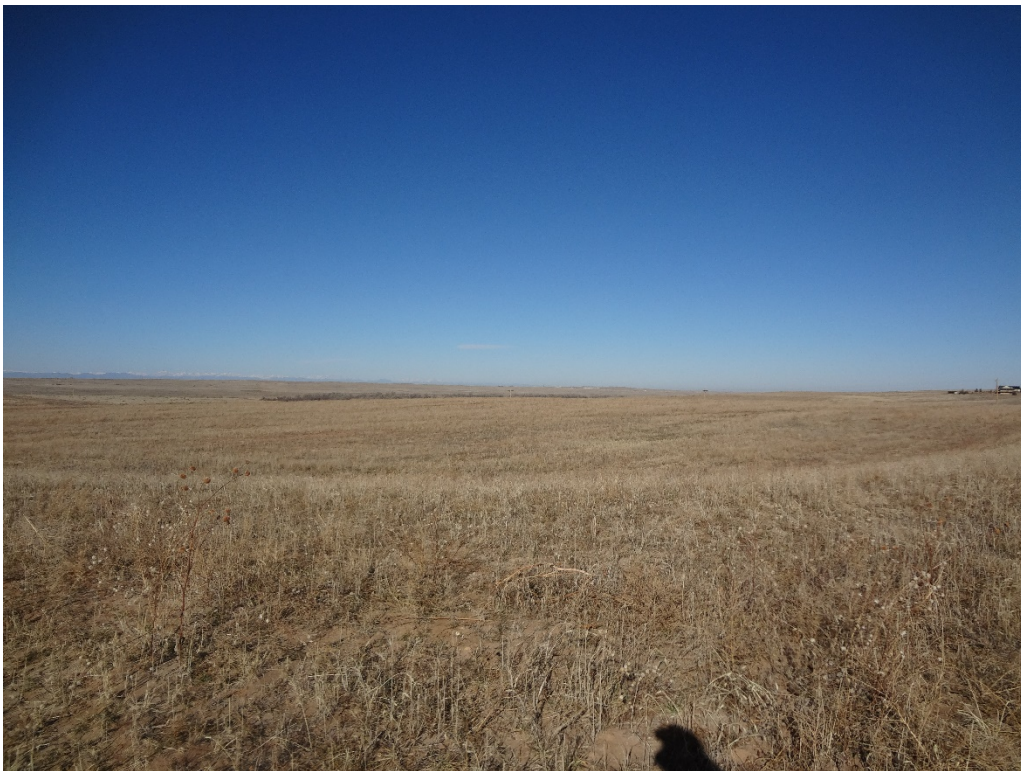
View of the reclaimed DWR west area from the SE corner looking NW

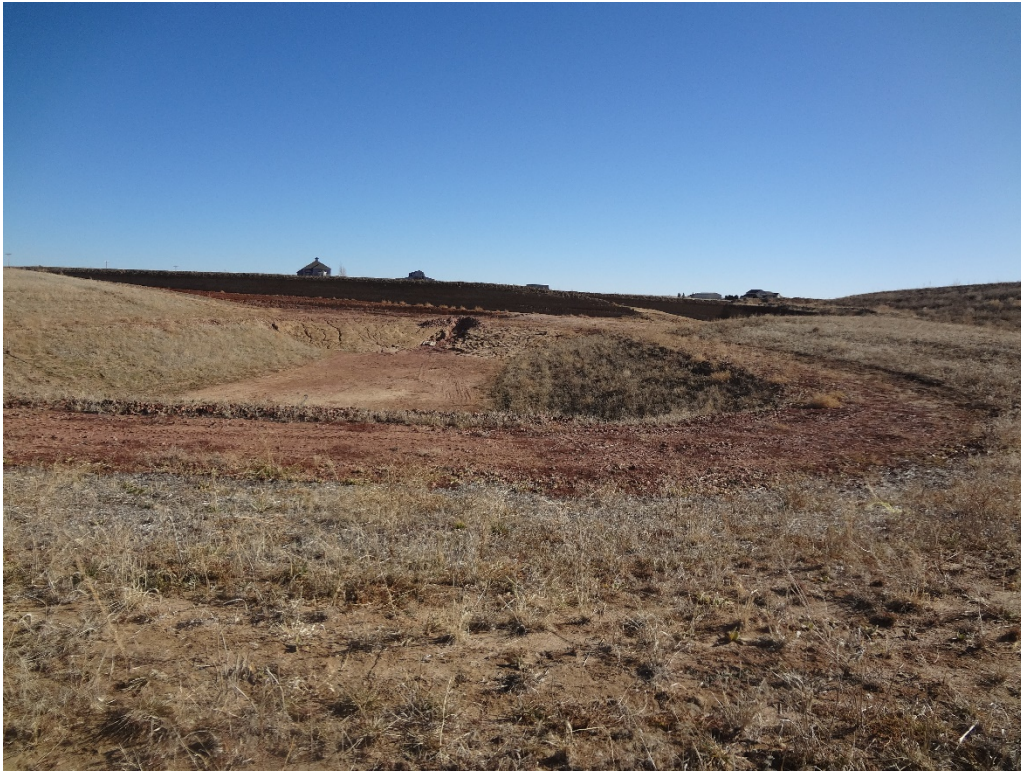
As cited as a problem on Page 1, a technical revision is required to update the Mine Plan for the relocation of the access road from the west portion to the middle portion of the site, to increase the maximum allowed disturbance acreage and include the new stormwater detention pond located in the east portion of the site. The current disturbed acreage was estimated by the Operator at 64.7 acres (38.7 acres for the west pit and 26.3 acres for the east pit) in the 2017 annual report, which exceeds the approved 60 acres of allowed disturbance. The technical revision must include all currently disturbed and reclaimed but not released areas of the site. The Division currently holds a reclamation bond in the amount of \$135,807. The required financial warranty will need to be updated by the Operator and reviewed by the Division as part of the technical revision.

View of new stormwater detention pond in the DWR east area

**CORRECTIVE ACTIONS:** The Operator shall submit a Technical Revision, with the required \$216 revision fee, to update and clarify the current approved mine plan to reflect existing and proposed activities by the corrective action date.

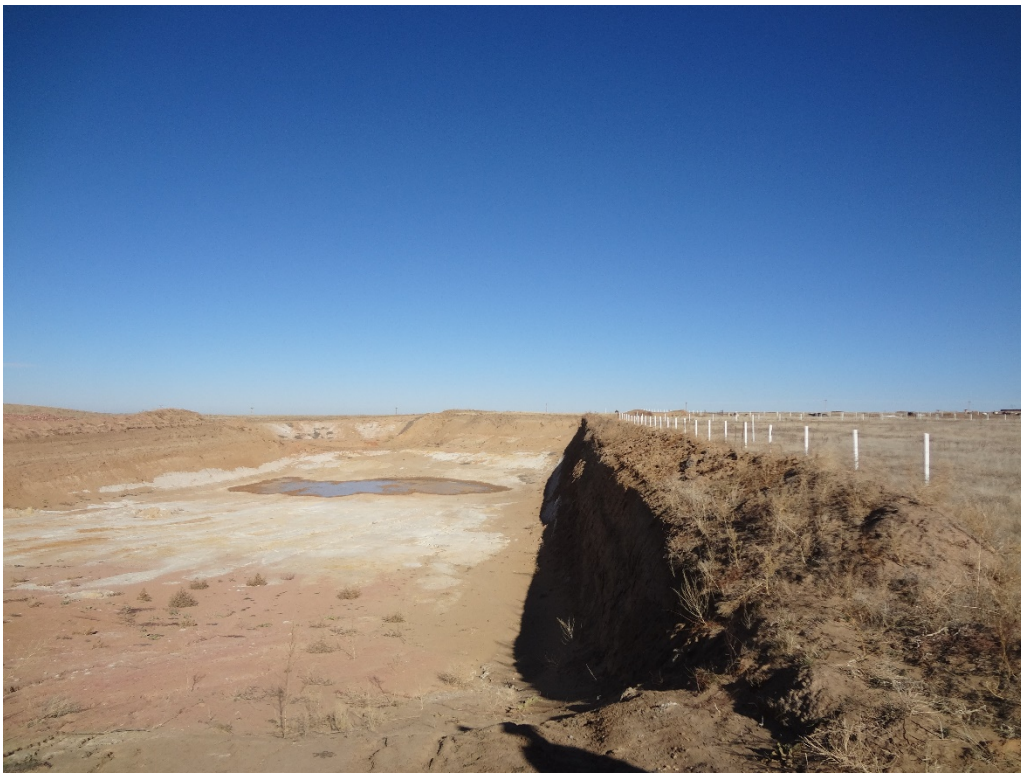
The east portion of the site contained the excavation area, a reclaimed area in the north portion of the area, a stormwater detention pond and a product, overburden and vegetated topsoil stockpiles in the south portion of the area. The mining excavation depth was estimated at 20 feet along the eastern highwall. The last mining campaign concluded on August 2, 2017. The Operator stated an additional clay deposit is present below the current pit floor. The pit floor contained a small amount of stormwater.

View of highwall and pit floor in the DWR east area from the southeast corner looking north

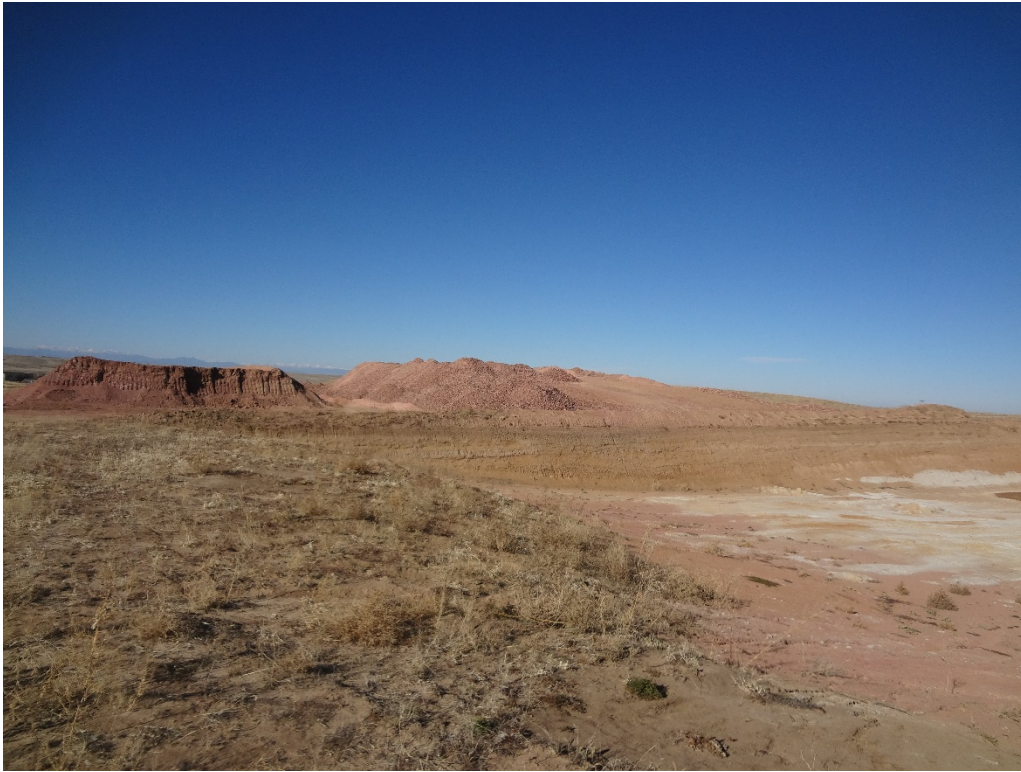
View of the pit, product stockpile and overburden stockpile in the DWR east area looking west from the southeast corner

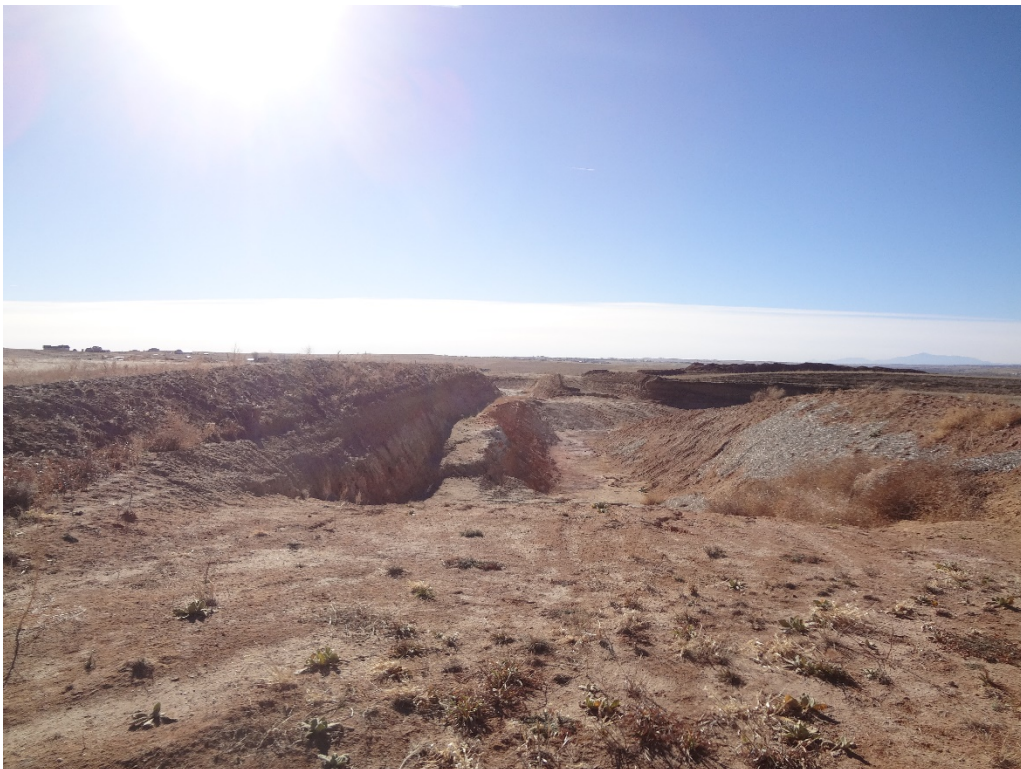
View of the mining excavation from the northeast corner of the DWR east area looking south

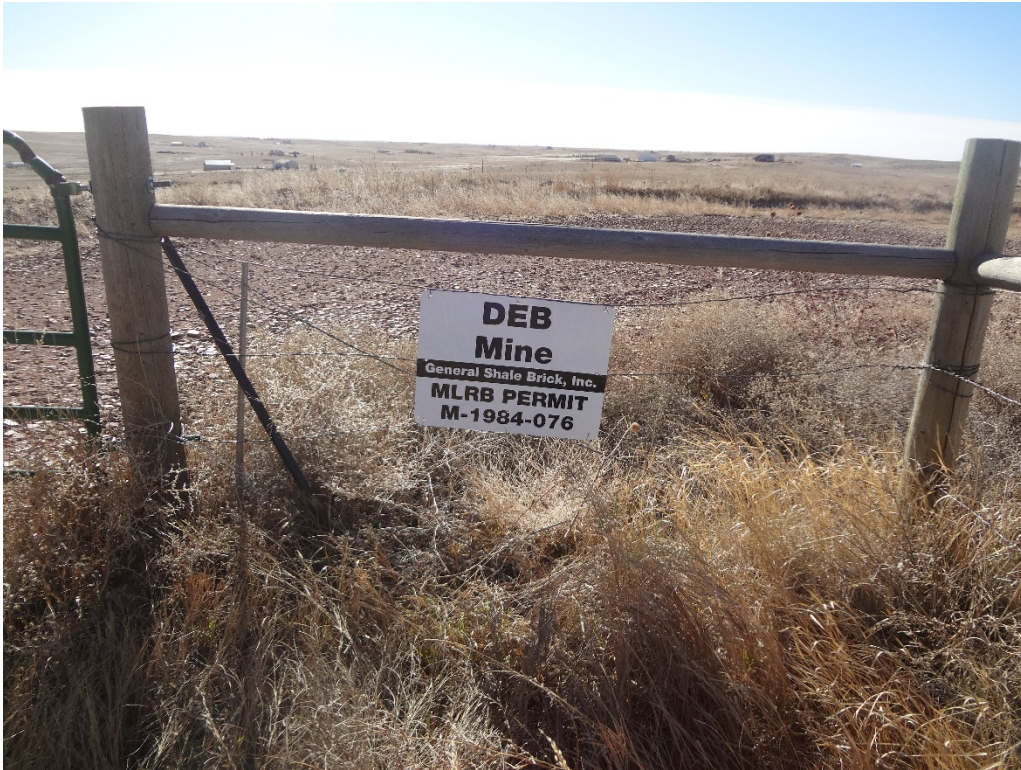
DEB (east pit) mine sign

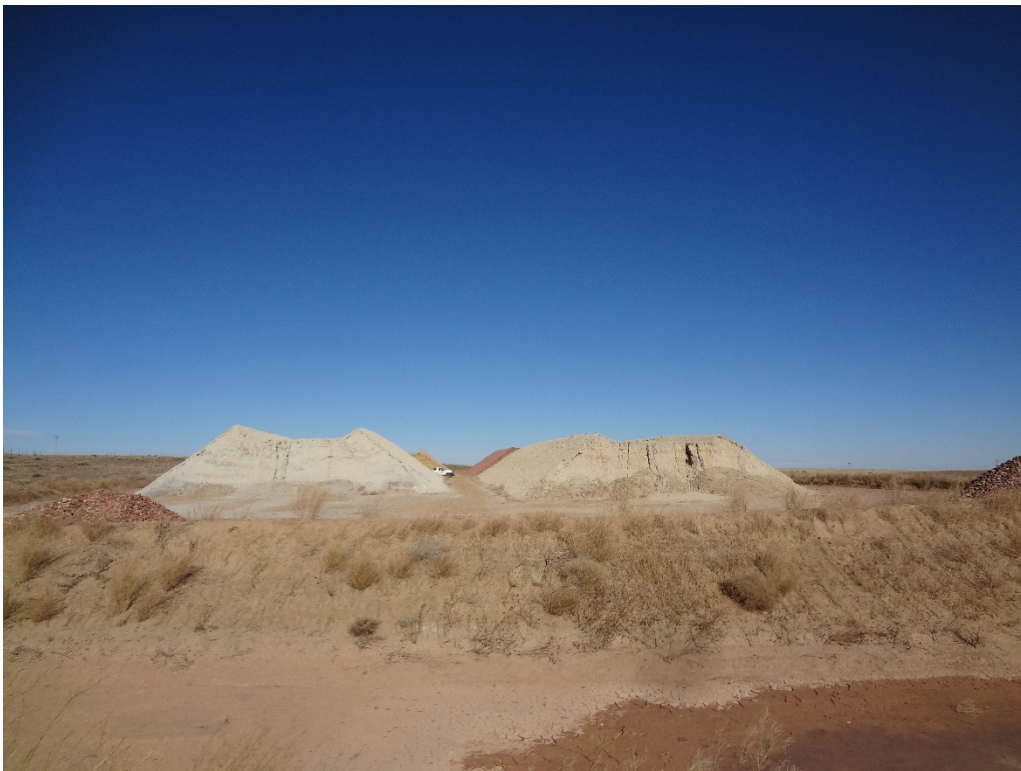
View of the DEB stockpile area from the detention pond looking north

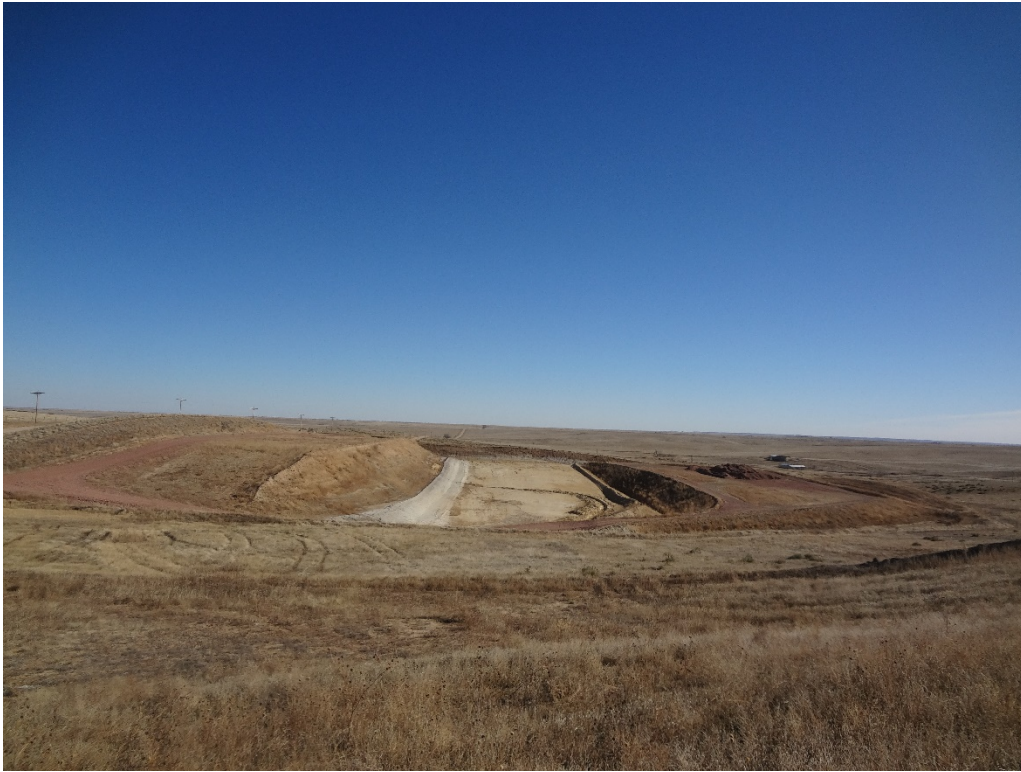
Two clay deposits are located below the current pit floor according to the Operator. The current northern highwall is approximately 30 feet. The pit is expected to be mined deeper another 15 to 20 feet from the current elevation. The partially reclaimed area was mined and backfilled to the current grade. Overburden has been replaced, but topsoil has not been replaced over the area. A stockpile of waste brick was located in the eastern portion of the partially reclaimed area.

View of the DEB excavation and reclaimed areas from the stockpile area looking east
