**COLORADO**Division of Reclamation,
Mining and Safety

MINERALS PROGRAM INSPECTION REPORT**PHONE: (303) 866-3567**

MINE NAME: Hazeltine Mine	MINE/PROSPECTING ID#: M-2004-031	MINERAL: Sand and gravel	COUNTY: Adams
INSPECTION TYPE: Monitoring	INSPECTOR(S): Jared L. Ebert and Wally Erickson	INSP. DATE: November 8, 2017	INSP. TIME: 09:30
OPERATOR: Aggregate Industries - WCR, Inc.	OPERATOR REPRESENTATIVE: Connie Davis and Mike Refer	TYPE OF OPERATION: 112c - Construction Regular Operation

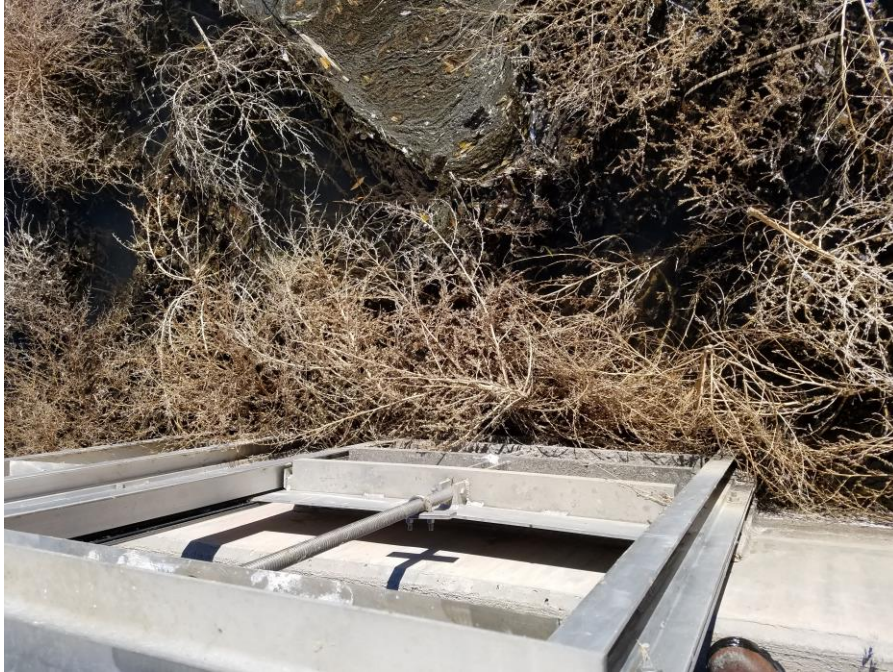
Figure 1. Inlet from the Fulton Ditch to the drain that flows to the Bull Seep.

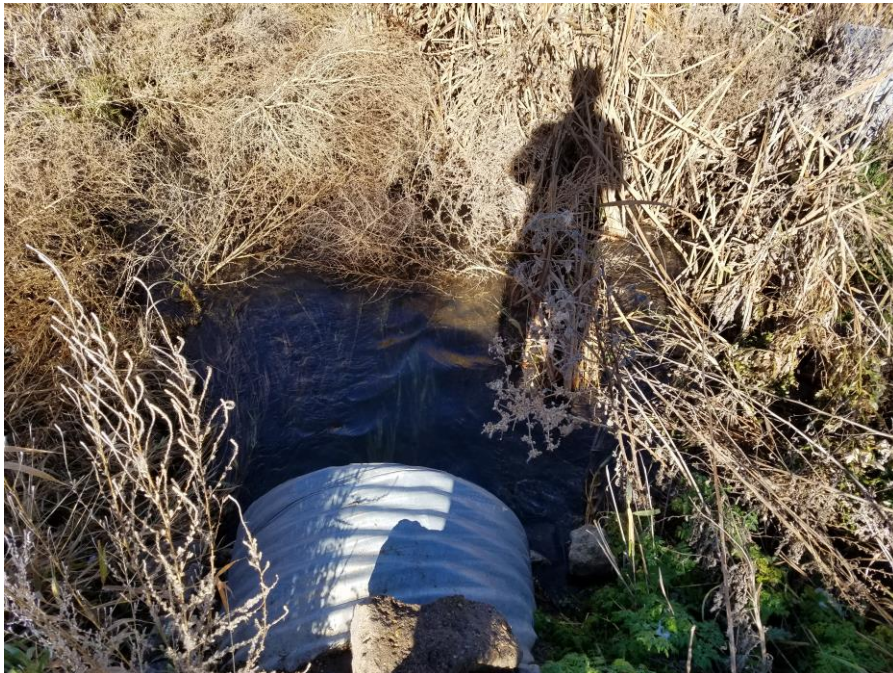
Figure 2. Outlets from the Fulton Ditch to the Bull Seep.

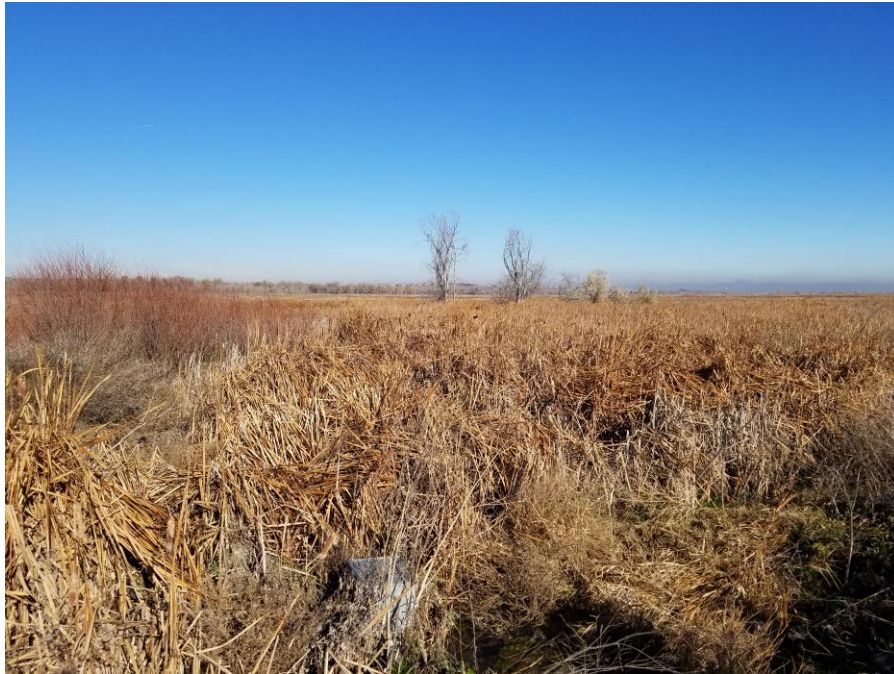
We first observed the Orr property with Steve O'Brian. At the time of the inspection, the Fulton Ditch was discharging through the turnout into the Bull Seep. Wetland vegetation is well established throughout the Orr property and standing water was observed throughout the property. A larger pond areas has developed on the northwest side of the Orr property. During the inspection, Mr. O'Brian took groundwater level measurements at three wells installed on the Orr property. They are designated as MW01, 02 and 03. The water elevations of these wells were found to be 5039.34 feet in MW01, 5040.18 feet in MW02 and 5040.27 feet in MW03. Steve O'Brian sent the Division the monitoring results of these wells taken from January 25, 2017 through November 8, 2017. These results are enclosed with this report. Overall, it appears the majority of the Orr property is flooded from both surface and groundwater sources.

Figure 3. From the turn-out from the Fulton Ditch on the Orr property looking north.

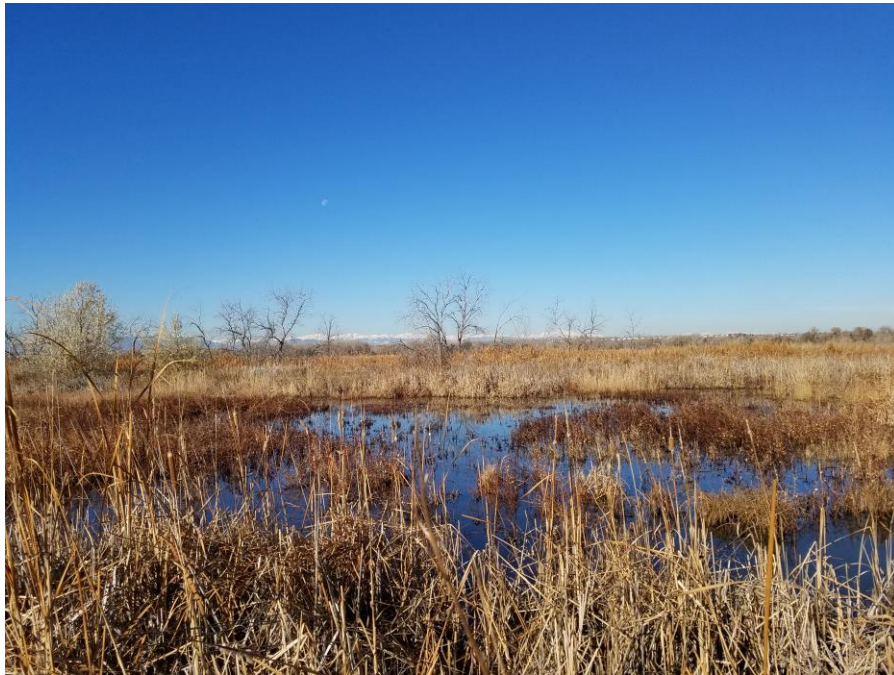
Figure 4. Small pond that has formed on the west side of the Orr property.

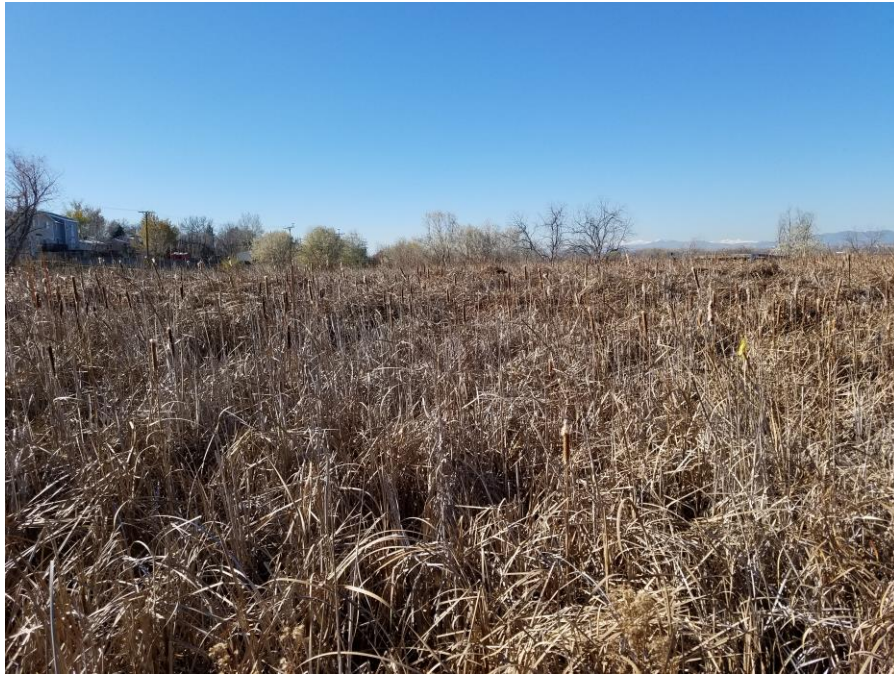
PROBLEM: The Orr property is still flooded and the Operator has failed to mitigate the disturbance to the prevailing hydrologic balance in the surrounding area and has failed to protect areas outside of the affected land from damage. This is a problem at this time pursuant to C.R.S. 34-32.5-116(4)(h) and 34-32.5-116(4)(i).

Figure 5. From the northeast end of the Orr property looking southwest.

- (1) The Operator shall take immediate action to sufficiently dry the surface of the Orr property. Mitigation measures shall be taken immediately and the Orr property must be sufficiently dry by the corrective action due date.

- (2) Submit a Technical Revision to the Permanent Plan for the Orr property so the mitigation measures to be taken for the Orr property will function year round with little maintenance.

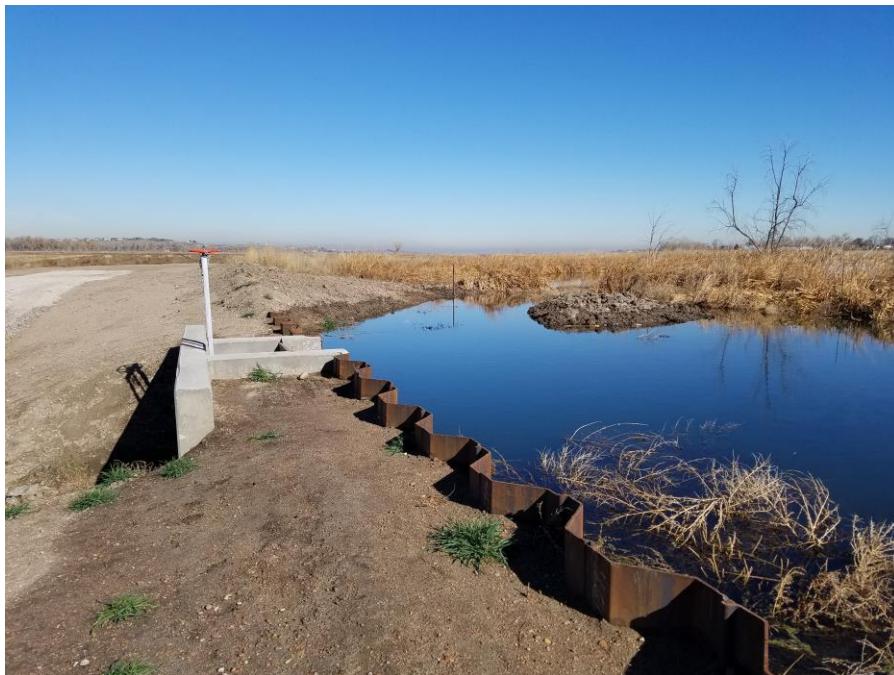
After inspecting the Orr property, we observed the Orr Drain with the representatives of AI and their consultants. Mr. Tom Hessman with Tetra Tech provided a brief description of the construction of the Orr drain. The drain consists of an 18 inch pipe installed through the slurry wall. The Operator installed a concrete headwall with a large metal pile wall driven into the slurry wall. The headwall included a gate to close the drain and stop logs. The discharge pipe discharges into a concrete lined channel that crosses the access road for the reservoir. A parshall flume was installed at the top of the pit slope used to measure discharge into the pit. A concrete and rip-rap lined channel allows the Orr Drain discharge to flow into the pit. Mr. Refer provided the Division with documentation that they initiated construction of the Orr Drain on November 23, 2016 and completed the drain on September 22, 2017. On November 21, 2017, the Operator supplied the Division with as-built certification for the Orr Drain. Based on the as-built, the upstream invert elevation of the Orr drain is at 5,036.40 feet about .1 foot lower than the approved design. It appears the Operator has installed the Orr Drain in accordance with the approved plan. At the time of the inspection, the Fulton Ditch was turned out and discharging through the channel on the Orr property into the relocated Bull Seep within the Hazeltine Mine site. In accordance with the approved plan submitted with AM01, the Orr Drain gate was closed because the Fulton Ditch was releasing water to the Bull Seep. The Orr Drain was not discharging with the exception of a very small leak from the pipe. Given this, a pond of water was observed behind the headwall of the Orr Drain approximately 5 feet deep. Monitoring Wells HZMW-2, 11a and 11b were observed. A significant amount of wetland vegetation has established around these wells and water was observed above the base of the casings.

Figure 6. Orr Drain, from the south looking north. Inlet and headwall.

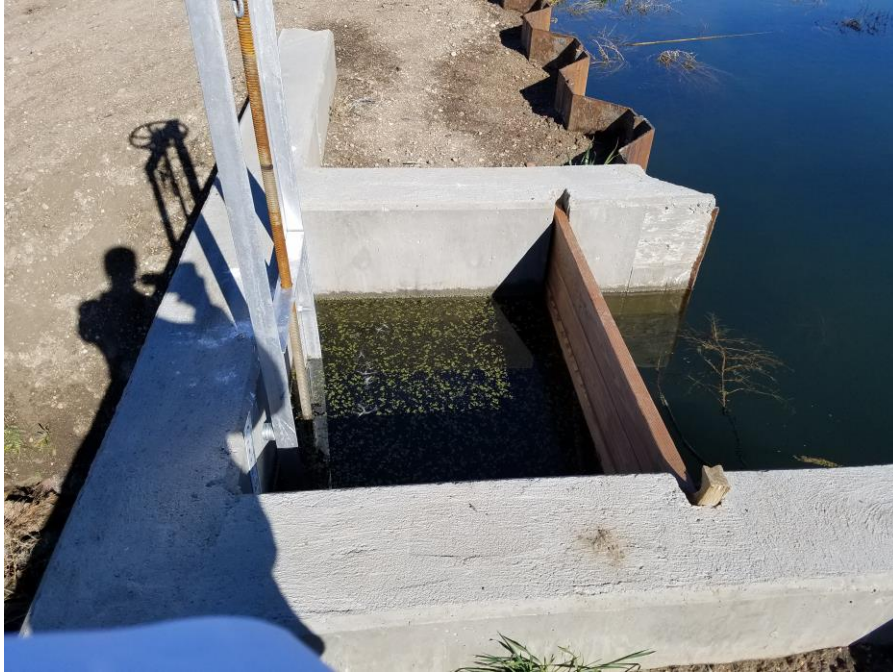
Figure 7. Headwall of the Orr Drain.

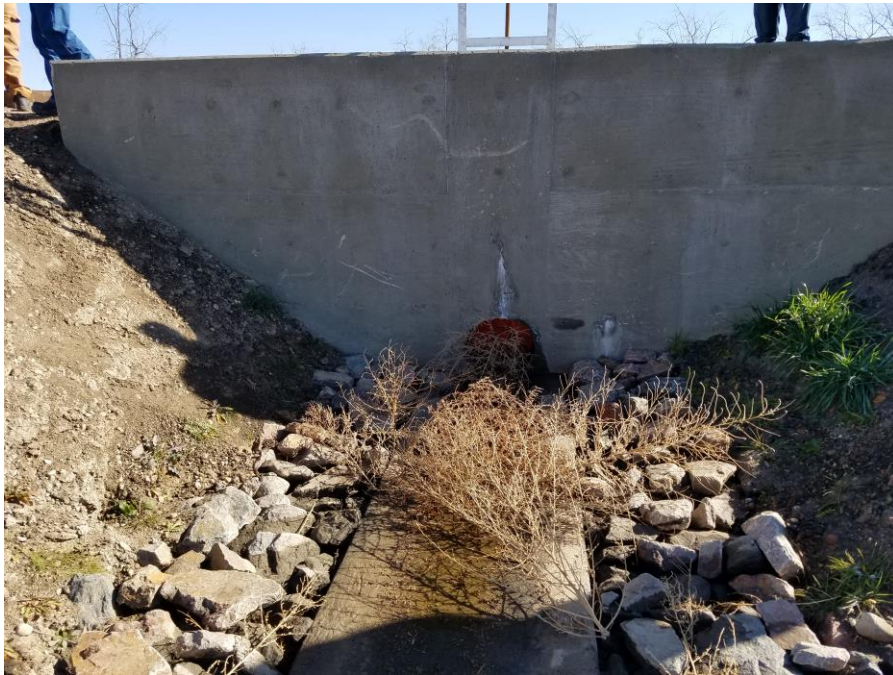
Figure 8. Outlet of the Orr Drain.

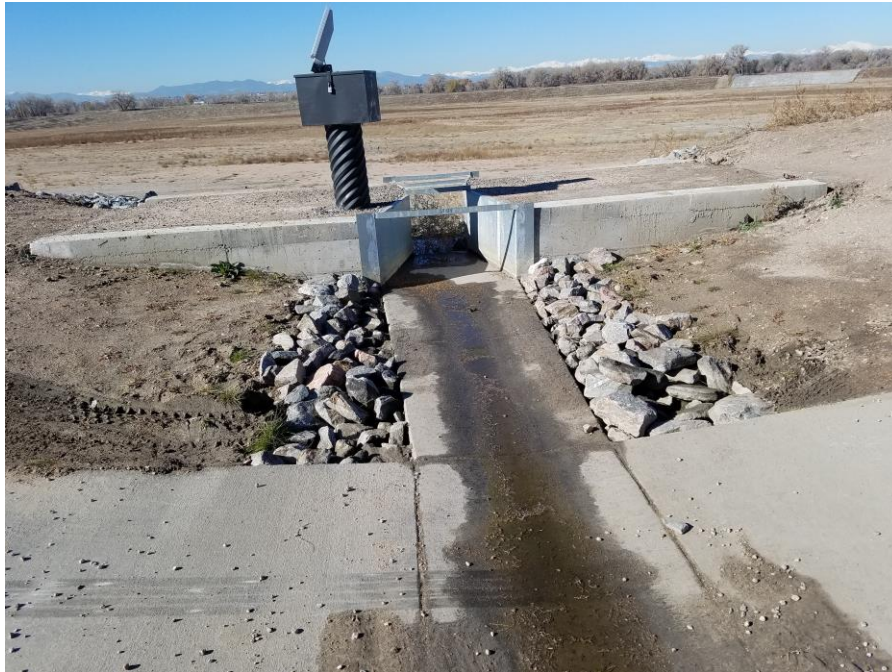
Figure 9. Parshall Flume of the Orr Drain.

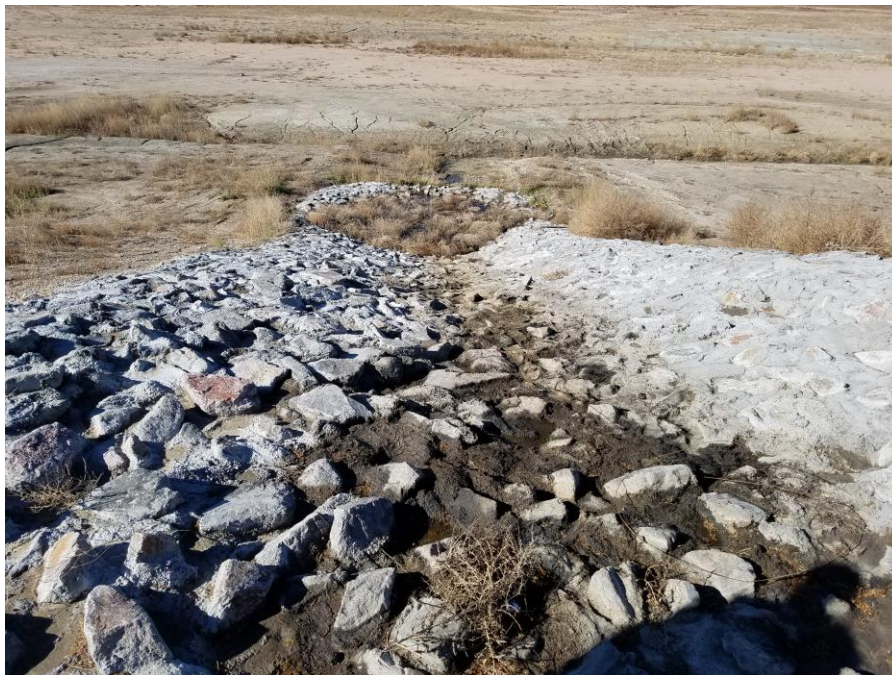
Figure 10. Orr Drain channel run-down into the pit.

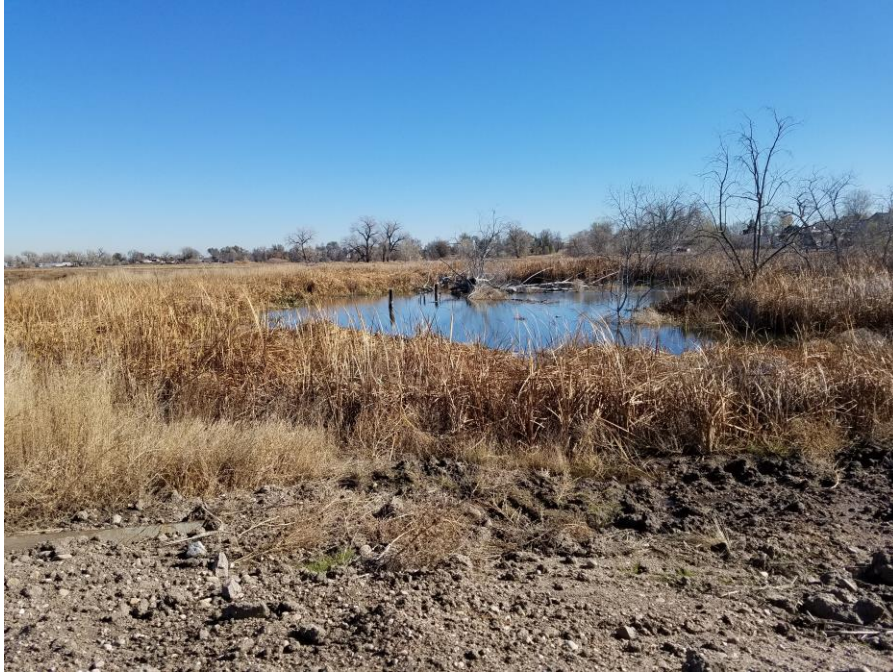
Figure 11. Bend in the Bull Seep drainage located north of the Orr Drain. Significant water back-up noted.

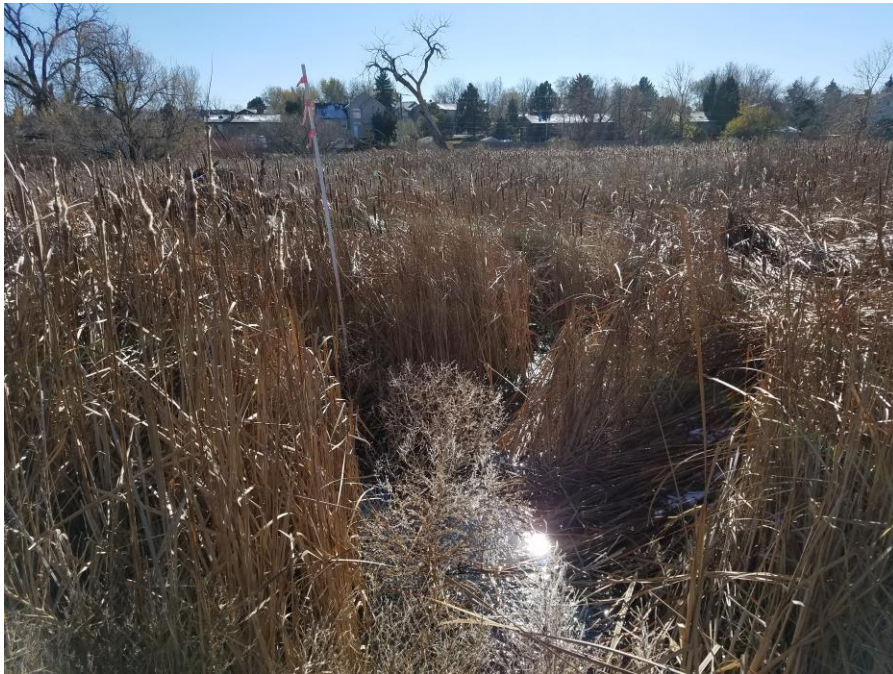
Based on the available data, the groundwater level reported for monitoring wells HZMW-2, 11a and 11b, it does not appear groundwater levels have dropped below the maximum groundwater elevation reported for the area prior to the completion of the slurry wall. It does not appear the Operator has lowered the groundwater level at the site either temporarily or permanently.

Figure 12. Picture taken west of HZMW-11a and 11b looking east. Water observed around the bottom of the well casings.
