**MINERALS PROGRAM INSPECTION REPORT**  
**PHONE: (303) 866-3567**

<b>MINE NAME:</b> West Fork Pit	<b>MINE/PROSPECTING ID#:</b> M-2005-069	<b>MINERAL:</b> Gravel	<b>COUNTY:</b> Garfield
<b>INSPECTION TYPE:</b> Surety-Related Inspection	<b>INSPECTOR(S):</b> Amy C. Yeldell	<b>INSP. DATE:</b> December 14, 2017	<b>INSP. TIME:</b> 09:30
<b>OPERATOR:</b> Caerus Piceance LLC	<b>OPERATOR REPRESENTATIVE:</b> Jason Eckman	<b>TYPE OF OPERATION:</b> 112c - Construction Regular Operation	
<b>REASON FOR INSPECTION:</b> Priority	<b>BOND CALCULATION TYPE:</b> Complete Bond	<b>BOND AMOUNT:</b> \$39,078.00	
<b>DATE OF COMPLAINT:</b> NA	<b>POST INSP. CONTACTS:</b> None	<b>JOINT INSP. AGENCY:</b> None	
<b>WEATHER:</b> Snowing	<b>INSPECTOR'S SIGNATURE:</b>

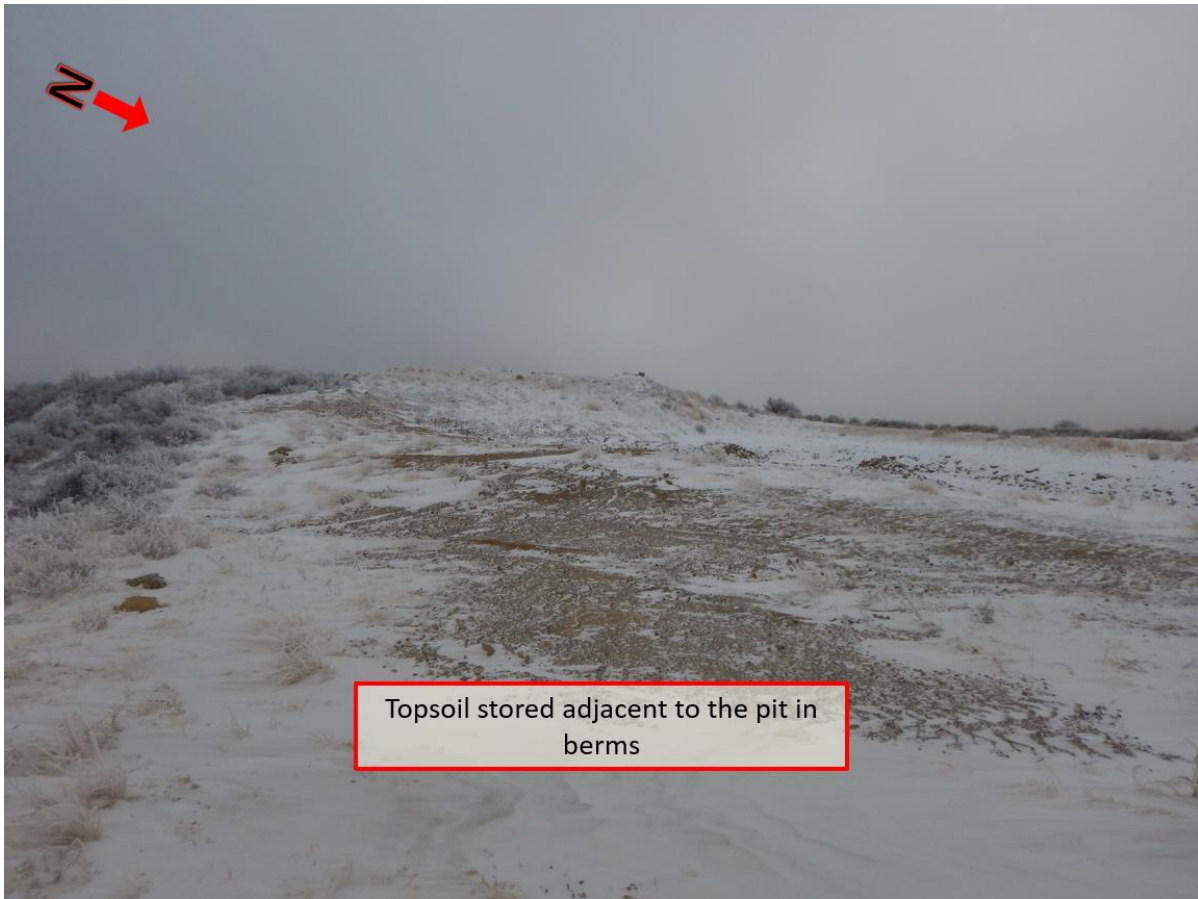
Topsoil stored adjacent to the pit in berms

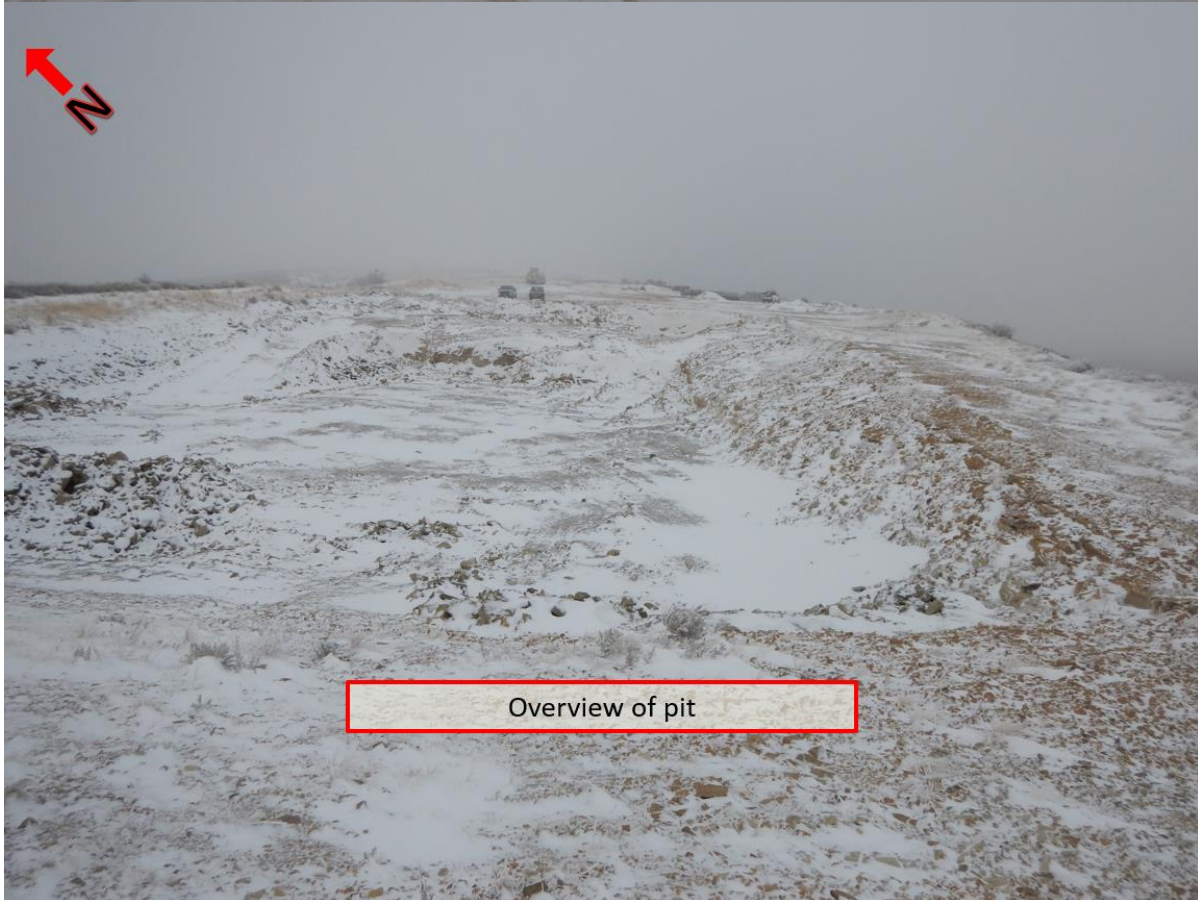
Overview of pit
