MINERALS PROGRAM INSPECTION REPORT
PHONE: (303) 866-3567

MINE NAME: Hogback Mine	MINE/PROSPECTING ID#: M-1980-245	MINERAL: Clay (general)	COUNTY: Douglas
INSPECTION TYPE: Monitoring	INSPECTORS: Peter S. Hays, Wally Erickson	INSP. DATE: December 18, 2017	INSP. TIME: 10:00
OPERATOR: General Shale Brick, Inc.	OPERATOR REPRESENTATIVE: Jason McGraw	TYPE OF OPERATION: 112c - Construction Regular Operation	
REASON FOR INSPECTION: Normal I&E Program	BOND CALCULATION TYPE: None	BOND AMOUNT: \$236,538.00	
DATE OF COMPLAINT: NA	POST INSP. CONTACTS: None	JOINT INSP. AGENCY: None	
WEATHER: Clear	INSPECTOR'S SIGNATURE:

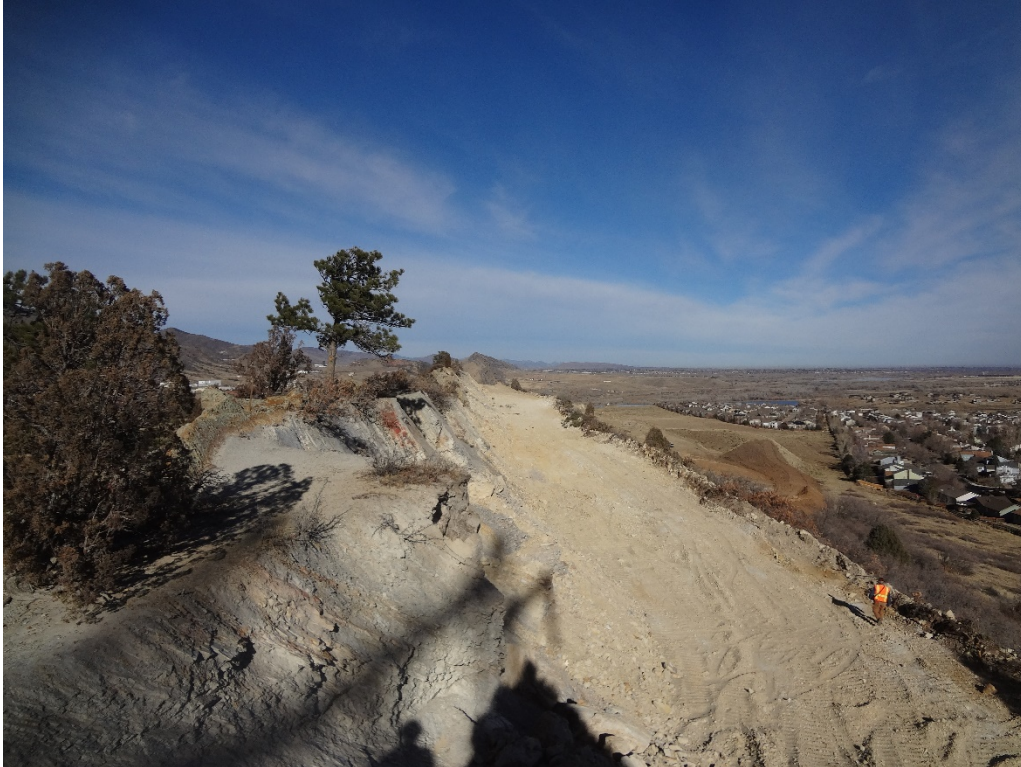
The Operator informed the Division the backfilling of the stopes was completed on December 4, 2017. The backfilling of the stopes was accomplished using a D8 Dozer. The dozer ripped the sandstone deposit east of the clay deposit containing the stopes and backfilled the stopes with the sandstone material. Surge piles of material were placed over the previously backfilled stopes in the middle bench of the site to prevent the stopes from reopening as the backfill material settles. The upper stope bench appeared stable and the stopes are safeguarded from access by the public. The Division commends the Operator for safeguarding the stopes quickly to prevent further incidents from occurring at the site.

View of the backfilled stopes from the south end of the property

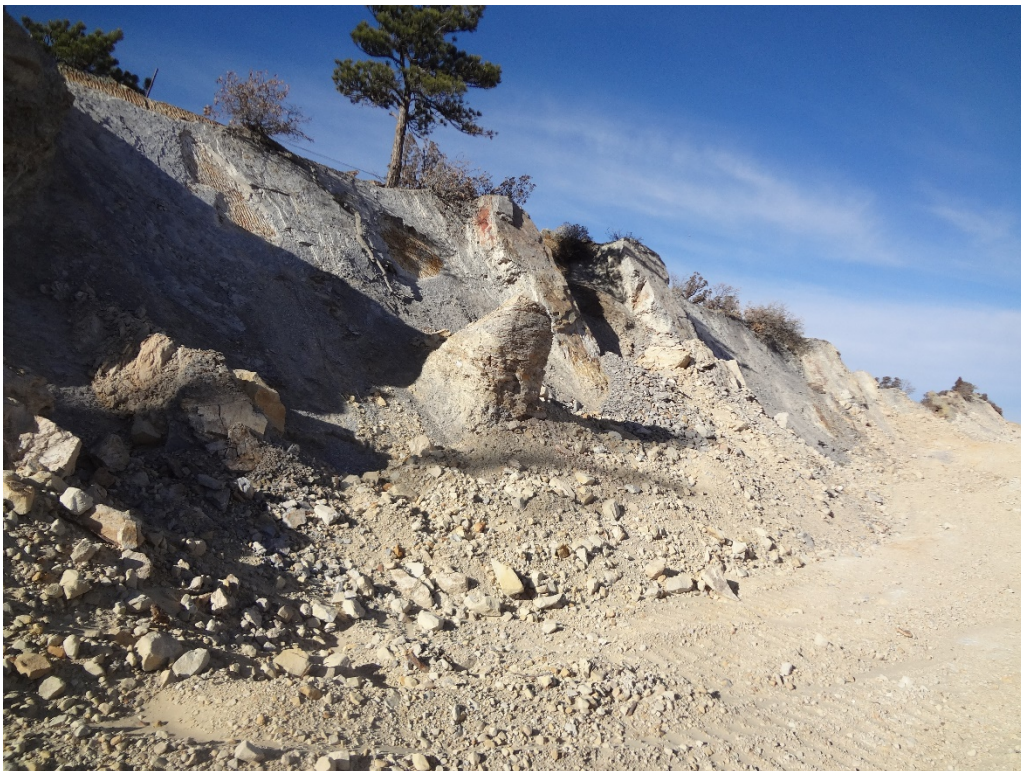
View of the backfilled stopes from the newly established upper bench looking south

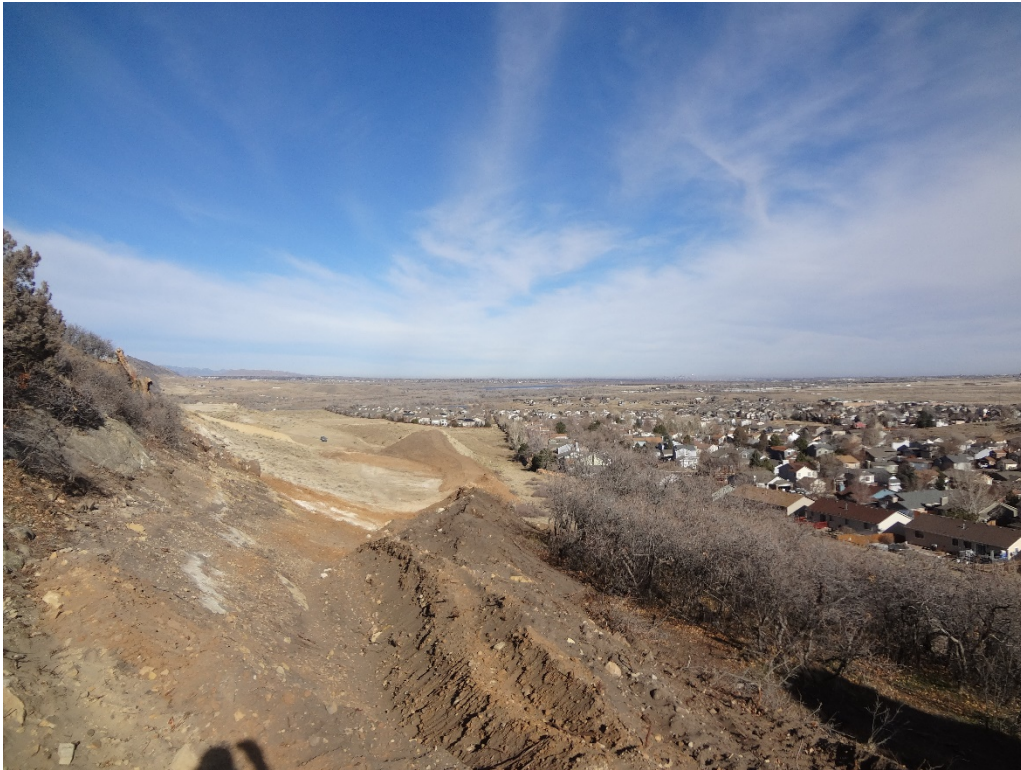
A catchment berm was constructed with topsoil along the eastern boundary of the mine site prior to performing the backfill work to protect the houses downhill of the mine site from rocks rolling down the ridge.

View of catchment berm from the south end of the berm looking north

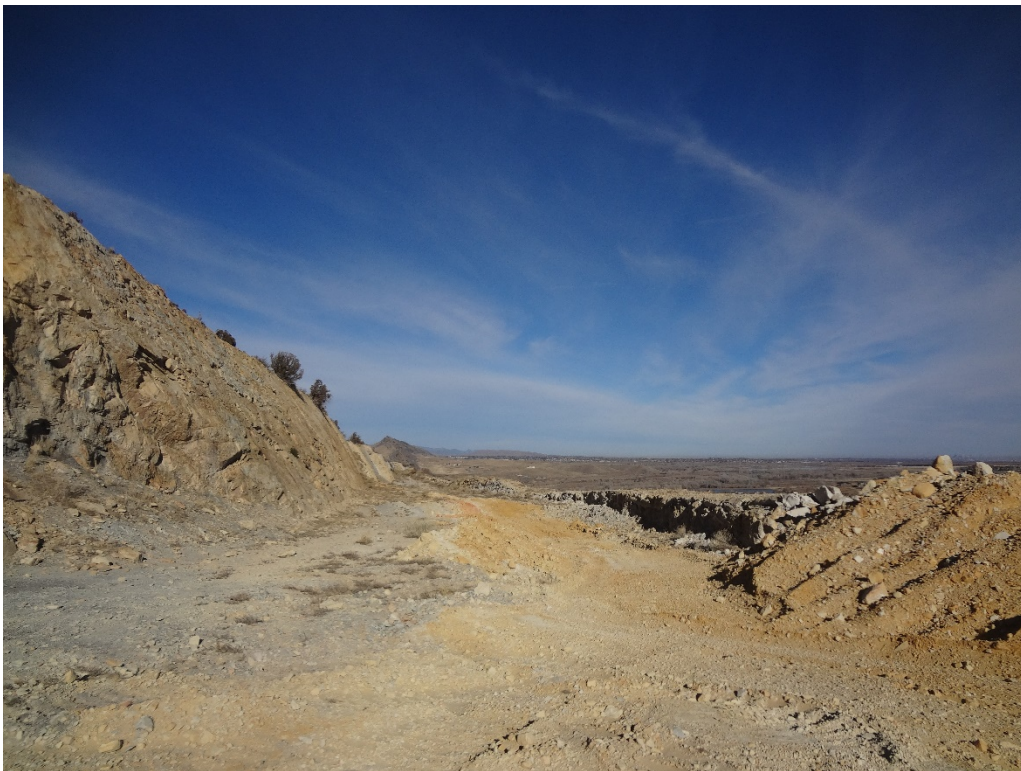
View of the surge pile over the backfilled stopes on the middle bench
