**COLORADO**Division of Reclamation,
Mining and Safety

MINERALS PROGRAM INSPECTION REPORT**PHONE: (303) 866-3567**

MINE NAME: Loloff Mine	MINE/PROSPECTING ID#: M-1985-112	MINERAL: Sand and gravel	COUNTY: Weld
INSPECTION TYPE: Monitoring	INSPECTOR(S): Peter S. Hays	INSP. DATE: December 1, 2017	INSP. TIME: 11:00
OPERATOR: Loloff Construction, Inc.	OPERATOR REPRESENTATIVE: Kelly Hodges	TYPE OF OPERATION: 112c - Construction Regular Operation

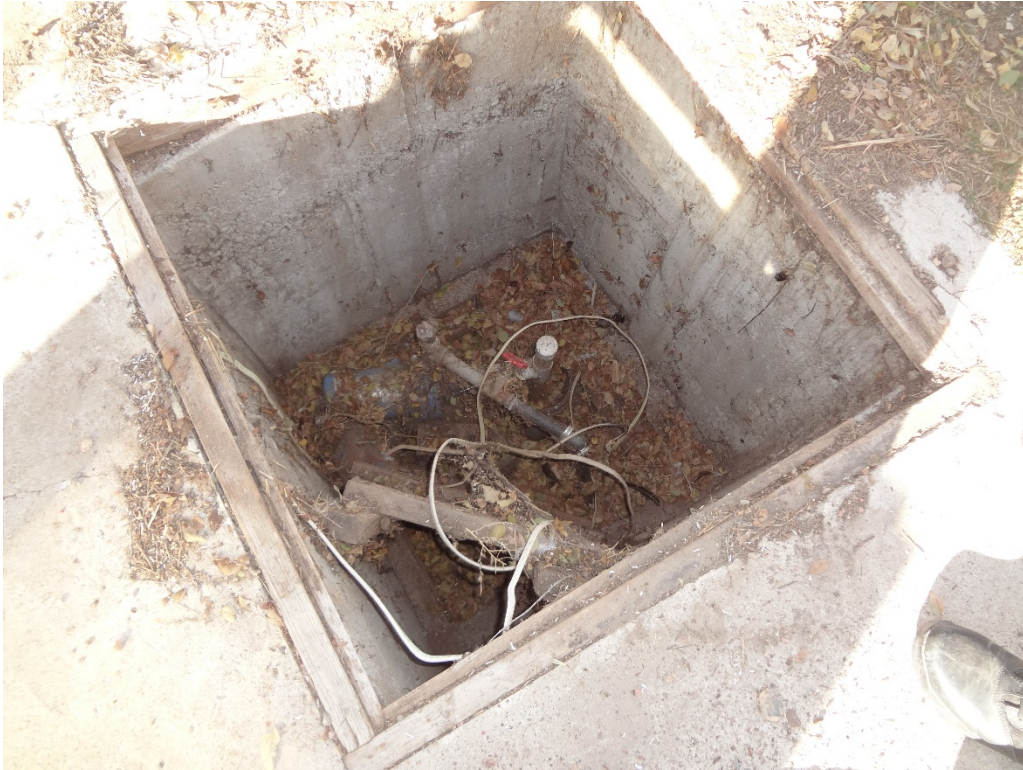
Well #5 – Unpermitted - Stock (Kohlhoff)

The Division observed a wellhead located north of the Kohlhoff residence. The Division determined the well is not permitted through the Division of Water Resources following the inspection. By law, every well in the state which diverts groundwater must have a well permit. The Operator will not be required to mitigate any impacts to the well since the well is unpermitted.

View of wellhead for Well # 5 – Unpermitted well on former Kohlhoff property

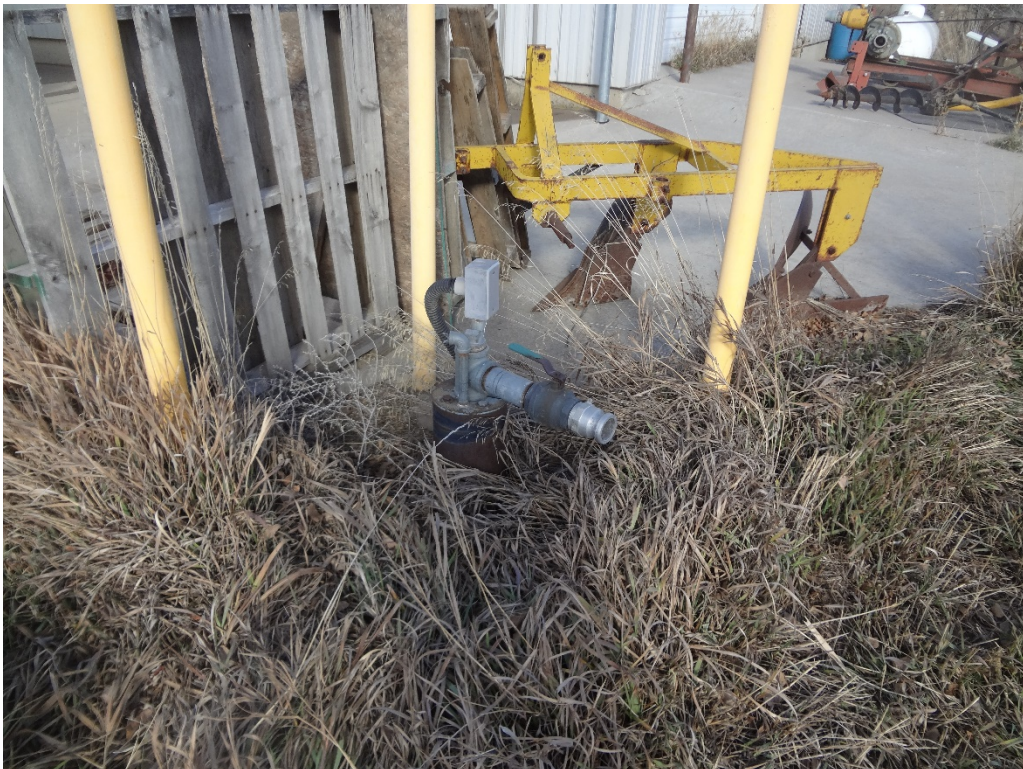
Well #1 – 26555A – Stock

The Division observed the wellhead for Well #1, Permit # 26555A. The well was installed in October 1, 1996 to a depth of 44 feet below grade with a static water level of 7 feet below grade based on Division of Water Resources (DWR) records. The well was installed two feet into bedrock. The Division measured the depth to water at 16.78 feet (an increase of 5.86 feet from the Division's 2015 reading of 22.64 feet) and the depth to top of the pump at 35.50 feet below top of casing. No data has been collected or reported by the Operator for Well #1, so additional groundwater elevations are not available for the well. The change in water elevation from 7 feet to 16.78 feet below grade is greater than the required 2 feet elevation change required to

implement the approved mitigation plan. The installation of the slurry wall appears to be reducing the effects of the groundwater impacts on the well from dewatering activities.

View of wellhead for Well #1 - 26555A - Stock

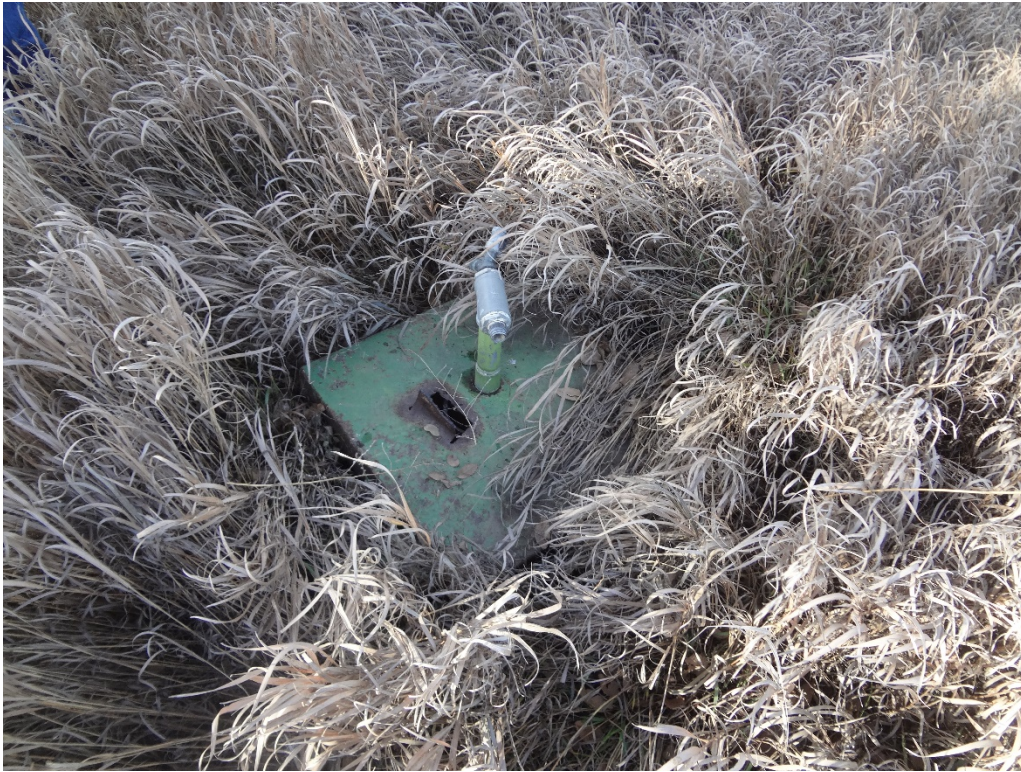
Well #3 – 135883 – Domestic

The Division observed the wellhead for Well #3, Permit # 135883. The first beneficial use of the well was June 20, 1963. The well is the water supply for the shop/garage building and the original residence located north of the shop/garage according to Mr. Francis. The main residence on the property is on City of Greeley water. The well is 32 feet deep with a pumping rate of 40 gallons per minute and is approved for domestic use at 2 acre feet annually based on DWR records. The Division measured the depth to water at 15.00 feet (an increase of at least 2.75 feet from the Division 2015) and the depth to top of the pump at 17.75 feet below top of casing. The latest monitoring data for the well, reported by the Operator on April 1, 2015, indicated the depth to water was 20 feet and 9 inches. No data has been collected or reported by the Operator since the April 2015 measurement, so recent groundwater elevations are not available for the well. The static water level at the time of well construction is not available in the DWR records, however the measured depth of 17.75 feet below grade is greater than the required 2 feet elevation change required to implement the approved mitigation plan based on the historic static groundwater levels in wells in the area. The installation of the slurry wall appears to be reducing the effects of the groundwater impacts on the well from dewatering activities.

View of wellhead for Well #3 - 135883 - Domestic

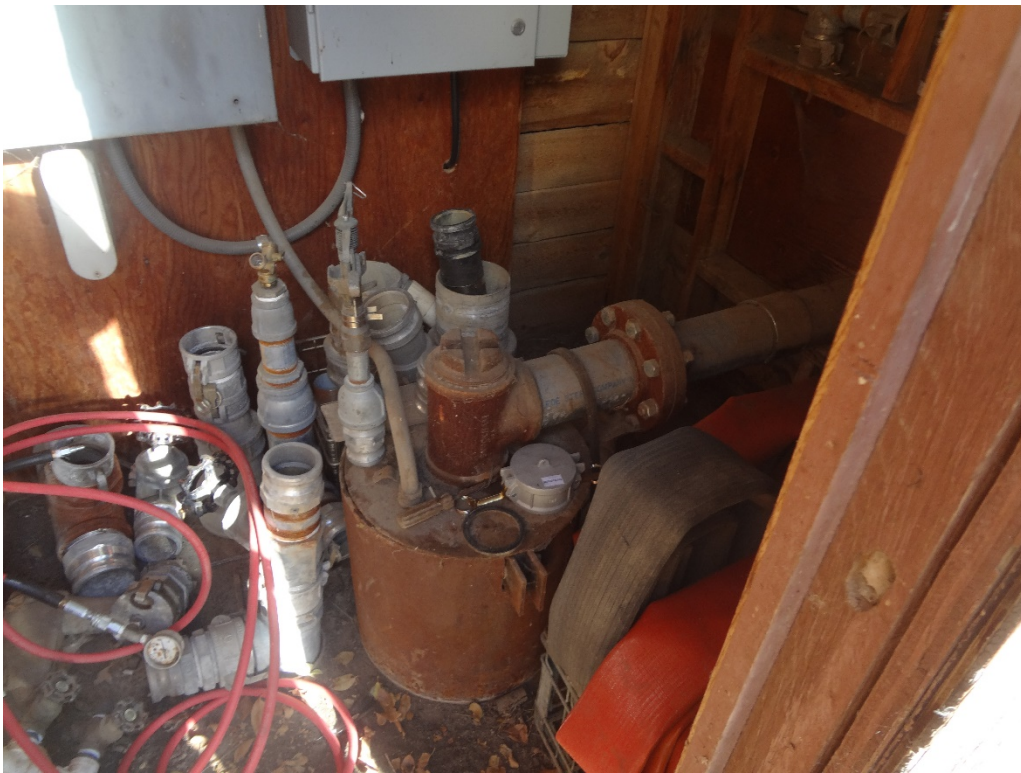
Well #2 – 30562-F – Irrigation

The Division observed the wellhead and pump house for Well #2, Permit # 30562-F. The well is permitted to irrigate the 8 acre parcel located in the eastern portion of the Francis property at 351 East 8th Street. The well was installed in March 18, 1986 to a depth of 38.5 feet below grade with a static water level of 5 feet below grade based on DWR records. The well was completed to bedrock depth. The Division was unable to measure the water level or the depth of the well due to the lack to accessibility. No data has been collected or reported by the Operator for Well #2, so recent groundwater elevations are not available for the well.

View of wellhead for Well #2 - 30562-F - Irrigation

Mr. Francis stated during the inspection of his properties his preference is to hire a well company himself to investigate the irrigation well, Well #2, Permit # 30562-F. He does not want the work completed by Loloff Construction, Inc.

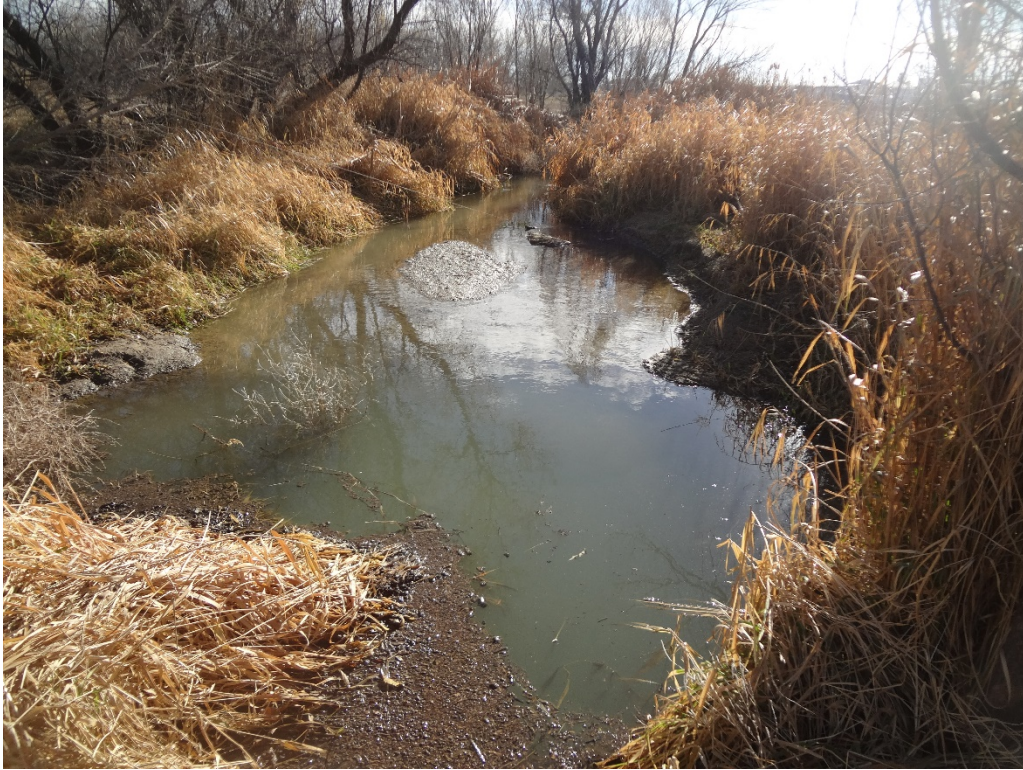
The waterway through the Francis properties was observed by the Division. Sediment deposits were observed throughout the inspected sections of the waterway.

View of sediment in the waterway south from land bridge on the Francis property

Mr. Francis stated during the inspection of his properties his preference is to clean out and restore the waterway with an independent contractor. He does not want the work completed by Loloff Construction, Inc. As stated above, the Division concluded the mine dewatering into the ditch is not the source of sediment in the Francis waterway therefore not action is required by the Operator.

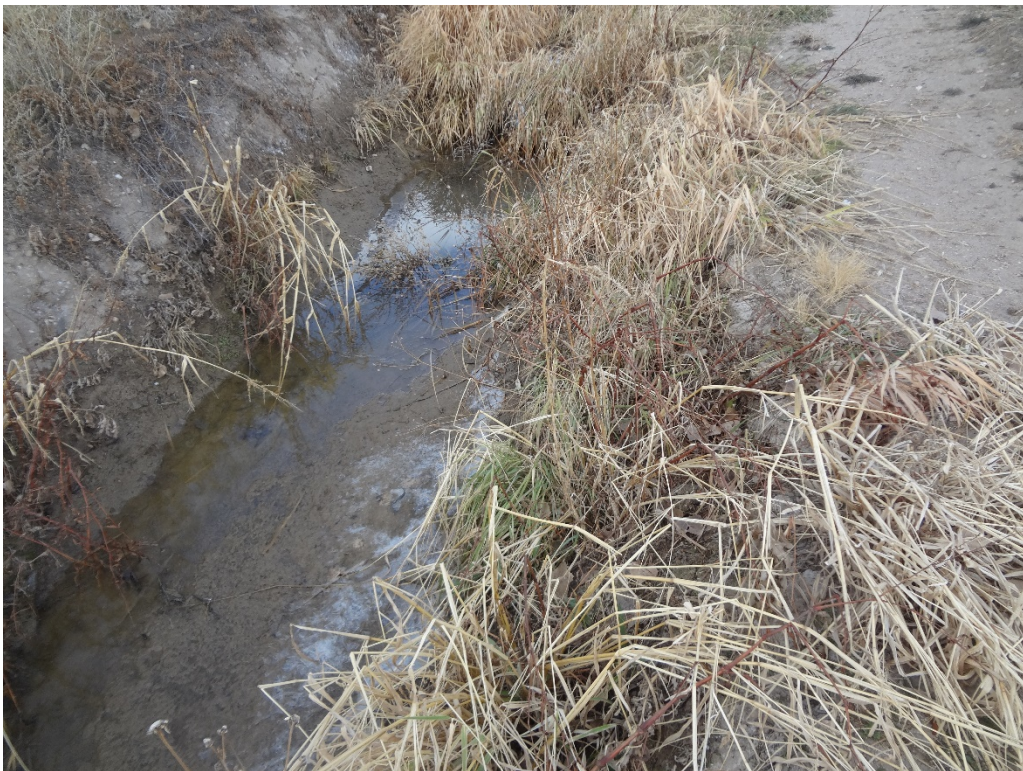
The ditch along the western boundary of the Loloff Mine was observed below and above the dewatering discharge point. Sedimentation deposits consistent with the deposits observed in the Francis waterway were observed above the discharge point. Therefore, the Division concluded the mine dewatering into the ditch is not the source of sediment in the Francis waterway. The Operator provided the Division with water sampling data performed by Weld County Department of Public Health and Environment in 2017 during the inspection. The data indicated the Total Suspended Solids were below the detectable level in a majority of the samples. The Colorado Department of Public Health and Environment Water Quality Control Commission Rule 31 does not set a standard for Total Suspended Solids.

View of sediment in the ditch along the western boundary of the Loloff Pit

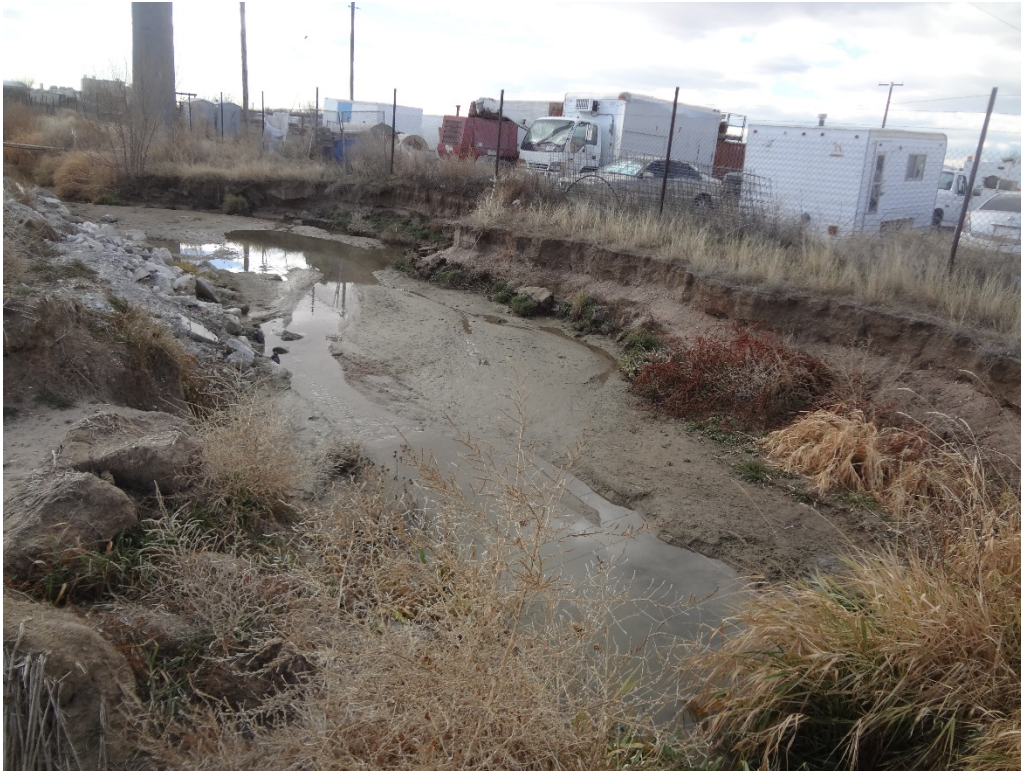
PROBLEM: Problem: An erosion feature was observed along the west bank of the ditch located along the western boundary of the site. The Operator stated the erosion feature was created by a flood event through the adjacent Harrell property. The erosion feature is very close to the western permit boundary.

As cited as a problem above, an erosion feature was observed along the west bank of the ditch located along the western boundary of the site. The Operator stated the erosion feature was created by a flood event through the adjacent Harrell property. The Operator's statement was supported by weeds and debris deposited along the fence east of the ditch in the area of the erosion feature which appeared to be deposited by a stormwater event. The erosion feature is very close to the western permit boundary. The Operator must repair the damaged area before the area erodes beyond the permit boundary. Failure to repair the erosion feature may result in a possible violation of C.R.S. 34-32.5-116(4)(i) for failure to protect areas outside of the affected land from slides or damage during the mining and reclamation if the erosion feature progresses into the Harrell property. The Operator stabilized the east bank the ditch with rock to prevent the flood event from breaching the ditch and entering the pit.

View of erosion feature along the ditch parallel to the Harrell property

CORRECTIVE ACTIONS: The Operator must repair the damaged area before the area erodes beyond the permit boundary. Failure to repair the erosion feature may result in a possible violation of C.R.S. 34-32.5-116(4)(i) for failure to protect areas outside of the affected land from slides or damage during the mining and reclamation.
