Re: King I Mine, C-1981-035  
Stoner Engineering: Quarterly Inspection: Refuse Pile  
4th Quarter 2017

Date: December 20, 2017

Re: King Coal I – Quarterly Waste Pile/Embankment Inspection

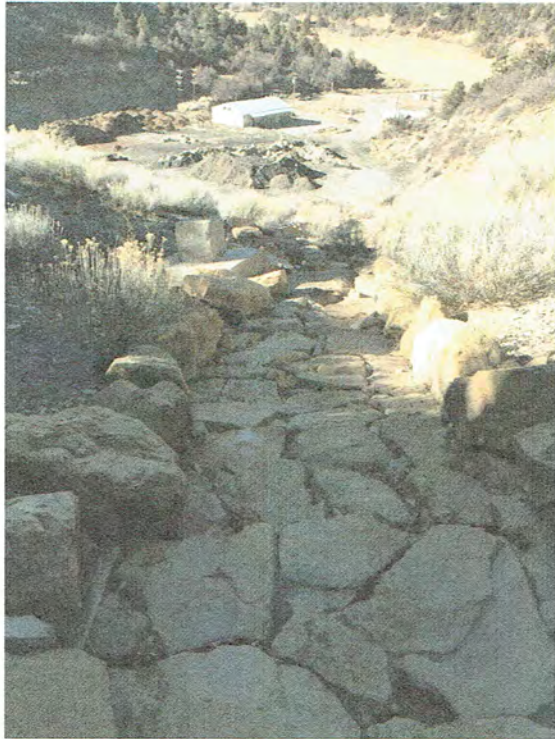
The condition of the perimeter ditches located along the north and south sides of the property were generally in good condition. The north, clean water channel still has some minor accumulation of sediment and small rock that should not impact the overall function of the channel during a storm event. The drainage channels were generally clear of debris (see Pic. 1) and there was no damage observed to any of the channel sections. The pipe sections were found to be clear of debris and functioning as designed (see Pic. 2).

Pic. 1 – South channel in good condition.

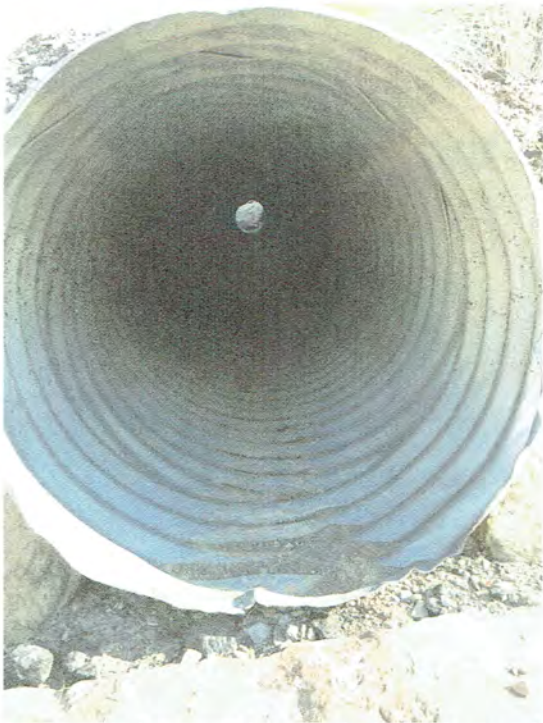
Pic. 2 – Culvert under road above base of embankment.

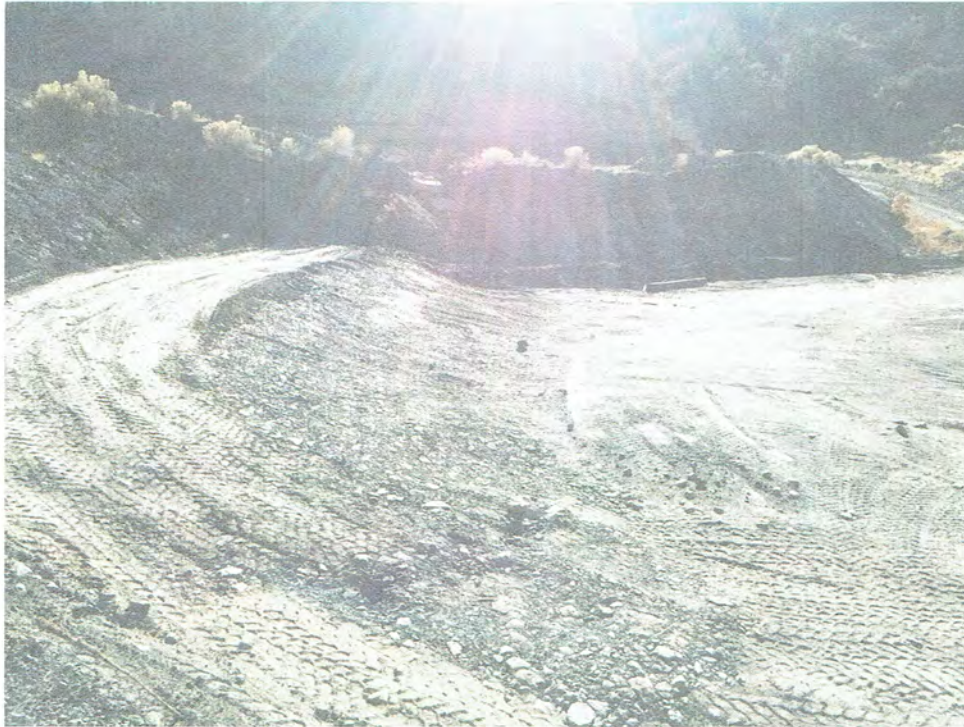
There has been some additional embankment fill installed along the base of the waste pile/emabankment (see Pic. 3). The berm directing the surface runoff and the under drain of the wastepile/embankment has been improved to direct flows to the west. The grade from the outlet of the under drain should be improved/increased to the west so that runoff is not allowed to accumulate near the under drain outlet. There was ice buildup at and around the area of the under drain outlet at the time of the inspection (see Pic. 4). If uncorrected, there is a potential for the under drain outlet to freeze completely thereby backing sub-surface water in the waste pile. This could result in damage to the under drain or the waste pile itself.

Pic. 3 – Additional material installed at base of embankment/waste pile.

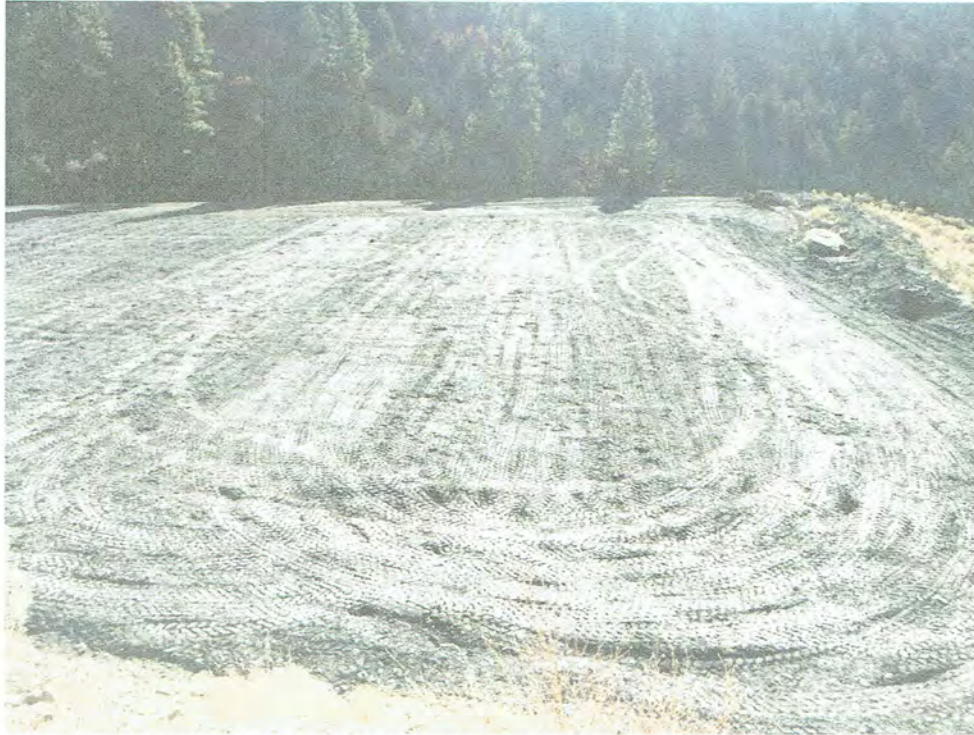
All material stockpiled at the top of the embankment has been placed as embankment fill (see Pic. 5). The face of the embankment was in good condition and does not show any signs of excessive erosion, instability or weakness (see Pic. 6).

Pic. 5 – Embankment material has been placed at the top of the waste pile.

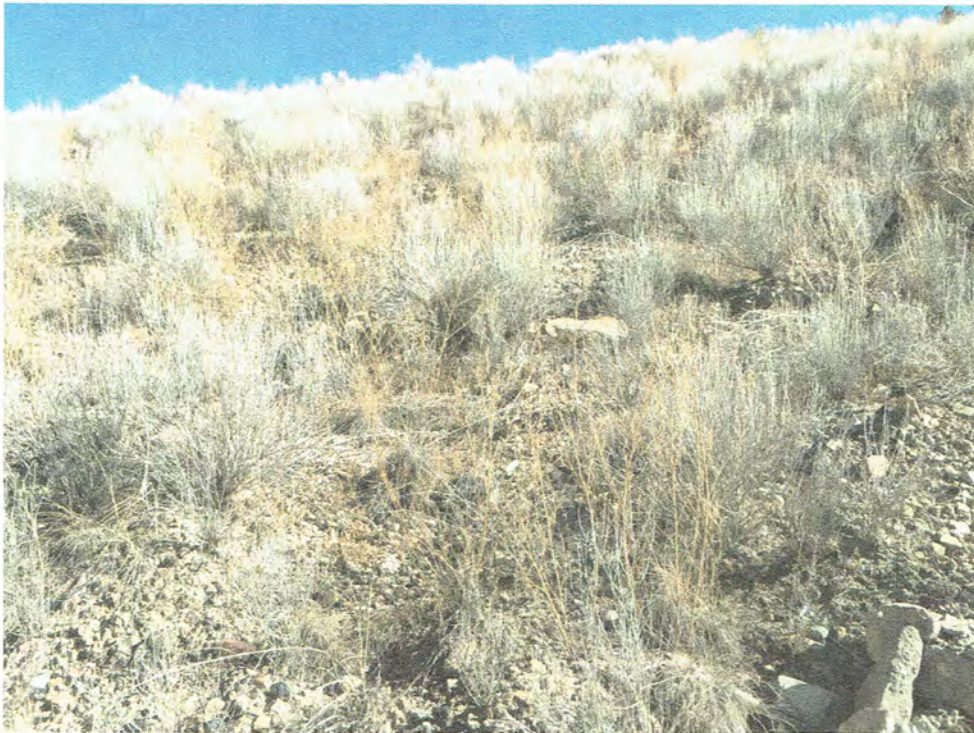
Pic. 6 – Waste pile/embankment face in good condition.
