Re: King I Mine, C-1981-035  
Stoner Engineering: Quarterly Inspection: Water Quality Improvements  
4th Quarter 2017

Date: December 20, 2017

Re: King Coal I – Quarterly Water Quality Improvements Inspection

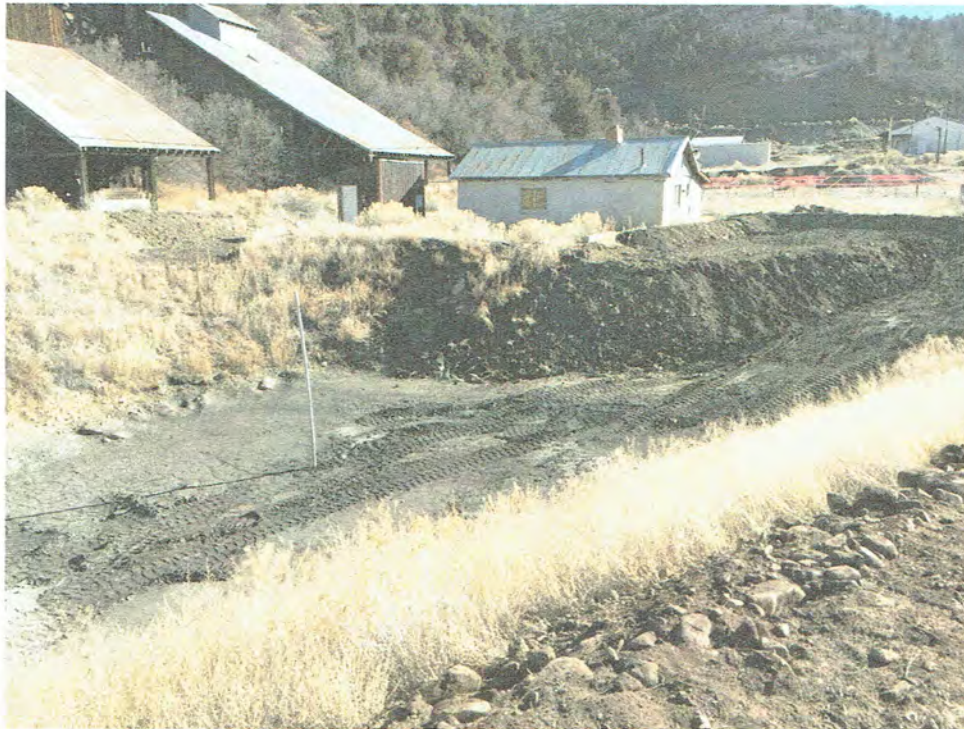
Both ponds were dry at the time of the inspection. The east pond construction appears to be completed. The berming around the top of the pond has been raised (see Pic. 1). The channeling at the southeast corner of the pond has been improved (see Pic. 2), a new outlet structure installed (see Pic. 3) and the sedimentation gage installed. The "as-built" survey information should be used to verify actual pond capacity though it visually appears the increased berm height is sufficient to offset the additional fill material installed to raise the base of the pond. The west pond outlet structure has been reconstructed at a more centralized location of the west pond (see Pic. 4).

Pic. 1 – Increased berm height and area of east pond.

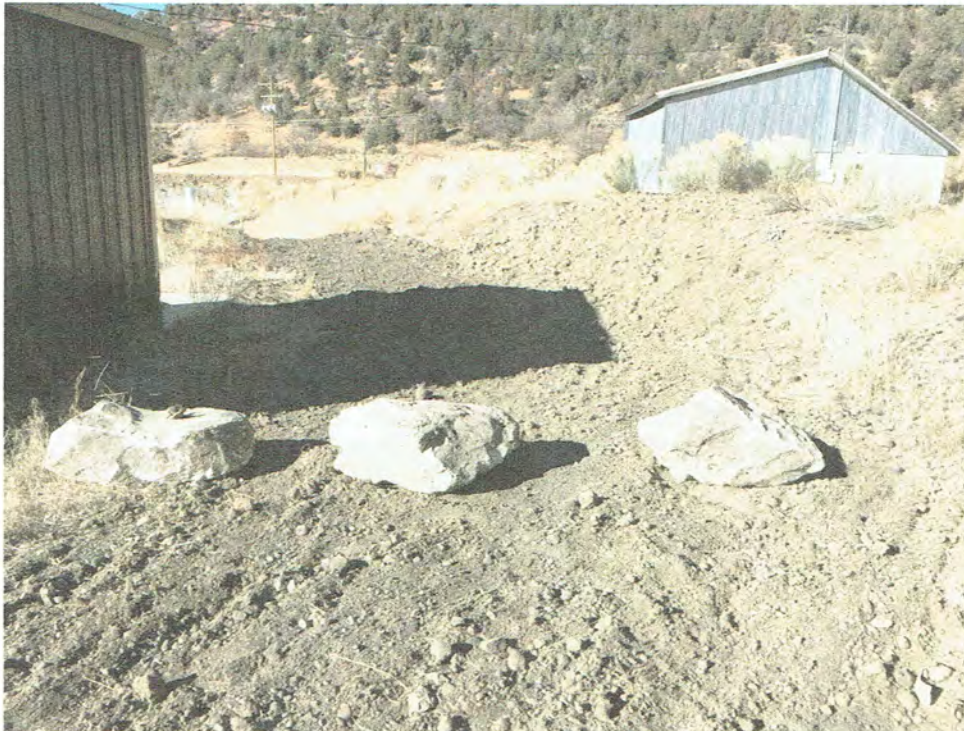
Pic. 2 – East pond channel improvements SE corner of pond.

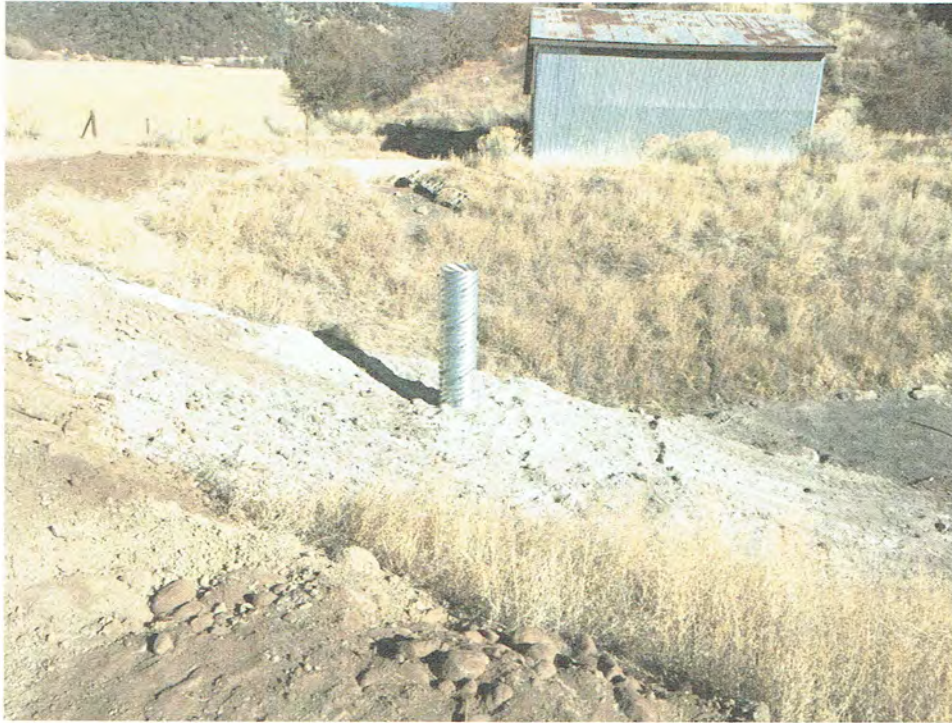
Pic. 3 – New outlet structure East Pond.

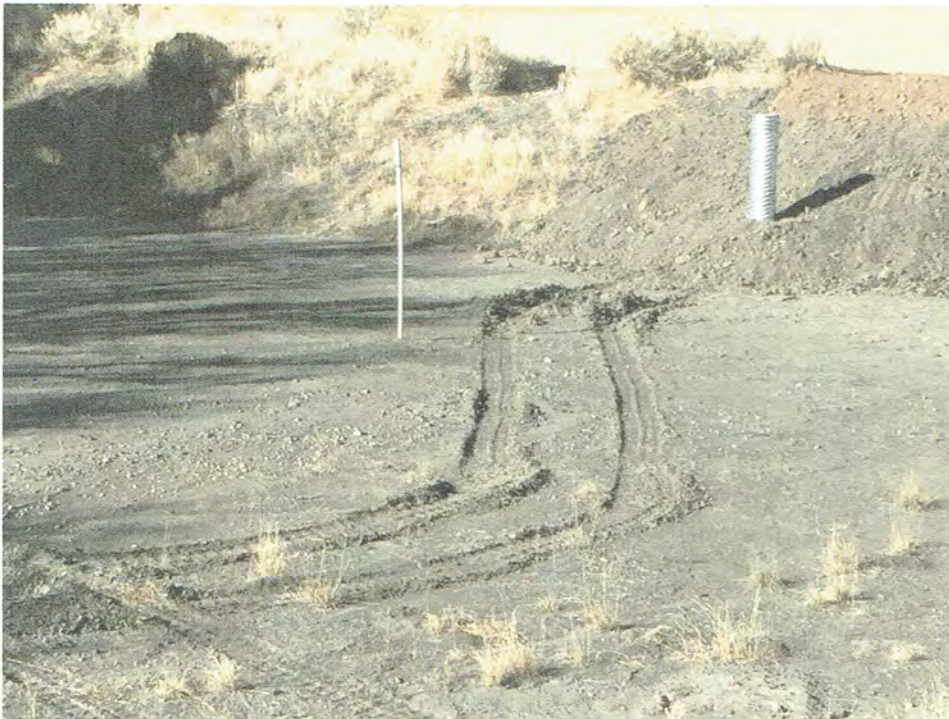
Pic. 4 – New outlet structure West Pond.

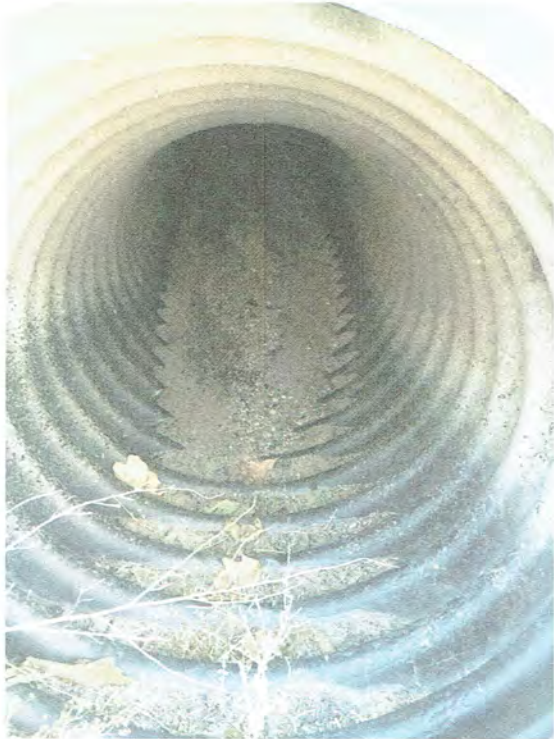
The drainage ditches and pipes were generally in good condition based upon a visual inspection from the inlet and outlet locations. There was some limited sedimentation visible in the plastic corrugated pipe which is not uncommon (see Pic. 5). All pipes, ditches and sediment traps should be inspected and repaired as necessary, especially after storm events.

Pic. 5 – Some sedimentation in base of corrugated plastic pipe.

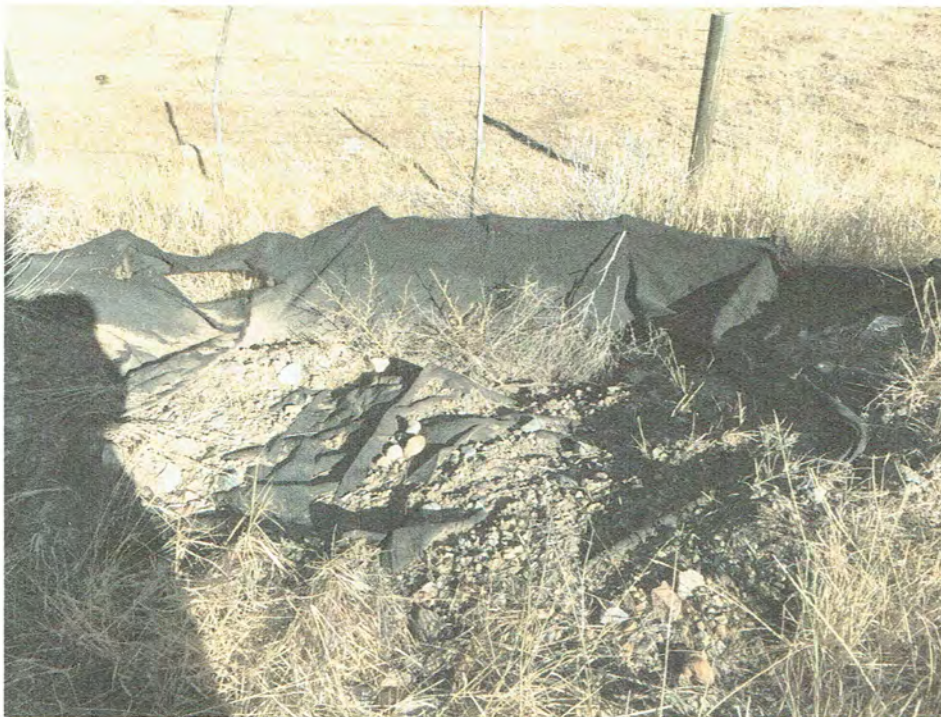
The sediment traps located along the west side of the driveway at the entrance are in good condition though the sediment trap on the east side of the driveway is in need of repair (see Pic. 6).

Pic. 6 – Sediment trap along east side of King I driveway.
