## MINERALS PROGRAM INSPECTION REPORT

<b>MINE NAME:</b> Midwestern Farms	<b>MINE/PROSPECTING ID#:</b> M-1993-059	<b>MINERAL:</b> Sand and gravel	<b>COUNTY:</b> Prowers
<b>INSPECTION TYPE:</b> Surety-Related Inspection	<b>INSPECTOR(S):</b> Amy Eschberger	<b>INSP. DATE:</b> October 5, 2017	<b>INSP. TIME:</b> 08:45
<b>OPERATOR:</b> Midwestern Farms	<b>OPERATOR REPRESENTATIVE:</b> David King	<b>TYPE OF OPERATION:</b> 112c - Construction Regular Operation

# M-1993-059 / Midwestern Farms / Midwestern Farms

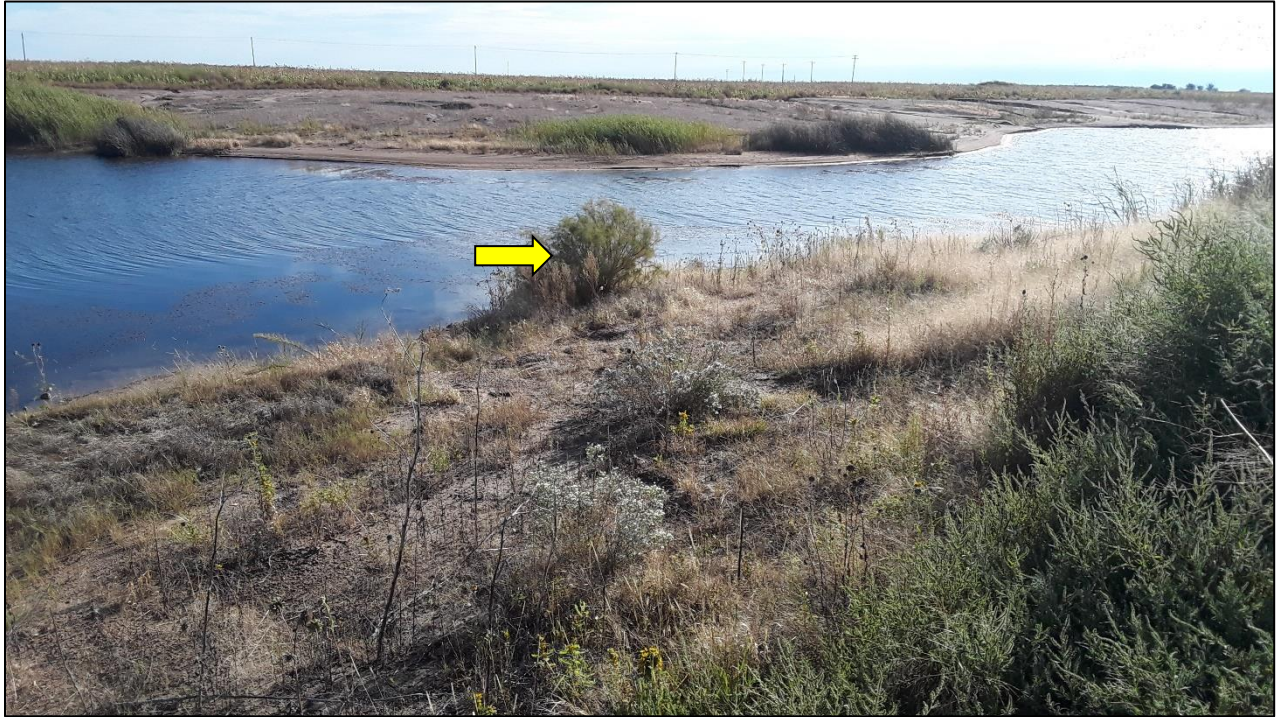
**Photo 3.** View looking southeast across western shoreline of western pond with slopes flatter than 3H:1V and vegetative cover consisting of native grasses, forbs, and weeds. Note early growth Tamarisk tree present along shoreline (indicated).

It should be noted the Division observed several weeds present on site, primarily annual weeds (i.e., Russian thistle, Kochia, wild sunflowers), but also a few state-listed noxious weed species (i.e., Tamarisk, Field bindweed). Some early growth Tamarisk trees were observed along the pond shoreline. Mr. King indicated the operator mechanically removed most of the Tamarisk trees that had been present on site last year. However, given the closeness of the site to the Arkansas River (a Tamarisk source) and site conditions, it will most likely require continual Tamarisk control efforts. Early growth Field bindweed was present particularly in the northeastern portion of the disturbed area. Pursuant to Rule 3.1.10(6), methods of weed control shall be employed for all prohibited noxious weed species, and whenever invasion of a reclaimed area by other weed species seriously threatens the continued development of the desired vegetation. Weed control methods shall also be used whenever the inhabitation of the reclaimed area by weeds threaten further spread of serious weed pests to nearby areas. Because the site is undergoing initial revegetation efforts, it is especially vulnerable to weed invasion. The Division recommends the operator implement the approved weed control plan at the site (especially for state-listed noxious weed species) as soon as possible, and continue to monitor the growth and spread of weeds in disturbed areas.

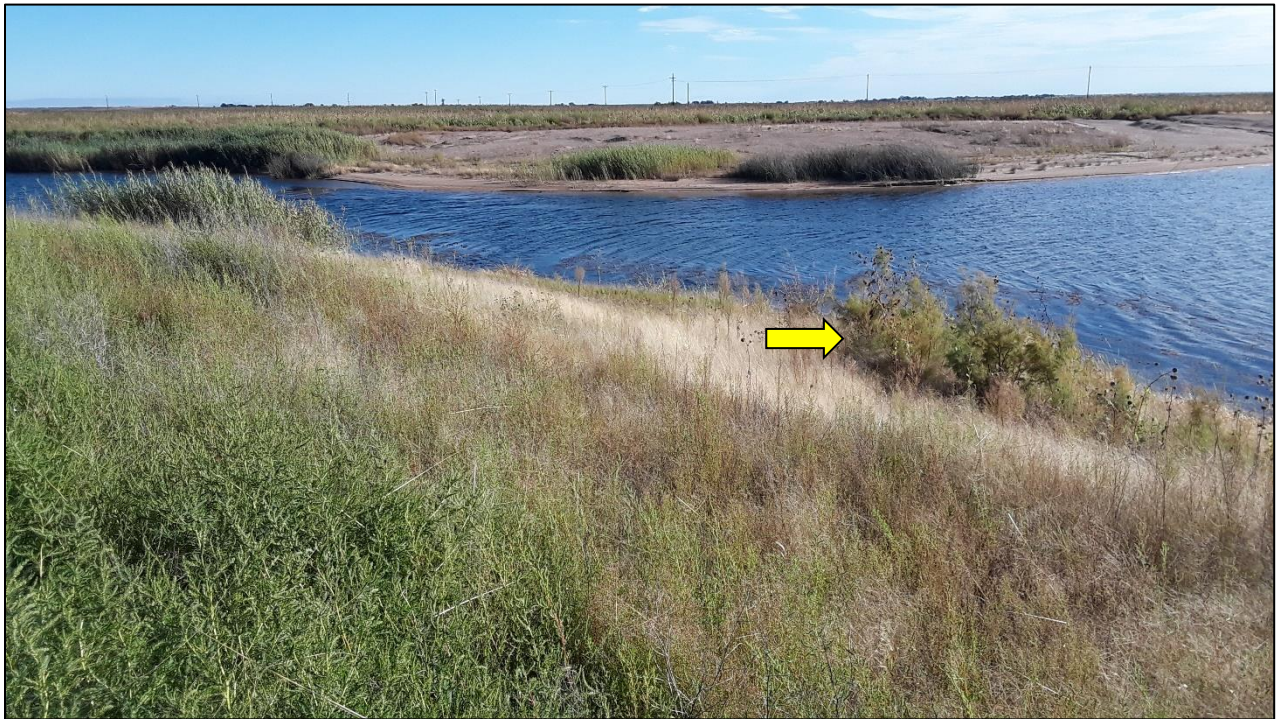
**Photo 4.** View looking southeast across western shoreline of western pond with slopes flatter than 3H:1V and vegetative cover consisting of native grasses, forbs, and weeds. Note presence of Tamarisk along shoreline (indicated).

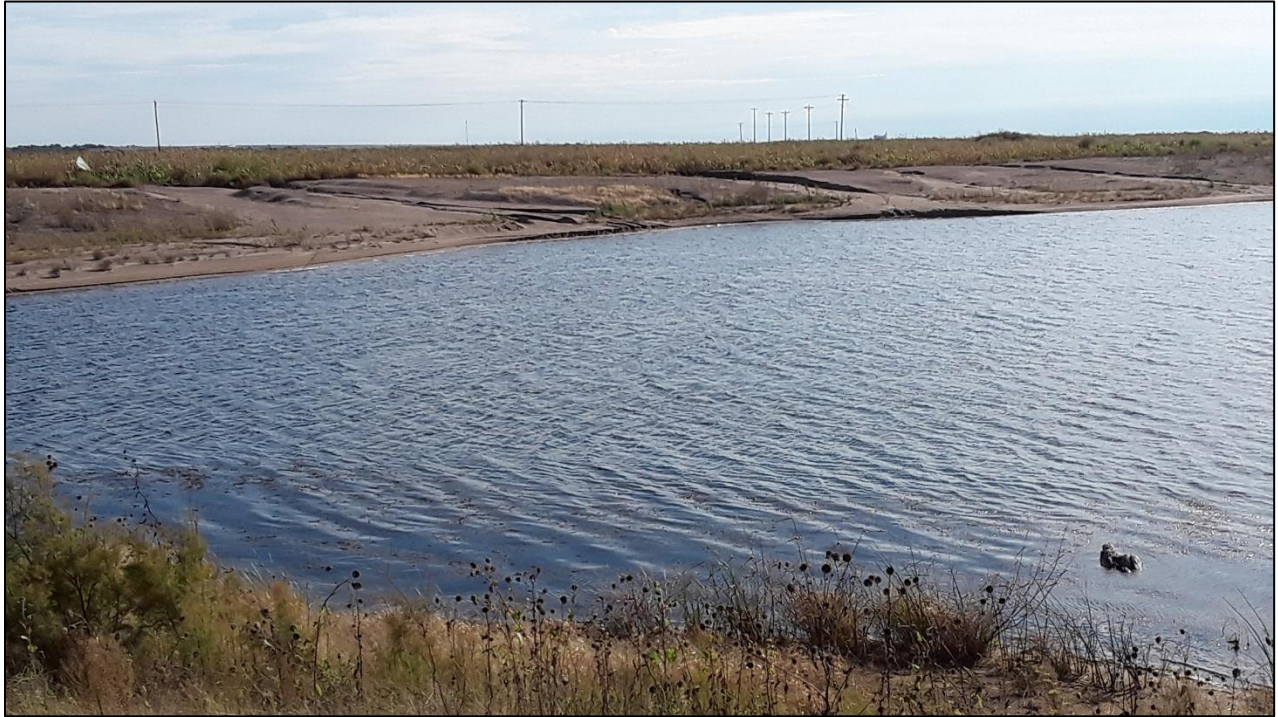
**Photo 5.** View looking east toward east shoreline of western pond, showing some erosion features present along the sandy shoreline.

The Division observed some erosion features along portions of the pond shoreline, particularly along the northern and southern shorelines. It appeared the erosion damage was more prevalent along the areas left as sandy shoreline which will not receive topsoil placement or revegetation. Pursuant to Rule 3.1.5(3), all grading shall be done in a manner to control erosion and siltation of the affected lands. Therefore, the Division recommends the operator repair this erosion damage and continue to monitor these areas. If the erosion problem persists, the sandy shorelines may need to be flattened to less than 3H:1V since these areas will not be stabilized by vegetative cover. The operator should be aware that the site cannot be released if significant erosion problems are present.

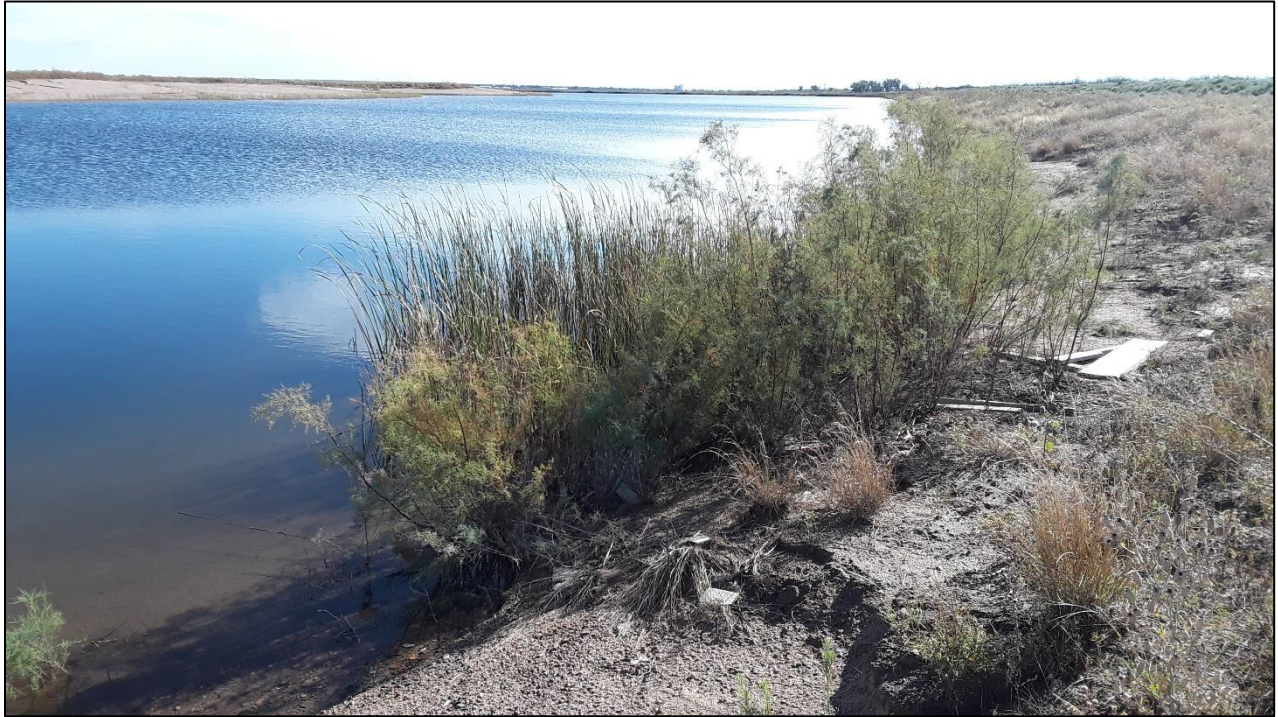
**Photo 11.** View of early growth Tamarisk present along southern shoreline of eastern pond. The operator will need to implement the approved weed control plan for the site, especially for state-listed noxious weed species such as Tamarisk.

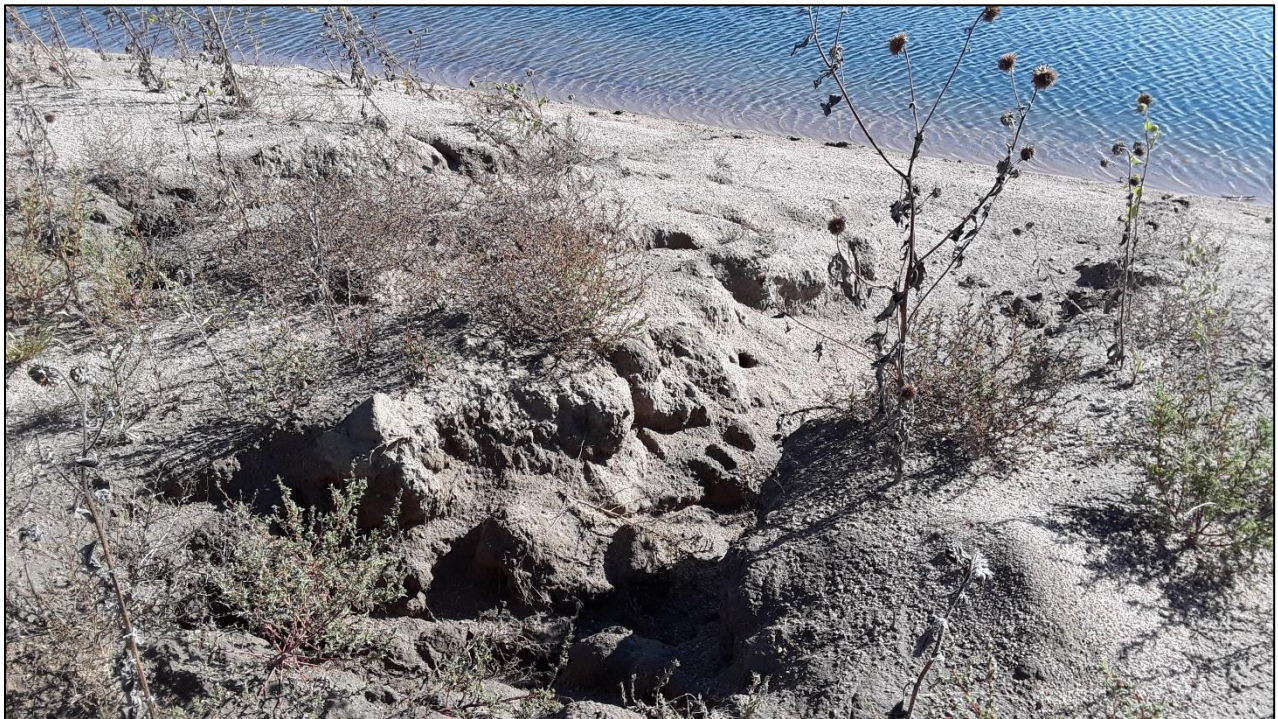
**Photo 12.** View of erosion gully present along southern shoreline of eastern pond, just east of channel connecting the two ponds.

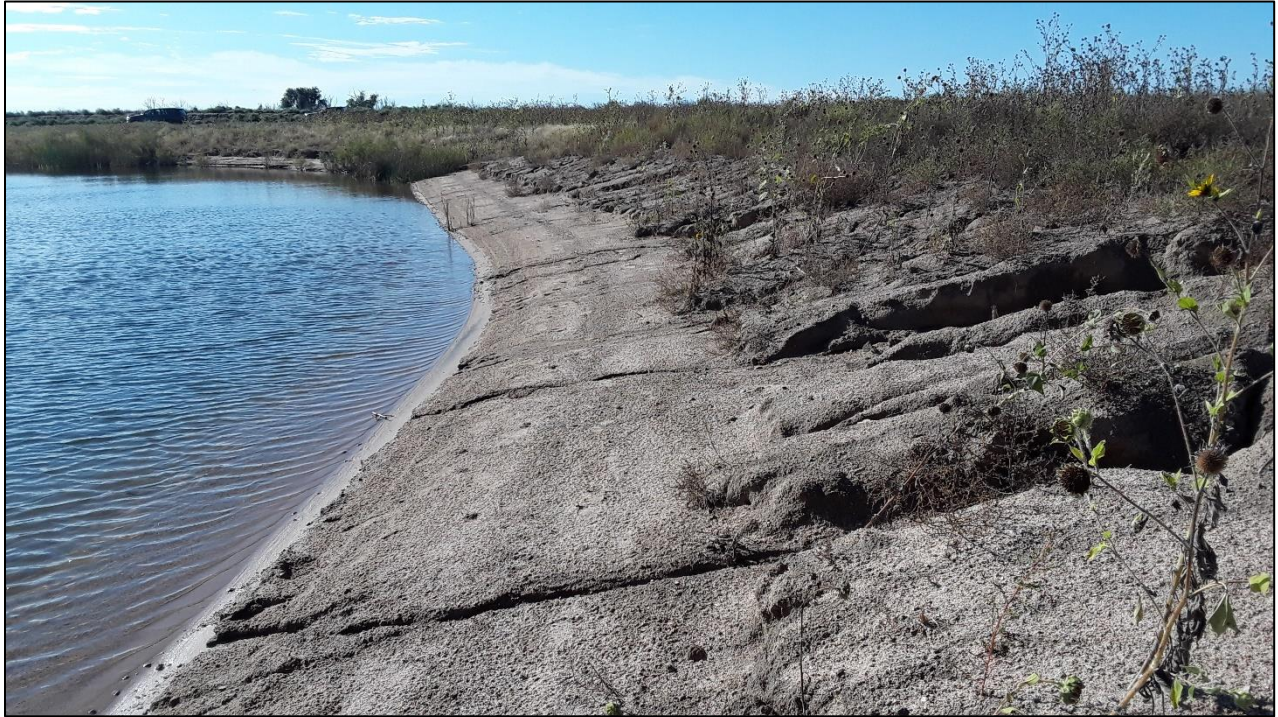
**Photo 15.** View looking across southern shoreline of eastern pond, showing erosion features present.

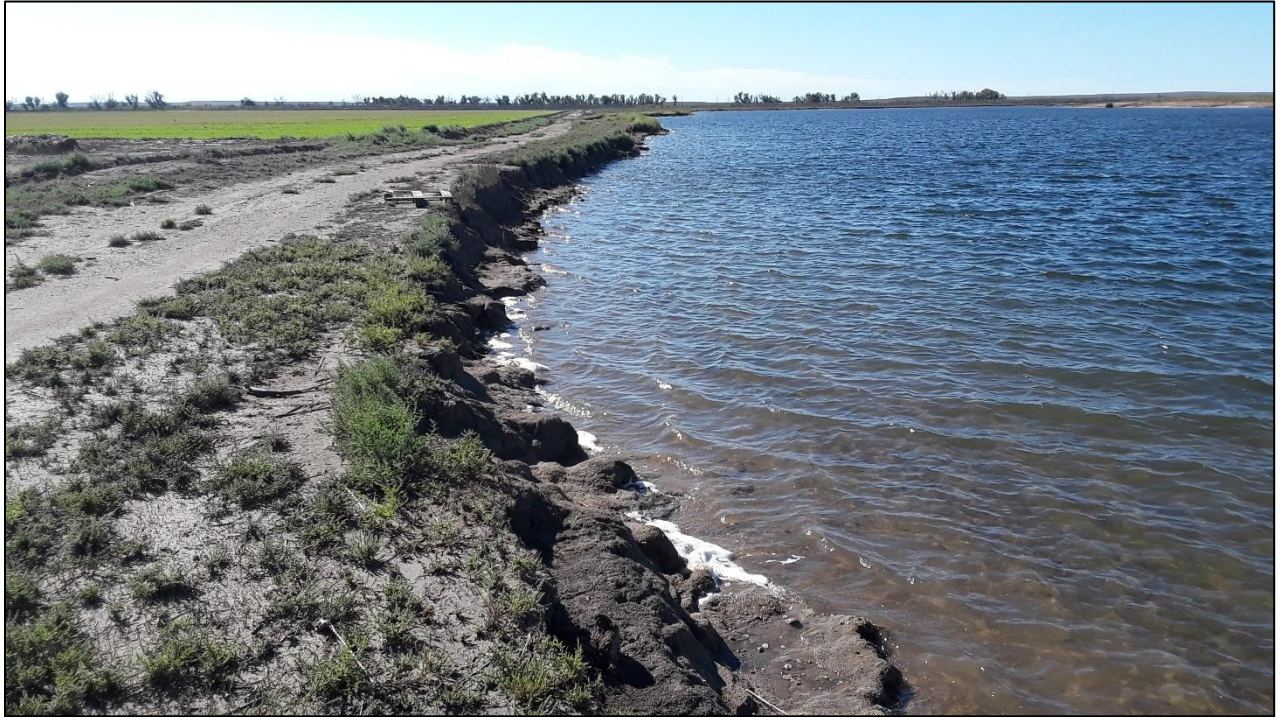
The Division observed a more serious erosion problem along the eastern pond shoreline. In this area, the shoreline had been graded to the approved 3H:1V or flatter slope gradient. However, the top 1-3 feet of the shoreline is eroding rapidly due to increased wave action in this portion of the pond. The eastern shoreline is not stable at this time and appears to be migrating eastward toward an active agricultural water ditch that runs approximately parallel to the shoreline. In some areas, the edge of shoreline was already within 20-25 feet of the ditch. The Division estimates approximately 2,000 feet of shoreline is eroding in this manner (see enclosed Google Earth image of site showing close-up view of disturbed area). Therefore, the Division determined the approved reclamation plan is not adequate for the eastern shoreline and required the operator to submit a Technical Revision to propose a shoreline stabilization plan. Accordingly, the Division was unable to continue processing Revision No. SR-1 until costs for stabilizing the shoreline were proposed. The Division approved the operator's request to extend the Revision No. SR-1 decision date to December 23, 2017 to allow time for addressing the shoreline erosion problem.

**Photo 17.** View looking south across portion of eastern shoreline of eastern pond which was graded 3H:1V but is eroding and requires additional stabilization measures.

The erosion problem along the eastern pond shoreline is not cited as a problem in this report, because on November 2, 2017, the operator submitted Technical Revision No. 6 (Revision No. TR-6) to address this issue. The Division approved Revision No. TR-6 on November 7, 2017, which revised the reclamation plan to include supply and installation of a 6 foot wide by 2,000 foot long riprap blanket (6 inch nominal) along the eastern pond shoreline which will first be regraded to correct the existing erosion. The Division recalculated the required financial warranty for the site to include costs for regrading and installing a riprap blanket along the eastern pond shoreline, repairing some erosion gullies along other portions of the shoreline, seeding the site, and conducting weed control. The Division estimated the required financial warranty to be in the amount of \$382,406.00. Therefore, on November 17, 2017, the Division approved Revision No. SR-1 for a reduction of \$1,200,594.00 from the currently held bond of \$1,583,000.00.

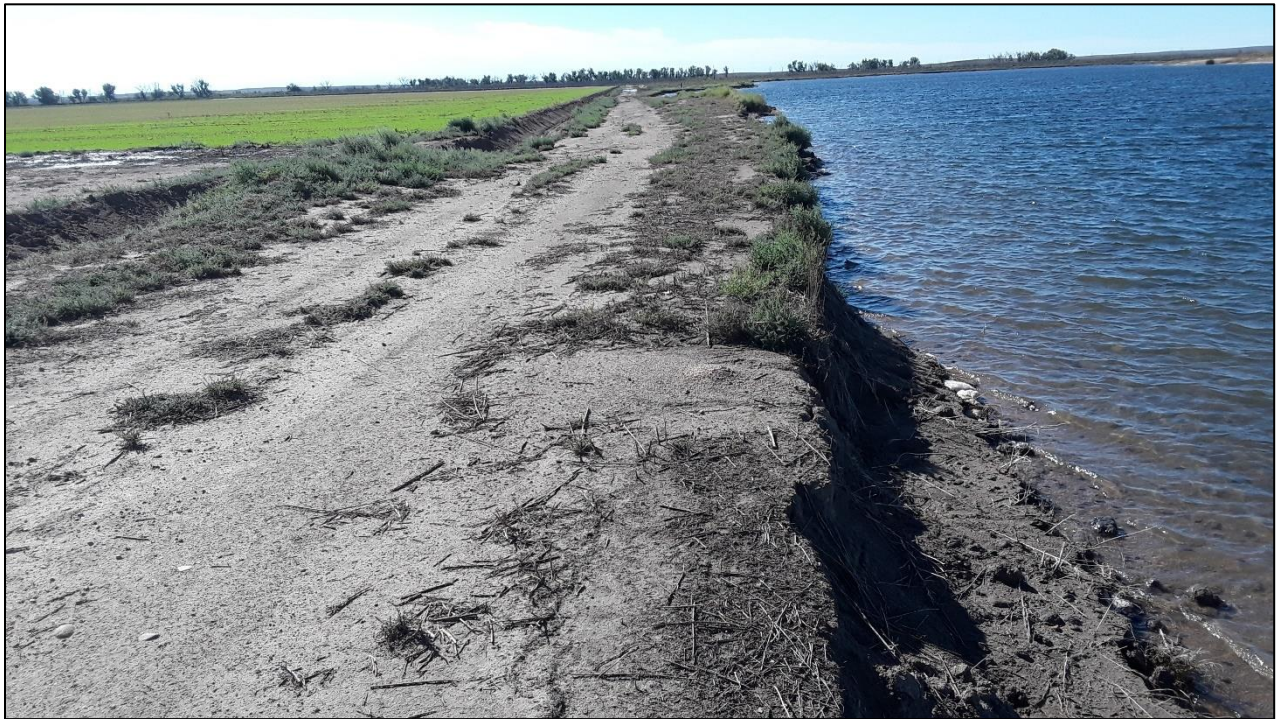
**Photo 18.** View looking south across portion of eastern shoreline of eastern pond which was graded 3H:1V but is eroding and requires additional stabilization measures. Note approximately upper 2-3 feet of bank has slope gradients of near vertical.

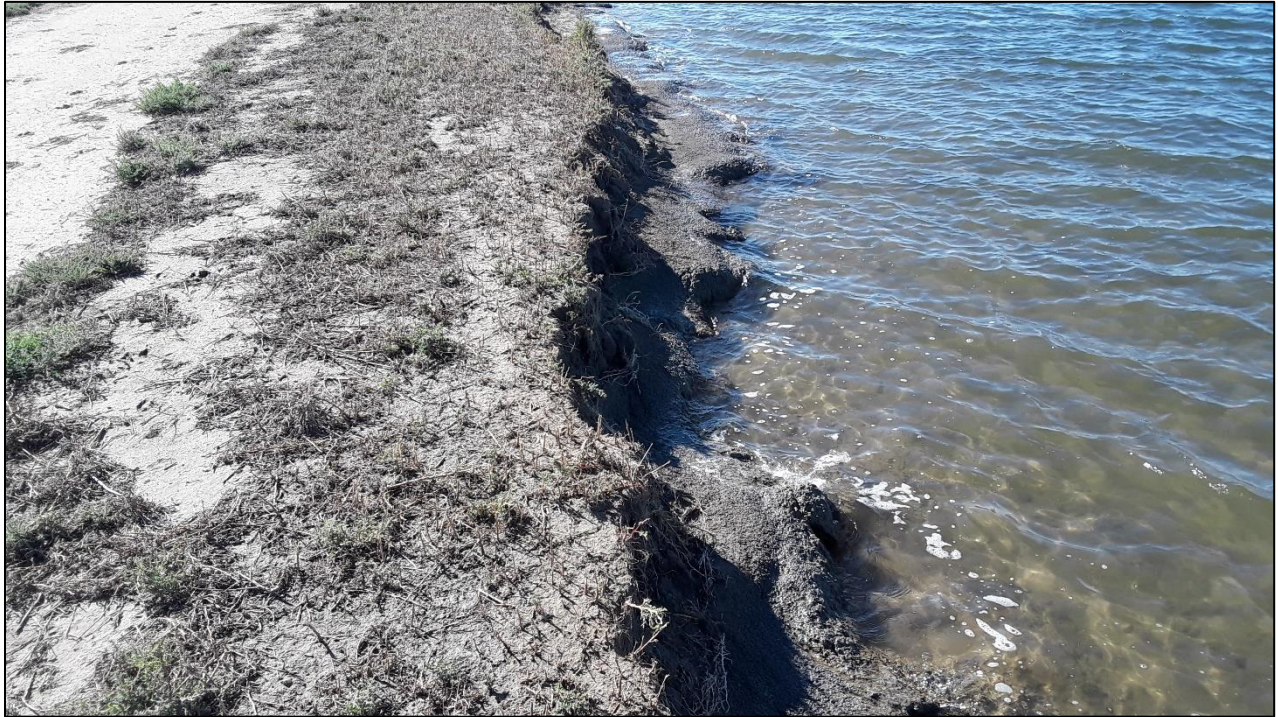
**Photo 19.** Closer view of portion of eastern shoreline of eastern pond with erosion problem requiring additional stabilization measures.

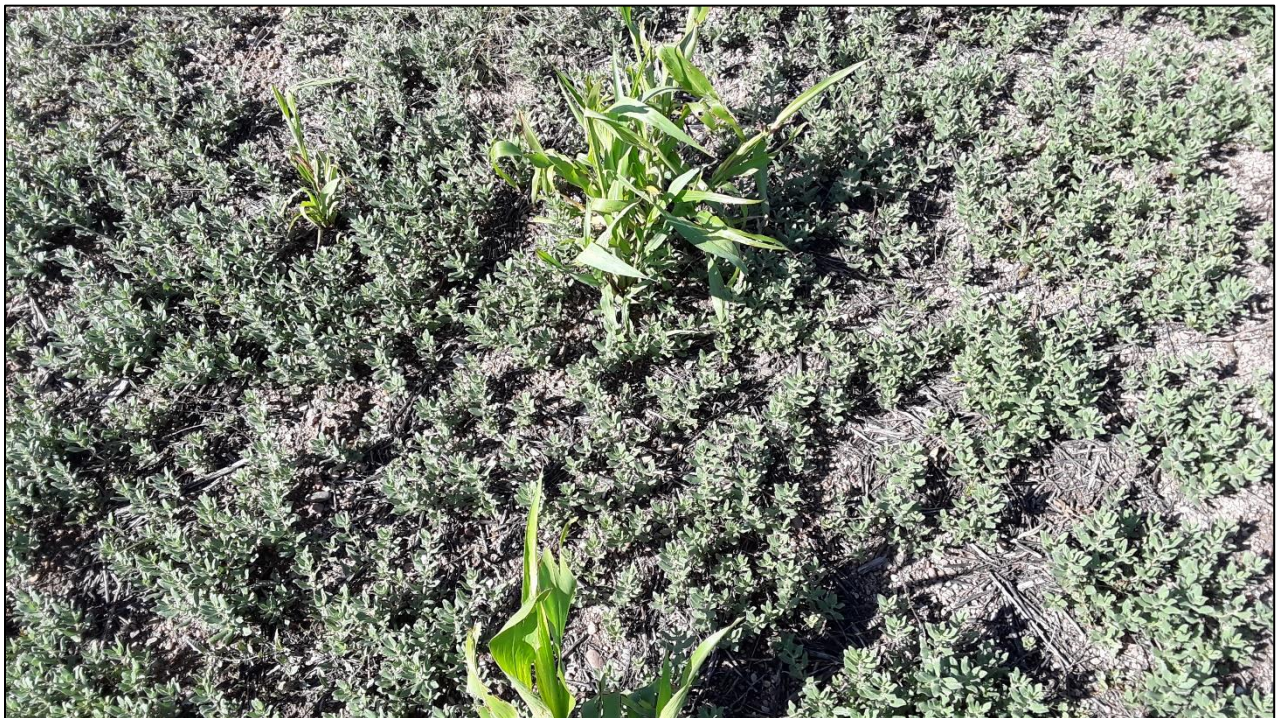
**Photo 22.** Close-up view of ground in northeastern portion of disturbed area, showing presence of Field bindweed. The operator will need to implement the approved weed control plan for the site, especially for state-listed noxious weed species such as Field bindweed.

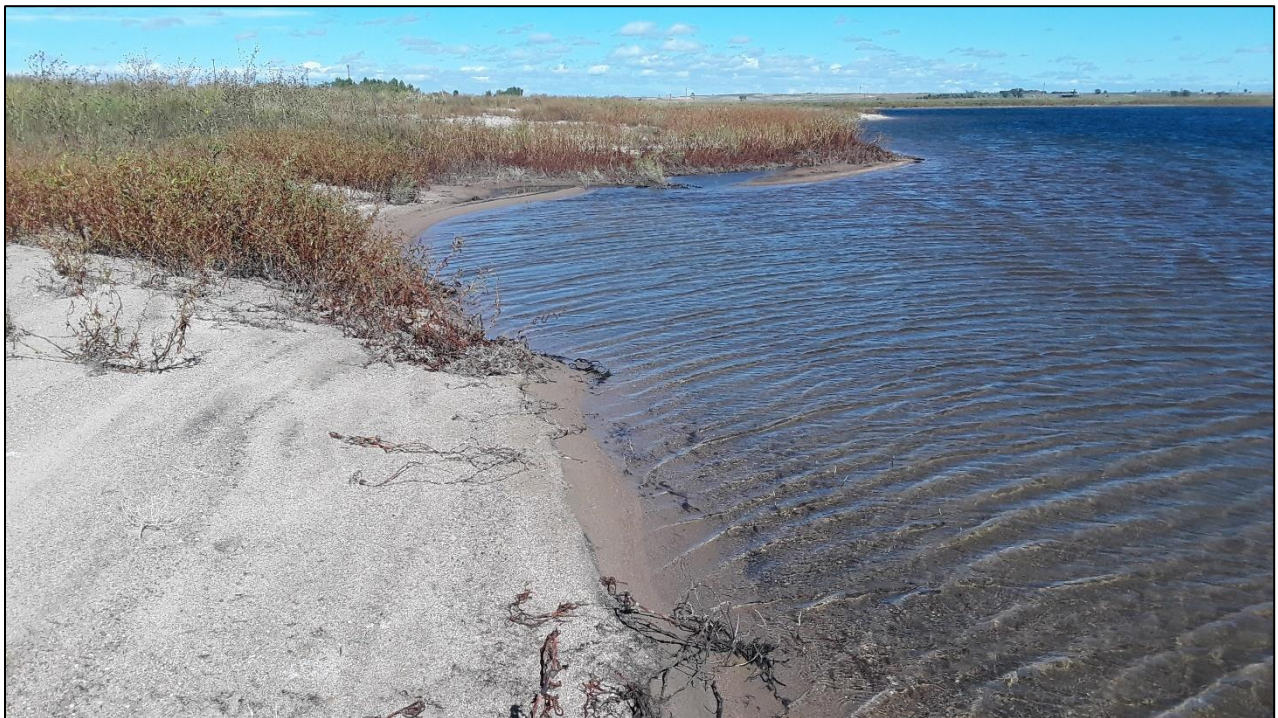
**Photo 24.** View looking north across western shoreline of eastern pond left as sandy beach as approved. Note presence of annual weeds which will require implementation of approved weed control plan for site.

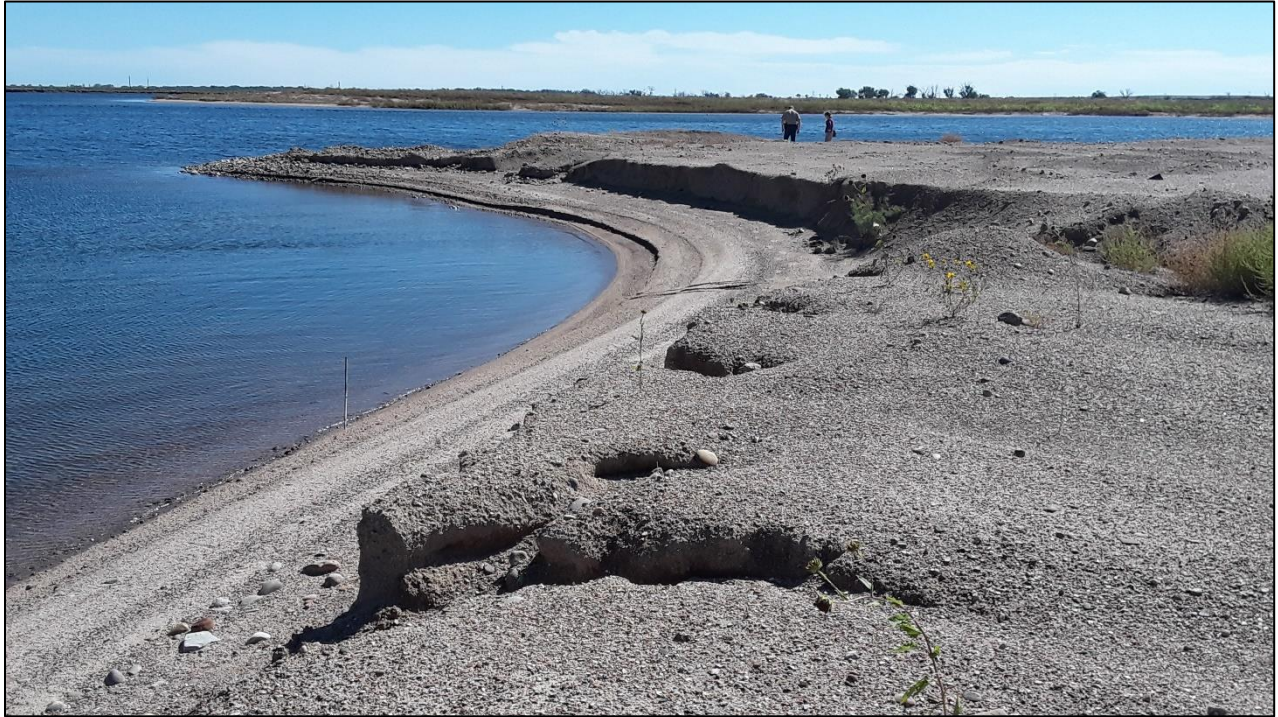
**Photo 25.** View looking southeast across western shoreline of eastern pond, showing erosion features present along this portion of the shoreline.

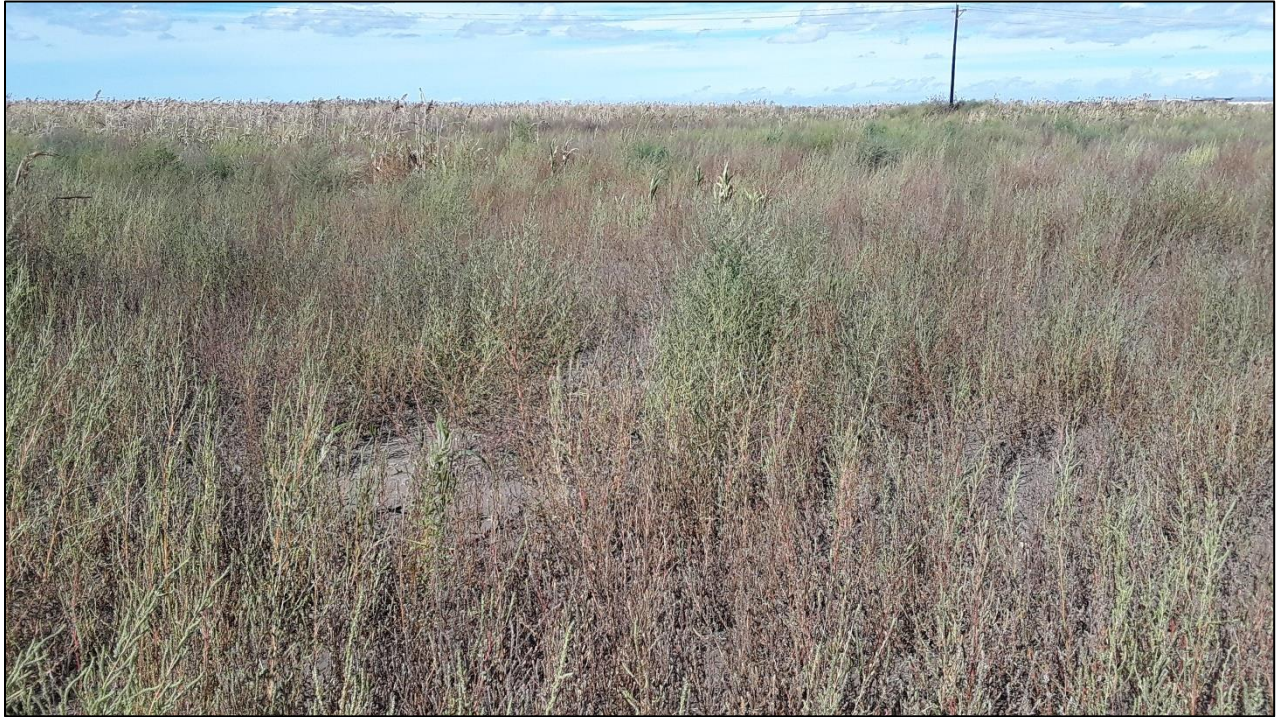
**Photo 29.** View looking west across disturbed area between ponds where annual weeds are abundant. The operator will need to implement the approved weed control plan for the site, including for nuisance weed species which could hinder growth of desired vegetation.

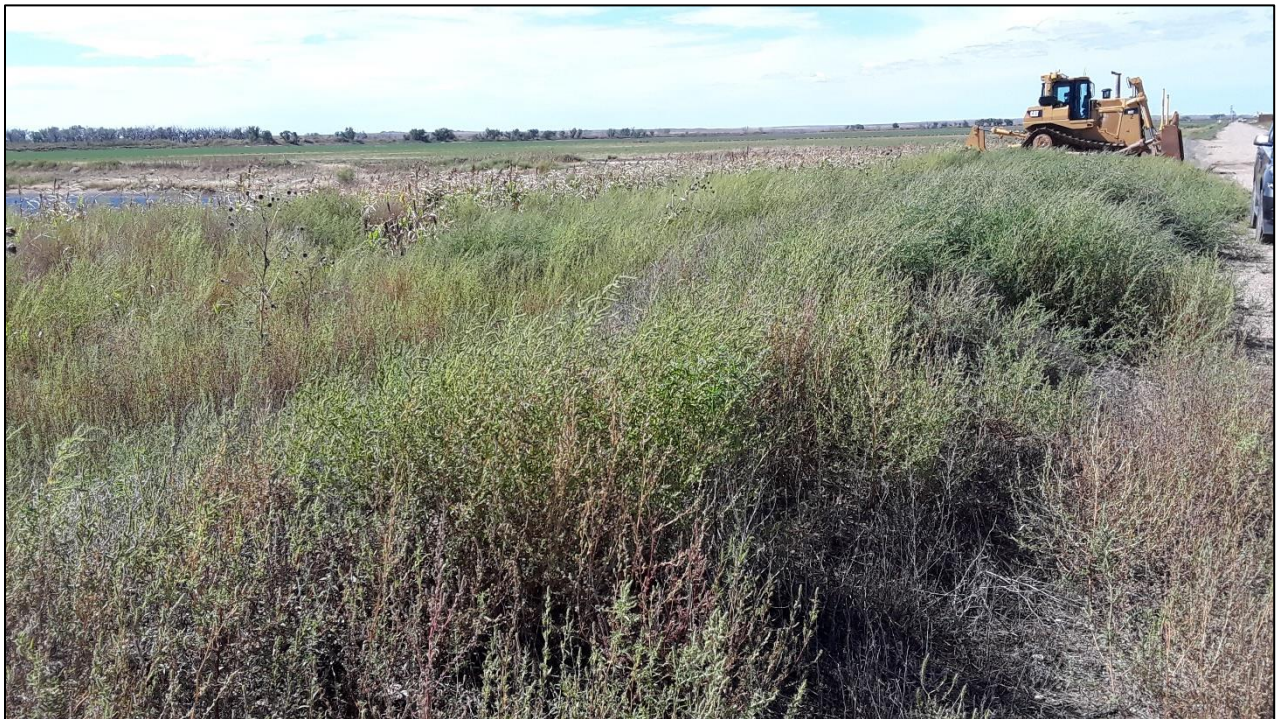
**Photo 30.** View looking west across disturbed land north of western pond and south of access road. Note abundance of annual weeds in this area. The operator will need to implement the approved weed control plan for the site, including for nuisance weed species which could hinder growth of desired vegetation.

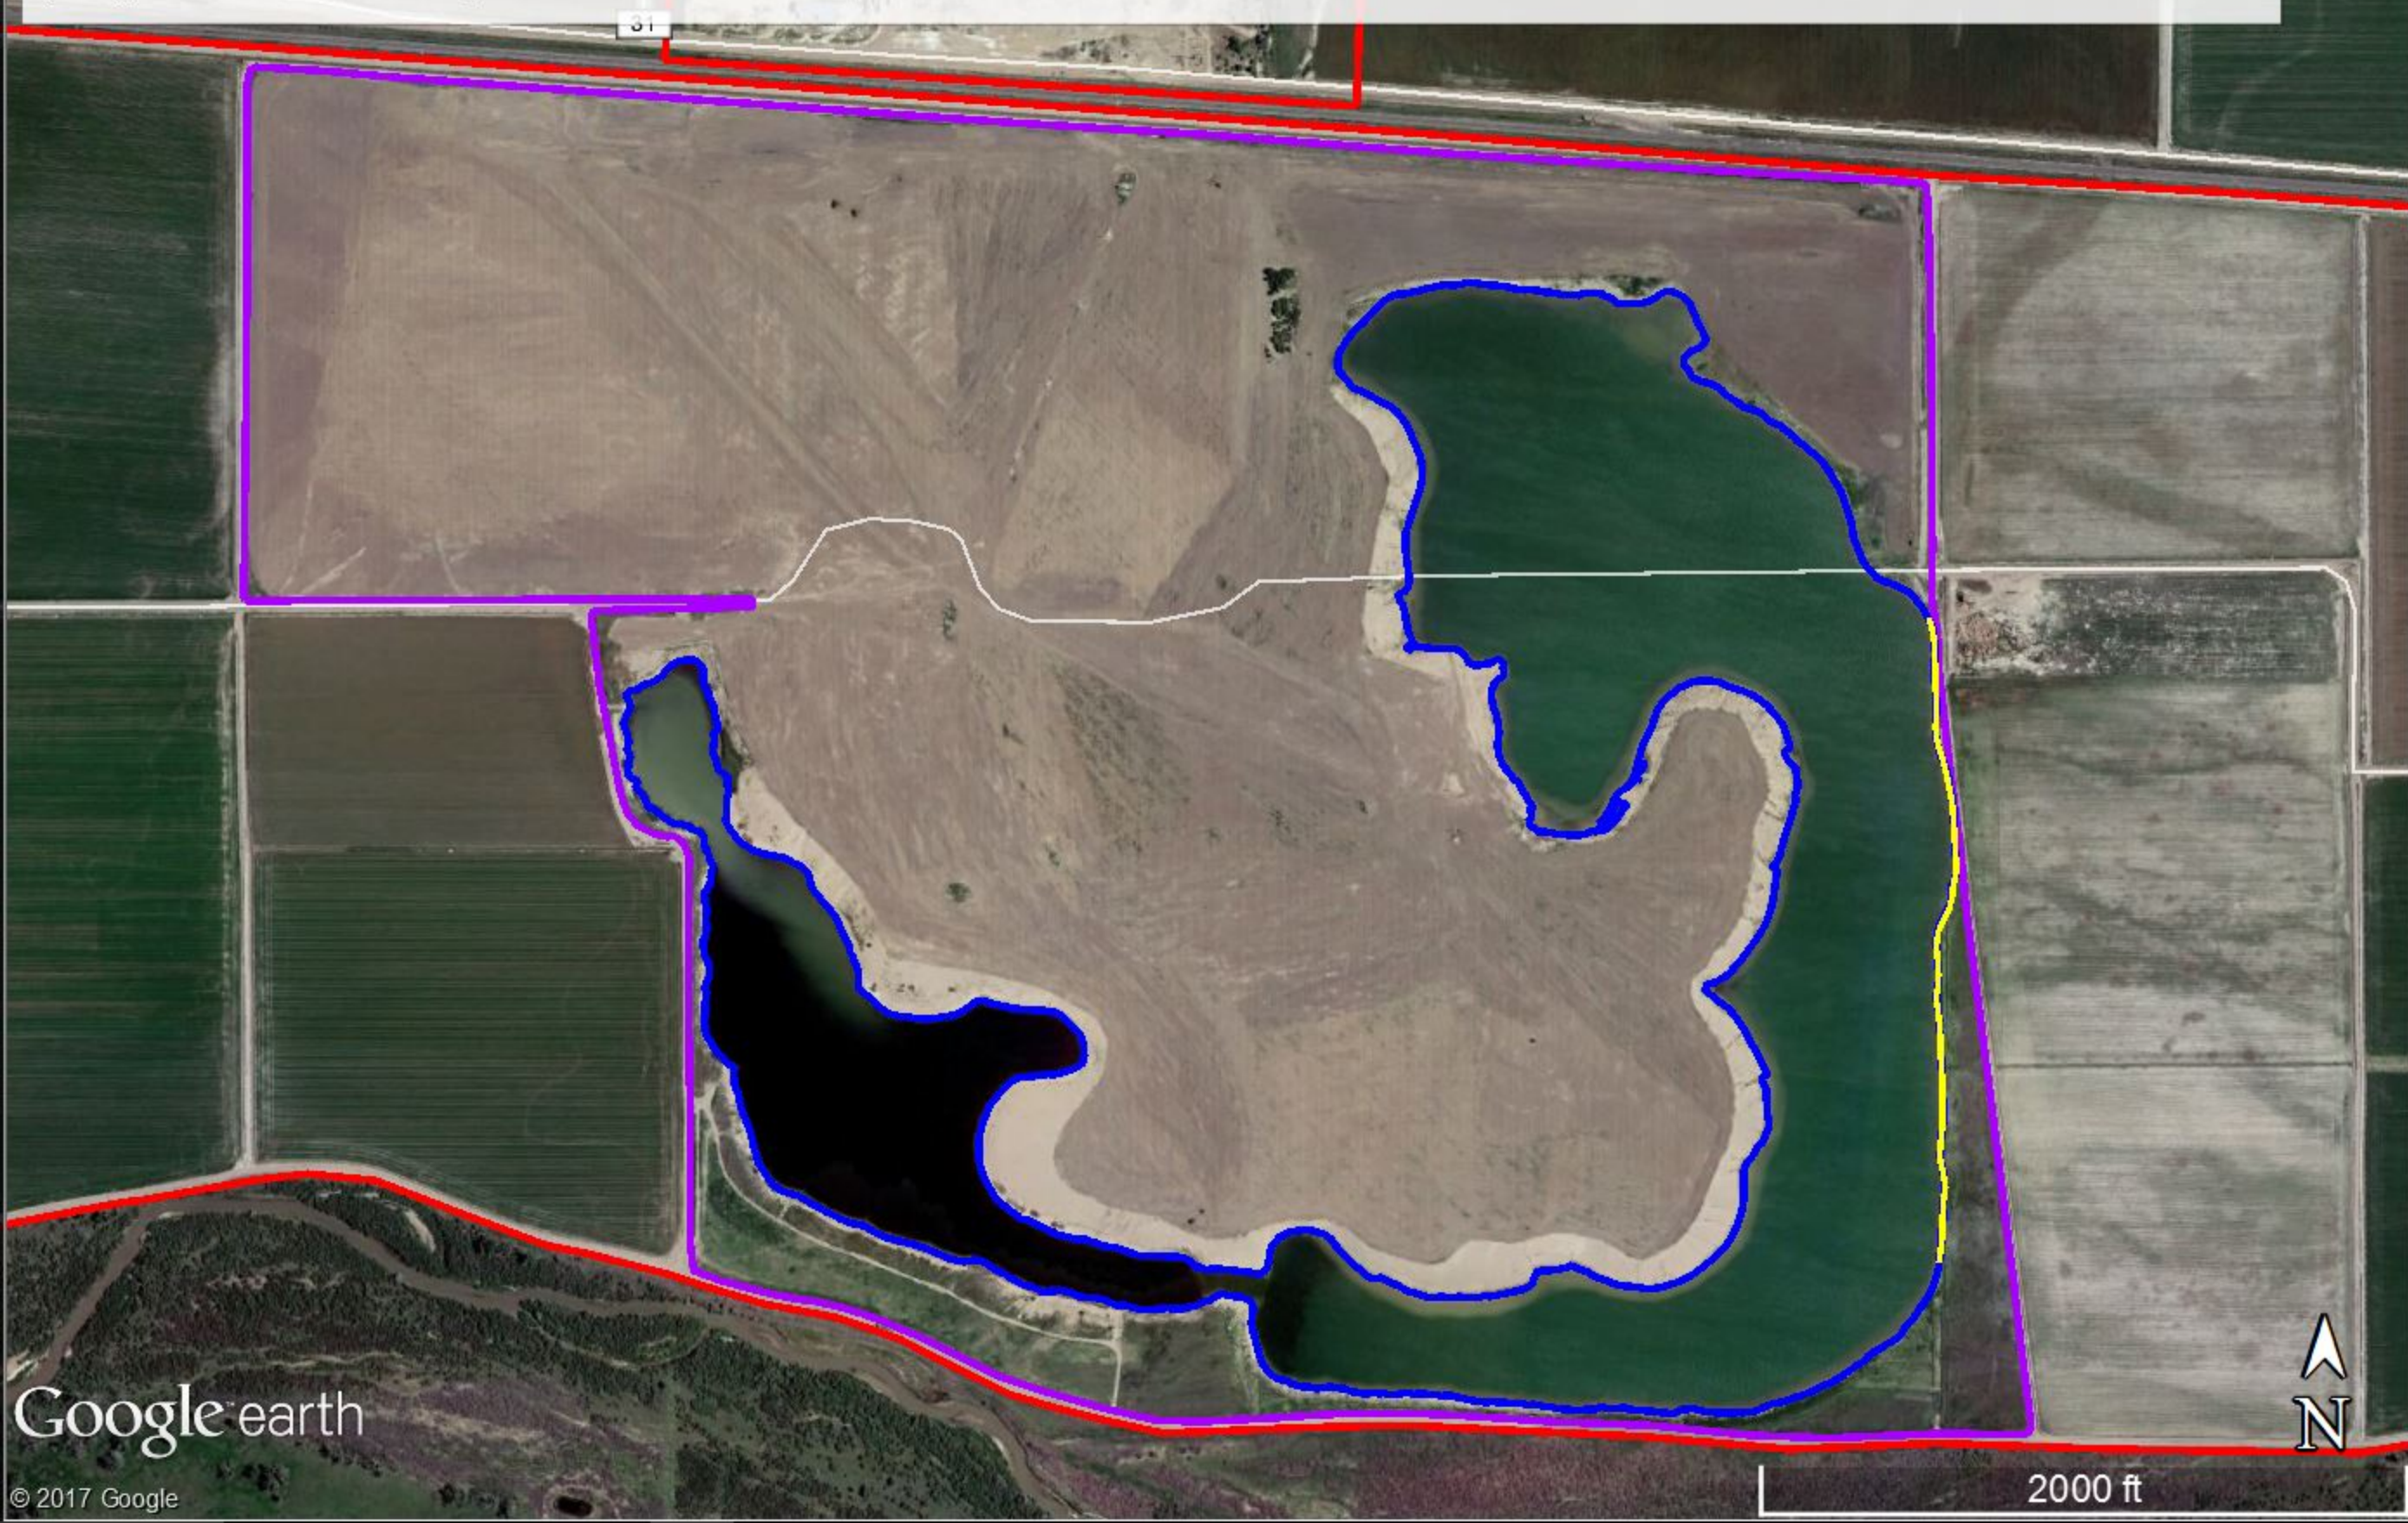
# M-1993-059 / Midwestern Farms / Midwestern Farms (Close-Up of Disturbed Area)

Yellow Outline = 2,000 feet = Approximate length of pond shoreline requiring additional stabilization measures
