MINERALS PROGRAM INSPECTION REPORT

MINE NAME: Vondy Pit	MINE/PROSPECTING ID#: M-1986-105	MINERAL: Sand and gravel and commodity	COUNTY: Morgan
INSPECTION TYPE: Monitoring	INSPECTOR(S): Jared L. Ebert	INSP. DATE: December 27, 2017	INSP. TIME: 09:50
OPERATOR: Dilleys Sand & Gravel	OPERATOR REPRESENTATIVE: Larry L Chartier	TYPE OF OPERATION: 110c - Construction Limited Impact

This was a monitoring inspection of the Vondy Pit, DRMS Permit Number M-1986-105, operated by Dilley Sand and Gravel (Operator). I, Jared Ebert with the Colorado Division of Reclamation, Mining and Safety (DRMS or Division) conducted the inspection. Mr. Larry Chartier with Dilley Sand and Gravel accompanied me during the inspection. This is a 9.9 acre 110c mining operation in Morgan County.

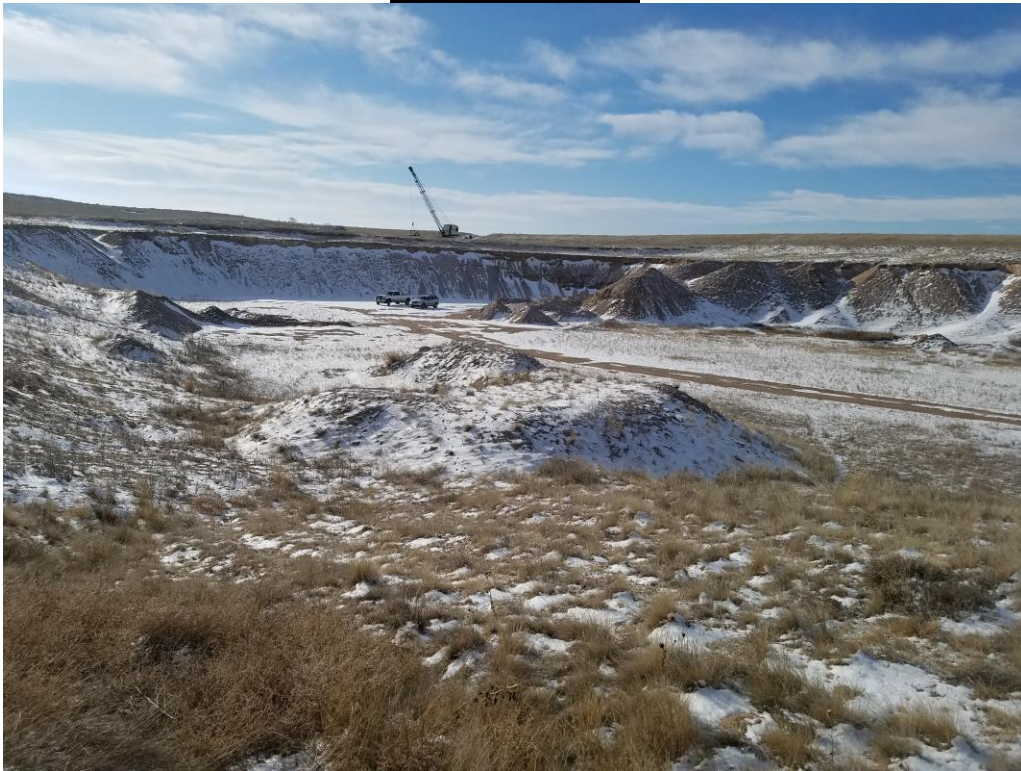
Figure 1. From the northeast end of the affected land looking south.

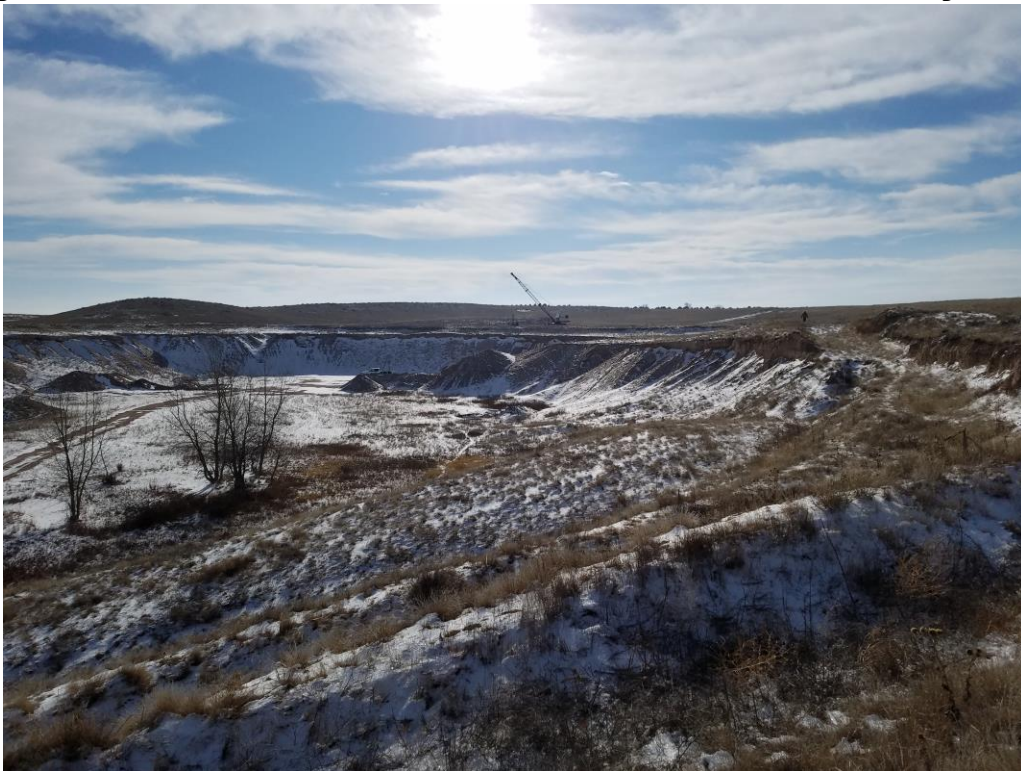
Figure 2. From the northwest end of the affected land looking south.

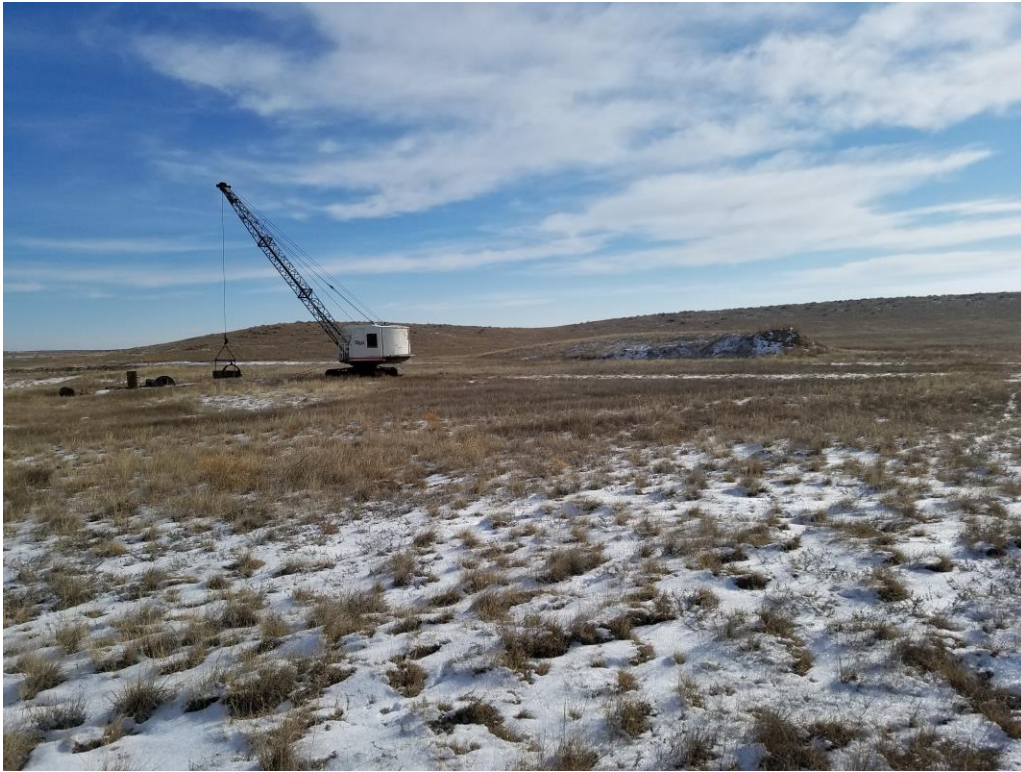
Figure 3. From the south end of the permit area looking northeast.
