**MINERALS PROGRAM INSPECTION REPORT**  
**PHONE: (303) 866-3567**

| <b>MINE NAME:</b><br>Elmer Stone Gravel Pit | <b>MINE/PROSPECTING ID#:</b><br>M-1978-080 | <b>MINERAL:</b><br>Sand and gravel | <b>COUNTY:</b><br>Lincoln |
| <b>INSPECTION TYPE:</b><br>Monitoring | <b>INSPECTOR(S):</b><br>Timothy A. Cazier | <b>INSP. DATE:</b><br>December 19, 2017 | <b>INSP. TIME:</b><br>11:50 |

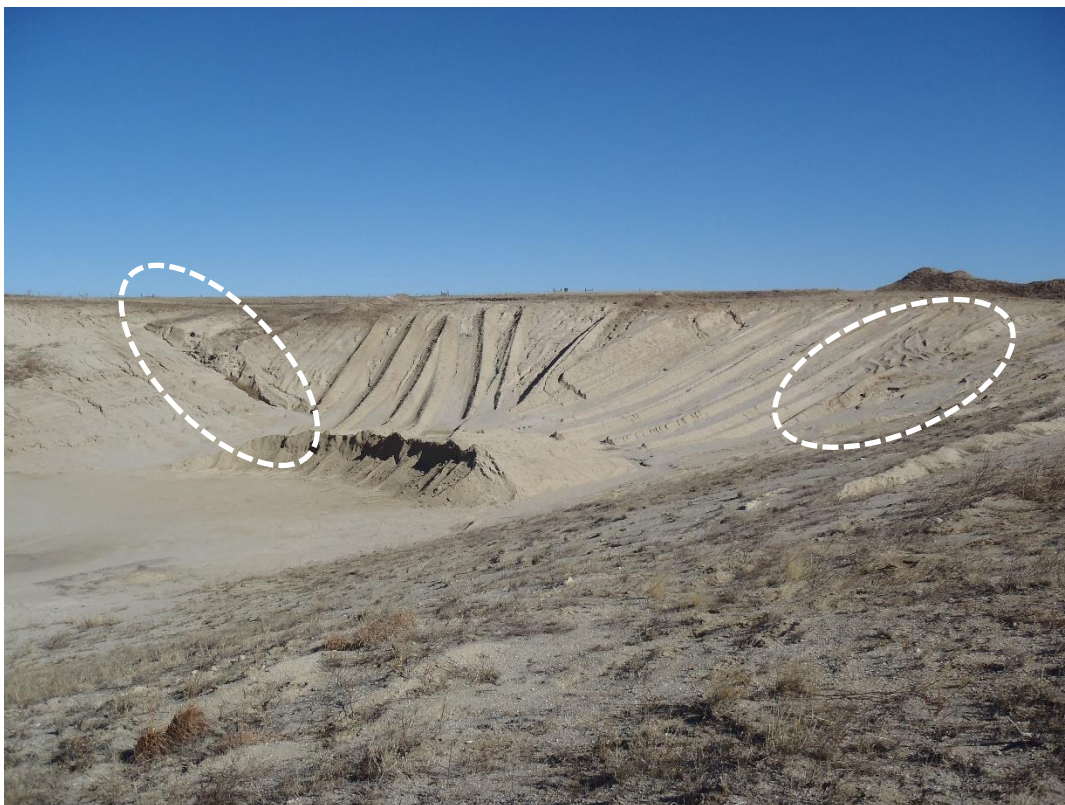
Gen. Compliance with Mine Plan: The operation appeared to be in compliance with the approved mine plan. Google Earth was used to measure the disturbed area, which was estimated to be approximately 6.7 acres. High walls were estimated to vary between 30 and 40 feet in height and appeared stable with the exception of some rilling and gulying in the active face (see **Photo 1**). The mine plan is to continue working towards the east. However, site representatives indicated material is running out, as evidenced by the lack of room between the topsoil stockpile on the crest of the east end of the pit and the access road east of the stockpile. We discussed the option to submit a conversion application to a 112c permit and expand the pit towards the south where acceptable material is expected to exist. Milled asphalt was observed stockpiled on the south side of the pit floor (see **Photo 2**). The storage of milled asphalt was approved by the Division as part of TR-04.

Photo 1. Rills and gullies in the active face (looking NE).

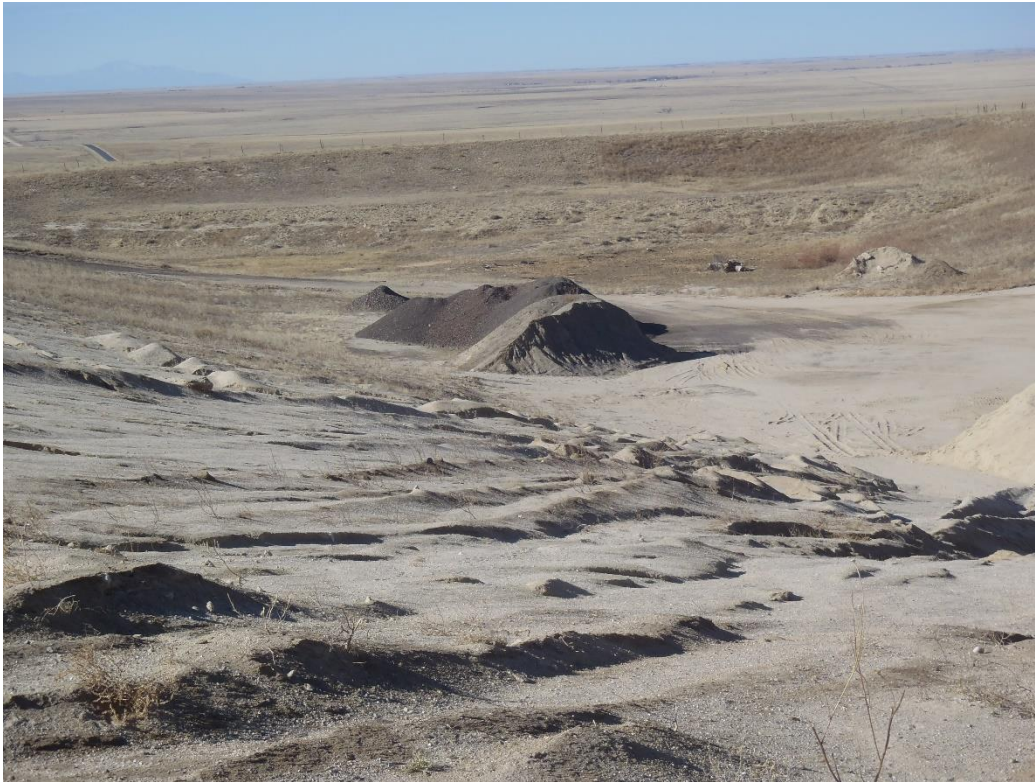
Reclamation Success: Reclamation has begun on the north side of the west end of the pit (see **Photo 2**). Grading appears to be near 3H:1V and some topsoil placement has been completed. Any established vegetation is expected to be a result of natural progression.

Photo 2. Milled asphalt stockpile, reclaimed area in background (looking WNW).

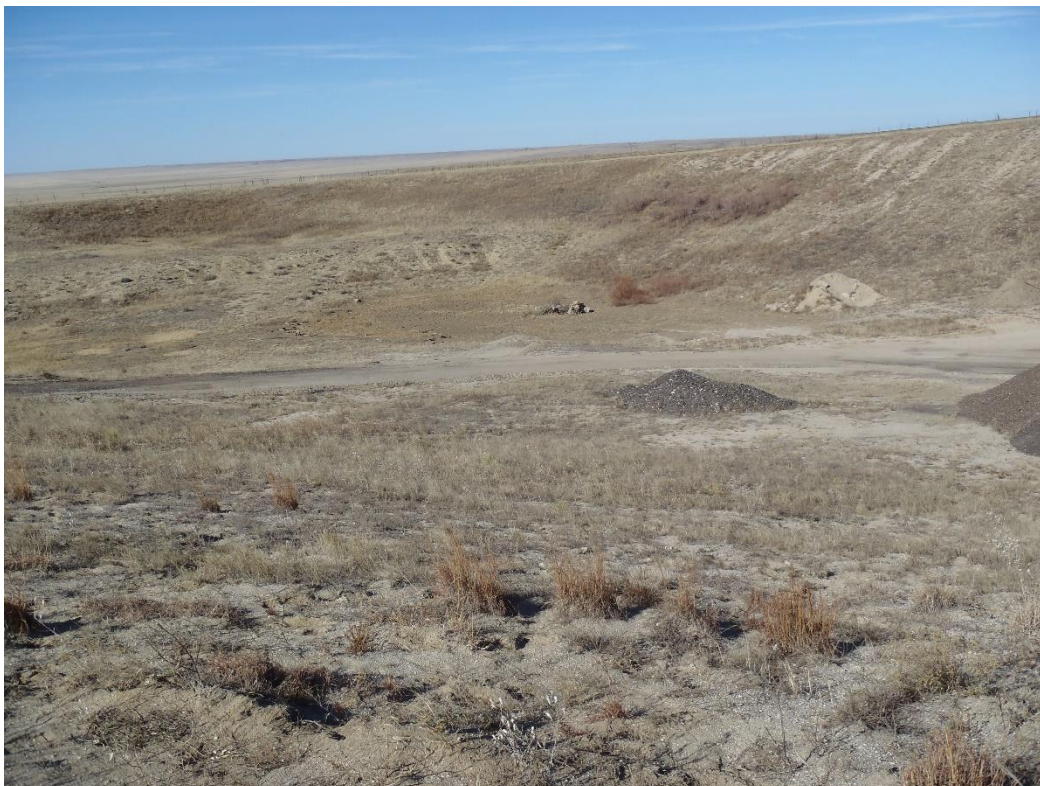
Revegetation: Some vegetation appears well established on the northwest highwall (see **Photo 3**). No noxious weeds were observed.

Photo 3. Some well established vegetation on the northwest highwall (looking NW).

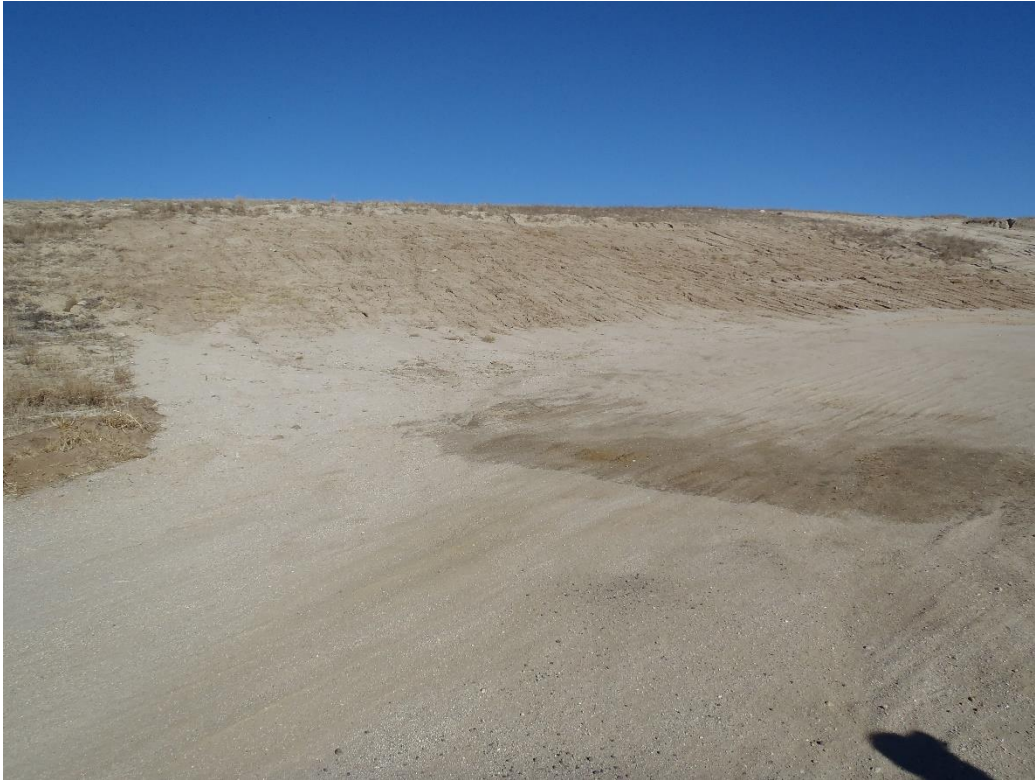
Sediment Control: Some minor erosion problems were observed on the south facing slopes on the middle of

the pit where the area was reported to have been topsoiled last spring. Heavy rains eroded the newly placed topsoil (see **Photo 4**). The Operator should consider implementing BMPs (best management practices) to help keep topsoil in place until the vegetation is established.

Photo 4. Eroded recently placed topsoil where BMPs are recommended (looking NE).

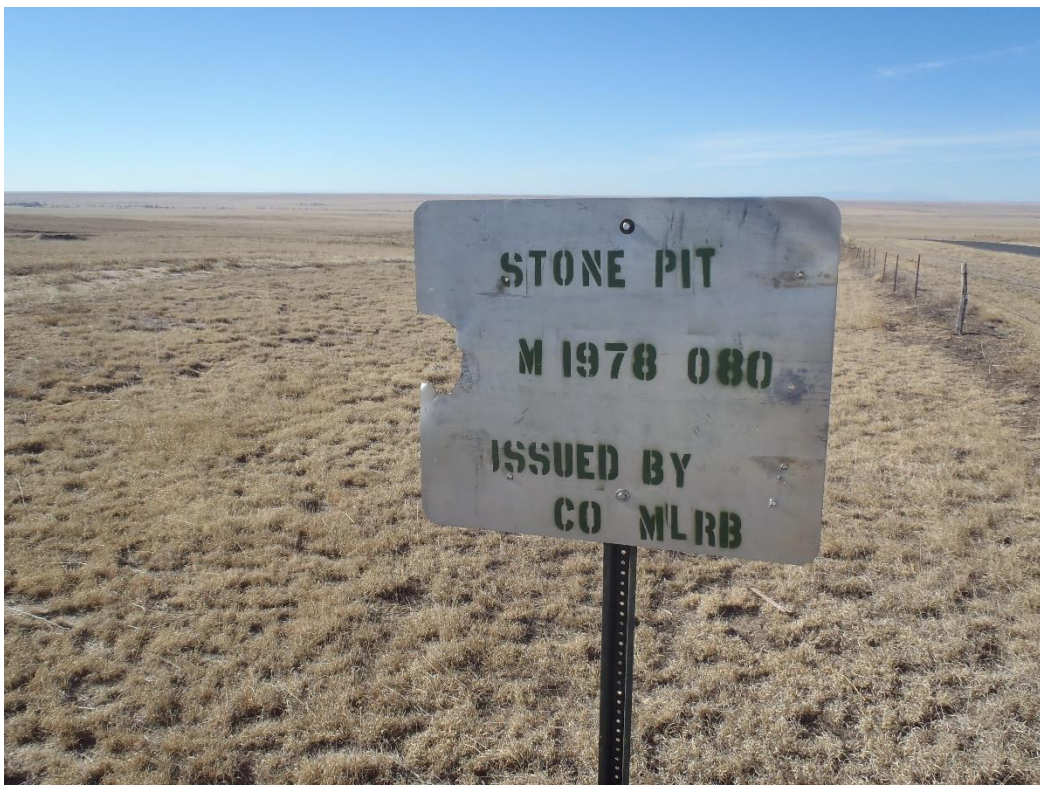
Signs and Markers: The permit sign was properly posted (see **Photo 5**) and T-post boundary markers were observed to delineate the permit boundary (see **Photo 6**).

Photo 5. Permit sign near entrance.

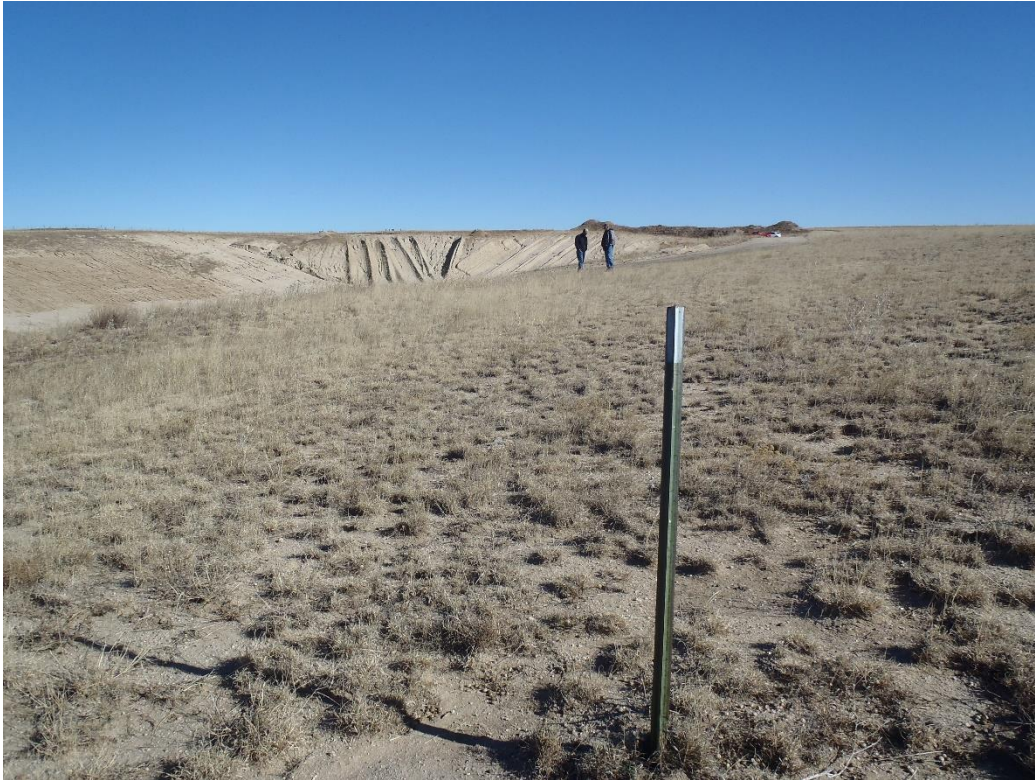
Photo 6. Typical T-post boundary marker (SW corner, looking NE).
