**MINERALS PROGRAM INSPECTION REPORT**  
**PHONE: (303) 866-3567**

<b>MINE NAME:</b> Montoya Pit	<b>MINE/PROSPECTING ID#:</b> M-1980-146	<b>MINERAL:</b> Sand and gravel	<b>COUNTY:</b> La Plata
<b>INSPECTION TYPE:</b> Monitoring	<b>INSPECTOR(S):</b> Lucas J. West	<b>INSP. DATE:</b> December 19, 2017	<b>INSP. TIME:</b> 14:00
<b>OPERATOR:</b> C & J Gravel Products, Inc.	<b>OPERATOR REPRESENTATIVE:</b> John Gilleland, Nathan Barton	<b>TYPE OF OPERATION:</b> 112c - Construction Regular Operation	
<b>REASON FOR INSPECTION:</b> Normal I&E Program	<b>BOND CALCULATION TYPE:</b> None	<b>BOND AMOUNT:</b> \$85,476.00	
<b>DATE OF COMPLAINT:</b> NA	<b>POST INSP. CONTACTS:</b> None	<b>JOINT INSP. AGENCY:</b> None	
<b>WEATHER:</b> Clear	<b>INSPECTOR'S SIGNATURE:</b>

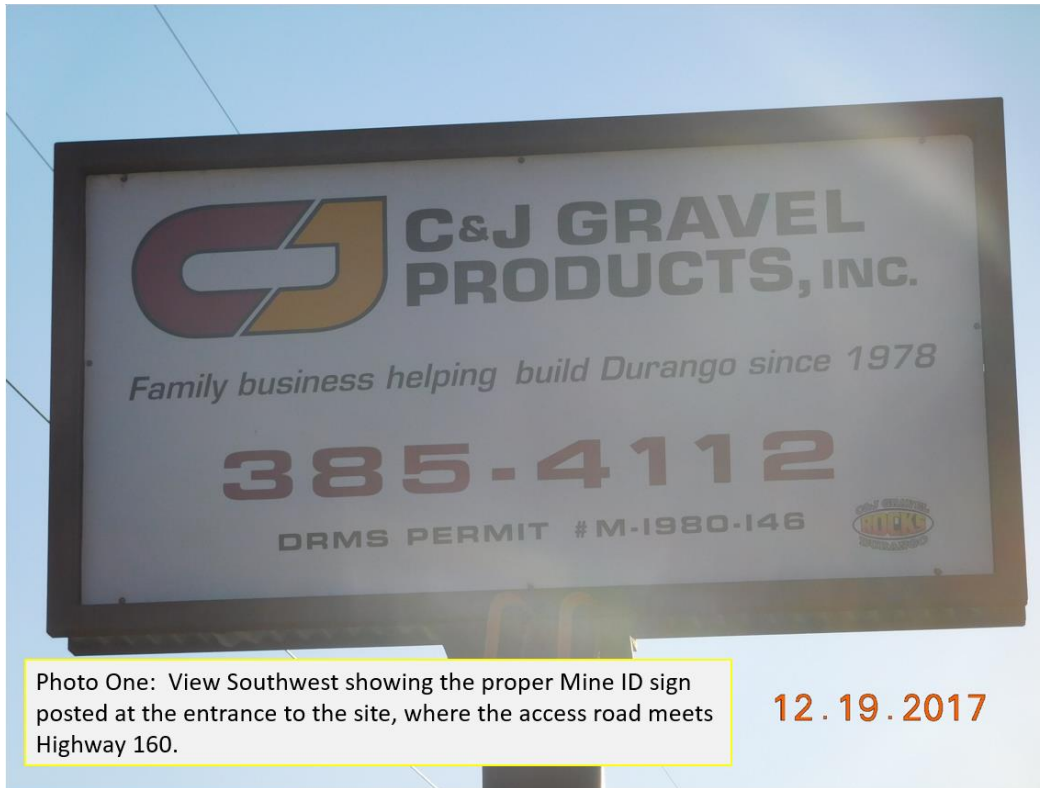
The proper Mine Identification sign was posted at the entrance to the site and can be seen in Photo One. The Permit Boundaries were clearly marked. The site shares it's southwestern boundary with the Crader Pit, permit no. M-1981-114 which was also clearly marked. The site was active the day of the inspection and various equipment was operating at the time. The main area of activity is near the center of the pit and can be seen in Photo Two. Operations consisted of active excavation, crushing, washing and stockpiling. Several Stockpiles were observed on the pit floor including several stockpiles of material, overburden and topsoil. Examples of the stockpiles can be seen in Photo Three. All the stockpiles appeared to be stable and in good condition during the inspection. The equipment operating was also in good order, and inactive pieces of equipment were stored in an orderly fashion on site.

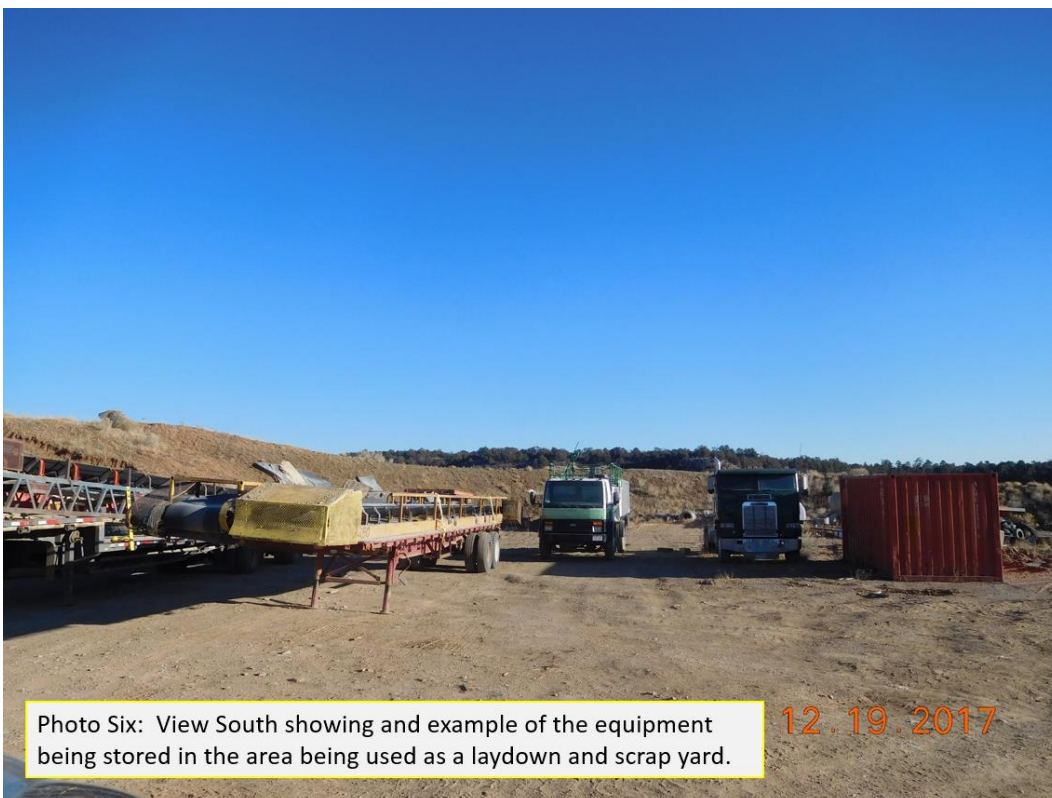
The sites stormwater controls include sediment ponds, bar ditches along the access road and drainage ditches. These structures appeared to be functioning as designed and no impounded stormwater was observed. The sediment ponds located on site were inspected and appeared to be in good condition. A large area on site is being used as an equipment storage as well as a scrap yard for discarded metal and other items. This area is generally well kept and the items are stored in an orderly fashion. An example of the equipment being stored can be seen in Photo Six.
