MINERALS PROGRAM INSPECTION REPORT

MINE NAME: Smith Ranch Pit No 2	MINE/PROSPECTING ID#: M-1988-022	MINERAL: Gravel	COUNTY: Lincoln
INSPECTION TYPE: Surety Release Inspection	INSPECTOR(S): Timothy A. Cazier	INSP. DATE: December 19, 2017	INSP. TIME: 11:15
OPERATOR: Lincoln County	OPERATOR REPRESENTATIVE: Trey James	TYPE OF OPERATION: 110c - Construction Limited Impact	
REASON FOR INSPECTION: Surety Release Requested	BOND CALCULATION TYPE: None	BOND AMOUNT: \$0.00	
DATE OF COMPLAINT: NA	POST INSP. CONTACTS: None	JOINT INSP. AGENCY: None	
WEATHER: Clear	INSPECTOR'S SIGNATURE:

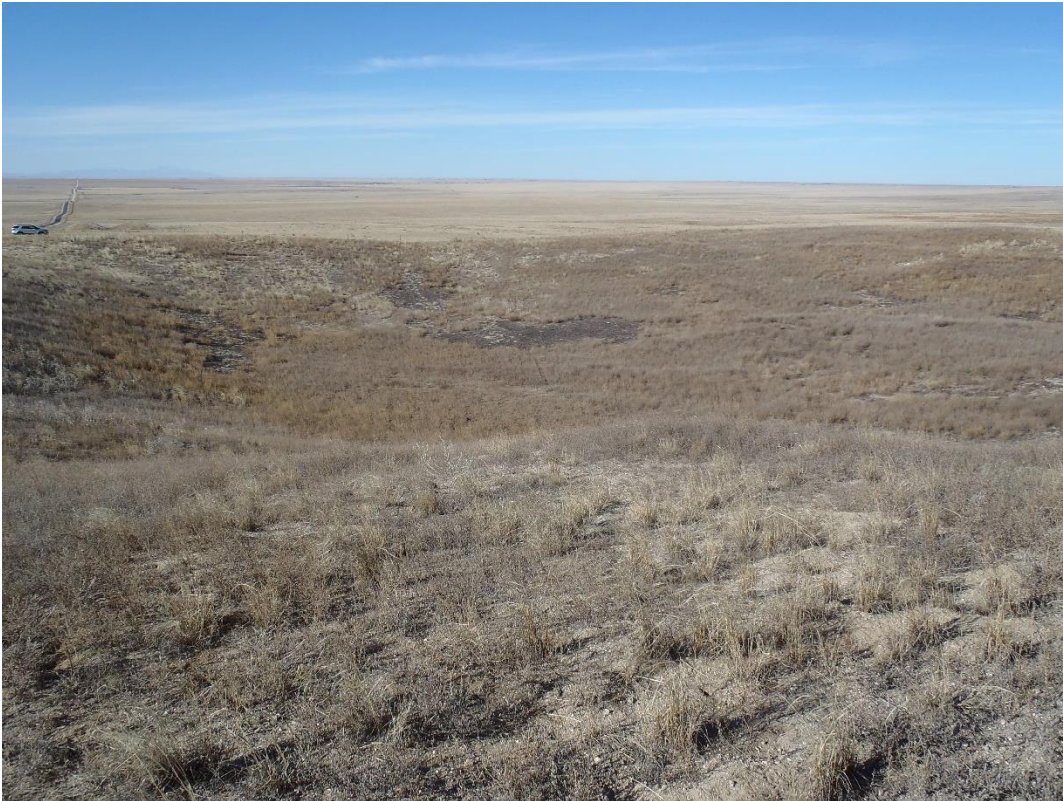
Reclamation Success: Reclamation grading has been completed for the pit (see **Photos 1** through **3**).

Photo 1. Reclamation grading (1 of 3, looking west from SE corner of site).

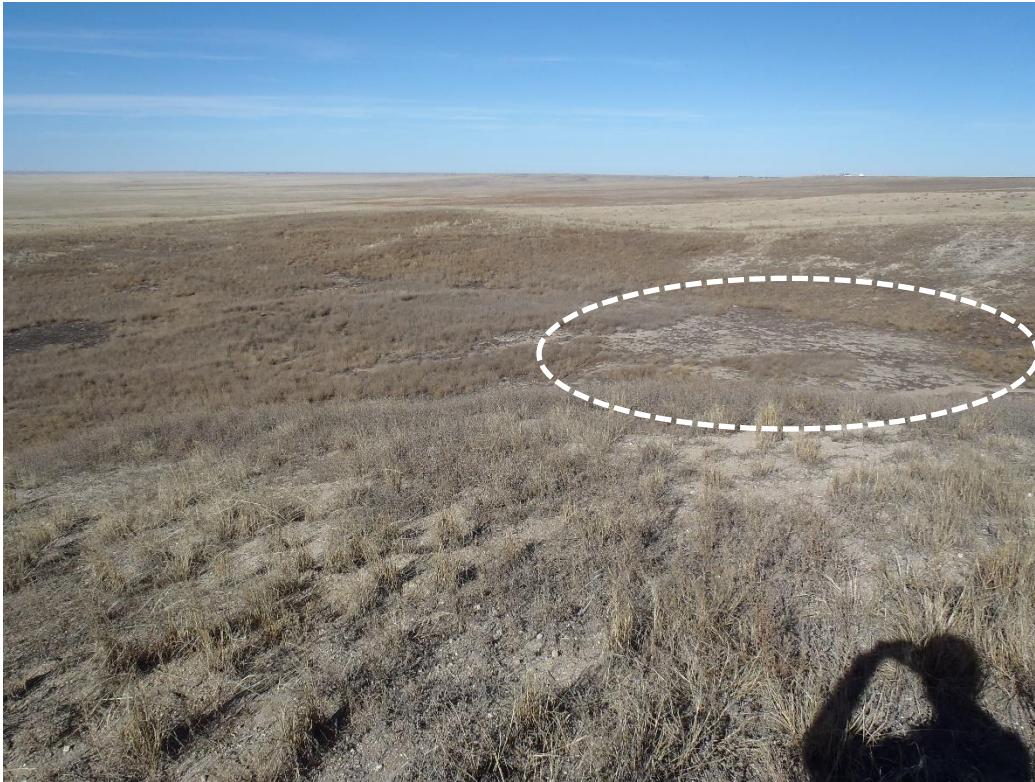
Photo 2. Reclamation grading (2 of 3, looking NW from SE corner of site, note bare area).

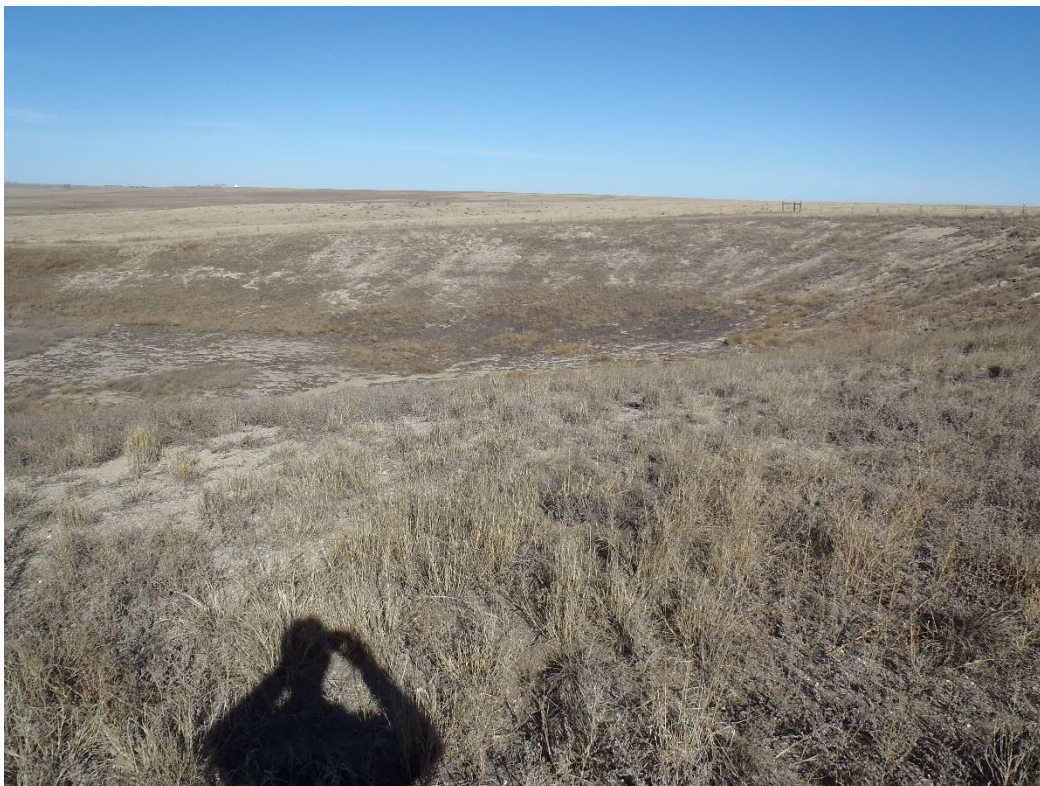
Photo 3. Reclamation grading (3 of 3, looking north from SE corner of site).

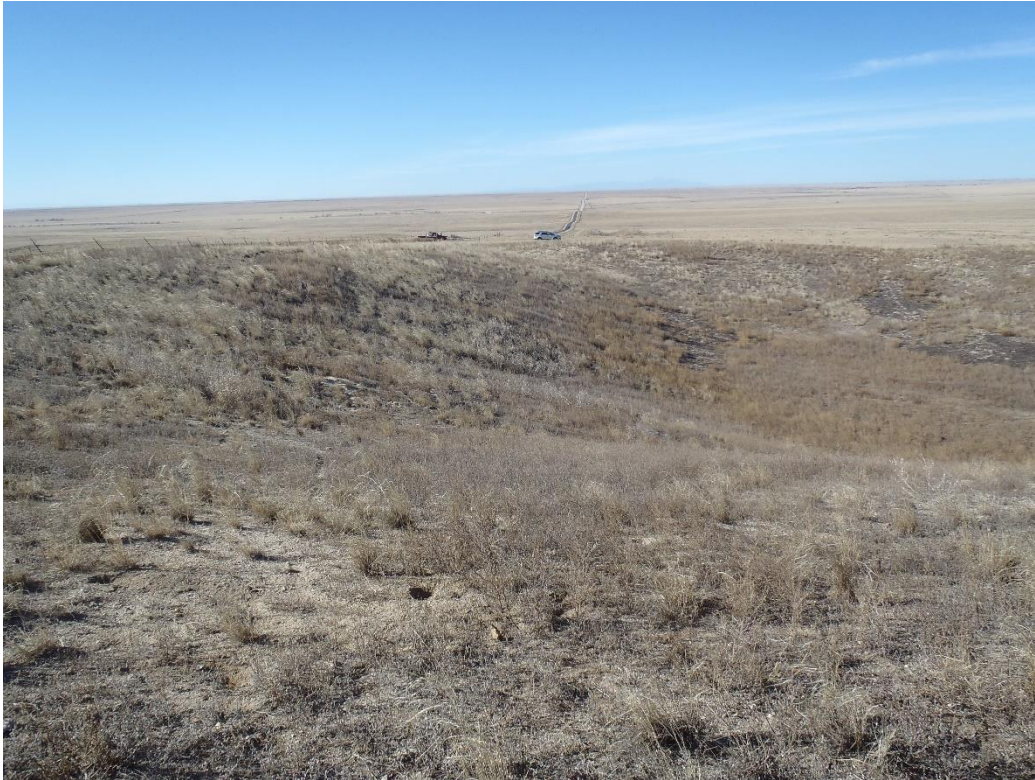
Revegetation: The only vegetation in the disturbed area is a mix of what appeared to be primarily two species of annual weeds (see **Photos 4** and **5**). Samples were taken to the DRMS office for identification, however, they could not be identified given their mid-winter condition. The DRMS is reasonably certain the two species are not on the Colorado noxious weed list. No grasses at all were observed in the disturbed area and there were bare spots on the pit floor (see **Photos 2** and **5**). As there appears to be no vegetation established other than annual weeds, the DRMS cannot recommend release of this site at this time. Previous inspections have suggested submitting a Technical Revision (TR) to change the approved seed mix to include grasses that are more drought tolerant (this was due to the recent drought experienced in eastern Colorado). The DRMS recommends mowing the weeds now and drill seeding this spring to take advantage of any late season moisture.

Photo 4. Typical weeds on south pit slope (looking west).

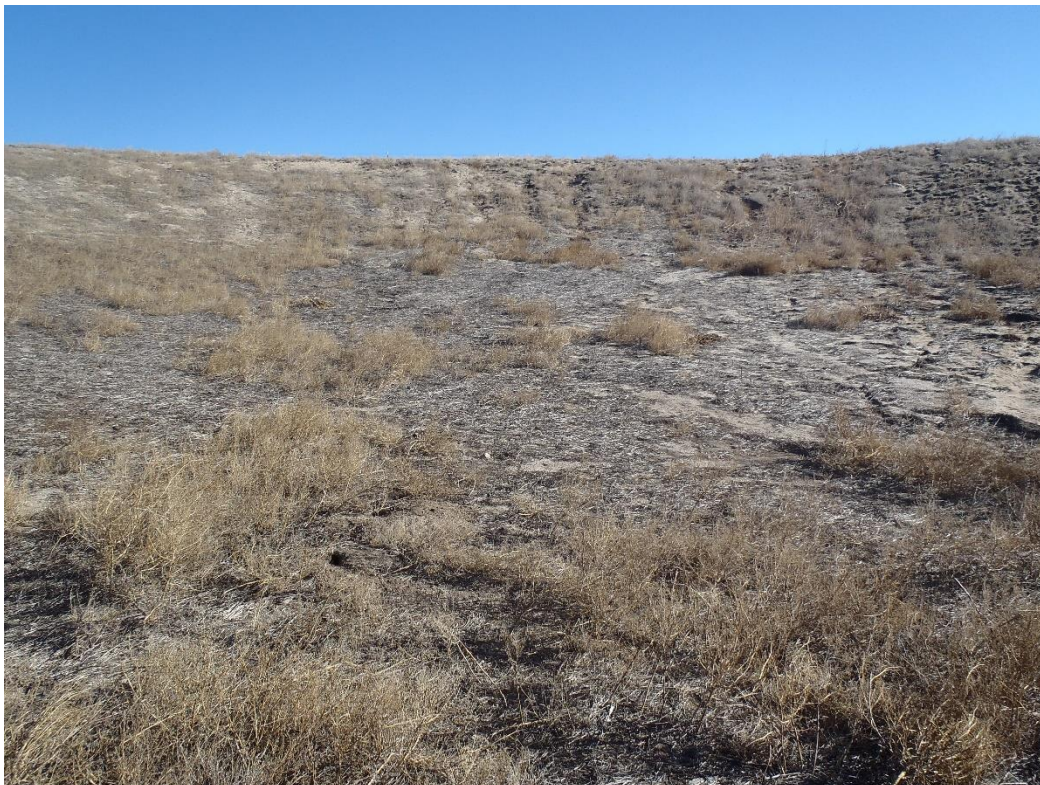
Photo 5. Typical weeds on east pit slope (looking east from pit floor).

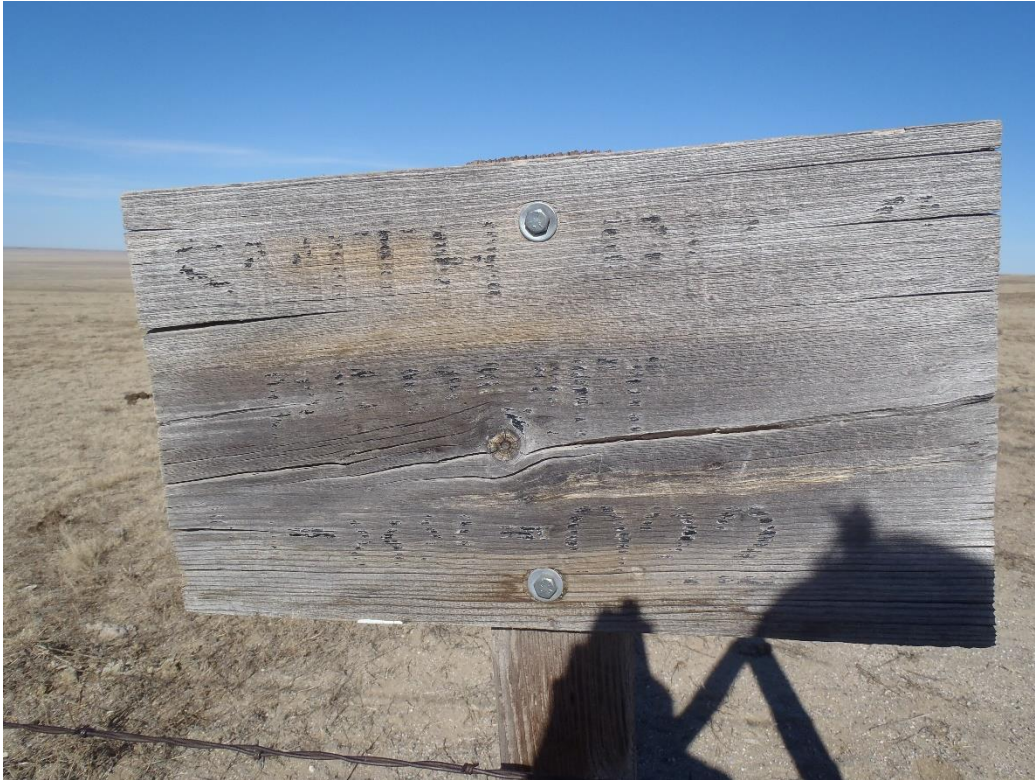
Signs and Markers: A permit sign was posted (see **Photo 6**), but was illegible due to faded lettering. Given the site cannot be released at this time, the permit sign should be repainted or replaced. The entire site was fenced with barbed wire to mark the permit boundary (see **Photo 7**).

Photo 6. Permit sign off County Road T (requires repainting or replacement).

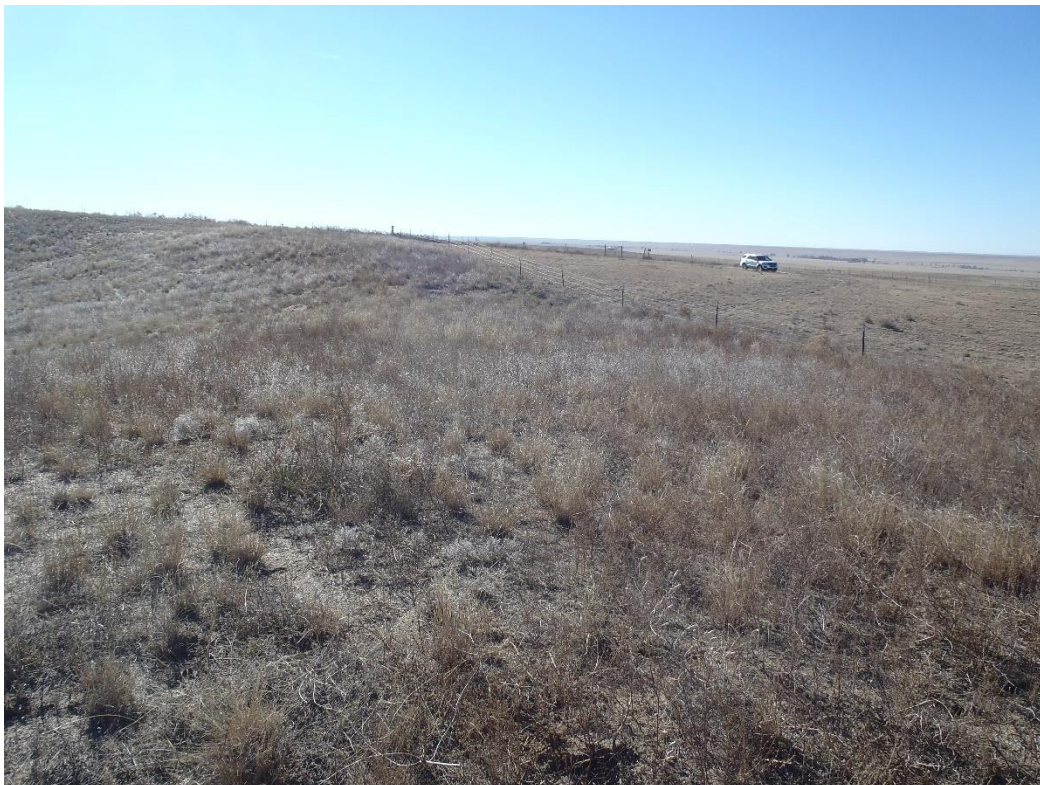
Photo 7. Fenced boundary on west side of pit (looking SSW).
