**COLORADO**Division of Reclamation,
Mining and Safety

MINERALS PROGRAM INSPECTION REPORT**PHONE: (303) 866-3567**

MINE NAME: Cash & Who Do Mines	MINE/PROSPECTING ID#: M-1983-141	MINERAL: Gold and silver	COUNTY: Boulder
INSPECTION TYPE: Monitoring	INSPECTOR(S): Amy Eschberger, Wally Erickson	INSP. DATE: August 1, 2017	INSP. TIME: 14:42
OPERATOR: Colorado Milling Company, LLC	OPERATOR REPRESENTATIVE: Mark Steen	TYPE OF OPERATION: 110(2) - Hard Rock Limited Impact	
REASON FOR INSPECTION: Normal I&E Program	BOND CALCULATION TYPE: None	BOND AMOUNT: \$216,200.00	
DATE OF COMPLAINT: NA	POST INSP. CONTACTS: None	JOINT INSP. AGENCY: None	
WEATHER: Clear	INSPECTOR'S SIGNATURE:

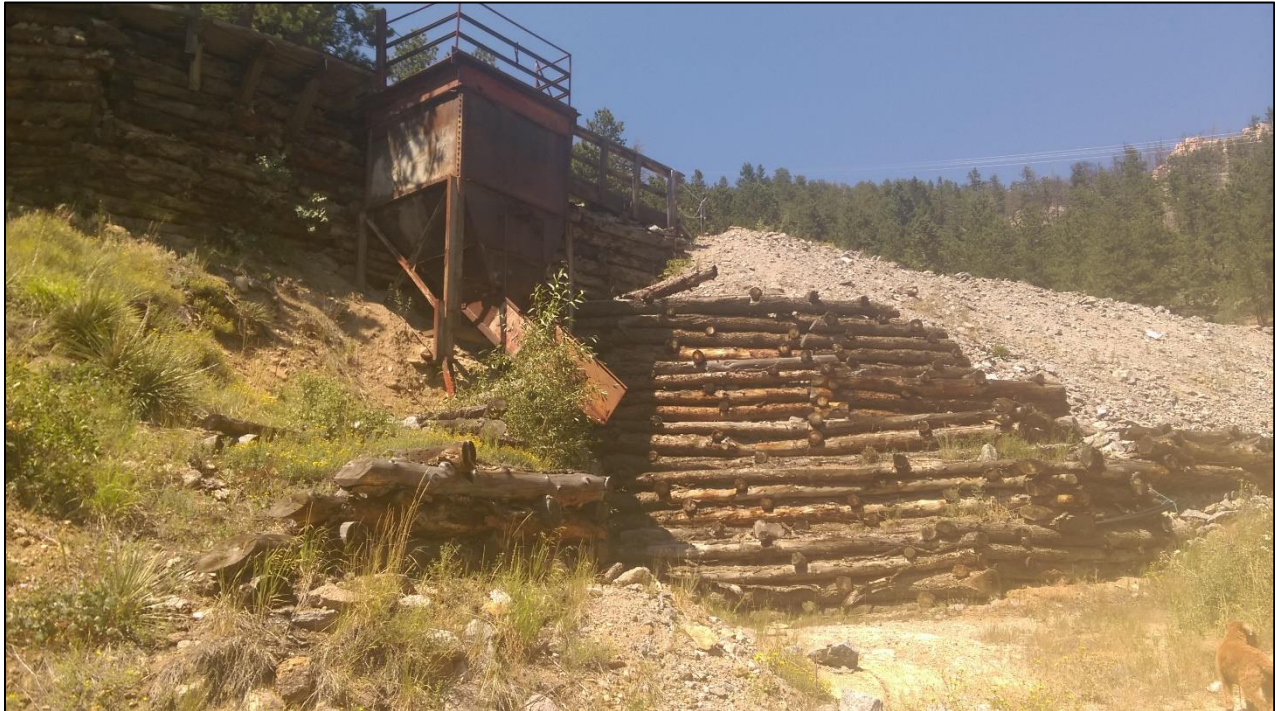
Photo 1. View looking east at Cash Mine Ore Bin/Loadout.

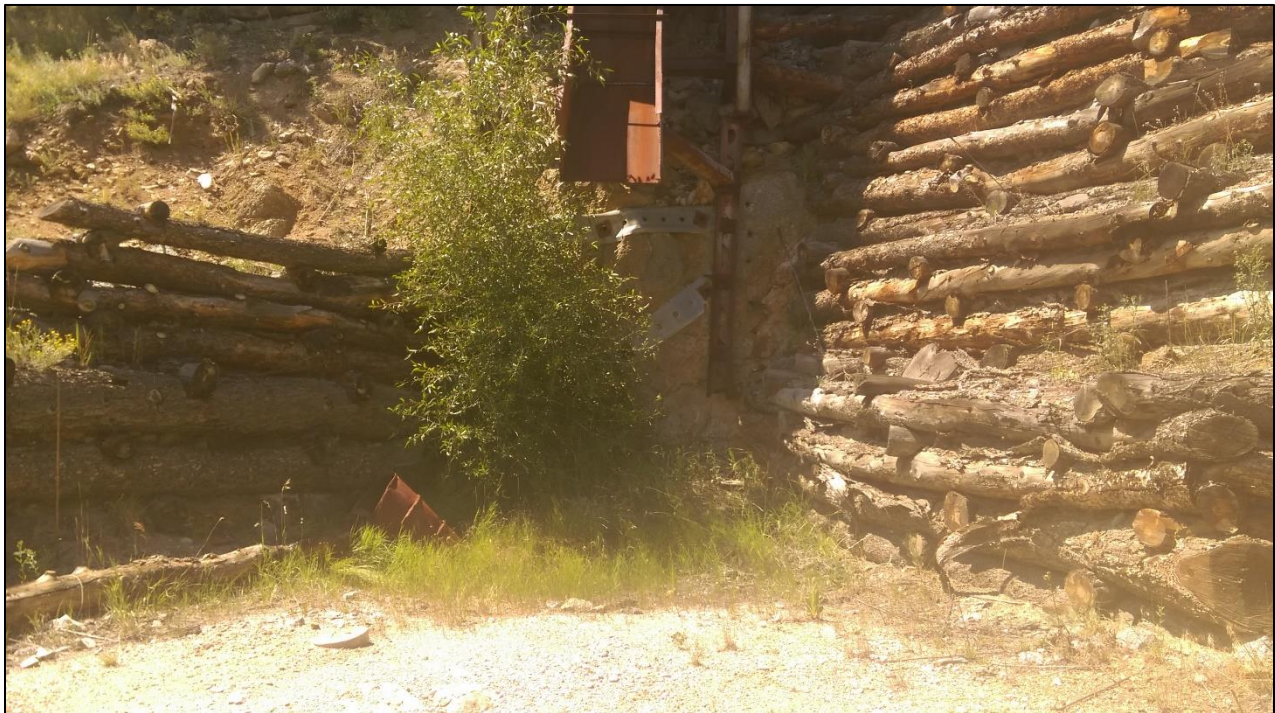
Photo 2. Closer view of Cash Mine Loadout area.

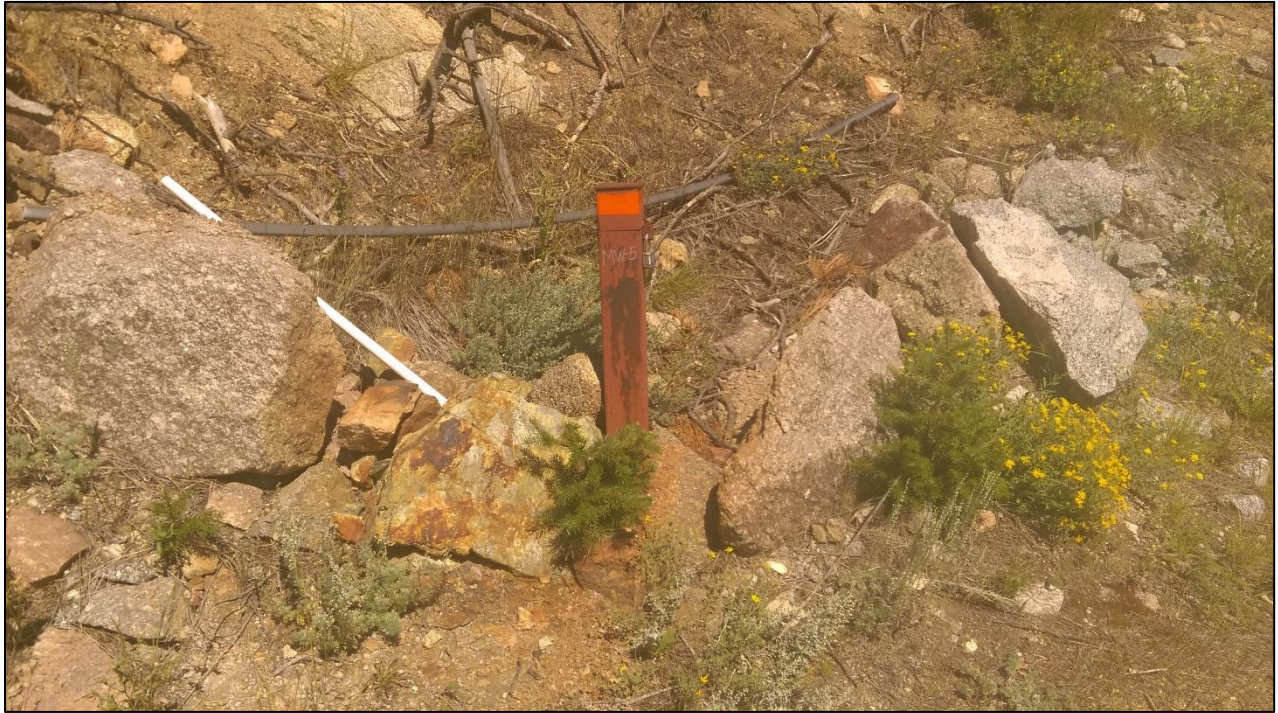
Photo 3. View of groundwater monitoring well MW-5, located just downgradient from the Mount Royale No. 1 Adit.

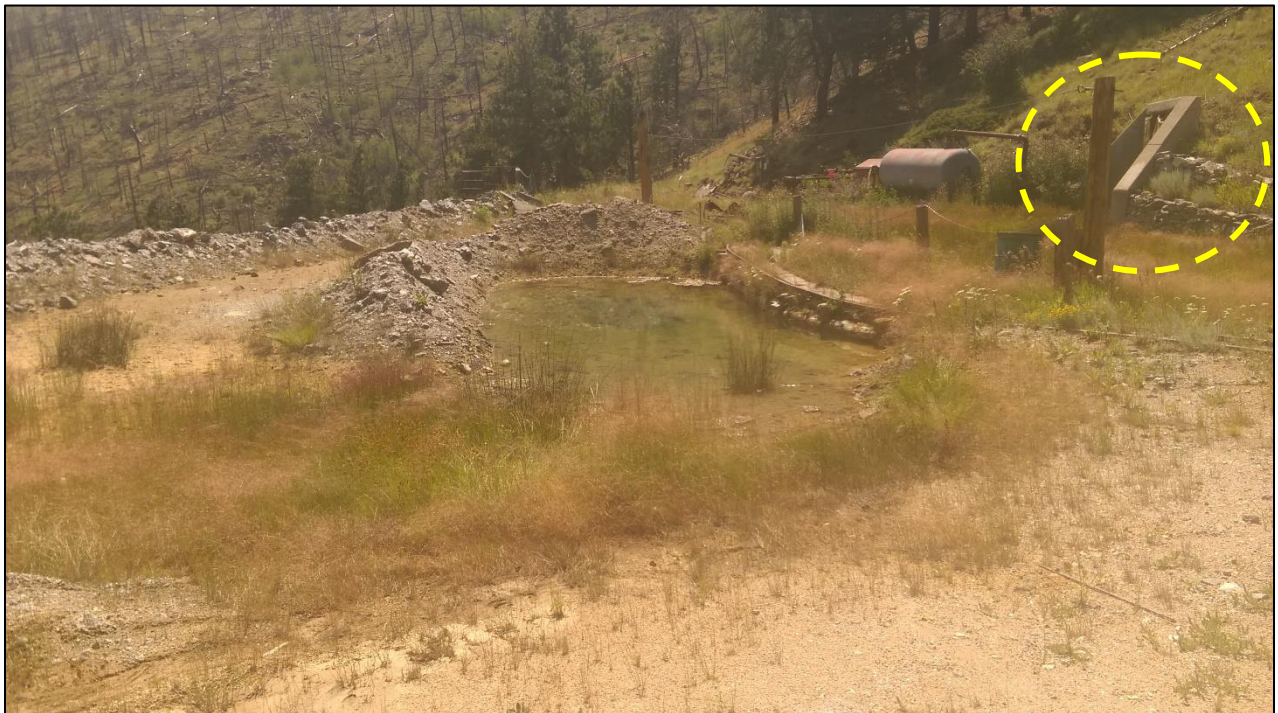
Photo 4. View looking southwest, showing small sediment pond located on top of waste rock pile, below the Mount Royale No. 1 Adit (adit circled). Note pond was partially full of water.

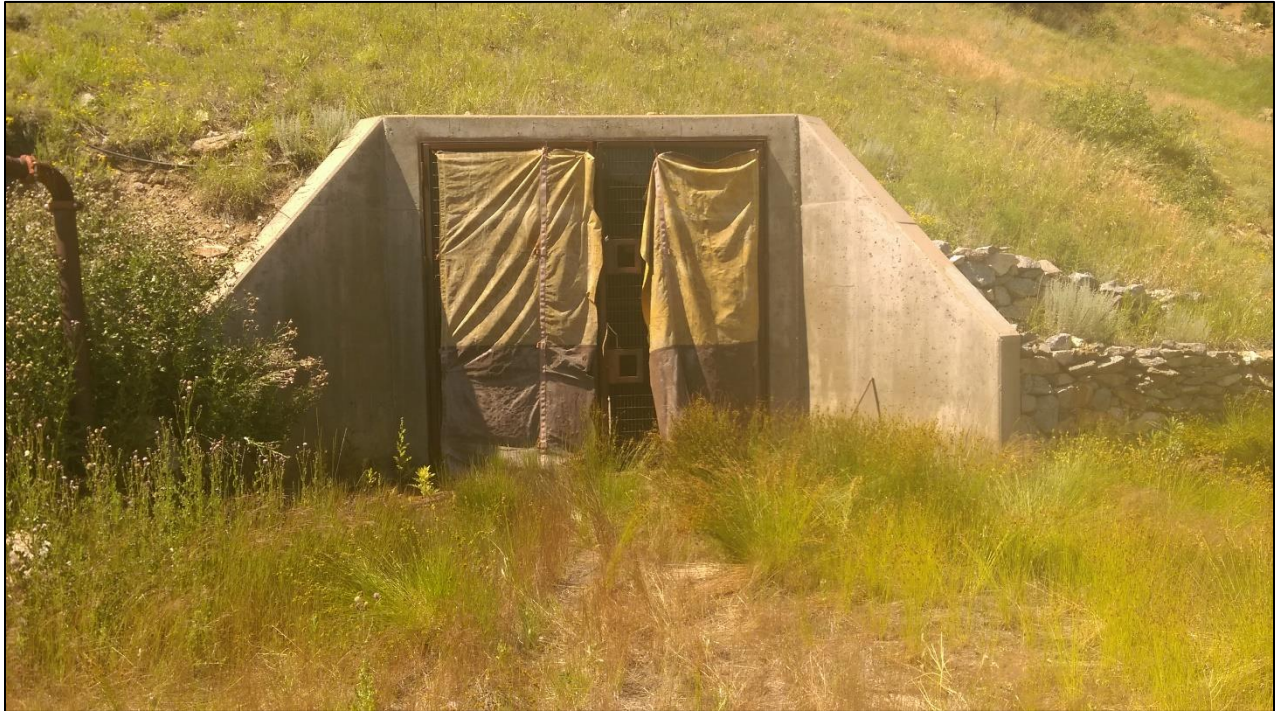
Photo 5. Closer view of Mount Royale No. 1 Adit.

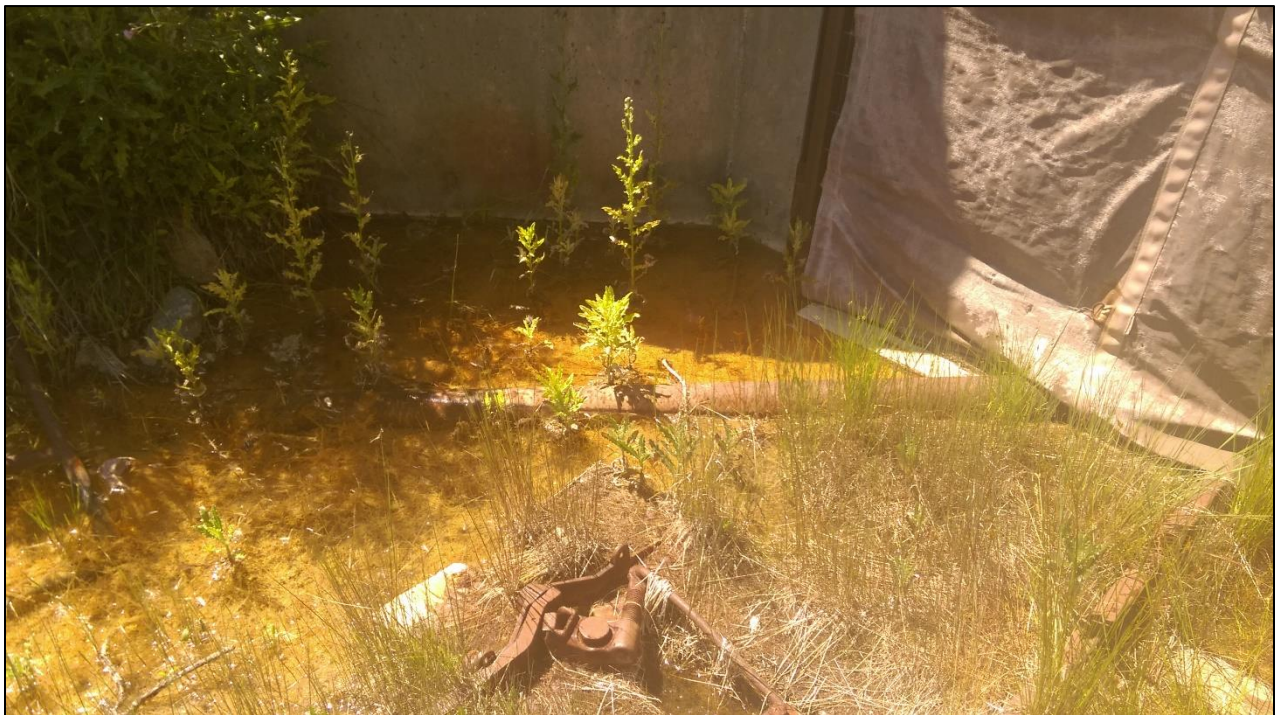
Photo 6. View of ground immediately in front of Mount Royale No. 1 Adit, showing water draining from portal. Note orange colored staining of ground where drainage occurs.

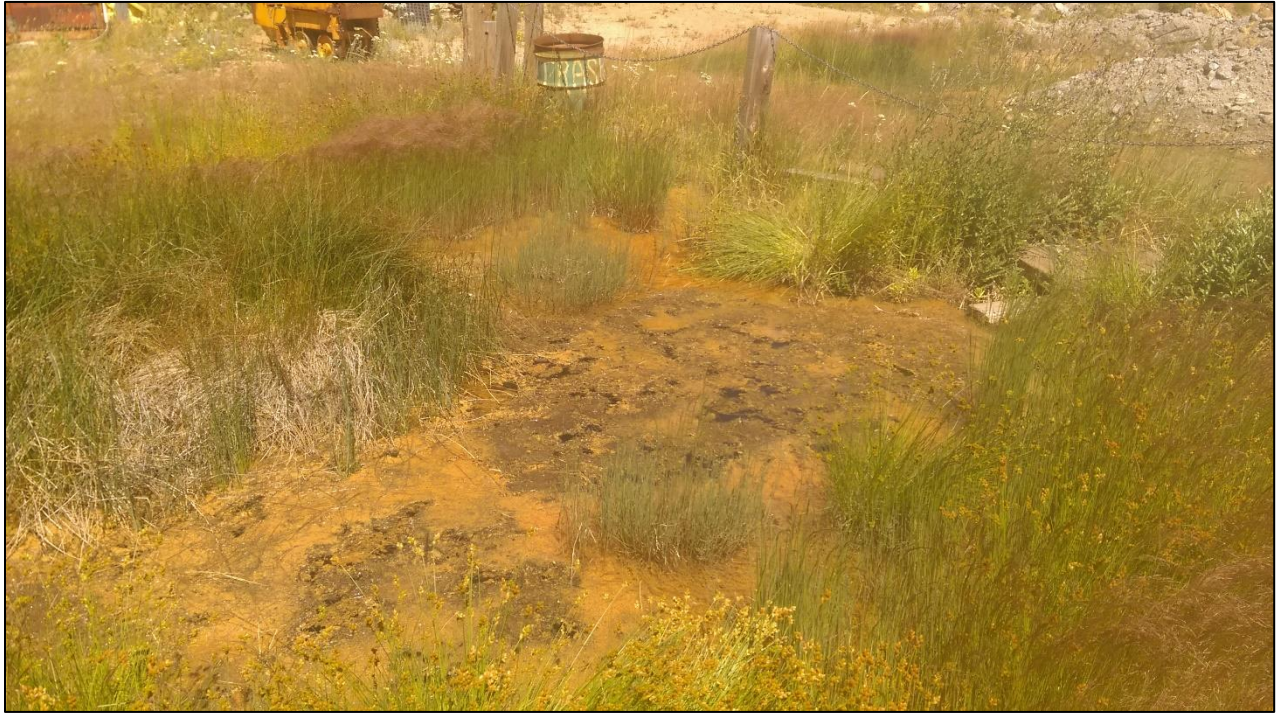
Photo 7. View looking southeast from Mount Royale No. 1 Adit, showing mine drainage flowing toward sediment pond. Note orange colored staining of ground where drainage occurs.

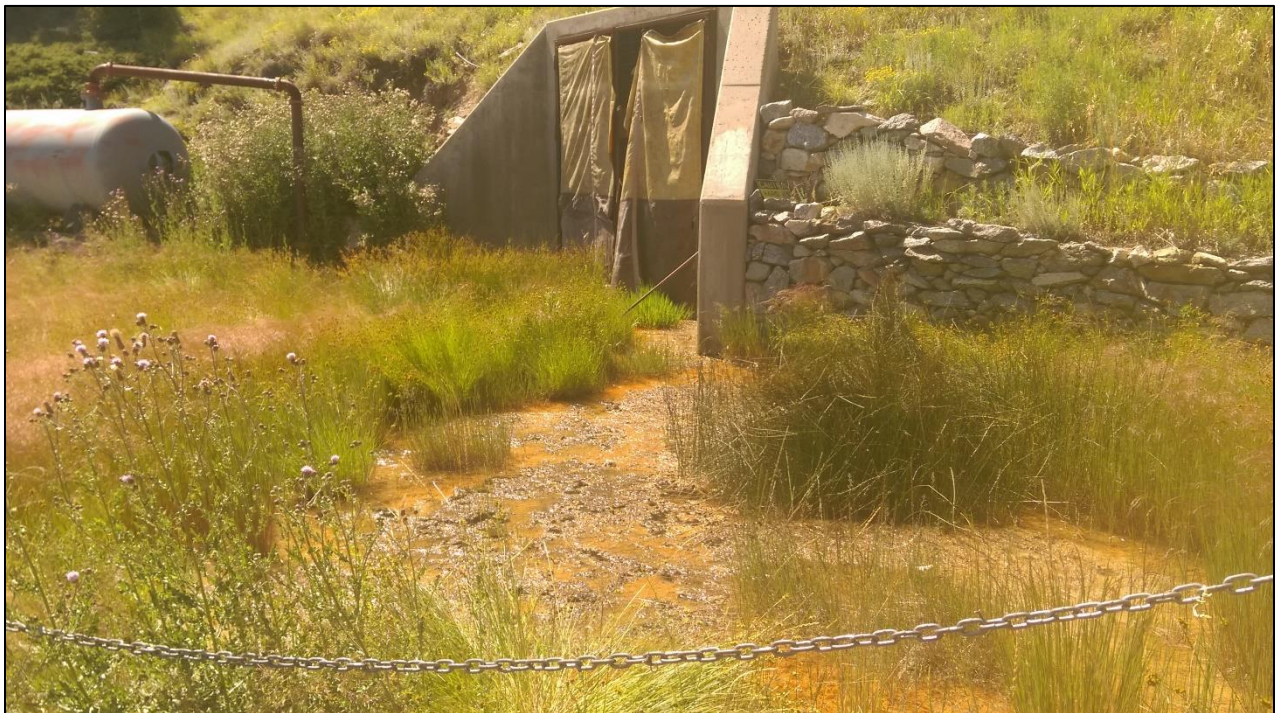
Photo 8. View looking toward Mount Royale No. 1 Adit from edge of sediment pond, showing mine drainage path toward pond. Note orange colored staining of ground where drainage occurs.

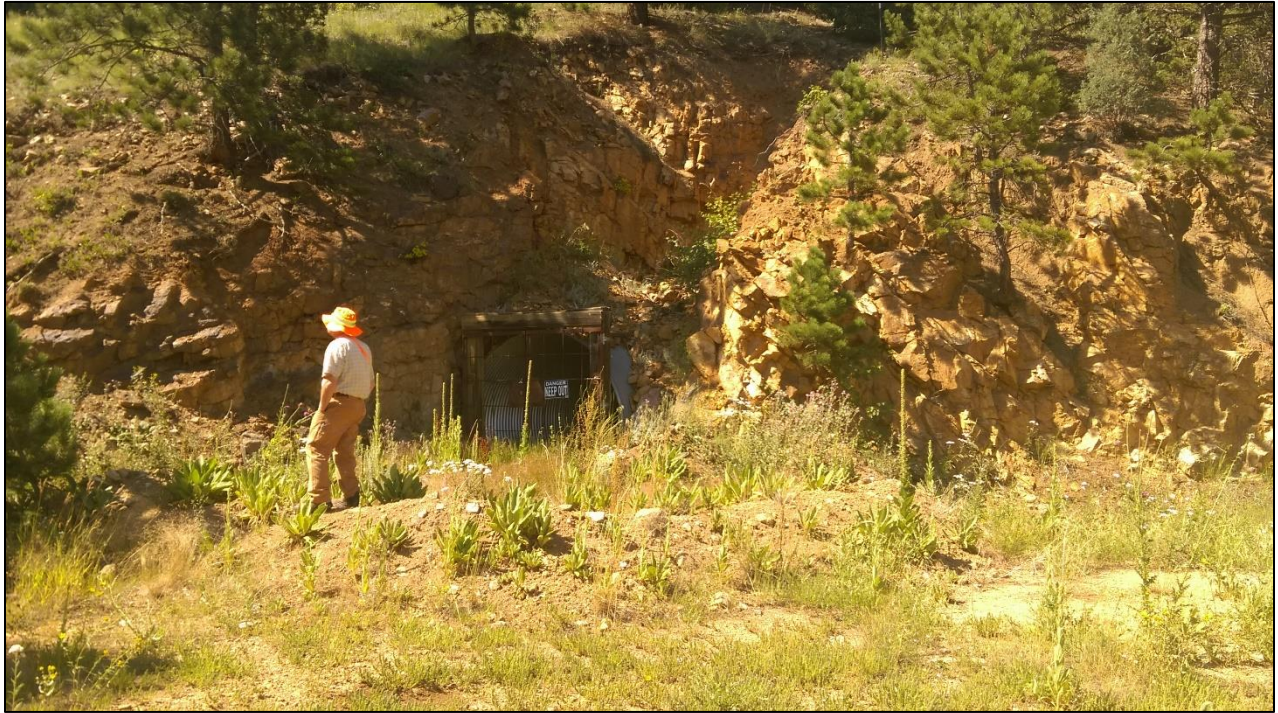
Photo 9. View looking north toward Who Do Portal.

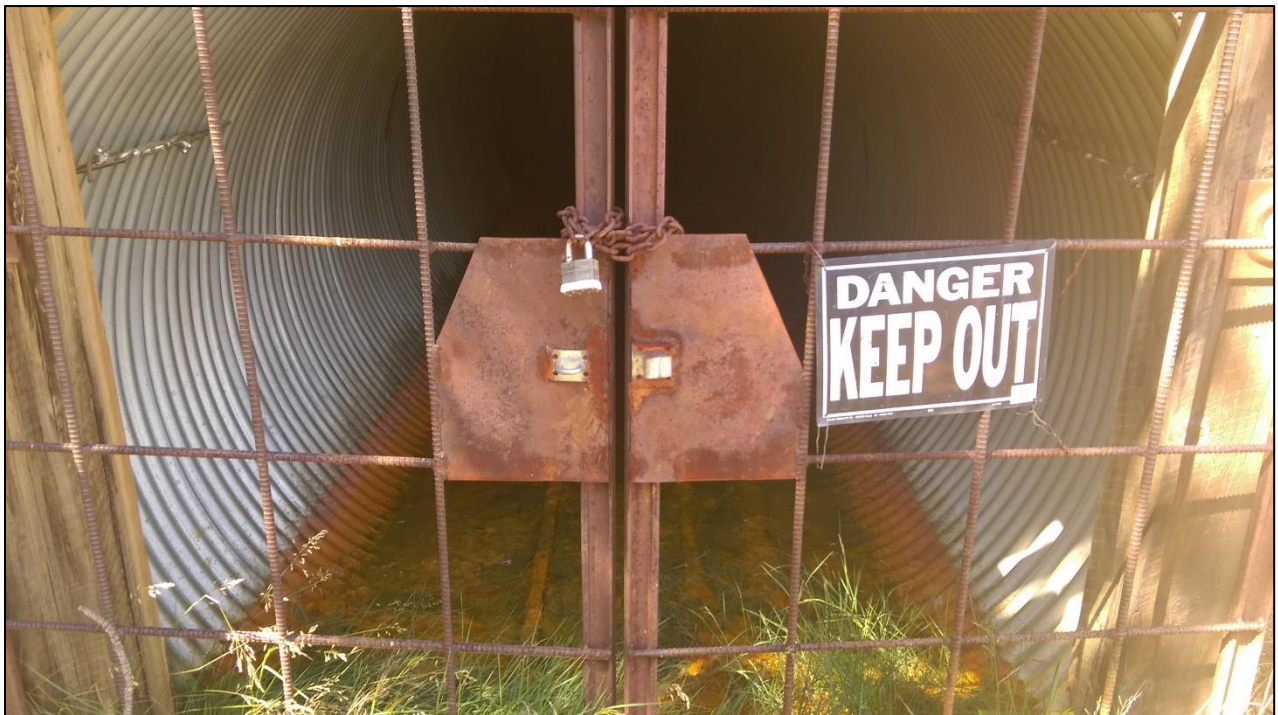
Photo 10. View looking inside Who Do portal, showing some water present. However, no water was observed discharging directly from the portal.

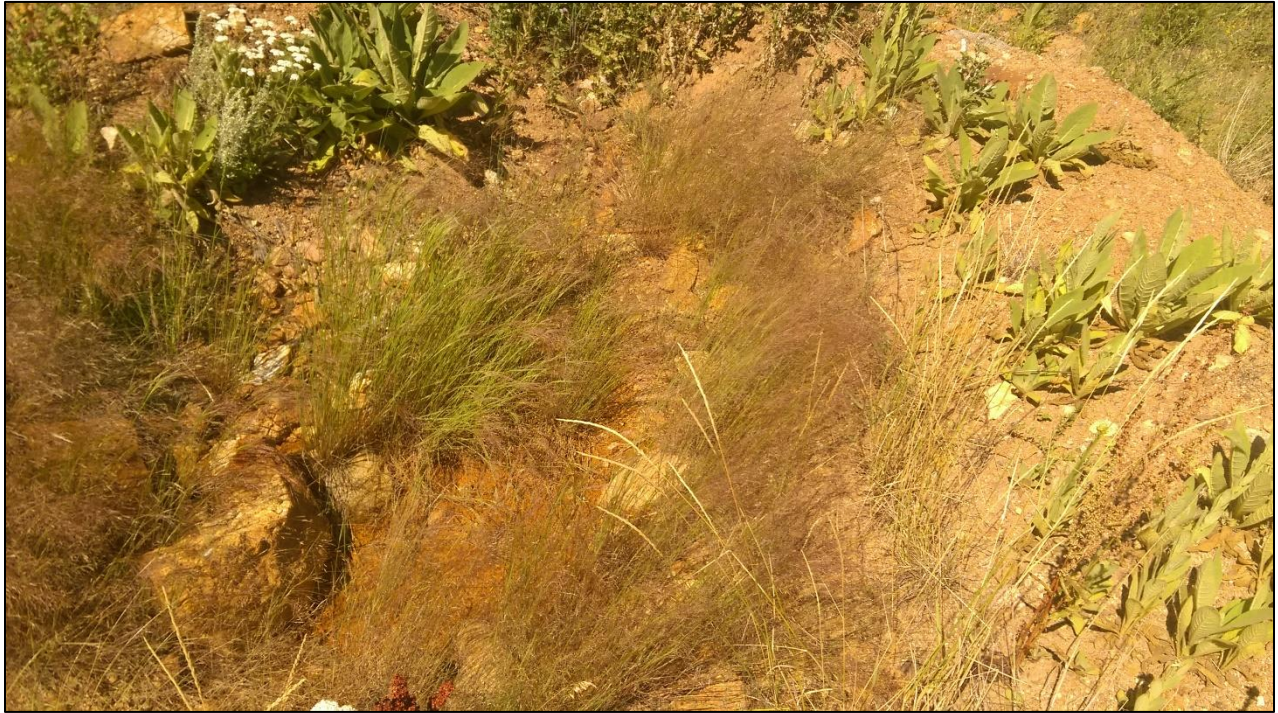
Photo 11. View of sump area located directly in front of Who Do portal. Note some orange colored staining of ground surface inside sump, indicating it does impound mine drainage as intended.

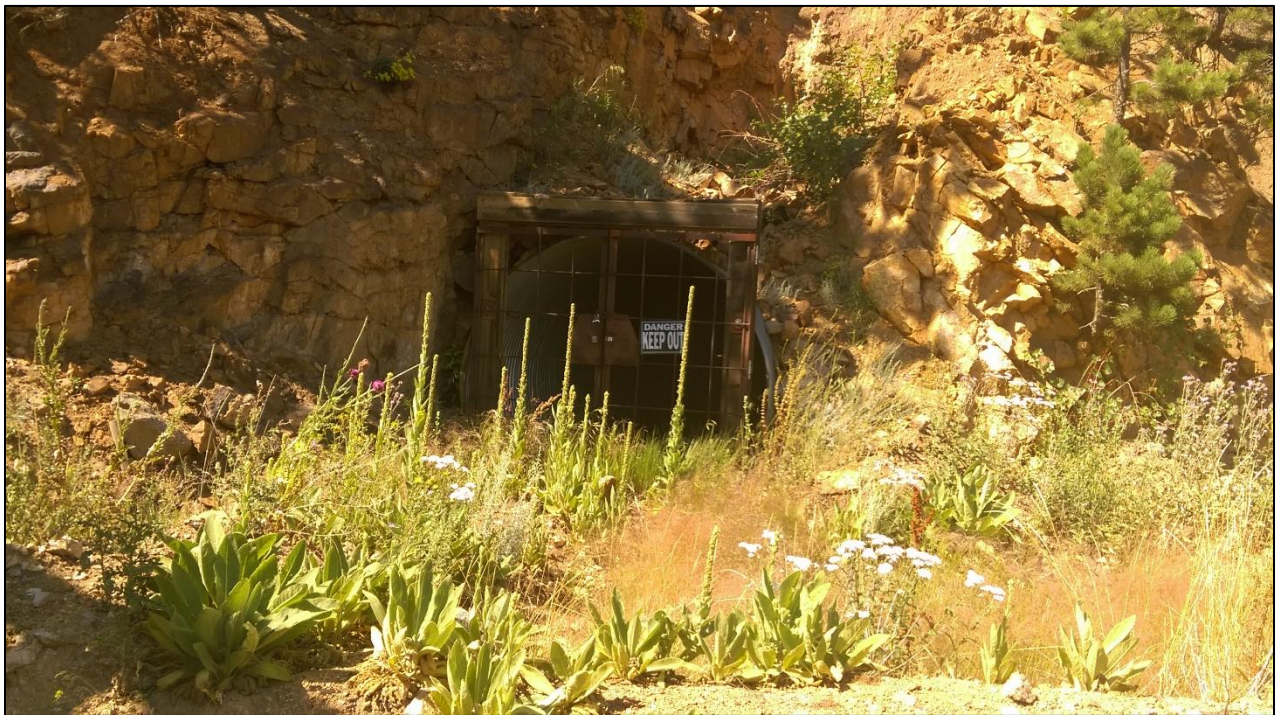
PROBLEM: There are state-listed noxious weeds present on site. This is a problem for failure to employ weed control methods for state-listed noxious weed species within the permitted area, and to reduce the spread of weeds to nearby areas as required by Rule 3.1.10(6).

The Division did note the presence of several weed species at the site, including Common mullein and Canada thistle, which are state-listed noxious weed species. Rule 3.1.10(6) requires that methods of weed control be employed for all prohibited noxious weed species and whenever invasion of a reclaimed area by other weed species seriously threatens the continued development of the desired vegetation. The Division cited a problem for weeds in the inspection report for Gold Hill Mill, sent on August 28, 2017. On November 29, 2017, the operator submitted a Technical Revision (Revision No. TR-10) to update the weed control plan for the Gold Hill Mill site. Because the Gold Hill Mill is a separate permit, the operator will need to address this issue separately for the Cash and Who Do Mines permit. Therefore, a problem is cited in this report for the presence of state-listed noxious weed species at the Cash and Who Do Mines. By the corrective action deadline, the operator will need to either provide proof that the approved weed control plan has been implemented at the site, or develop a weed control plan and submit it as a Technical Revision to the Cash and Who Do Mines permit. The operator may submit the same weed control plan submitted for Gold Hill Mill.

Photo 12. View of area in front of Who Do Portal showing abundance of weeds, including state-listed noxious weed species Common mullein.

CORRECTIVE ACTIONS: Implement the approved weed control plan and provide proof to the Division that this has been done. If a weed control plan is not already in place, the operator shall develop a weed control and management plan in accordance with Rule 3.1.10(6). This plan should be developed in consultation with the county extension agency, or weed control district office and should include specific control measures to be applied, a schedule for when control measures will be applied and a post-treatment monitoring plan. This weed control plan shall be submitted to the Division as a Technical Revision to the approved plan with the appropriate fee of \$216.00 by the corrective action due date.

CORRECTIVE ACTION DUE DATE: February 10, 2018

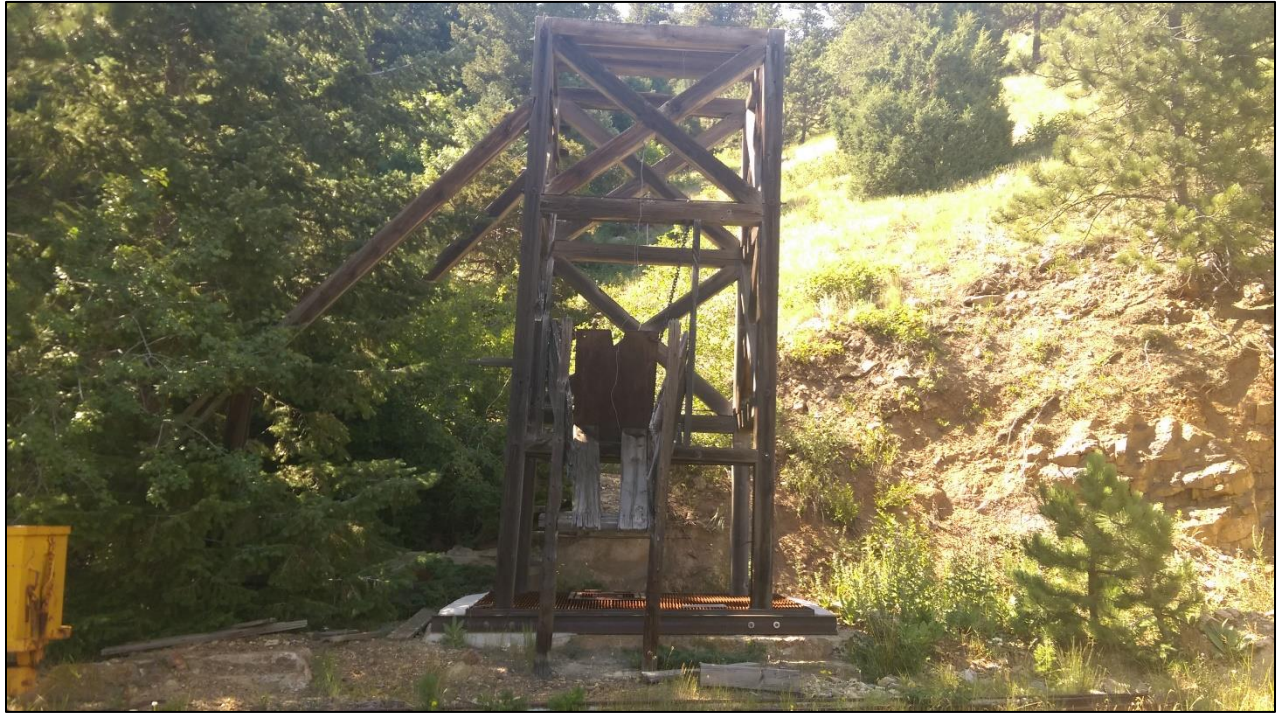
Photo 13. View of Who Do headframe.

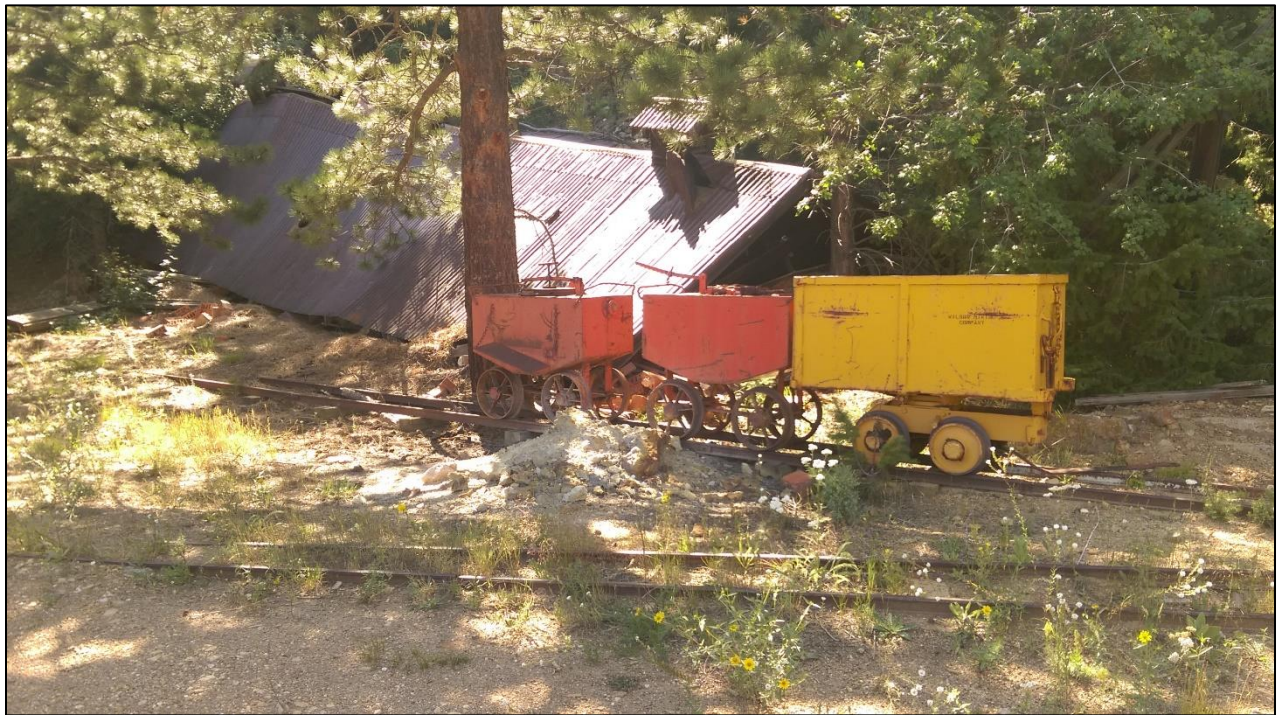
Photo 14. View of collapsed building (behind old mine carts) located southwest of Who Do headframe. This building may be the remnant Hoist House mentioned in the mining plan.

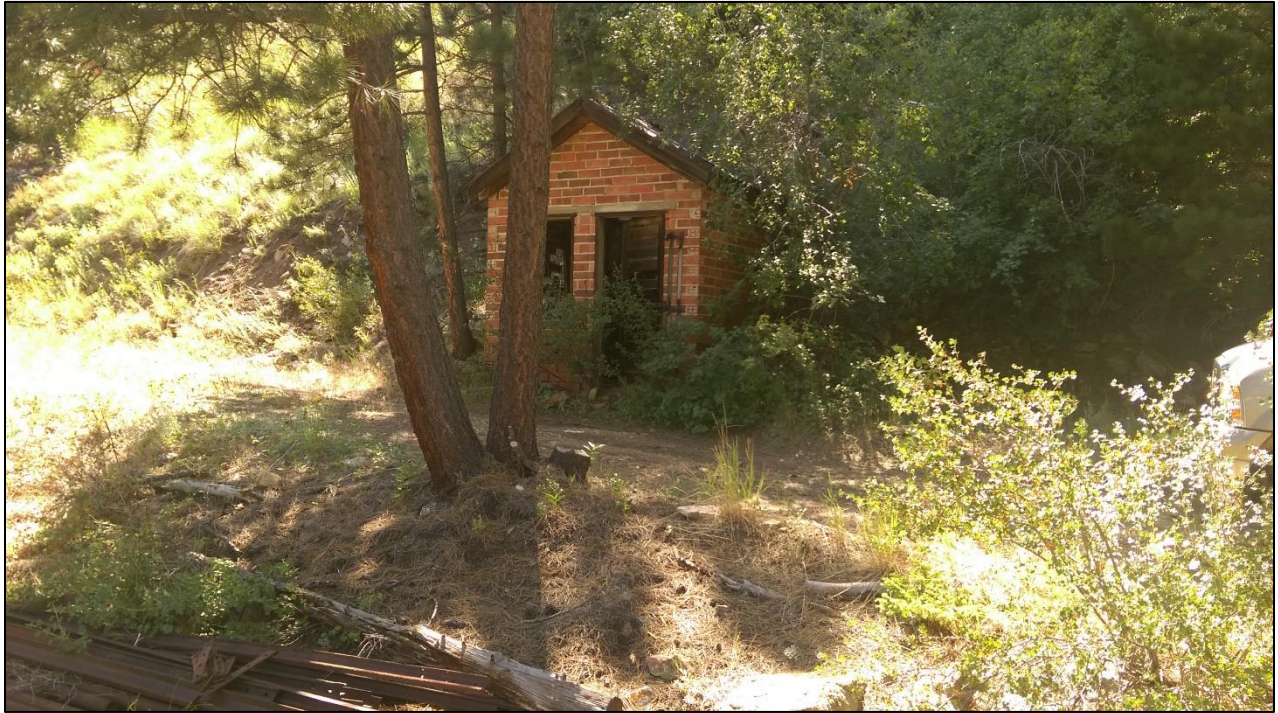
Photo 15. View of small brick shed located southwest of collapsed building in Who Do Mine Area. This building may be the remnant Powder Magazine mentioned in the mining plan.

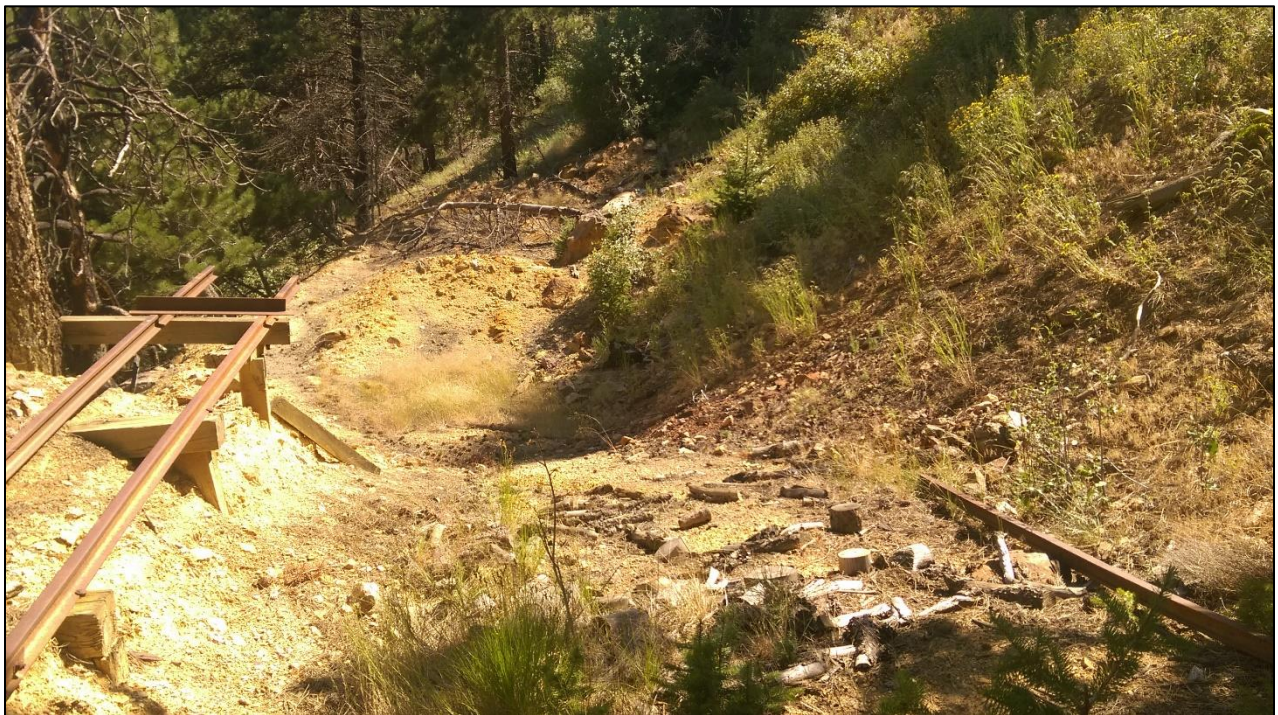
Photo 16. View looking southwest where rails end at edge of mine dump in Who Do Mine Area.
