**COLORADO**Division of Reclamation,
Mining and Safety

MINERALS PROGRAM INSPECTION REPORT**PHONE: (303) 866-3567**

MINE NAME: Specification Aggregates Quarry	MINE/PROSPECTING ID#: M-1974-004	MINERAL: Granite, granite gneiss	COUNTY: Jefferson
INSPECTION TYPE: Monitoring	INSPECTOR(S): Michael A. Cunningham	INSP. DATE: December 19, 2017	INSP. TIME: 09:00
OPERATOR: Martin Marietta Materials, Inc.	OPERATOR REPRESENTATIVE: Keith Buescher, David Bieber	TYPE OF OPERATION: 112c - Construction Regular Operation

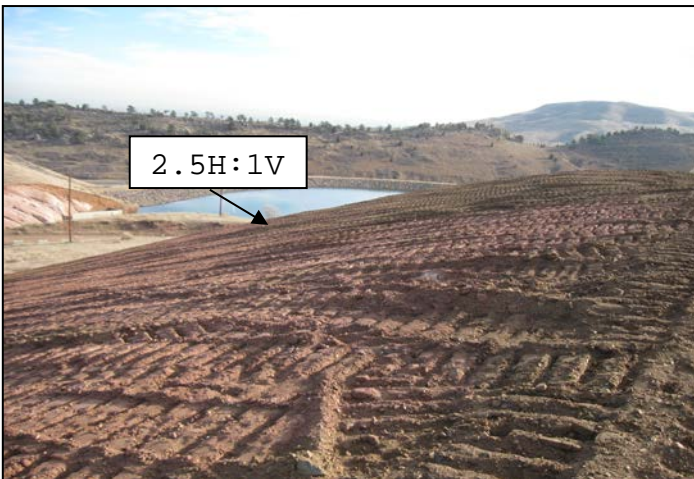
PROBLEM/POSSIBLE VIOLATION: Problem: Land has been affected outside of the approved permit boundary. This is a problem at this time pursuant to C.R.S. 34-32.5-116(4)(i) for failure to protect areas outside of the affected land from slides or damages occurring during the mining operation.

During the inspection, the Division observed the placement of structural fill material along the northwest side of Magic Mountain Reservoir. The Operator informed the Division the material was placed in this location to act as a visual barrier between the processing area and the Heritage Amusement Park which is located immediately north of the mining operation. The Operator of the mine is also the owner of Heritage Square, the location of where the amusement park is situated. The outslope of the fill area had been graded to 2.5H:1V and the Operator recently awarded a contract for seeding the visual barrier. The Division observed that the permit boundary bisected the fill area from east to west and estimated that approximately 1.5 acres of structural fill material was placed outside of the approved permit boundary, but within the property boundary of the mine. The Operator informed the Division the construction of the visual barrier was approved by the City of Golden. Pursuant to C.R.S. 34-32.5-116(4)(i), areas outside of the affected land shall be protected from slides or damage occurring during the mining operation and reclamation. Affected lands are defined as the surface of an area within the state where a mining operation is being or will be conducted, which surface is disturbed as a result of an operation. The disturbance created outside of the permit boundary is the direct result of the mining operation; a visual barrier would not be needed if there was not a mine at this location. In considering this matter, the Division has taken into account that the Operator is the owner of the

1. Outslope of visual barrier, photo taken facing east.

CORRECTIVE ACTIONS: The Operator shall submit a Technical Revision, with the required \$216 revision fee, to update and clarify the approved Reclamation Plan. The Technical Revision shall address how the visual barrier will be reclaimed within the limits of the permit boundary. In addition, the Operator shall submit any available documentation which demonstrates the necessary local government agencies reviewed and approved the

construction of the visual barrier. The Technical Revision shall be submitted by the corrective action date.

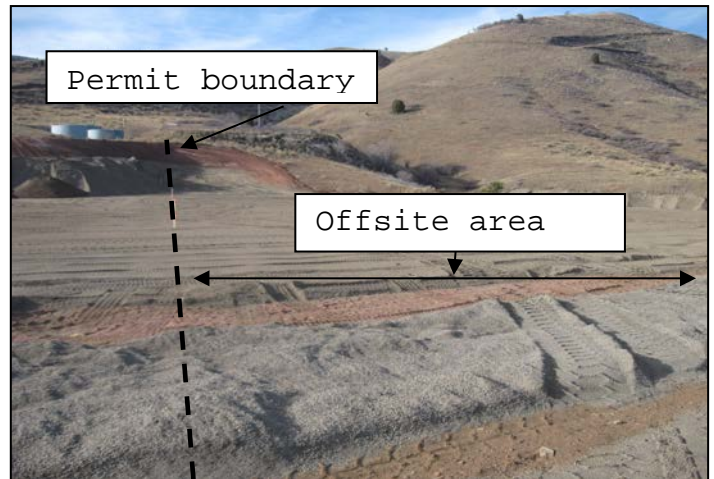
2. Top of visual barrier, photo taken facing west.

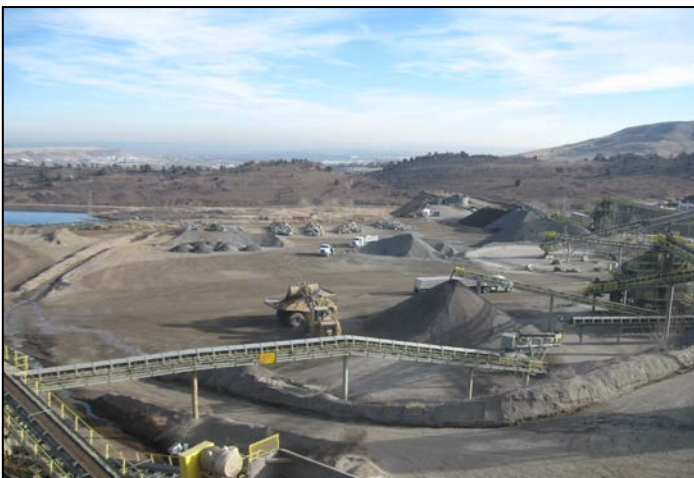
3. Overview of processing area.

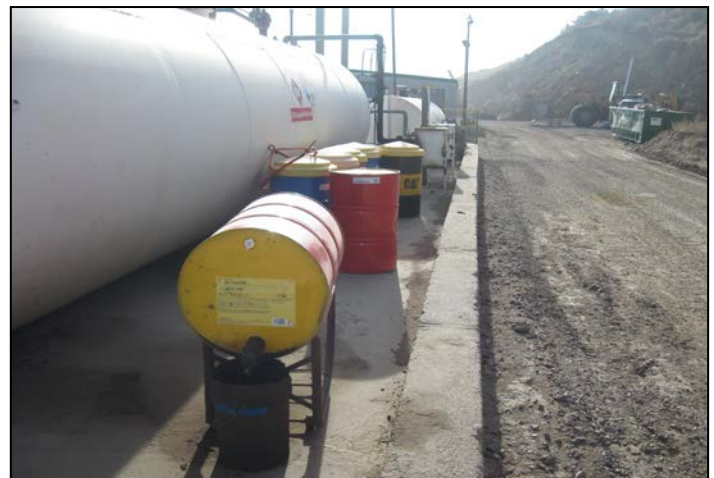
The Division inspected the fuel storage area and found all fuel was stored in double-walled tanks located within a concrete containment barrier. In addition, the maintenance shop and bulk oil storage area was inspected and was found to have the appropriate secondary containment.

4. Fuel containment area.

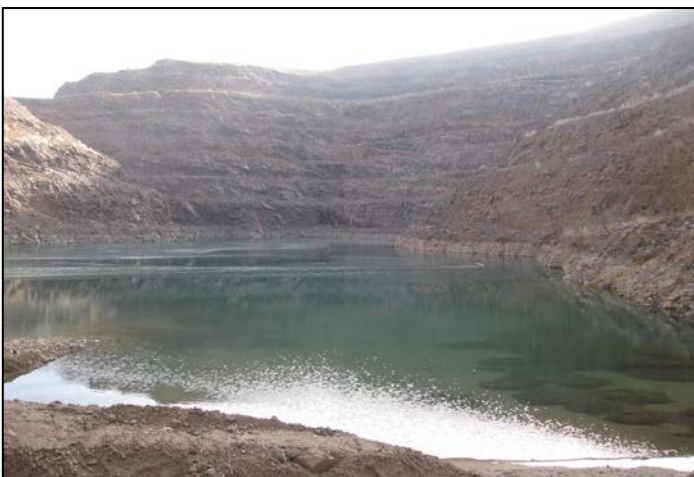
PROBLEM/POSSIBLE VIOLATION: Problem: The Division has no evidence the operator has a valid well permit, substitute water supply plan, or approved water augmentation plan for the exposed groundwater at the site. This is a problem related to 34-32.5-116(4)(h) of the Colorado Revised Statutes and 3.1.6(1)(a) of the Construction Materials Rules and Regulations governing injury to existing water rights.

PROBLEM/POSSIBLE VIOLATION: Problem: Failure to follow approved reclamation plan, or current reclamation plan needs to be updated and clarified pursuant to C.R.S. 34-32.5-116 (1). The current reclamation plan does not address how the exposed groundwater within the main pit will be eliminated.

The Division observed impounded water in the main pit. It is the Division's understanding the water is comprised of stormwater runoff and groundwater. According to the Operator, the depth of the water within the main pit is approximately 28 ft. A review of the permit file shows the Operator reported, through the Annual Report received on March 6, 2012, that a sump was installed into the main pit in 2011. In addition, the report states the Operator was pumping water at a rate of 81,000 gallons per day to keep the main pit dry. In

5. Impounded water within the main pit.

CORRECTIVE ACTIONS: The operator shall demonstrate the operation is in compliance with the Office of the State Engineer by providing evidence the operator has obtained a valid well permit, substitute water supply plan, or approved water augmentation plan by the corrective action date specified.

CORRECTIVE ACTIONS: The operator shall submit a Technical Revision, with the required \$216 revision fee, to update and clarify the approved reclamation plan to account for the exposure of groundwater by the corrective action date.

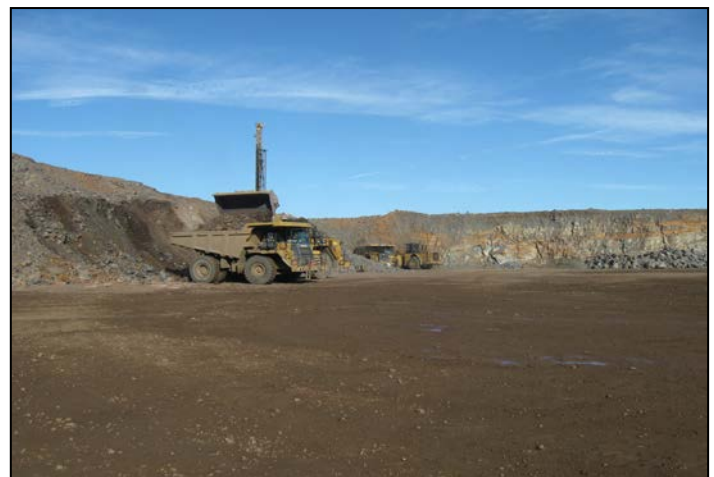
Mining is currently occurring in the southern expansion area and there were four active benches at the time of the inspection. The bench dimensions conformed to the approved bench width (35ft.) and bench height (35ft.). The Operator utilizes a 'mining from behind' method which is a technique that hides the active area of a bench until the entire bench has been mined. Mining will continue in the southern expansion area until the benches reach an elevation equal to that of the main pit. Mining has not occurred in the main pit for approximately four years. An 11 acre parcel of land located to the east of Magic Mountain Reservoir has not yet been affected by the mining operation. The Mining Plan indicates this area would be used to store excess overburden.

6. Active mining bench.
