MINERALS PROGRAM INSPECTION REPORT
PHONE: (303) 866-3567

MINE NAME: Cresson Project	MINE/PROSPECTING ID#: M-1980-244	MINERAL: Gold	COUNTY: Teller
INSPECTION TYPE: Aerial Inspection	INSPECTOR(S): Timothy A. Cazier	INSP. DATE: March 30, 2017	INSP. TIME: 11:22
OPERATOR: Cripple Creek & Victor Gold Mining Company	OPERATOR REPRESENTATIVE: N/A	TYPE OF OPERATION: 112d-3 - Designated Mining Operation	
REASON FOR INSPECTION: Normal I&E Program	BOND CALCULATION TYPE: None	BOND AMOUNT: \$207,828,54.00	
DATE OF COMPLAINT: NA	POST INSP. CONTACTS: None	JOINT INSP. AGENCY: None	
WEATHER: Clear	INSPECTOR'S SIGNATURE:

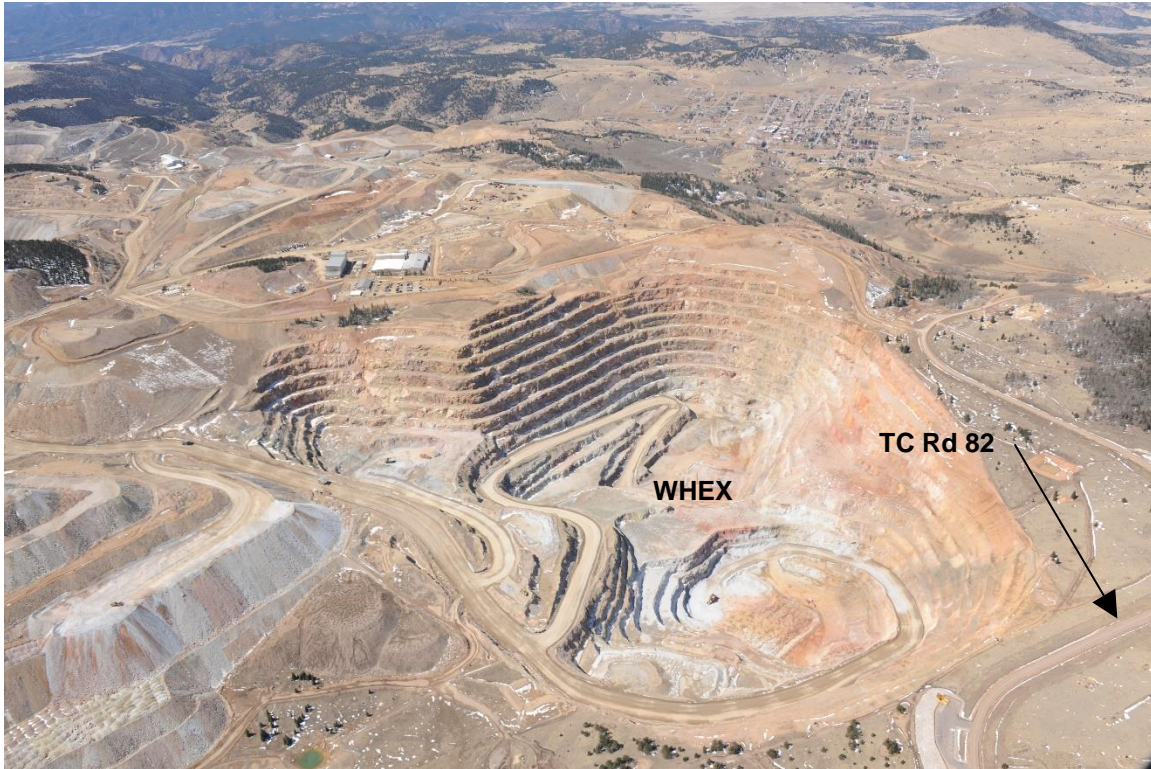
Photo 1. Wildhorse Extension Pit (Looking NW).

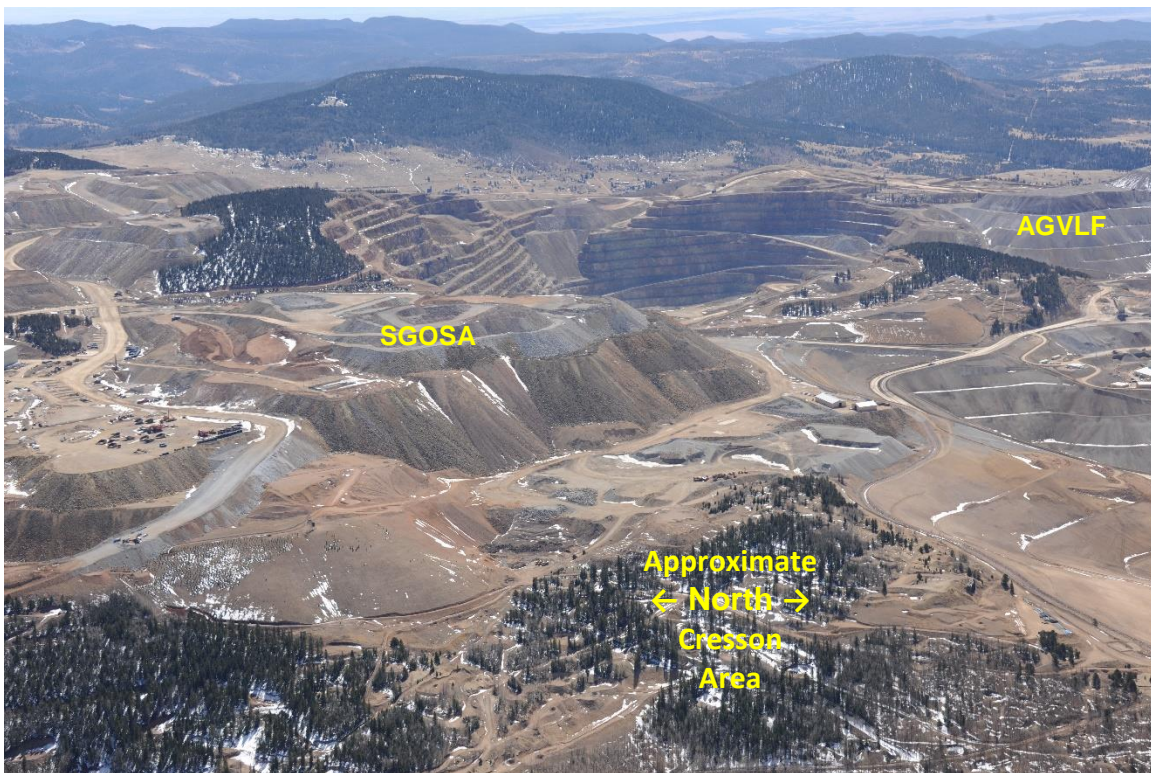
Photo 2. North Cresson (future) / Squaw Gulch Area (Looking south).

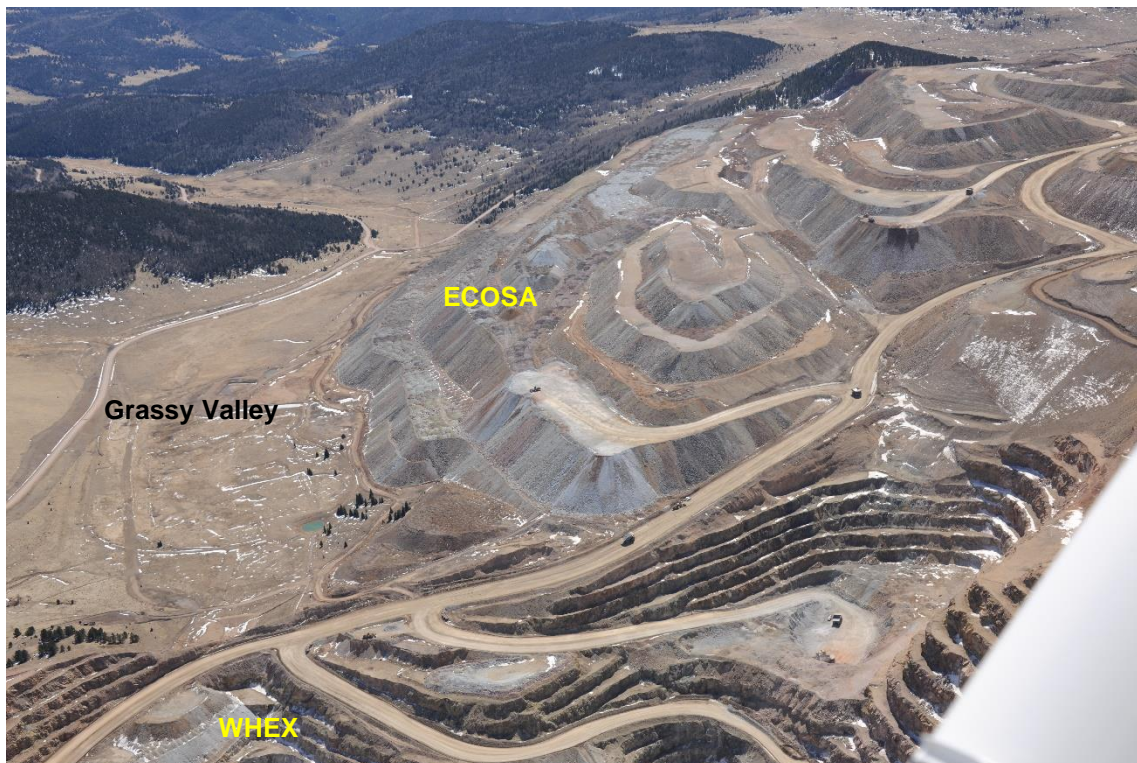
Photo 3. East Cresson OSA (looking SE).

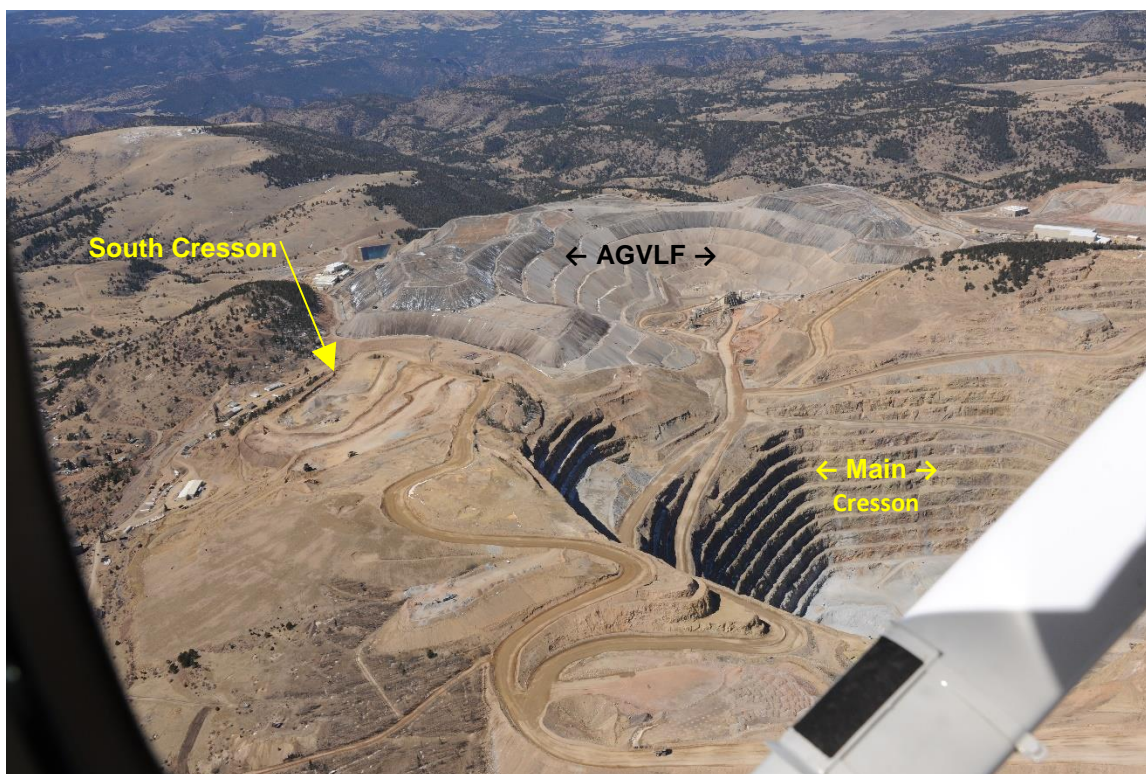
Photo 4. South Cresson (looking SW).

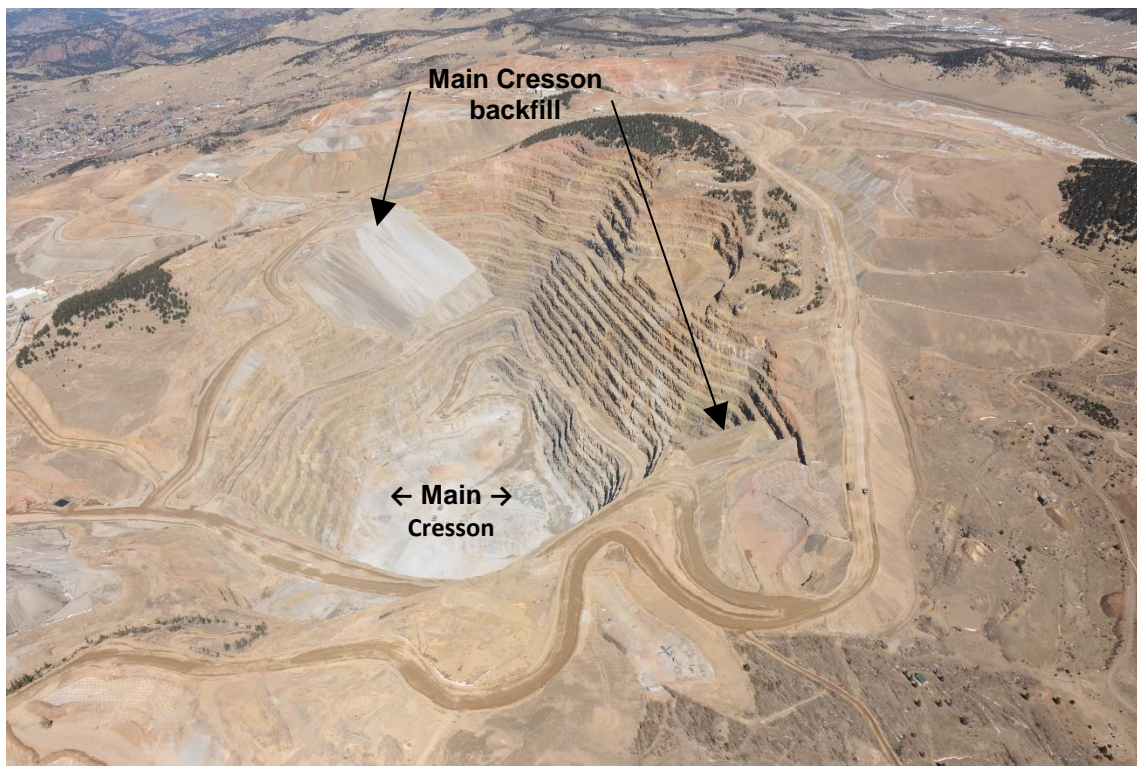
Photo 5. Main Cresson Pit (looking north).

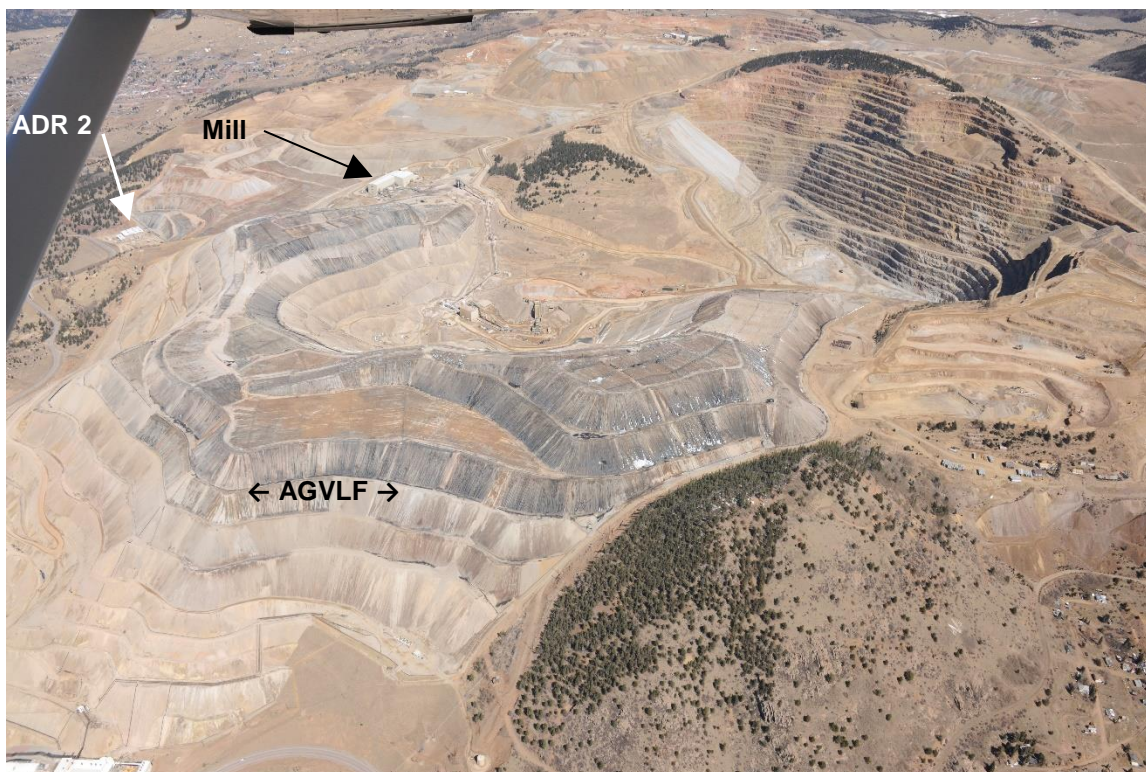
Photo 6. Arequa Gulch VLF (looking north).

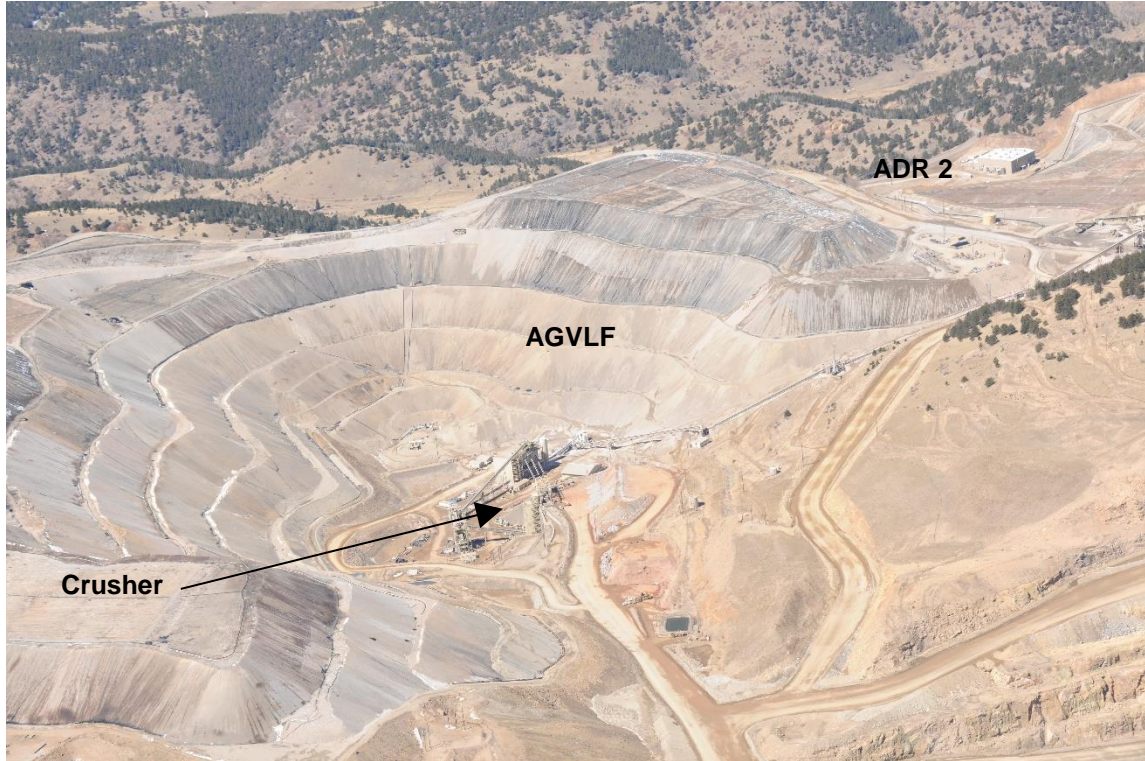
Photo 7. Arequa Gulch VLF (looking NW).

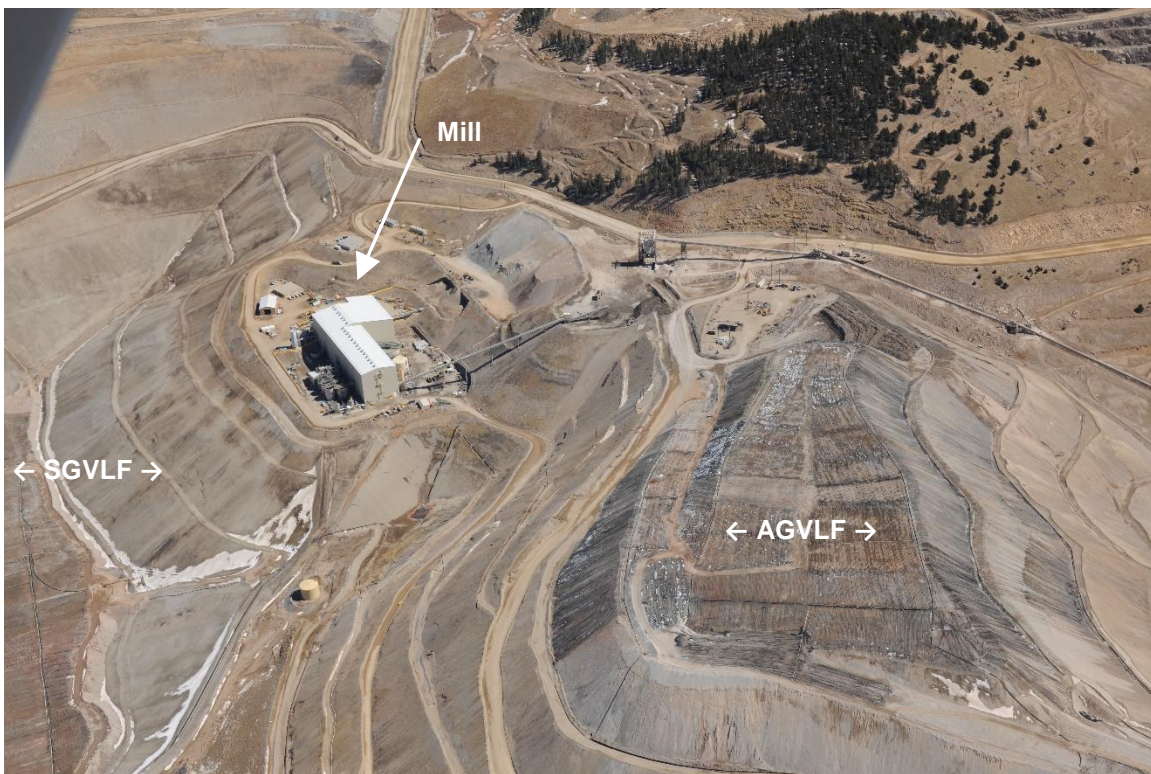
Photo 8. Mill building between SGVLF & AGVLF (Looking NE).

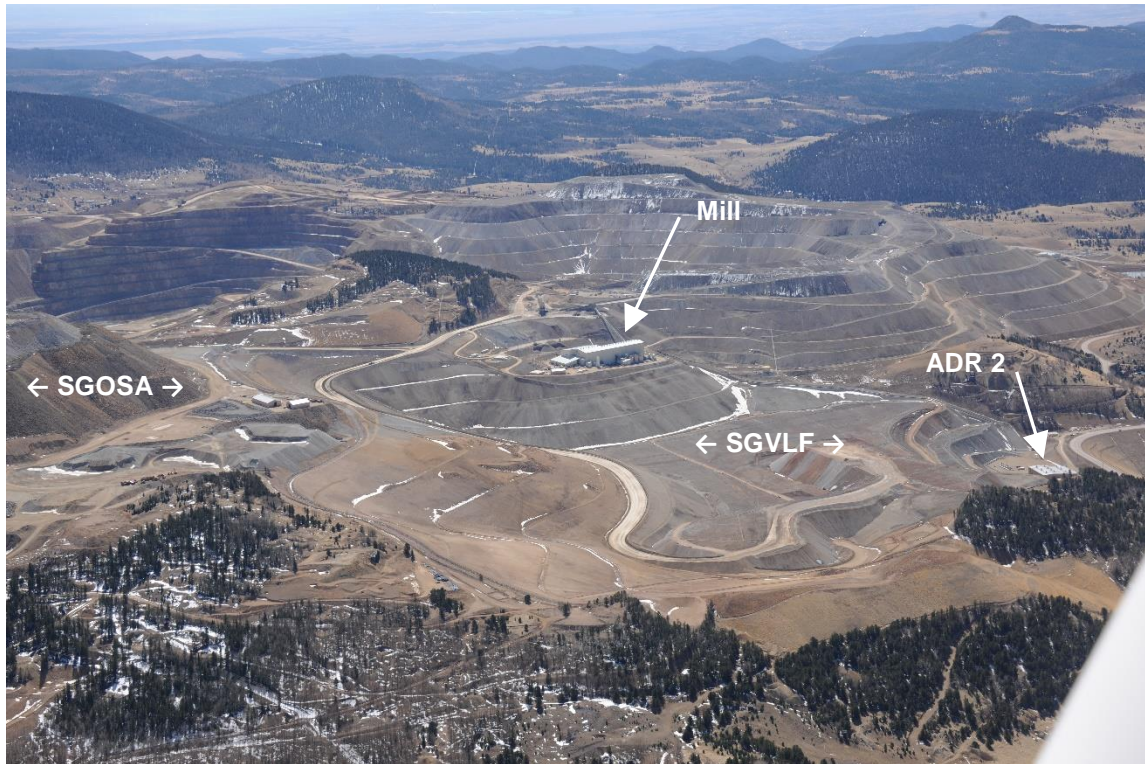
Photo 9. Squaw Gulch VLF (Looking SE).

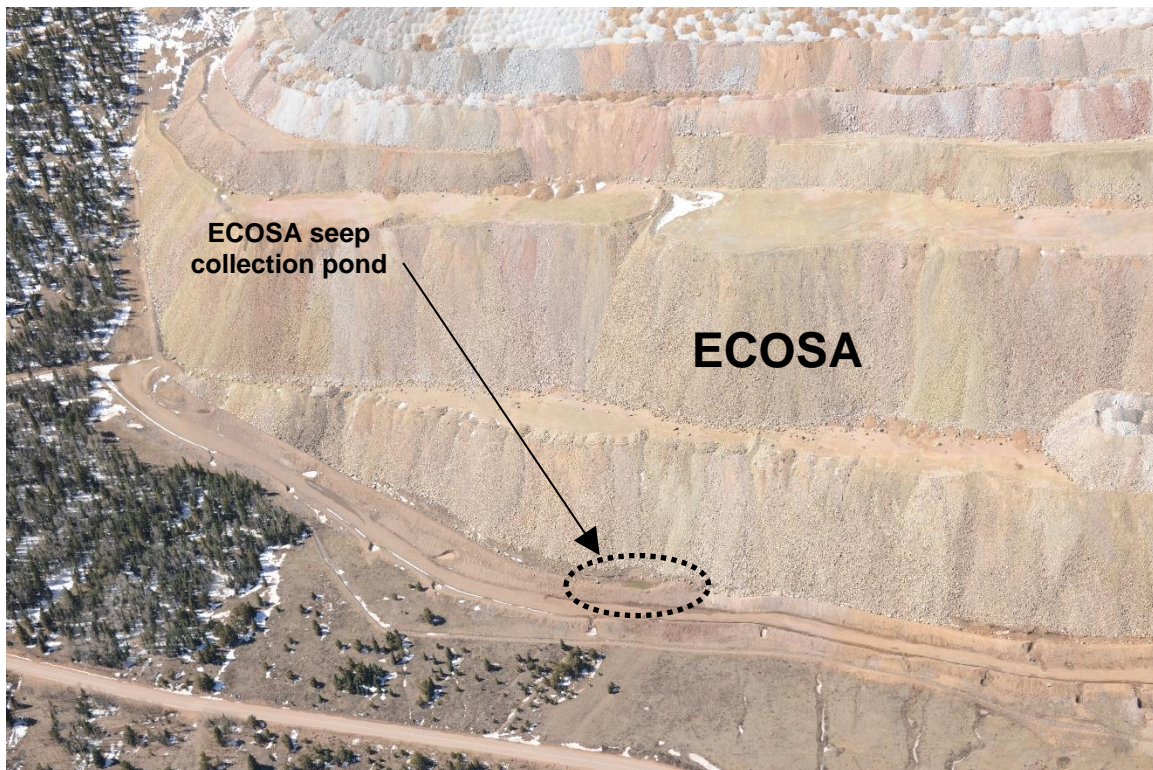
Photo 10. ECOSA – note water in seep collection pond (SE Toe, looking west).
