MINERALS PROGRAM INSPECTION REPORT
PHONE: (303) 866-3567

MINE NAME: Cresson Project	MINE/PROSPECTING ID#: M-1980-244	MINERAL: Gold	COUNTY: Teller
INSPECTION TYPE: Aerial Inspection	INSPECTOR(S): Timothy A. Cazier	INSP. DATE: January 17, 2017	INSP. TIME: 16:35
OPERATOR: Cripple Creek & Victor Gold Mining Company	OPERATOR REPRESENTATIVE: N/A	TYPE OF OPERATION: 112d-3 - Designated Mining Operation	
REASON FOR INSPECTION: Normal I&E Program	BOND CALCULATION TYPE: None	BOND AMOUNT: \$207,828,540.00	
DATE OF COMPLAINT: NA	POST INSP. CONTACTS: None	JOINT INSP. AGENCY: None	
WEATHER: Clear	INSPECTOR'S SIGNATURE:

This was an aerial photo inspection of the Cresson Project conducted by Tim Cazier of the Colorado Division of Reclamation, Mining and Safety (Division) based on aerial photographs taken by the Division. No operator was present during the inspection. The site is a 112d-3 gold mine located between Cripple Creek and Victor in Teller County.

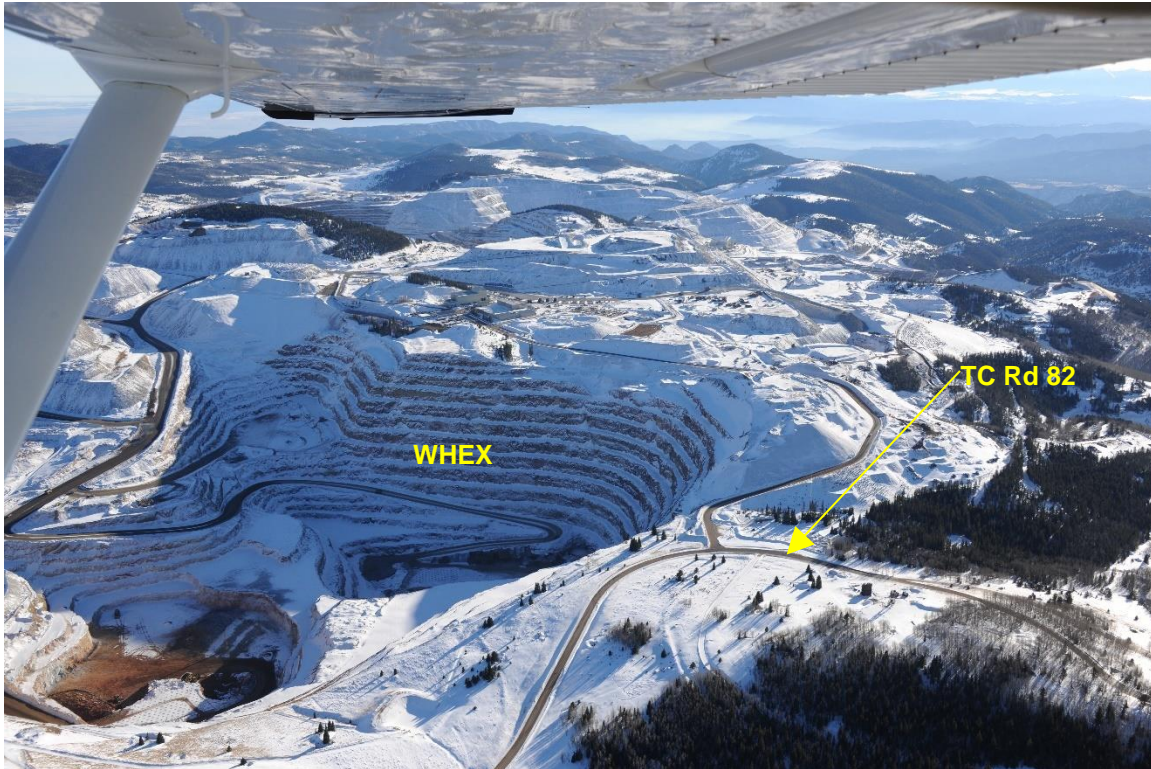
Photo 1. Wildhorse Extension Pit (Looking south).

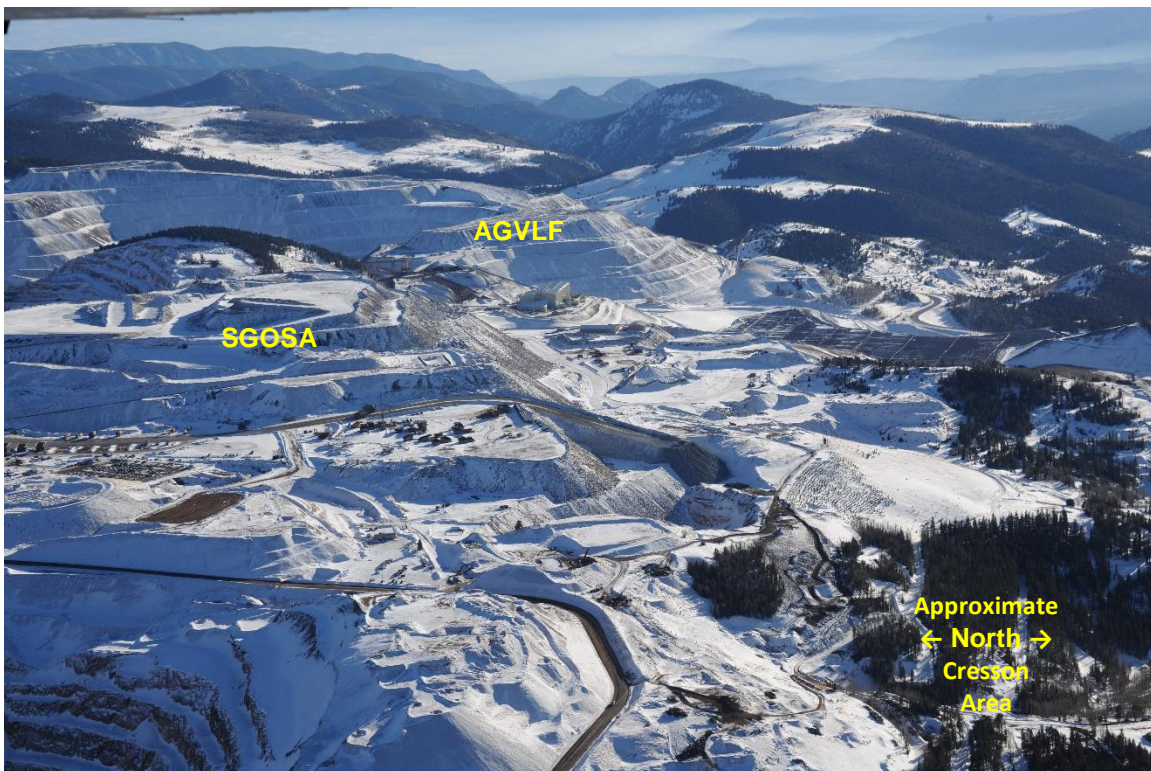
Photo 2. North Cresson (future) / Squaw Gulch Area (Looking south).

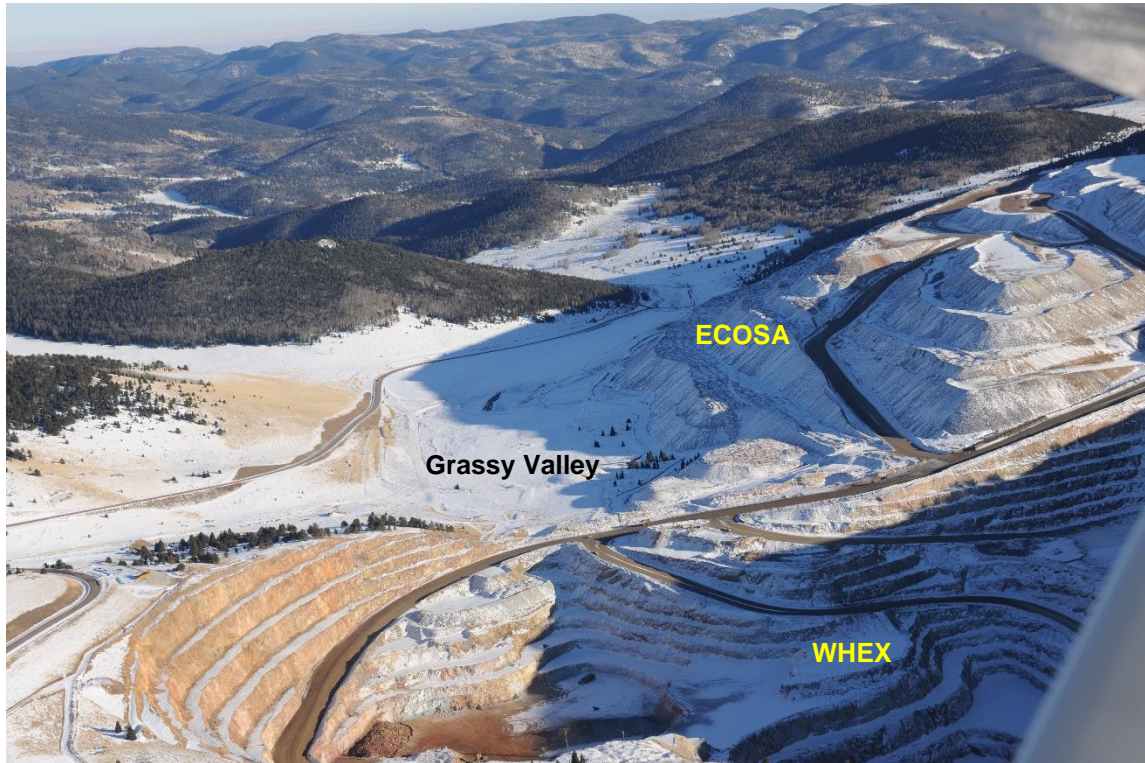
Photo 3. East Cresson OSA (looking SE).

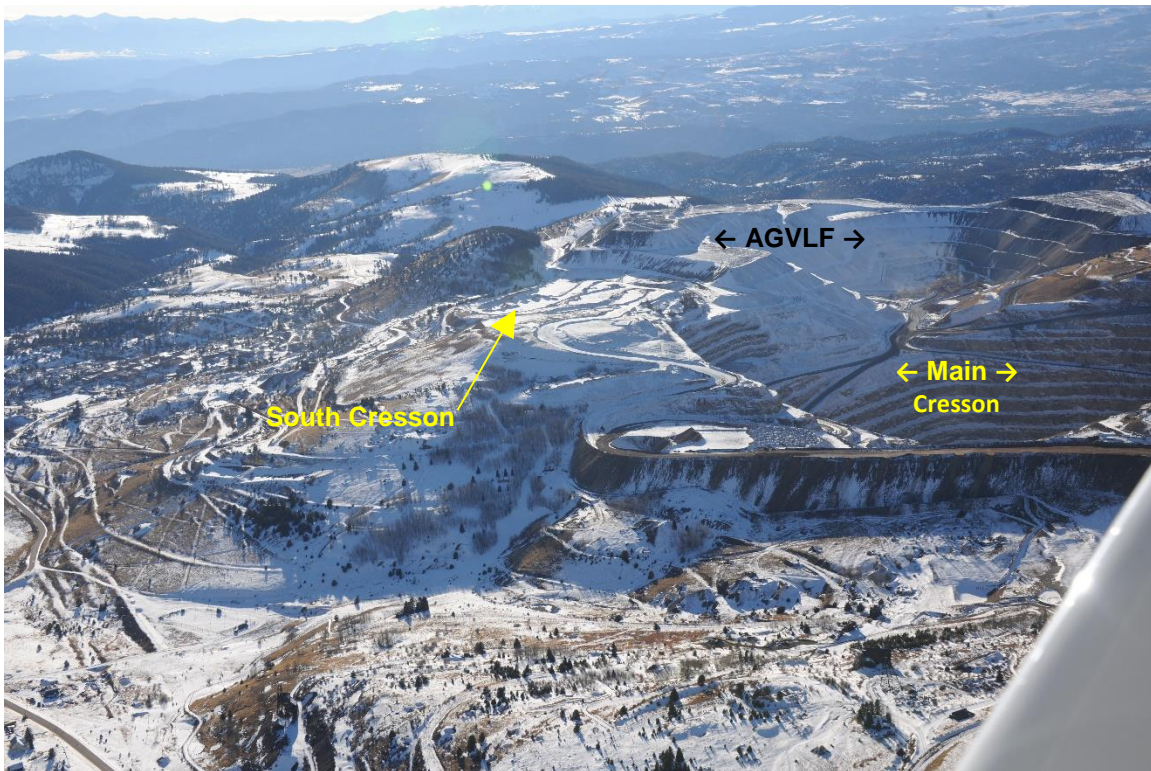
Photo 4. South Cresson (looking SW).

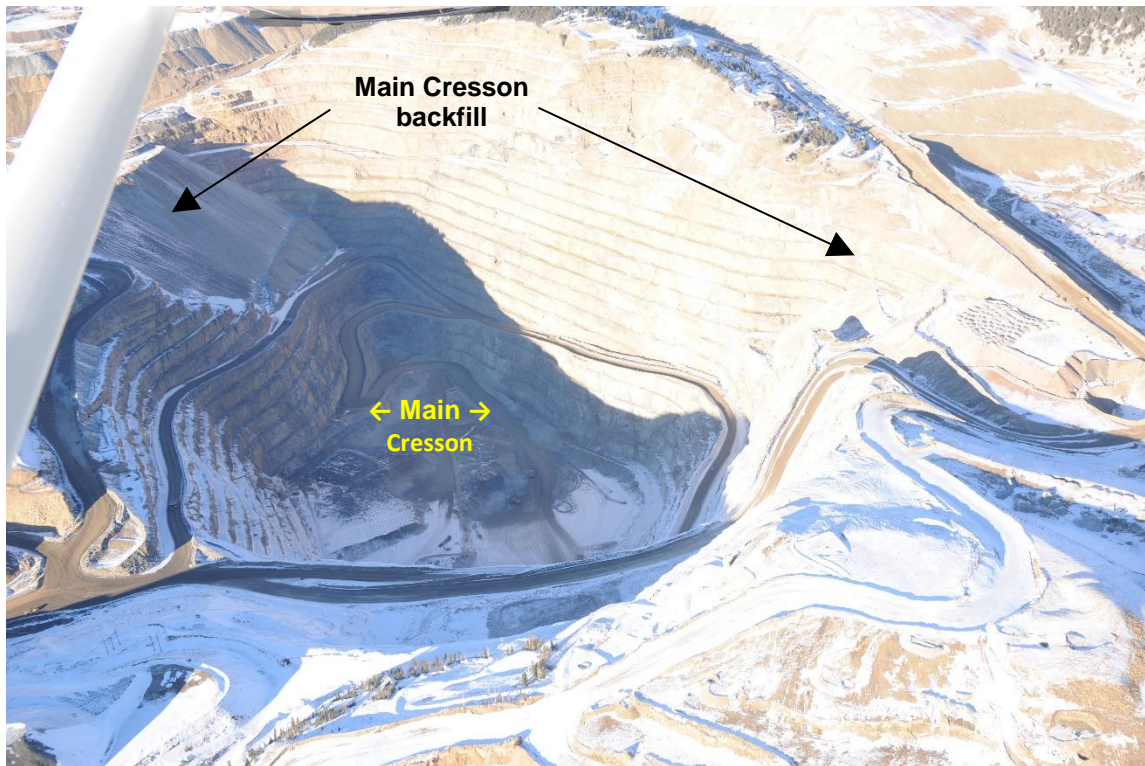
Photo 5. Main Cresson Pit (looking north).

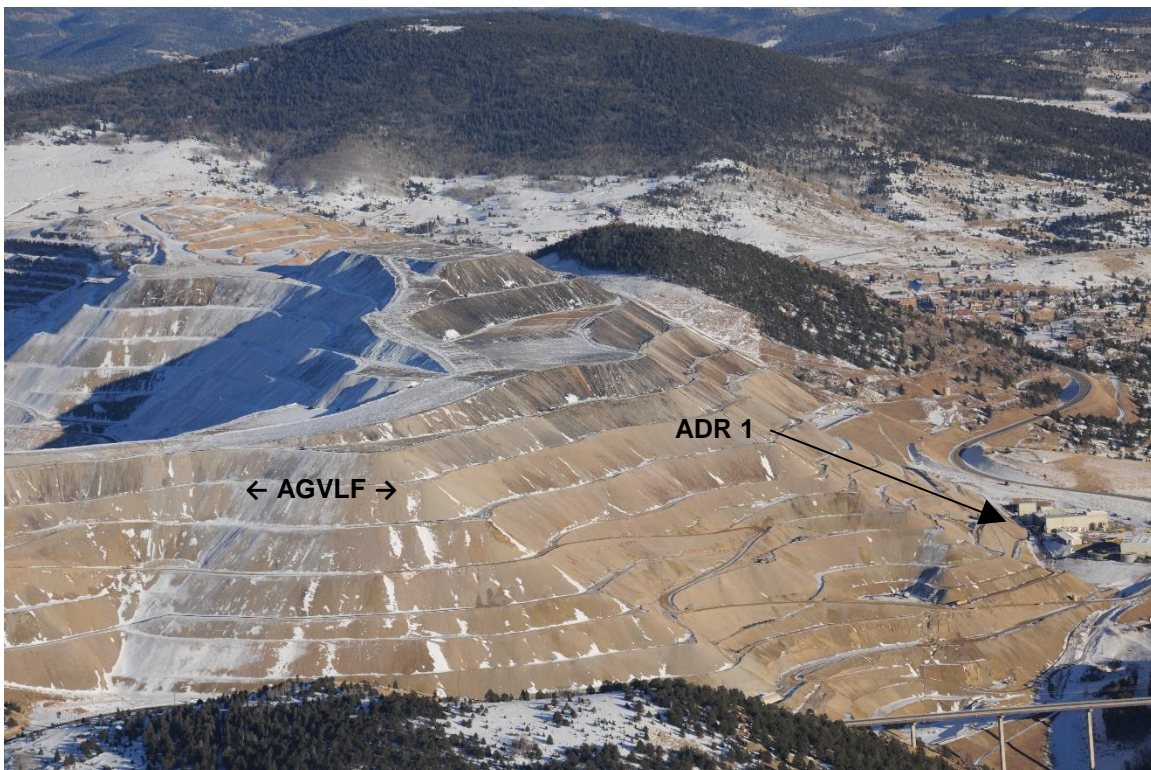
Photo 6. Arequa Gulch VLF (looking SE).

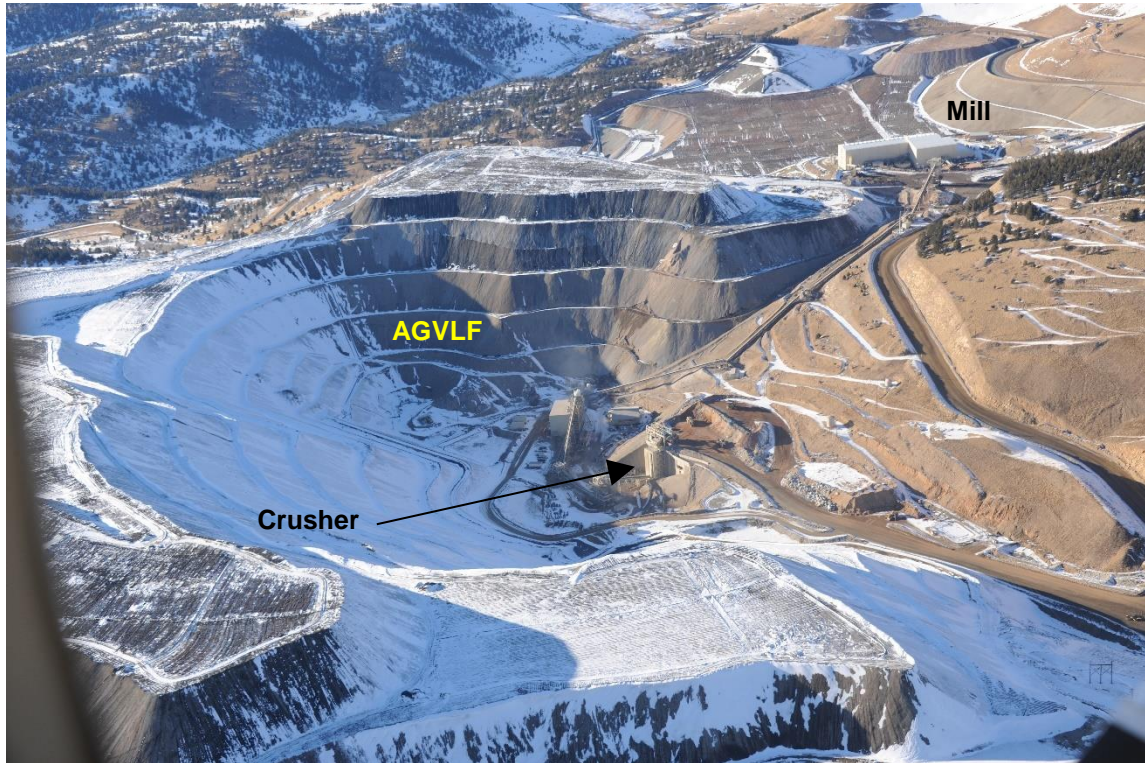
Photo 7. Arequa Gulch VLF (looking NW).

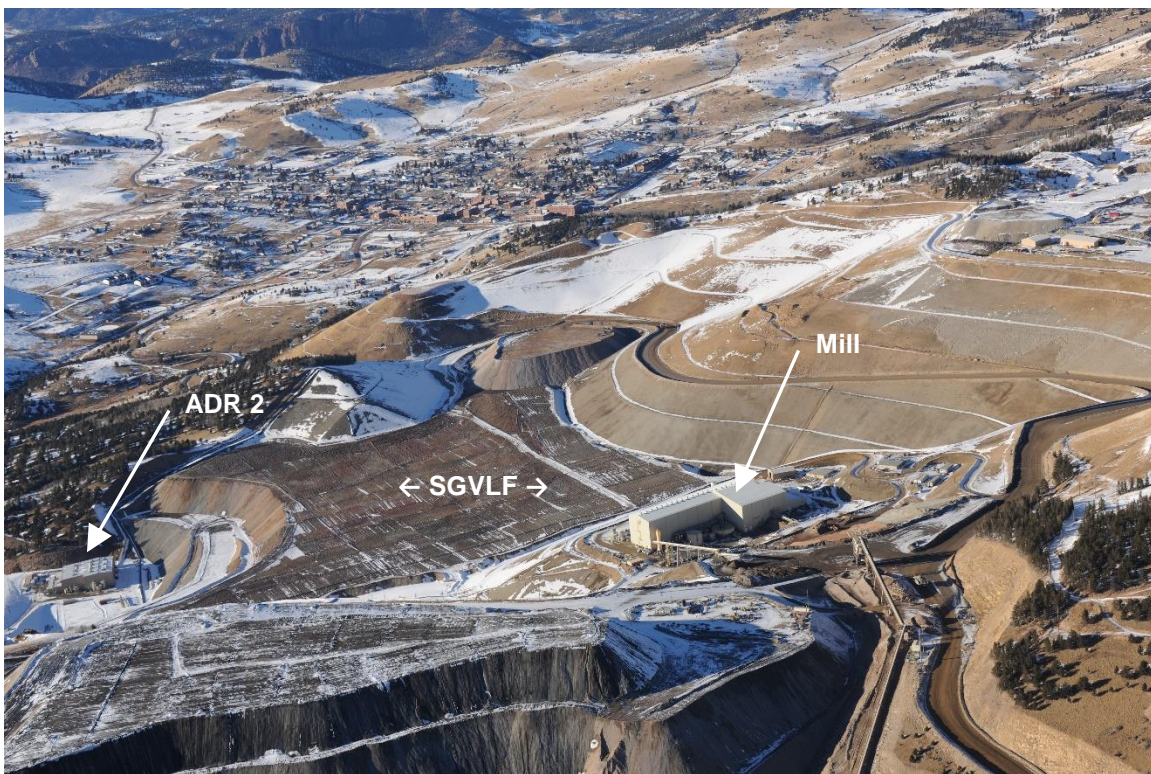
Photo 8. Squaw Gulch VLF (Looking NW).

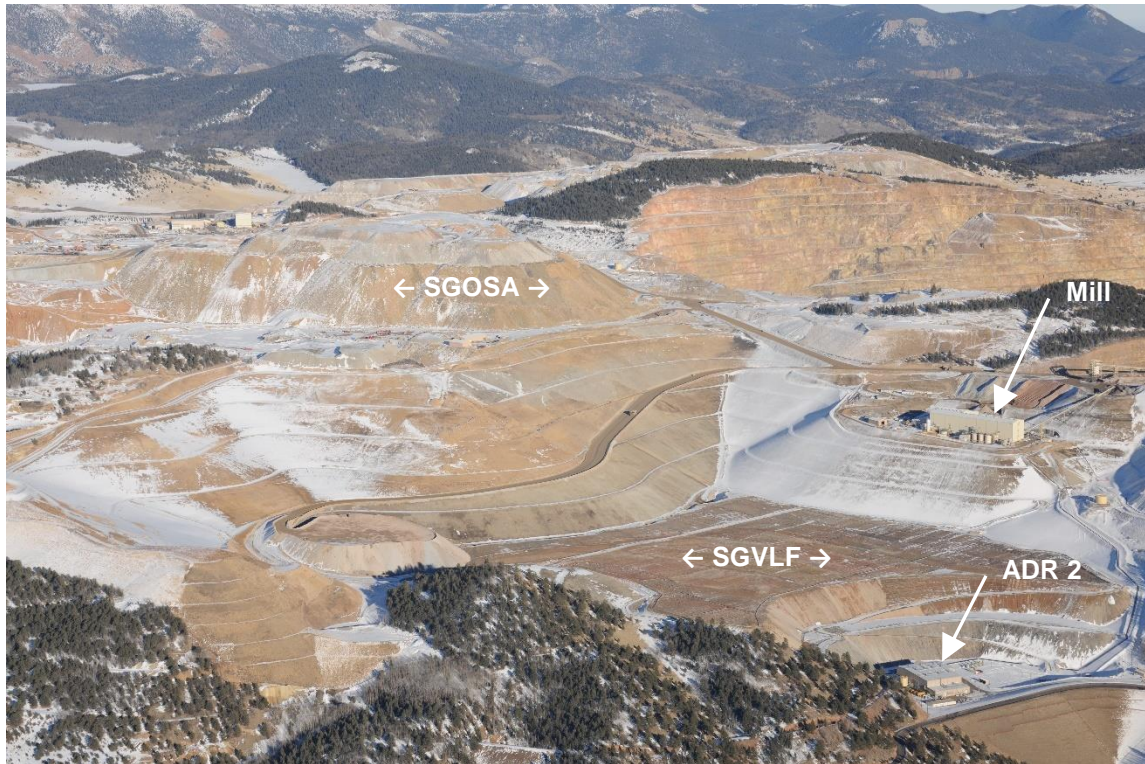
Photo 9. Squaw Gulch VLF (Looking east).

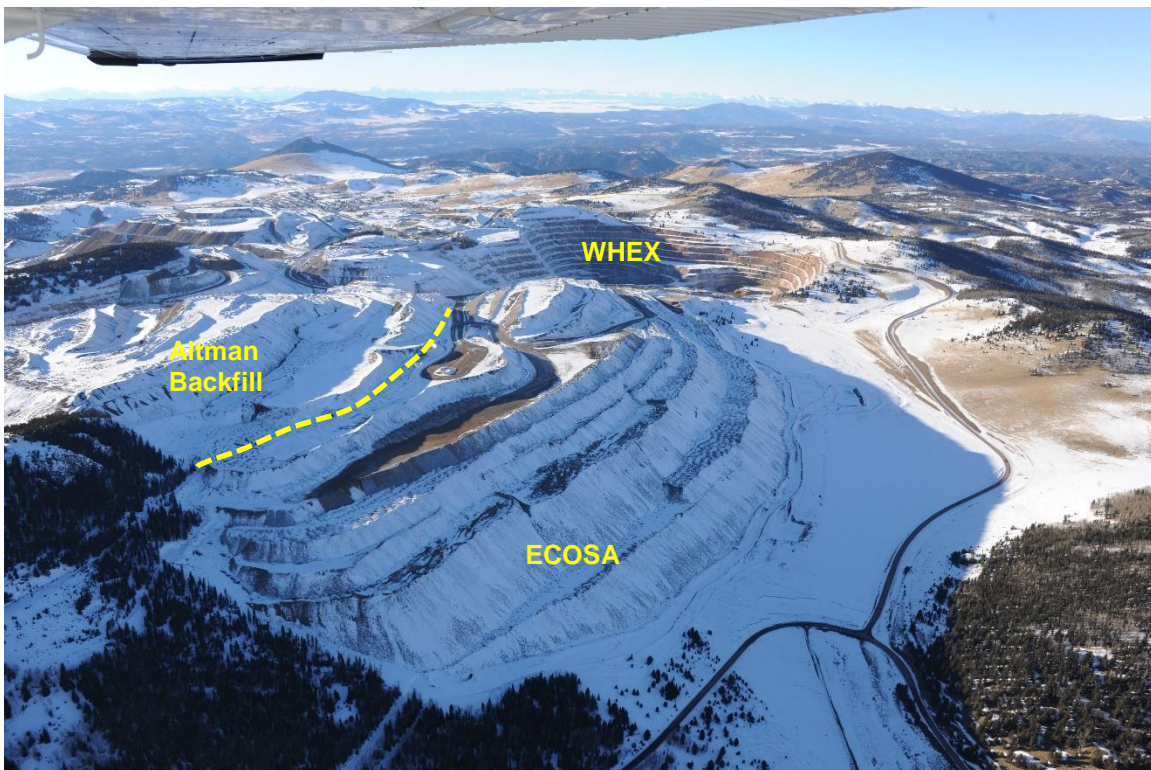
Photo 10. ECOSA, WHEX, & Altman Backfill (looking NW).
