**COLORADO**  
Division of Reclamation,  
Mining and Safety  
Department of Natural Resources

<b>Permit Number:</b> C-1981-008 <b>Mine Name:</b> New Horizon Mine <b>Operator:</b> Elk Ridge Mining and Reclamation, LLC <b>Operator Address:</b> Mr. Tony Tennyson 5731 State Highway 13 Meeker, CO 81641	<b>County:</b> Montrose <b>Operation Type:</b> Surface <b>Permit Status:</b> Active <b>Ownership:</b> Private
	<b>Operator Representative Present:</b>  Frank Ferris
<b>Operator Representative Signature: (Field Issuance Only)</b>

<b>Inspection Start Date:</b> January 9, 2018 <b>Inspection Start Time:</b> 09:00 <b>Inspection End Date:</b> January 9, 2018 <b>Inspection End Time:</b> 13:00		<b>Inspection Type:</b> Coal Partial Inspection <b>Inspection Reason:</b> Normal I&E Program <b>Weather:</b> Foggy	
<b>Joint Inspection Agency:</b>  None		<b>Joint Inspection Contacts:</b>  	
<b>Post Inspection Agency:</b>  None		<b>Post Inspection Contacts:</b>  	
<b>Inspector(s):</b>  Brock F. Bowles	<b>Inspector's Signature:</b>

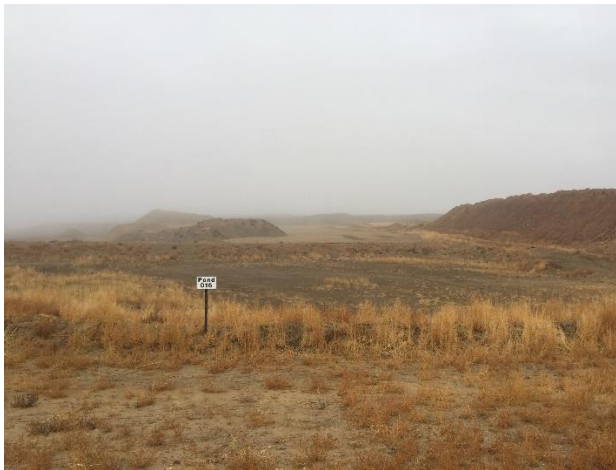
Photo 1 – Pond 16

Ponds 9, 16 (photo 1) and 18 did not contain water.

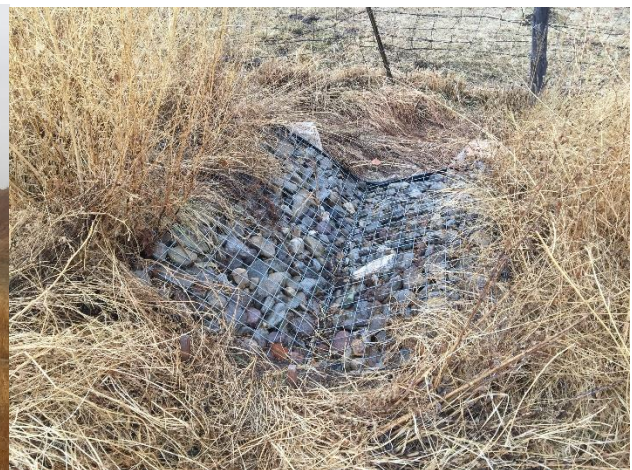
Photo 2 – Sediment Control Structure

The sediment control structure on the northwest corner of the Morgan property was stable and in good condition (photo 2).

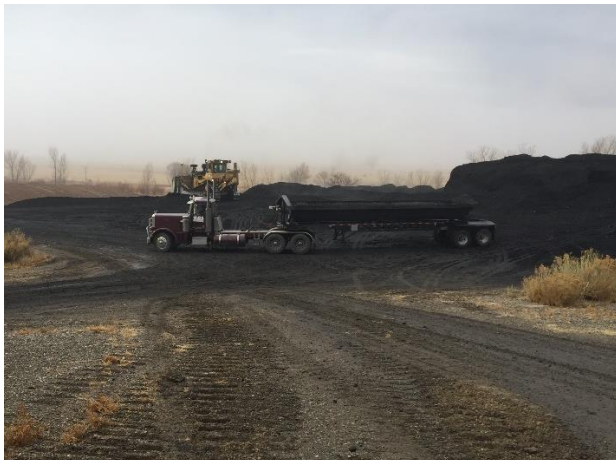
Photo 3 – Coal Being Stockpiled

Haul trucks were moving the coal stockpile from the New Horizon North Mine to the New Horizon Mine. A bulldozer was moving the coal on the pile (photo 3). No dust was seen during this inspection, but it must be noted that the conditions were foggy and damp.

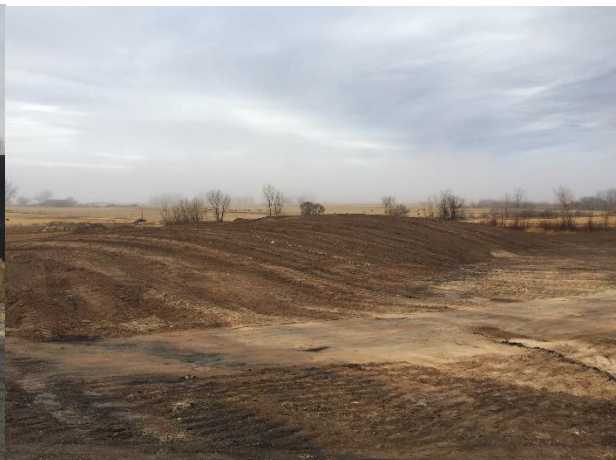
Photo 4 – Topsoil Salvaged Ahead of Coal Pile

The stockpile was positioned west of the maintenance building in the facilities area, within the sediment control boundary. As more coal is being brought in, the footprint is moving south towards Pond 18. The topsoil is being salvaged and will be managed according to the permit (photo 4). A section of the area where the coal stockpile is being placed received Phase I bond release in SL-18. When the pile is in its final configuration, the Phase I bond release acres will be adjusted to reflect the changes.
