Permit Number: C-2010-089

Mine Name: New Horizon North Mine

January 17, 2018

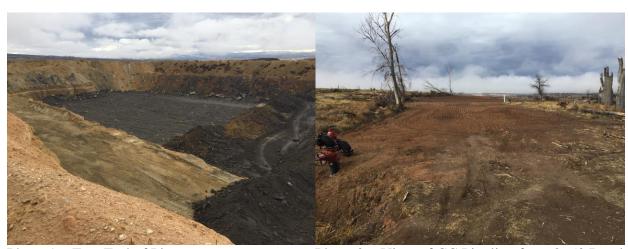
The east end of the pit remains open. It will be used to dispose the coal waste from the bottom of the coal stockpile once the pile has been moved to NH2 (photo 1).

The CC Ditch pipeline is now completely installed to its final configuration. The pipeline is backfilled from the 2650 Road across (photo 2) the permit area to the 2600 Road but is not completely topsoiled yet. The spur line off the main pipeline to the center pivot has been installed, backfilled and topsoiled.

Photo 1 – East End of Pit

Photo 2 – View of CC Pipeline from 2650 Road

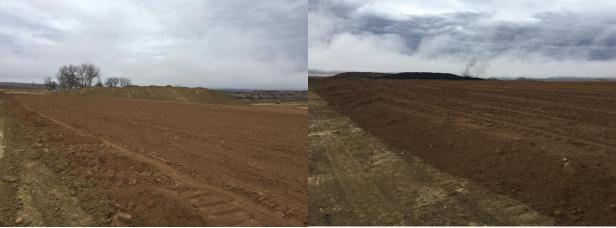
Topsoil had been spread on the west side of the pit (photo 3). The area around pond 2 has not been topsoiled.

Topsoil was spread on the area east of the open pit, north of the coal stockpile (photo 4).

Photo 3 – West Pit Area

Photo 4 – East Pit Area
