MINERALS PROGRAM INSPECTION REPORT PHONE: (303) 866-3567

MINE NAME:		MINE/PROSPECTING ID#:	MINERAL:	COUNTY:		
Harmony Windsor Site		M-2017-056	Sand and gravel	Weld		
INSPECTION TYPE:		INSPECTOR(S):	INSP. DATE:	INSP. TIME:		
Preoperation Inspection		Peter S. Hays	January 17, 2018	09:00		
OPERATOR:		OPERATOR REPRESENTATIVE:	TYPE OF OPERATION:			
Serfer Land Ventures, LLC.		Kevin Anderson, Bill Schenderlein	110c - Construction Limited Impact			
REASON FOR INSPECTION:		BOND CALCULATION TYPE:	BOND AMOUNT:			
Pre-Operation Inspection		IT.Bondcalculationtype.CD.Desc	No Bond Held			
DATE OF COMPLAINT:		POST INSP. CONTACTS:	JOINT INSP. AGENCY:			
NA		None	None			
WEATHER:	INSPECTOR'S SIGNATURE:		SIGNATURE DAT	E:		
Clear	$\Omega_1 = I$		January 18, 2018			
	1/49/					
	D	16/mg

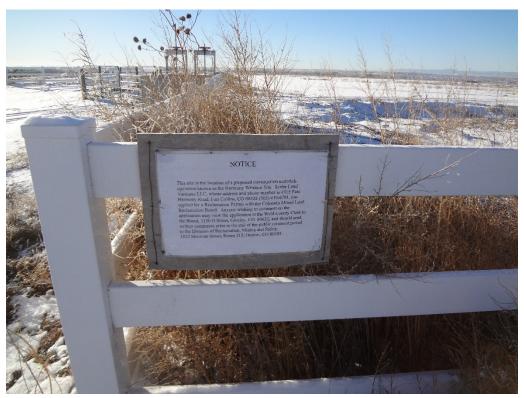
An entrance sign was not posted as required by Rule 3.1.12. The permit boundary were observed as required by Rule 3.1.12 and mining limit markers were installed. The Applicant was aware of the requirement to post a sign prior to starting the mining operation. All permanent man-made structures within 200 feet of the proposed affected area appear to have been identified by the Applicant. The required notice sign was posted at the site entrance from WCR 74.

Notice sign at entrance off of WCR 74

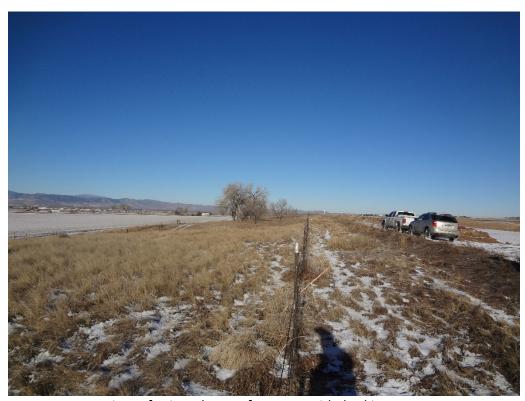
View of Mine Phase 1 from east side looking west

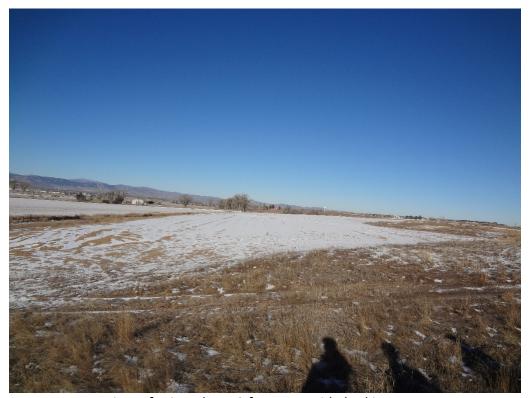
The site vegetation consisted of intermediate wheatgrass and other wheatgrass varieties. The southern portion of Mine Phase 2 and the northern portion of Mine Phase 3 consisted of non-vegetated fill material placed by the landowner of level the areas.

View of Mine Phase 2 from east side looking west

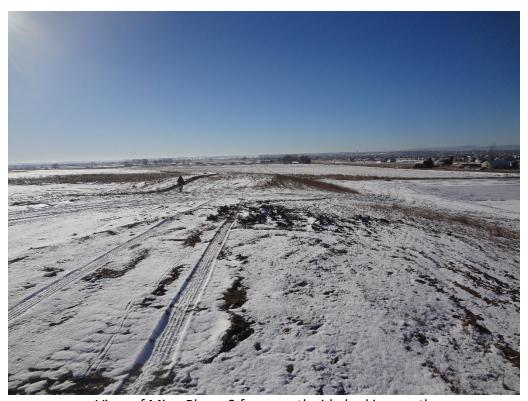
View of Mine Phase 3 from north side looking south
