**MINERALS PROGRAM INSPECTION REPORT**  
**PHONE: (303) 866-3567**

<b>MINE NAME:</b> Cresson Project	<b>MINE/PROSPECTING ID#:</b> M-1980-244	<b>MINERAL:</b> Gold	<b>COUNTY:</b> Teller
<b>INSPECTION TYPE:</b> Aerial Inspection	<b>INSPECTOR(S):</b> Timothy A. Cazier	<b>INSP. DATE:</b> January 16, 2018	<b>INSP. TIME:</b> 15:20
<b>OPERATOR:</b> Cripple Creek & Victor Gold Mining Company	<b>OPERATOR REPRESENTATIVE:</b> N/A	<b>TYPE OF OPERATION:</b> 112d-3 - Designated Mining Operation	
<b>REASON FOR INSPECTION:</b> Normal I&E Program	<b>BOND CALCULATION TYPE:</b> None	<b>BOND AMOUNT:</b> \$207,828,54.00	
<b>DATE OF COMPLAINT:</b> NA	<b>POST INSP. CONTACTS:</b> None	<b>JOINT INSP. AGENCY:</b> None	
<b>WEATHER:</b> Clear	<b>INSPECTOR'S SIGNATURE:</b>

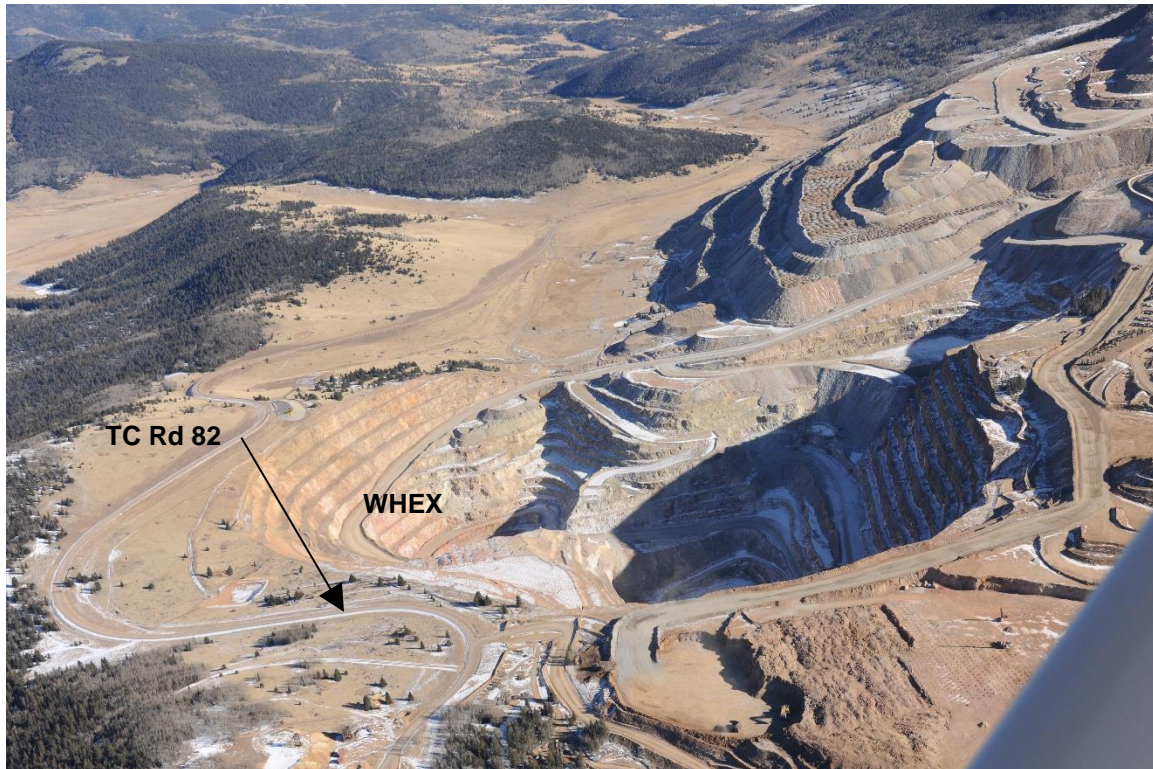
Photo 1. Wildhorse Extension Pit (Looking SE).

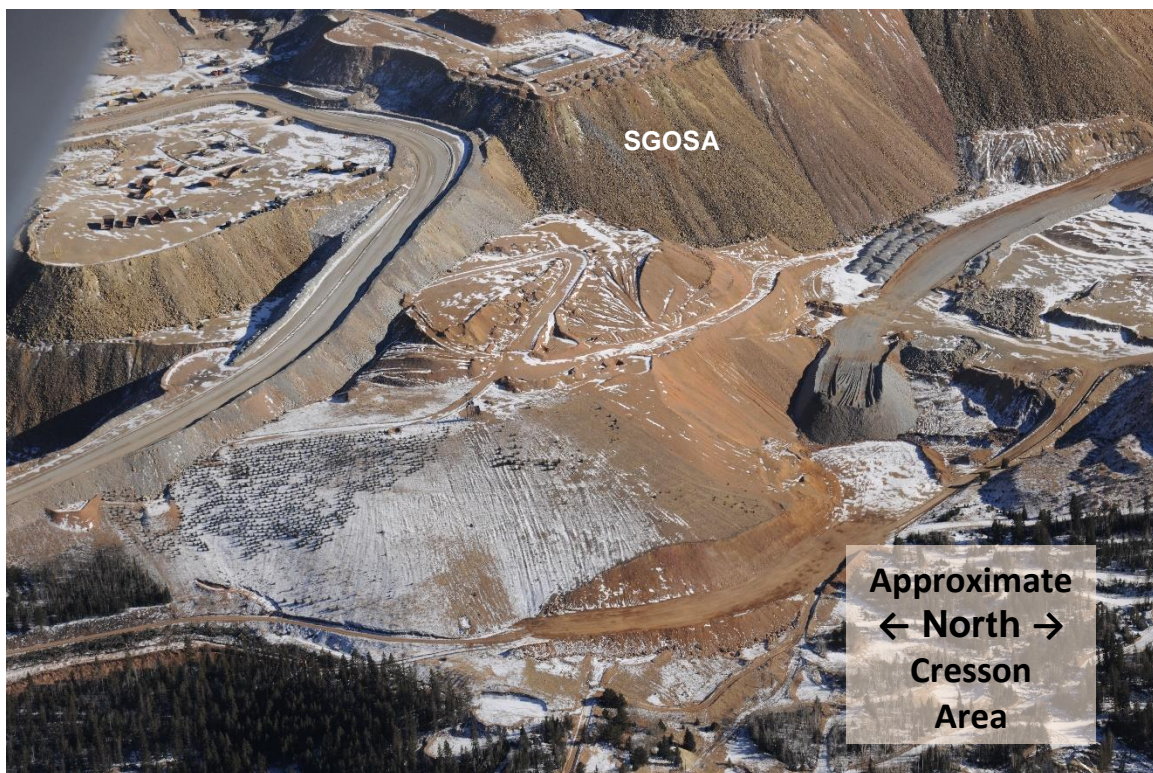
Photo 2. North Cresson (future, Looking SE).

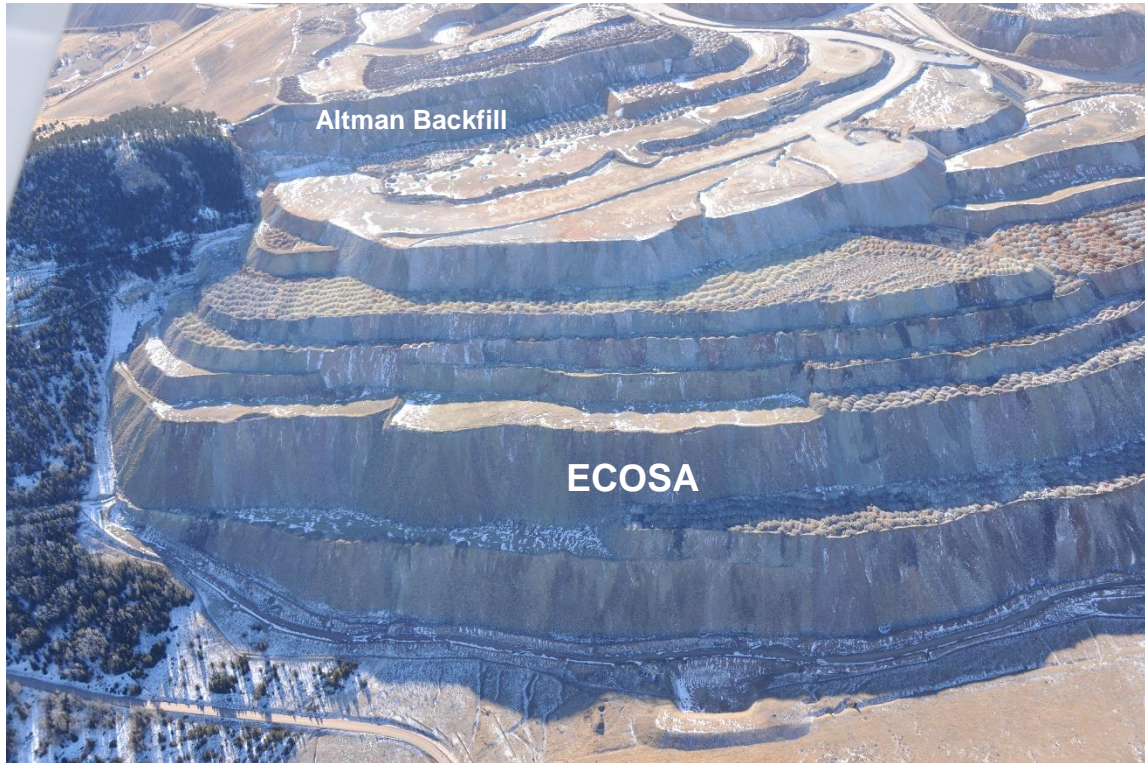
Photo 3. East Cresson OSA (looking west).

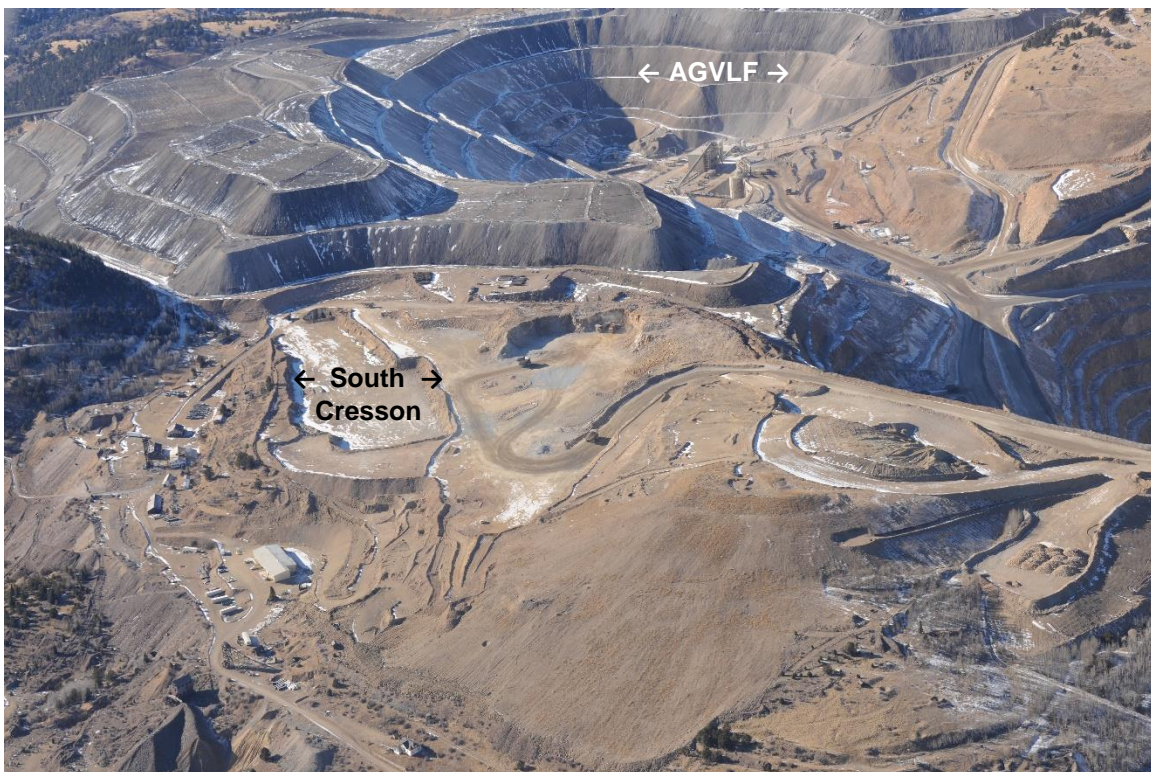
Photo 4. South Cresson (looking west).

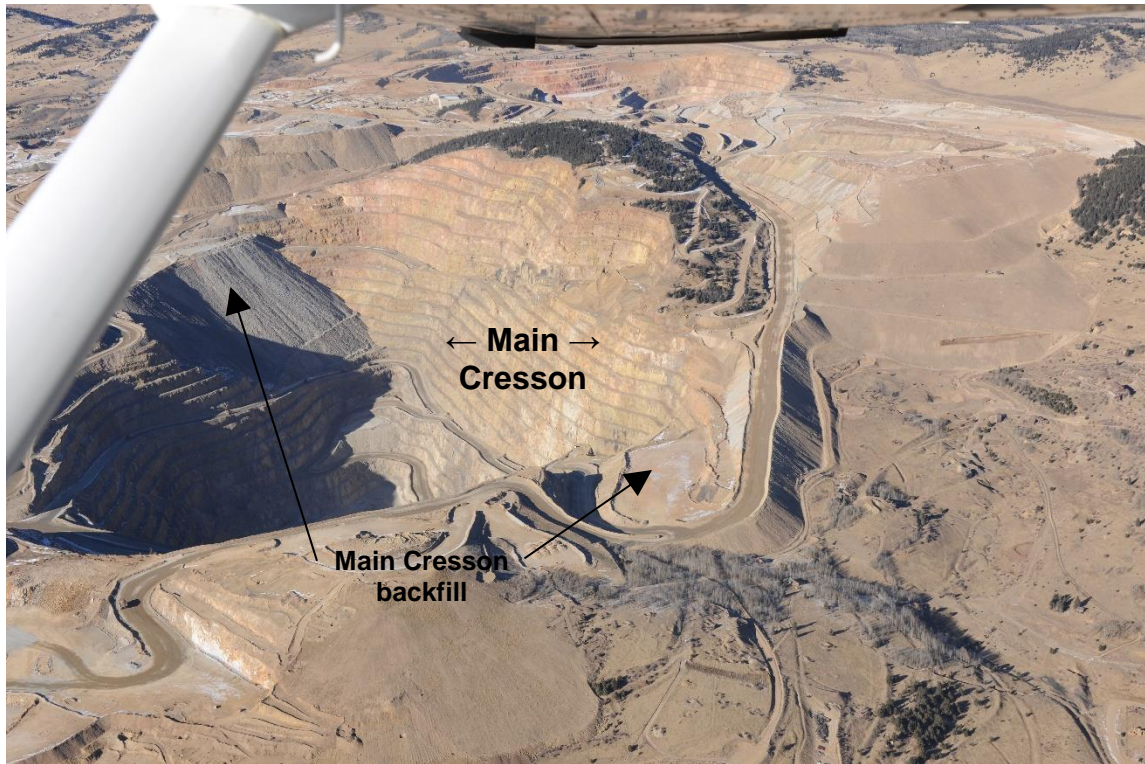
Photo 5. Main Cresson Pit (looking NW).

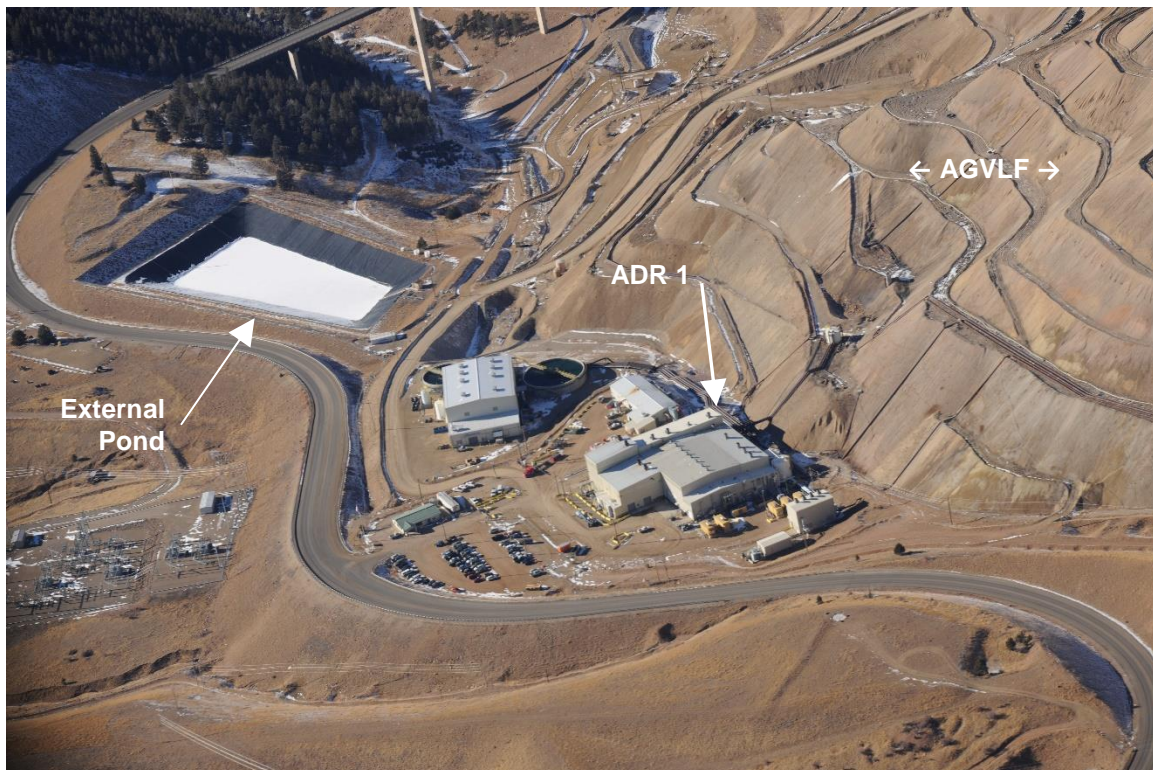
Photo 6. ADR 1 (looking west).

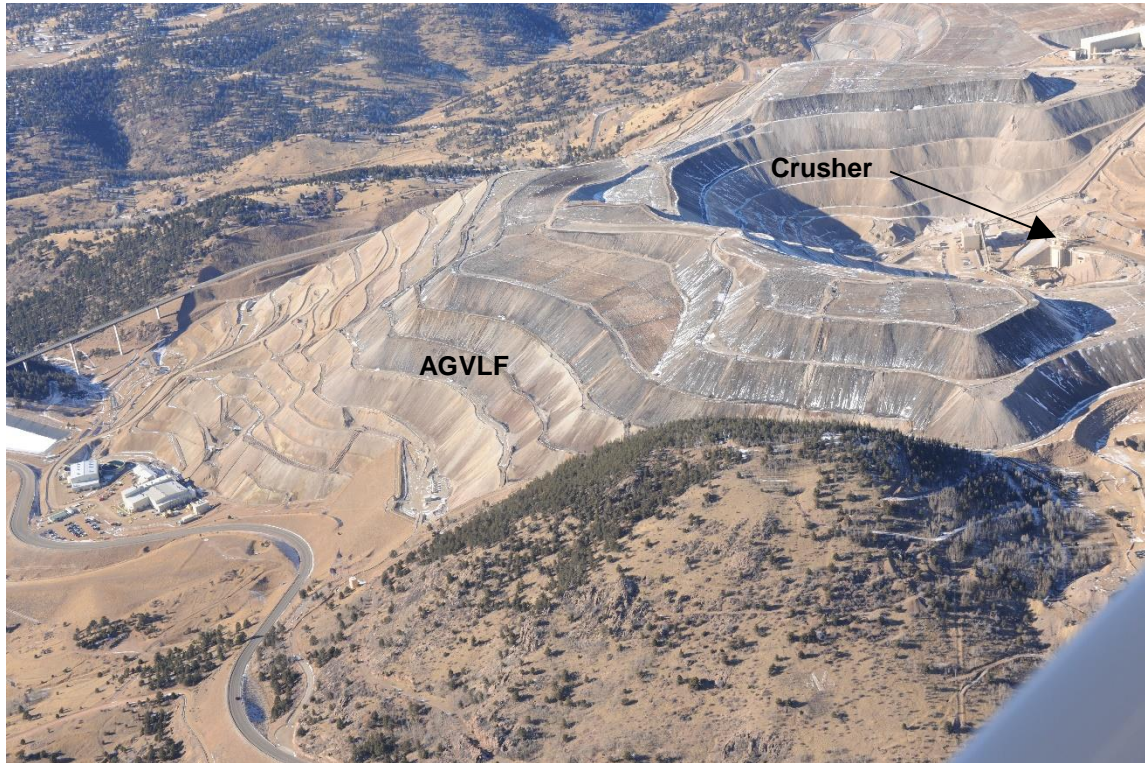
Photo 7. Arequa Gulch VLF (looking NW).

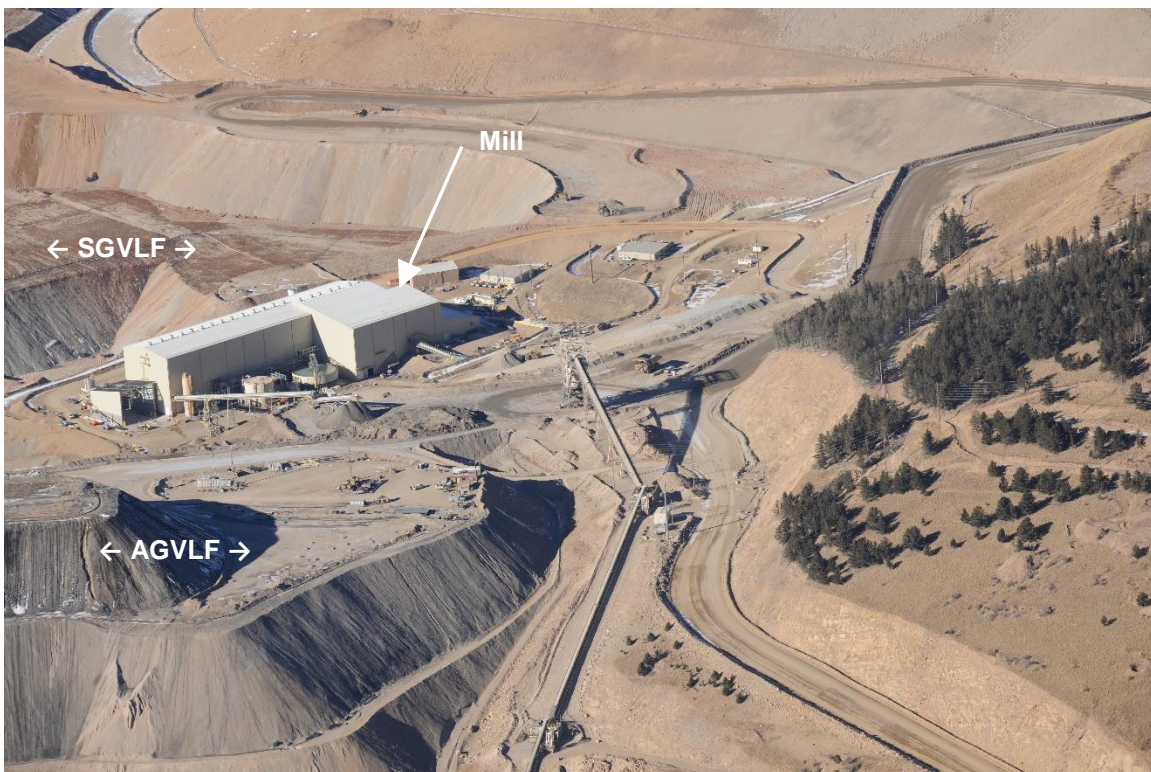
Photo 8. Mill building between SGVLF & AGVLF (Looking NW).

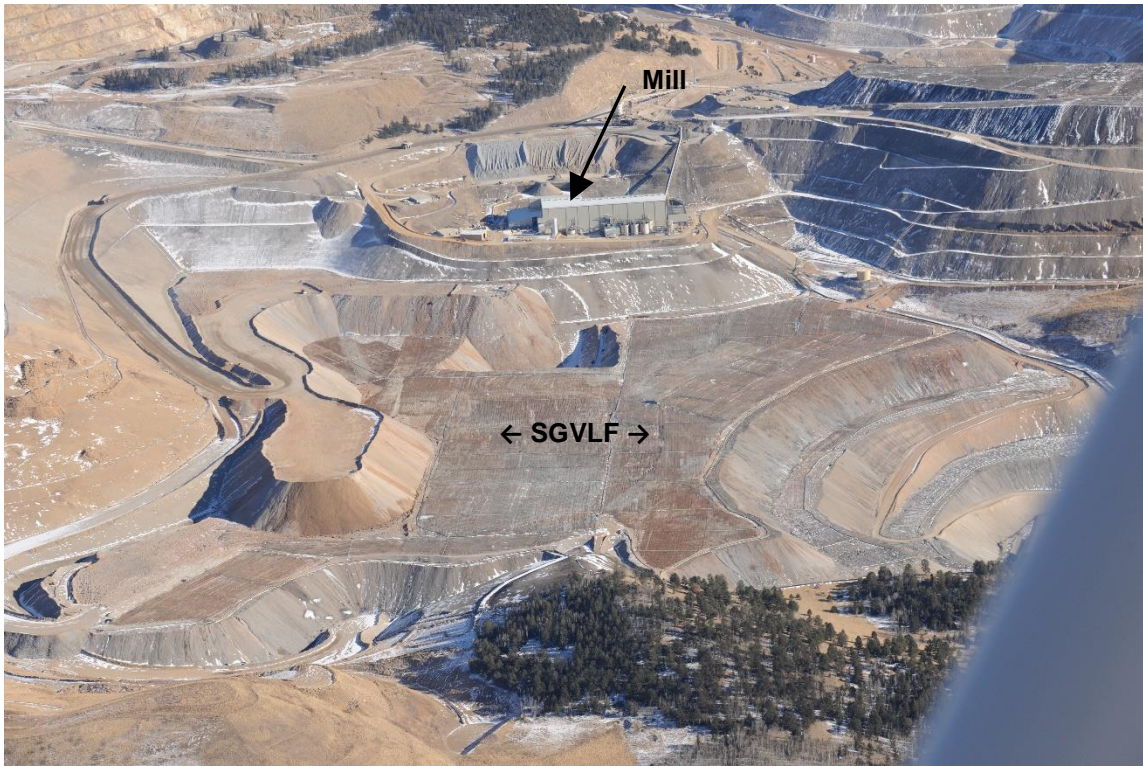
Photo 9. Squaw Gulch VLF (Looking SE).

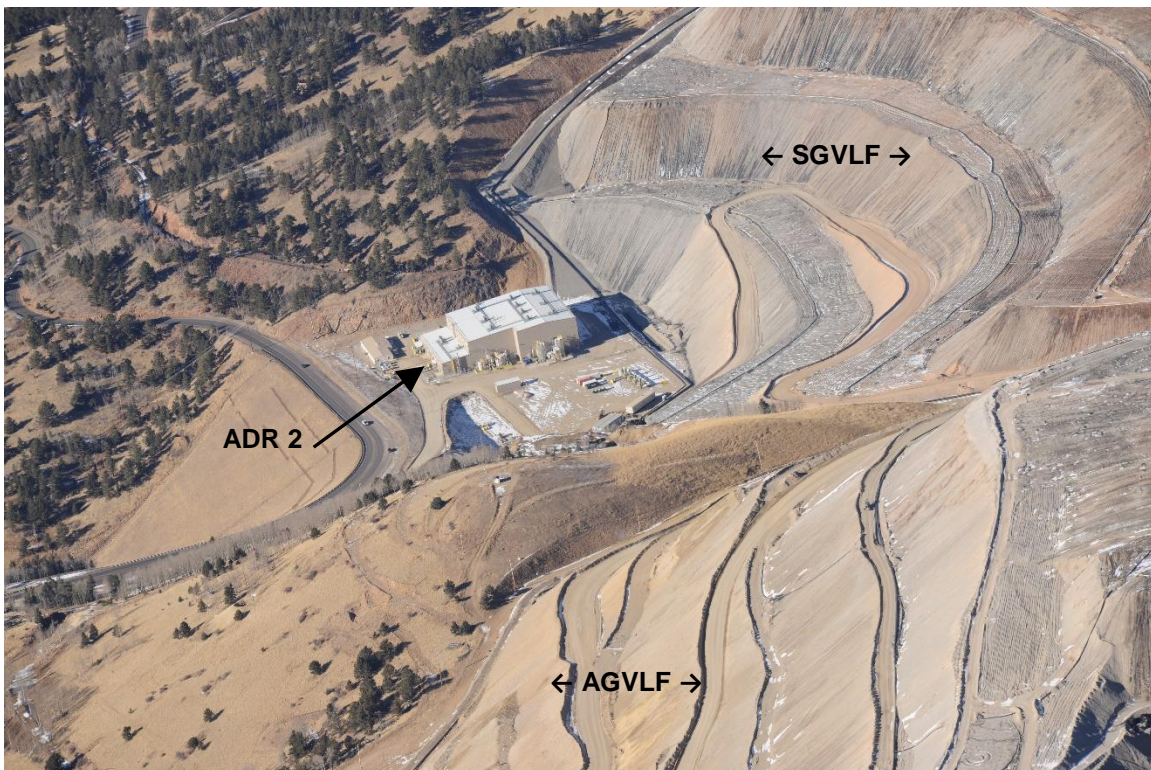
Photo 10. ADR 2 (looking NE).
