**MINERALS PROGRAM INSPECTION REPORT****PHONE: (303) 866-3567**

<b>MINE NAME:</b> Climax Mine	<b>MINE/PROSPECTING ID#:</b> M-1977-493	<b>MINERAL:</b> Molybdenum	<b>COUNTY:</b> Summit
<b>INSPECTION TYPE:</b> Monitoring	<b>INSPECTOR(S):</b> Lucas J. West	<b>INSP. DATE:</b> January 17, 2018	<b>INSP. TIME:</b> 10:00
<b>OPERATOR:</b> Climax Molybdenum Company	<b>OPERATOR REPRESENTATIVE:</b> James Haag, Diana Kelts	<b>TYPE OF OPERATION:</b> 112d-3 - Designated Mining Operation	
<b>REASON FOR INSPECTION:</b> Normal I&E Program	<b>BOND CALCULATION TYPE:</b> None	<b>BOND AMOUNT:</b> \$78,246,088.00	
<b>DATE OF COMPLAINT:</b> NA	<b>POST INSP. CONTACTS:</b> None	<b>JOINT INSP. AGENCY:</b> None	
<b>WEATHER:</b> Clear	<b>INSPECTOR'S SIGNATURE:</b>

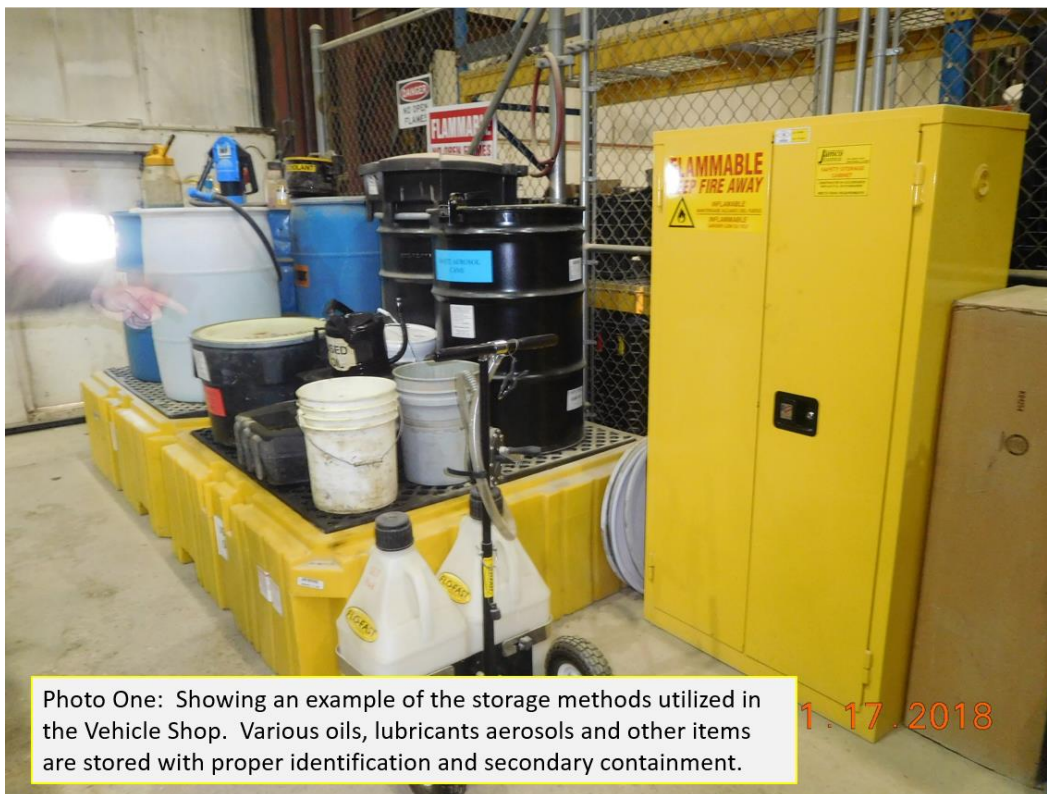
Photo One: Showing an example of the storage methods utilized in the Vehicle Shop. Various oils, lubricants aerosols and other items are stored with proper identification and secondary containment.

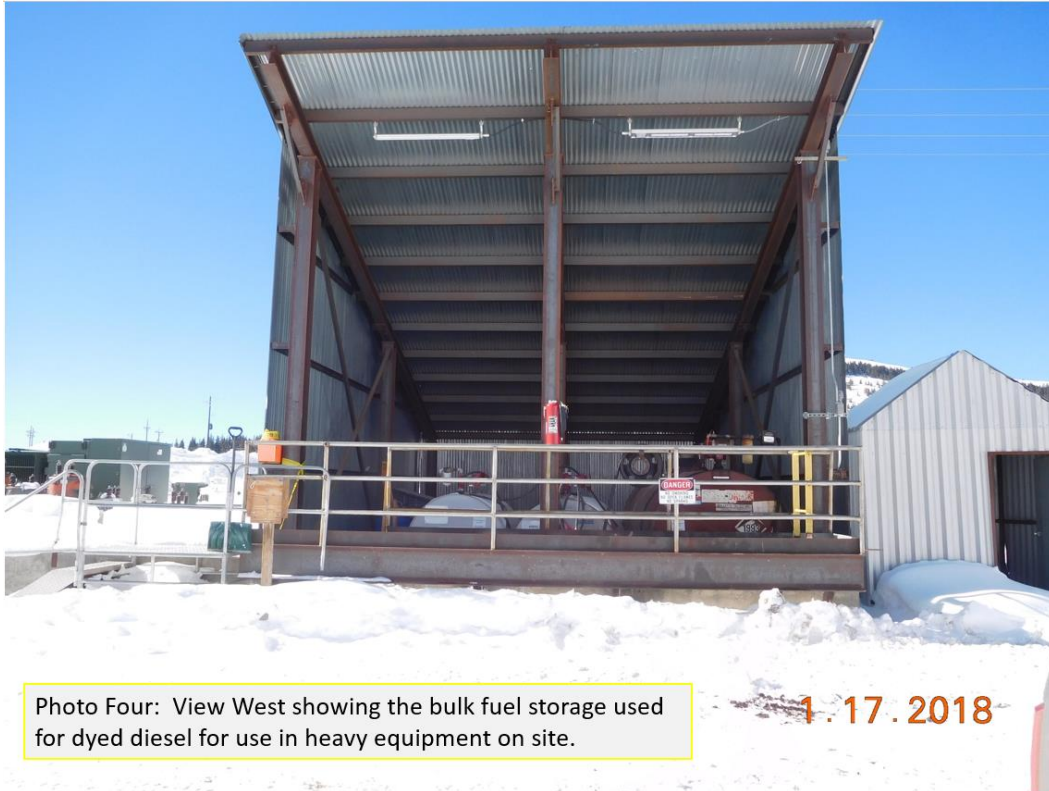
The bulk fuel storage consists of two separate locations. One is used for dyed diesel fuel for on-site heavy equipment as seen in Photo Four. The other consists of unleaded and un-dyed diesel fuel for use in light vehicles used on site as seen in Photo Five. Both storage areas are clean, organized and well-kept with spill kits readily available. All fuel tanks on site have adequate secondary containment and are in good condition.

Photo Four: View West showing the bulk fuel storage used for dyed diesel for use in heavy equipment on site.

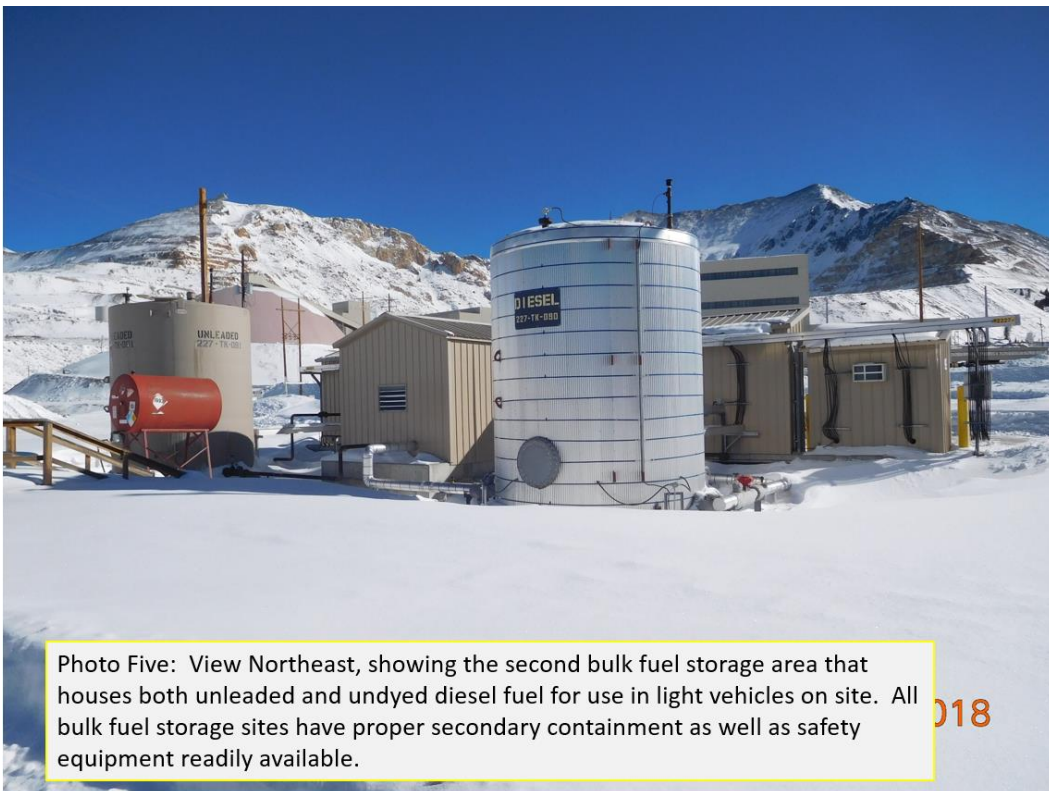
Photo Five: View Northeast, showing the second bulk fuel storage area that houses both unleaded and undyed diesel fuel for use in light vehicles on site. All bulk fuel storage sites have proper secondary containment as well as safety equipment readily available.

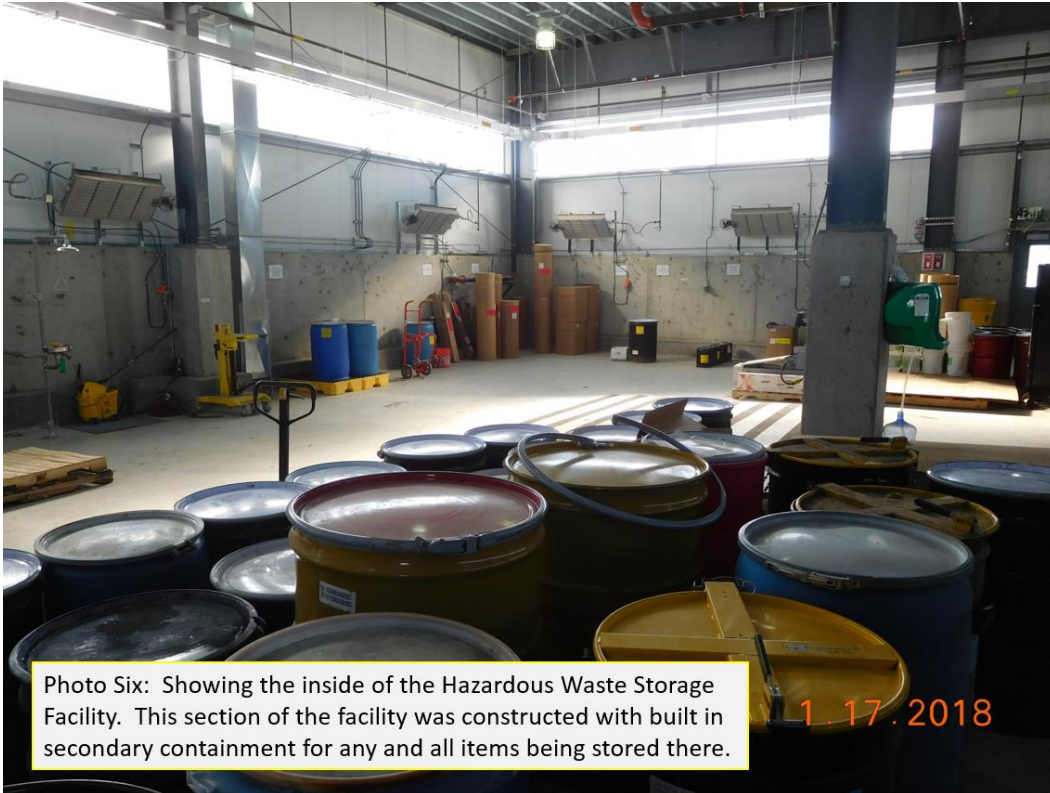
The Hazardous Waste Storage Facility is a small building located near the Main Building on site. All manner of hazardous materials are stored there for disposal including used oils, oily rags, various electronics and other materials that are regulated as hazardous materials. The building was constructed in a way that the storage area acts as secondary containment for any and all items stored there. The storage area can be seen in Photo Six. All materials being stored in the facility are well kept and organized. No problems or possible violations were observed in this area.

Photo Six: Showing the inside of the Hazardous Waste Storage Facility. This section of the facility was constructed with built in secondary containment for any and all items being stored there.

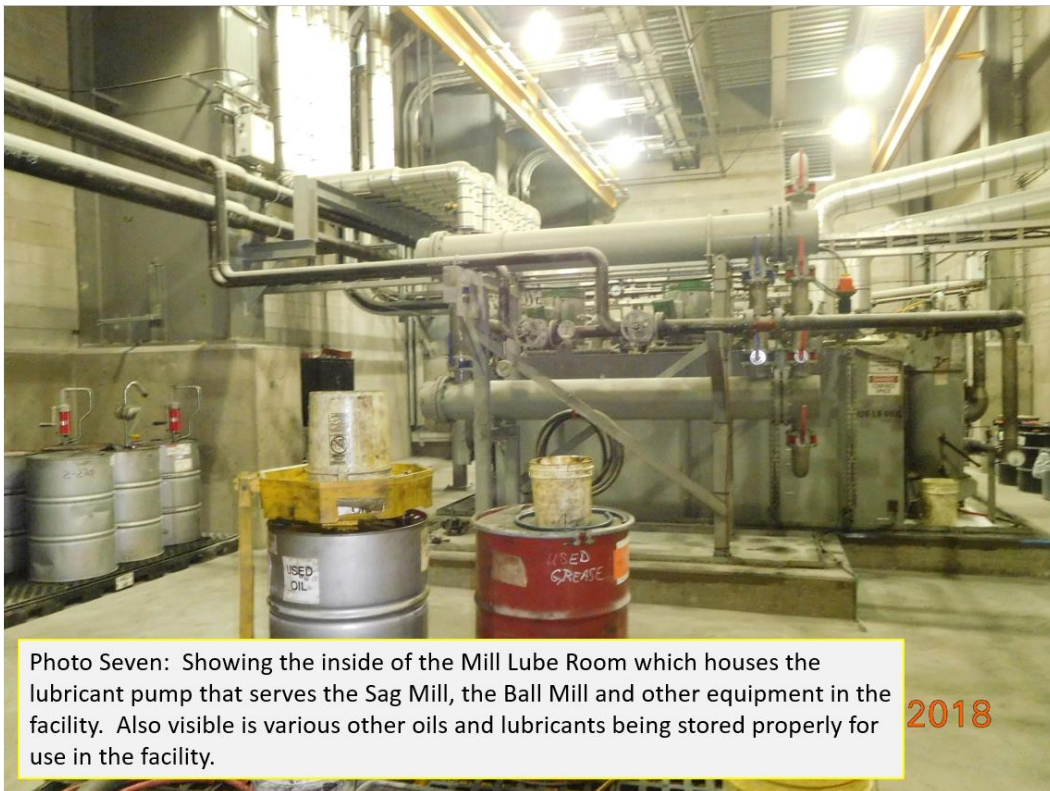
used in the milling process and can be seen in Photo Seven. Also stored in the Mill Lube Room are various other lubricants and oils used throughout the milling process. All materials stored in the room are stored with proper secondary containment. The room is well organized and is in good condition. The flow of material was followed through the Mill Facility from the Sag Mill through the Flotation Circuits and to packaging and storage areas of the concentrate. All conveyors and equipment observed in operation during the inspection were in good condition and appeared to be functioning as designed. No signs of leakage of hazardous materials or spills were observed within the facility. Safety equipment as well as first aid and spill kits was observed at several locations throughout the facility and appeared to be in good condition. The Mill Facility as a whole is in excellent condition and in good working order.

Photo Seven: Showing the inside of the Mill Lube Room which houses the lubricant pump that serves the Sag Mill, the Ball Mill and other equipment in the facility. Also visible is various other oils and lubricants being stored properly for use in the facility.
