PERMIT INFORMATION

Permit Number: C-1981-035 Mine Name: King Coal Mine Operator: GCC Energy, LLC Operator Address: Mr. Tom Bird 6473 County Road 120 Hesperus, CO 81326	County: La Plata Operation Type: Underground Permit Status: Active Ownership: Federal
	Operator Representative Present: Michael McFarland
Operator Representative Signature: (Field Issuance Only)

Inspection Start Date: January 18, 2018 Inspection Start Time: 08:00 Inspection End Date: Inspection End Time:	Inspection Type: Coal Partial Inspection Inspection Reason: Normal I&E Program Weather: Clear
Joint Inspection Agency: None	Joint Inspection Contacts:
Post Inspection Agency: None	Post Inspection Contacts:
Inspector(s): Robert D. Zuber, P.E.	Inspector's Signature:

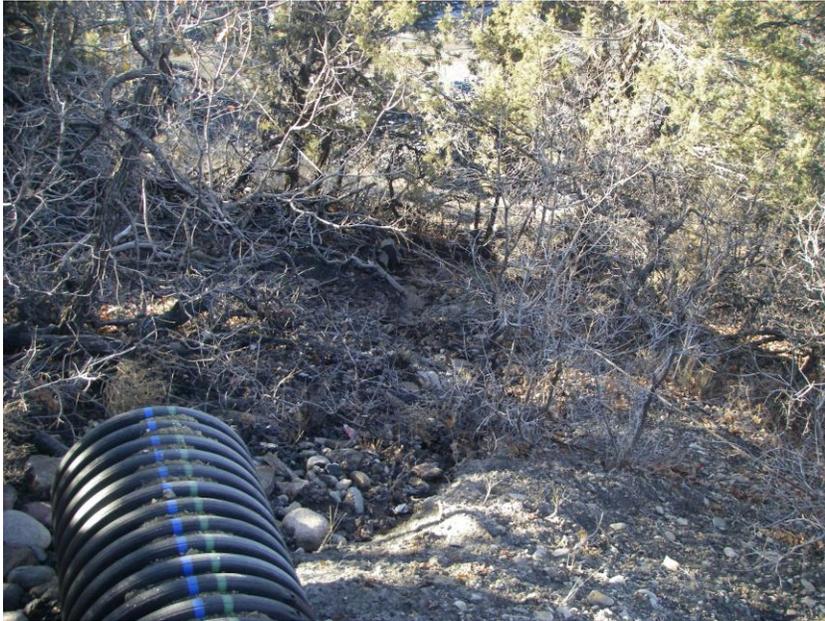
Potential problems were seen with erosion and sediment loading onto the hill below the newly constructed fan. There is a small rill below the culvert that is below the conveyor, and measures should be taken to keep this from getting worse. Branches or wattles in the rill would likely be effective. As recommended in the past, a sump above the culvert would help reduce sediment loading from this area.

Hillside below new fan where erosion control is recommended

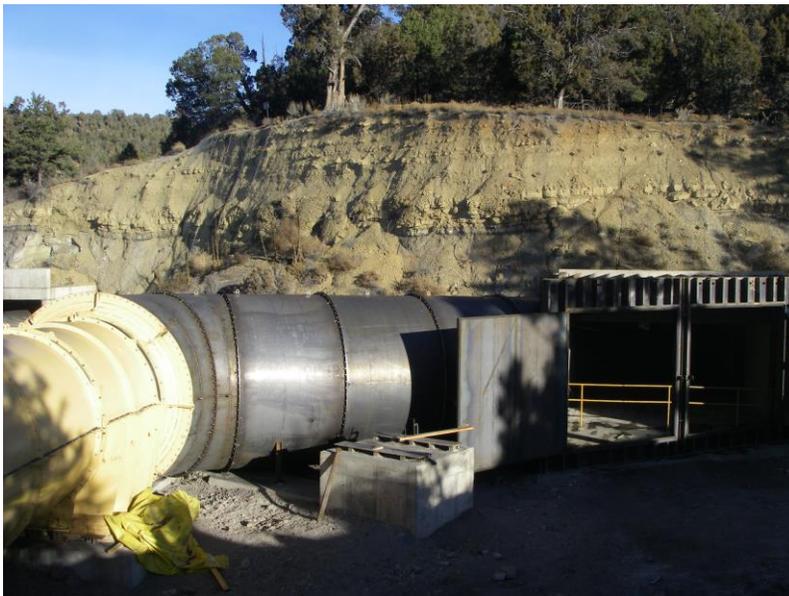
The primary cut slopes at the mine appear to be stable. This includes the King I facilities area (where portals were located) and the King II portal areas.

New fan structure and cut slope above

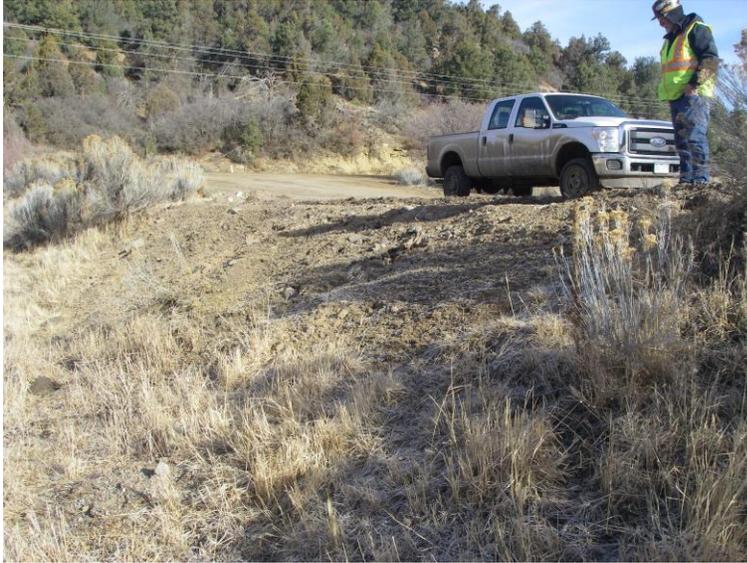
As noted in the December 2017 inspection report, near the King I entrance, activities by the road contractor (Four Corners) created a source of sediment that could be transported off site. This problem has been addressed with a berm to direct runoff to a silt fence sump, and hydroseed has been sprayed on the slope between the entrance road and the adjacent pasture. No issues were seen with the sumps and silt fence at the entrance area.

Erosion control near King I entrance

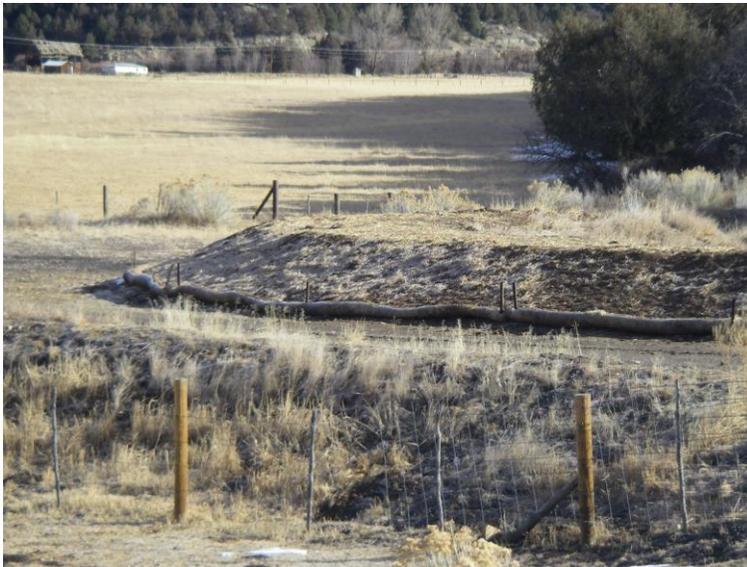
At the King I Mine, the West and East Ponds were dry. No problems were seen with the West Pond's structures (e.g., no rills on the embankment, no obstruction of the spillways).

Reconstructed embankment of East Pond (King I)

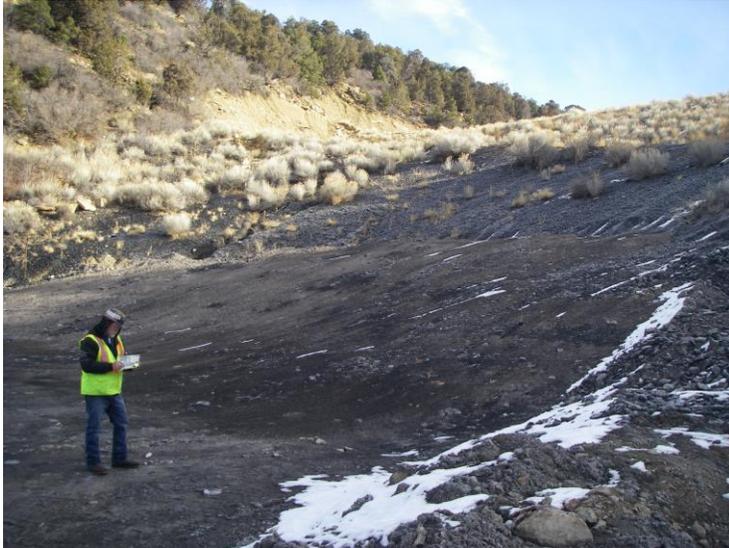
Significant material has been added to the lower portion of the Refuse Pile, and it appears to be well compacted. It appears to be waste from King II and not roadway material.

New material at toe of Refuse Pile

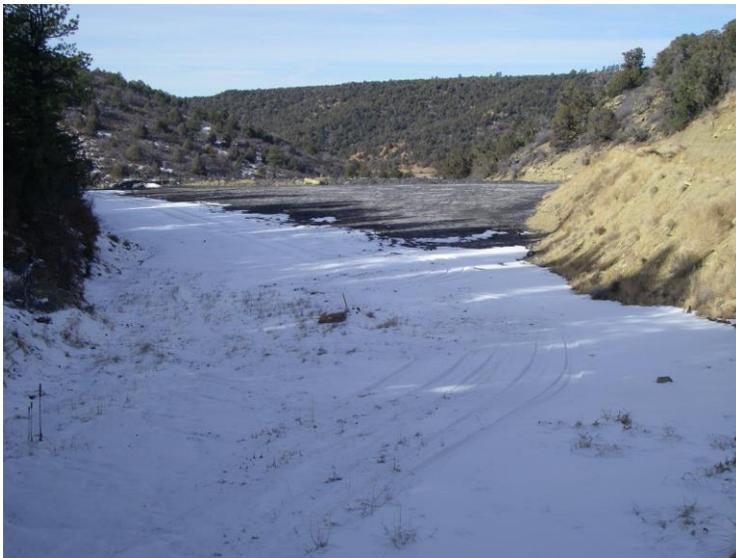
The un-reclaimed portion of the Refuse Pile (upper portion) had no piles of waste rock, and was in good condition. No puddles were seen on the surface of the Refuse Pile.

Upper portion of Refuse Pile
