**COLORADO**  
Division of Reclamation,  
Mining and Safety  
Department of Natural Resources

<b>Permit Number:</b> C-1981-012 <b>Mine Name:</b> New Elk Mine <b>Operator:</b> New Elk Coal Company, LLC <b>Operator Address:</b> Mr. Louis Head 12250 Highway 12 Weston, CO 81091	<b>County:</b> Las Animas <b>Operation Type:</b> Underground <b>Permit Status:</b> Active <b>Ownership:</b> Private
	<b>Operator Representative Present:</b>  Nick Mason
<b>Operator Representative Signature: (Field Issuance Only)</b>

<b>Inspection Start Date:</b> January 19, 2018 <b>Inspection Start Time:</b> 08:00 <b>Inspection End Date:</b> <b>Inspection End Time:</b>		<b>Inspection Type:</b> Coal Partial Inspection <b>Inspection Reason:</b> Normal I&E Program <b>Weather:</b> Clear	
<b>Joint Inspection Agency:</b>  None		<b>Joint Inspection Contacts:</b>  	
<b>Post Inspection Agency:</b>  None		<b>Post Inspection Contacts:</b>  	
<b>Inspector(s):</b>  Robert D. Zuber, P.E.	<b>Inspector's Signature:</b>

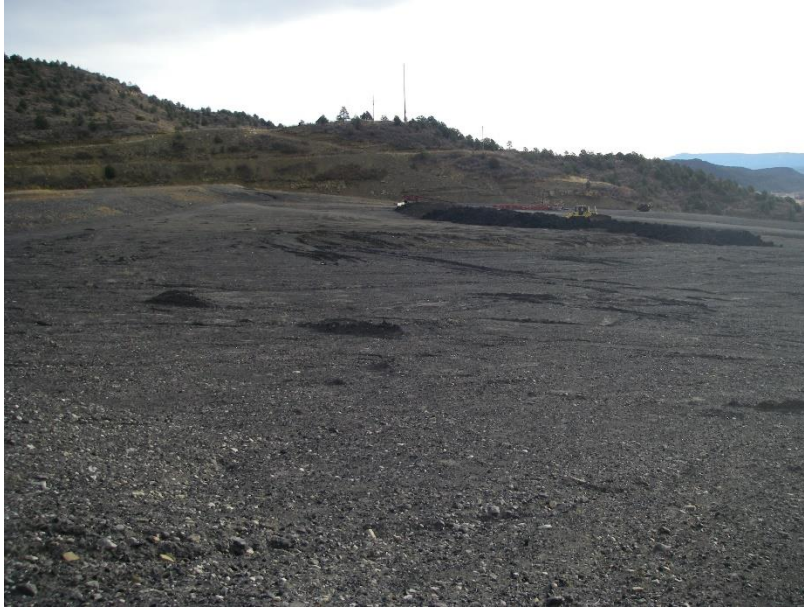
**Upper RDA**

No problems were seen on the upper portion of the RDA (un-reclaimed), however NECC should closely monitor it (especially the area that has ungraded material such as pond cleanings) to assure that large areas of ponded water do not form. No problems were seen with the top of the eastern underdrain.

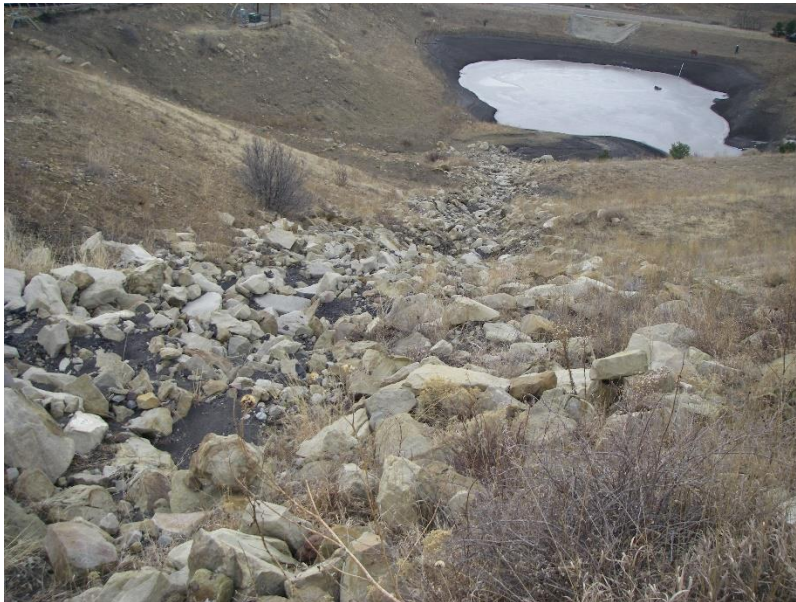
There is good vegetation cover on the reclaimed portion of the RDA, and no large rills or gullies were seen on the face or in the side ditches. Some sediment is visible in the eastern side ditch, but is not currently a large enough quantity to illicit concern about the surface water control structures (ditches, sumps) above this area.

**Sediment in eastern side ditch of RDA**

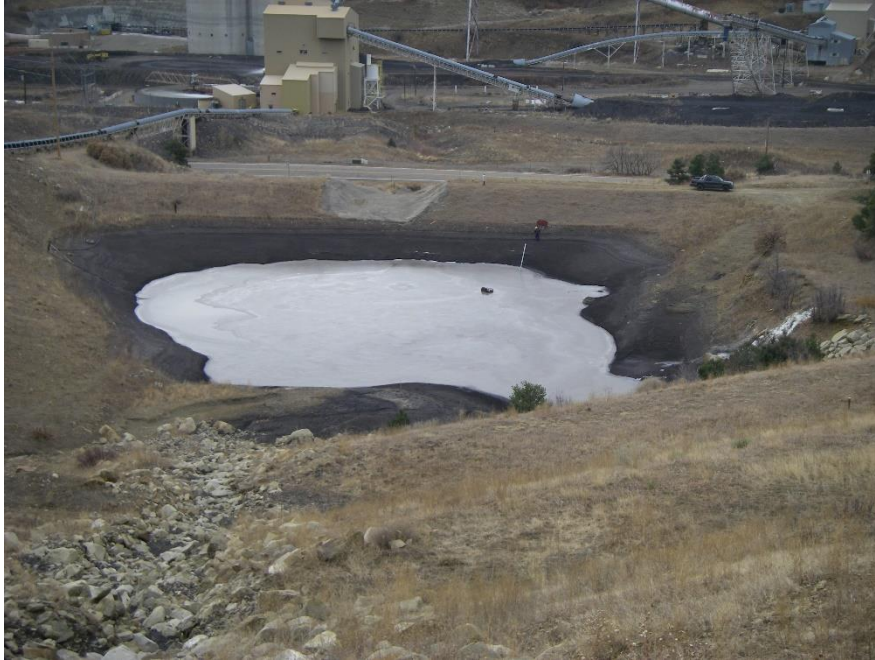
**Pond 08**

Ponds 001A, 006A, 007A, and 08 were inspected. None of them were discharging, but all held water. The water levels were relatively low in most ponds compared to recent months (the exception was Pond 007A). The impounded water in Pond 007A was below four rows of holes in the primary spillway (in recent months the water was lower). No flow into the ponds was seen. No significant issues were seen with the pond spillways or embankments of any ponds.

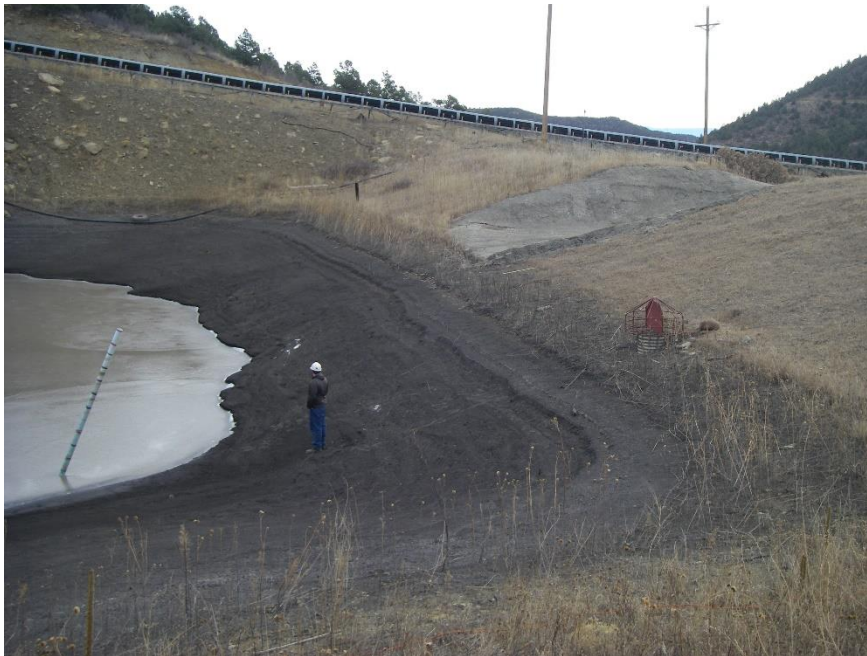
**Pond 08 – water level well below typical level for recent months**

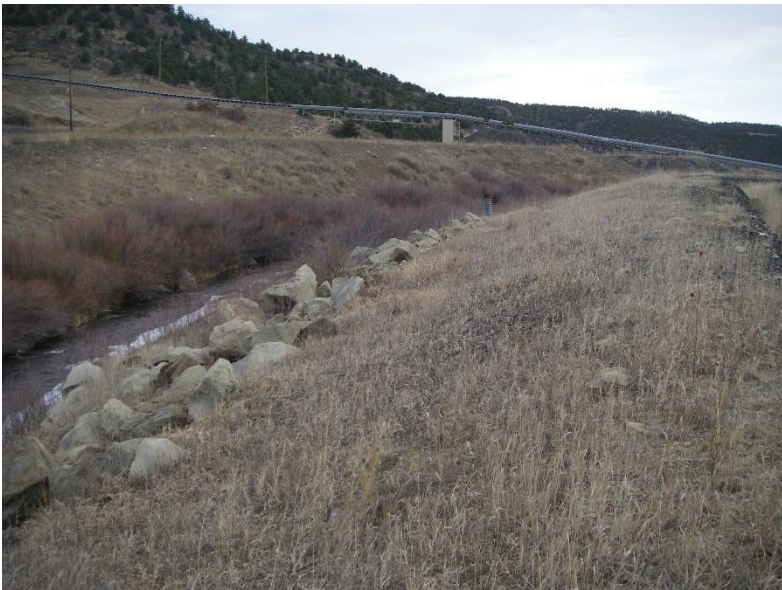
The Middle Fork of the Purgatoire River was inspected below the DWDA#2, and no issues were observed in terms of eroding banks or pollutant loading from the New Elk Mine.

**Middle Fork of the Purgatoire River, looking downstream near raw coal storage**

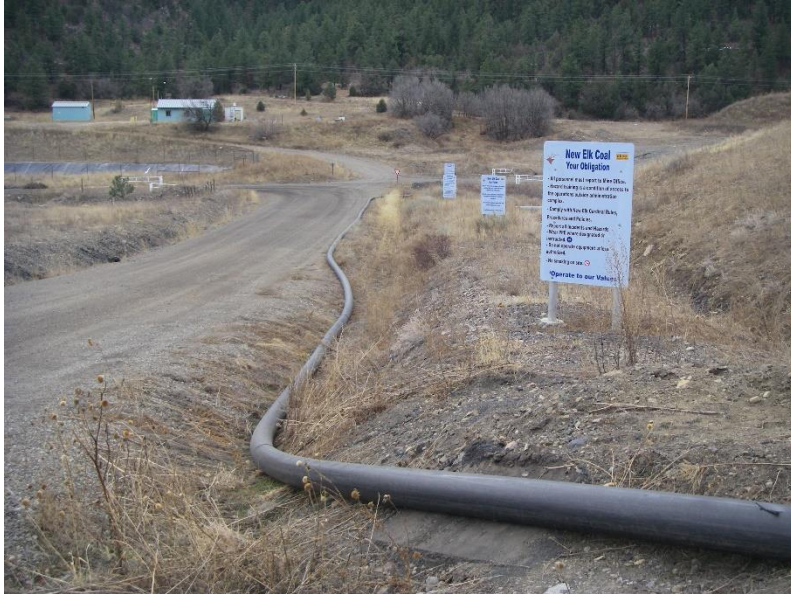
No significant problems with ditches were seen. The particular ditches that were inspected included: D10, D10A, D11, D13, D15, and D32. There is minor erosion in D13 that should be monitored and possibly repaired.

The entrance sign has the required information.

**Ditches and signs near entrance**

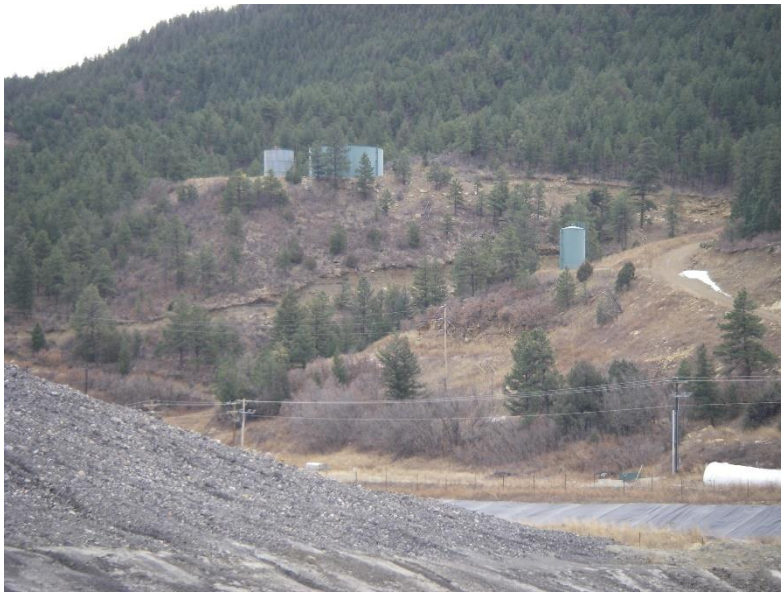
The hill below the water tanks was observed from afar, and no erosion or other problems were seen. The retaining wall by the Bates Portals appears stable.

**Water tanks and hill below**
