**COLORADO**Division of Reclamation,
Mining and Safety

MINERALS PROGRAM INSPECTION REPORT**PHONE: (303) 866-3567**

MINE NAME: Fox #1 Clay Mine	MINE/PROSPECTING ID#: M-1977-219	MINERAL: Clay, sandstone, and borrow material	COUNTY: Pueblo
INSPECTION TYPE: Preoperation Inspection	INSPECTOR(S): Elliott R. Russell	INSP. DATE: October 24, 2017	INSP. TIME: 08:30
OPERATOR: Summit Brick & Tile Co.	OPERATOR REPRESENTATIVE: Matt Welte	TYPE OF OPERATION: 112c - Construction Regular Operation	
REASON FOR INSPECTION: Preoperation Inspection	BOND CALCULATION TYPE: Complete Bond	BOND AMOUNT: \$83,000.00	
DATE OF COMPLAINT: NA	POST INSP. CONTACTS: None	JOINT INSP. AGENCY: None	
WEATHER: Clear	INSPECTOR'S SIGNATURE:

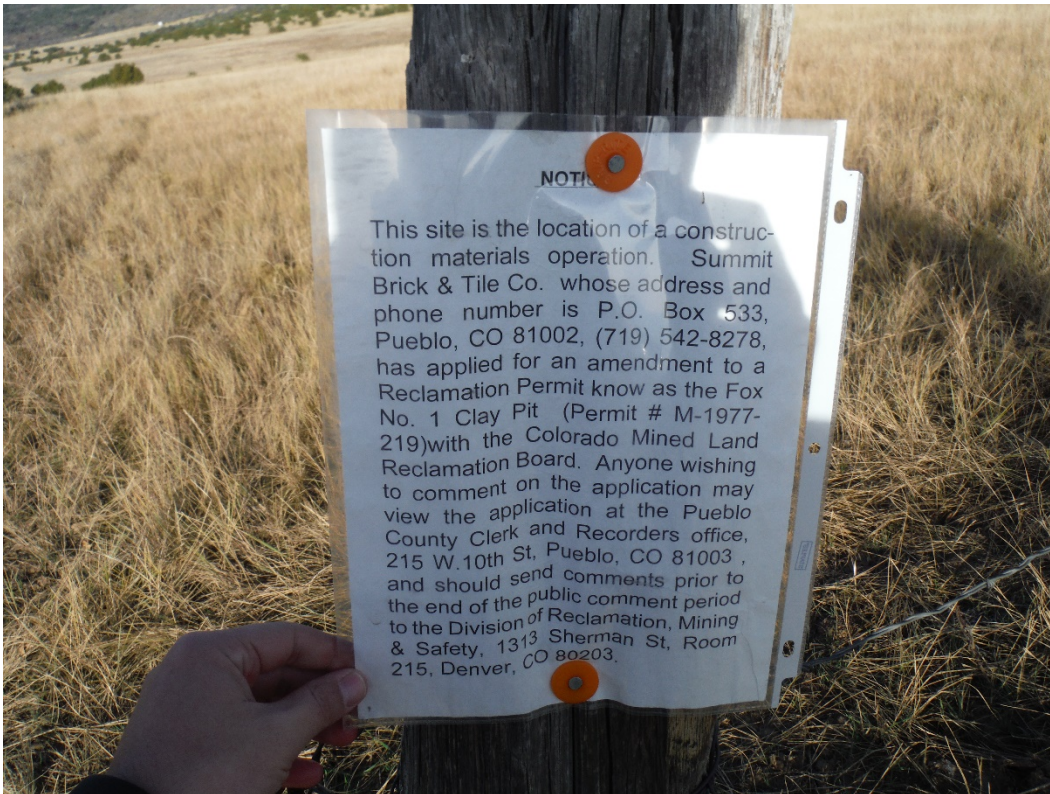
Photo 1. Sample site notice posted along Siloam Road; looking west.

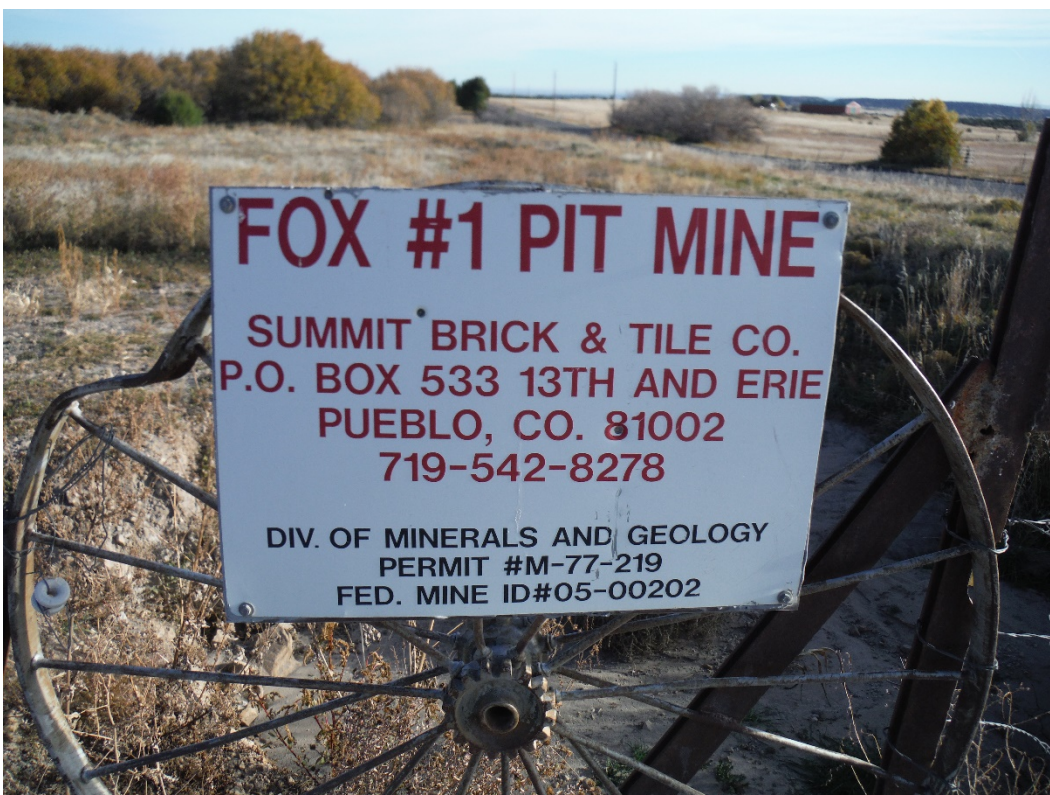
Photo 2. Permit identification sign posted at the entrance to the mine site; looking north.

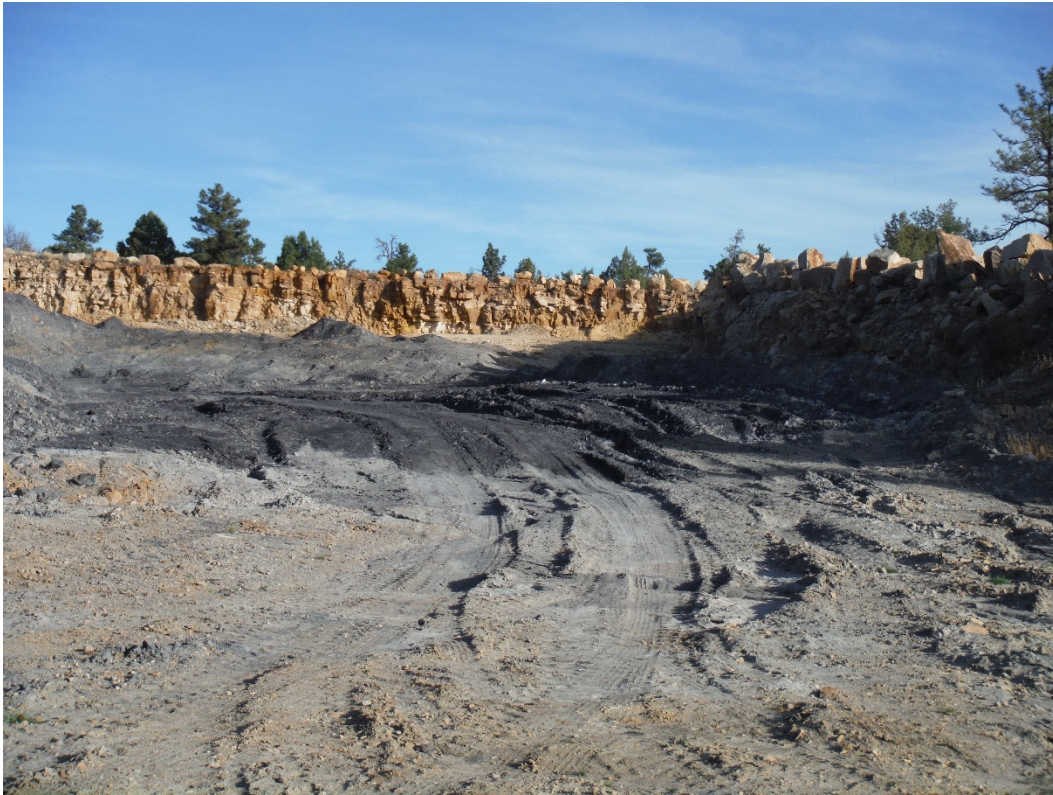
Photo 3. Sample photo of existing operations, sandstone has been removed, clay is exposed for mining; looking north.

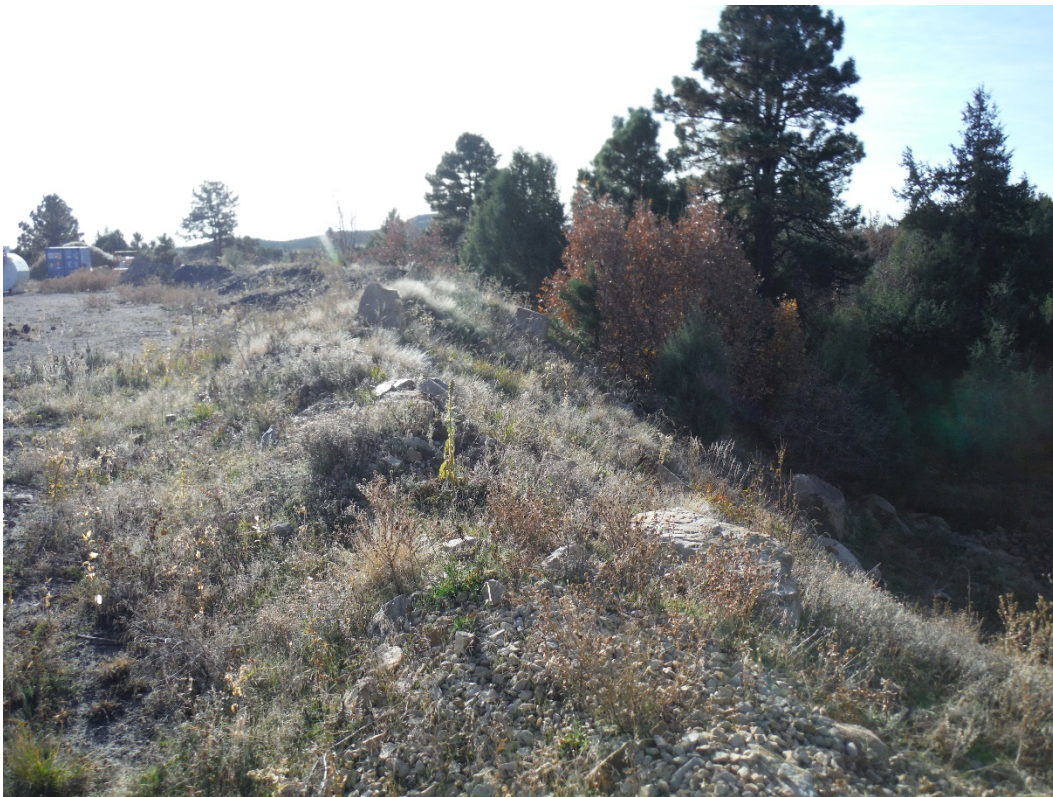
Photos 4. Berm between the southern edge of the operation and the drainage canyon located to the south of the existing operation; looking east.

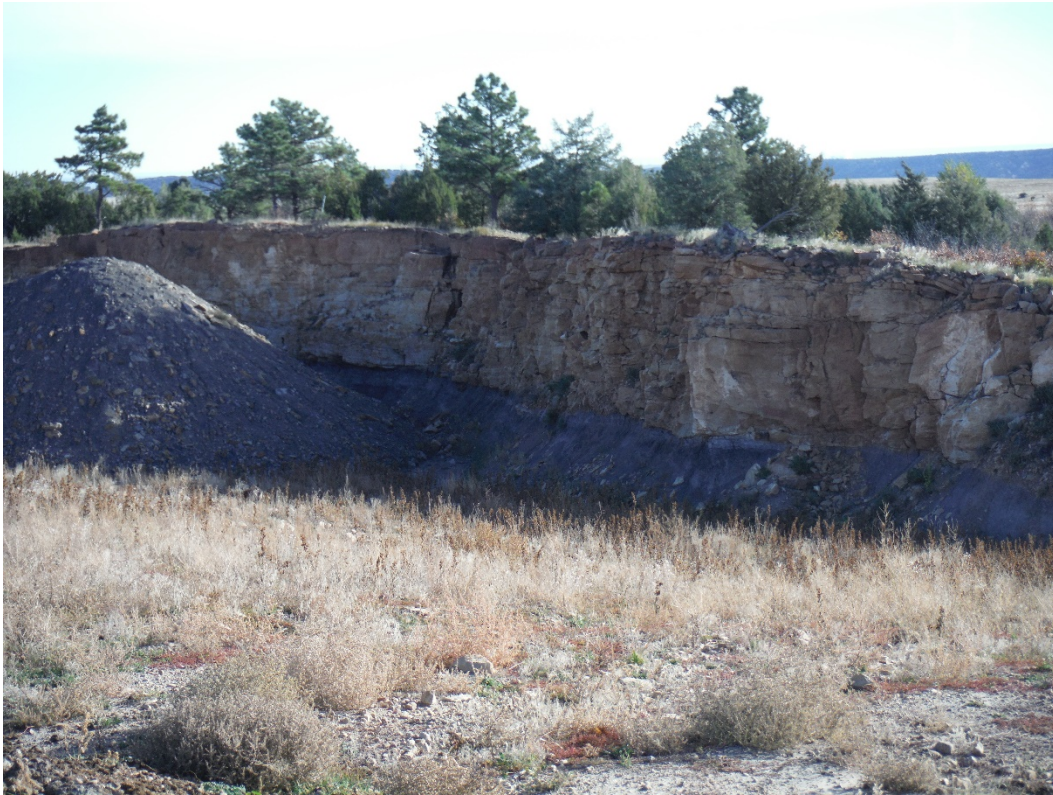
Photo 5. Sample photo of existing operations, sandstone and clay has been mined; looking northeast.

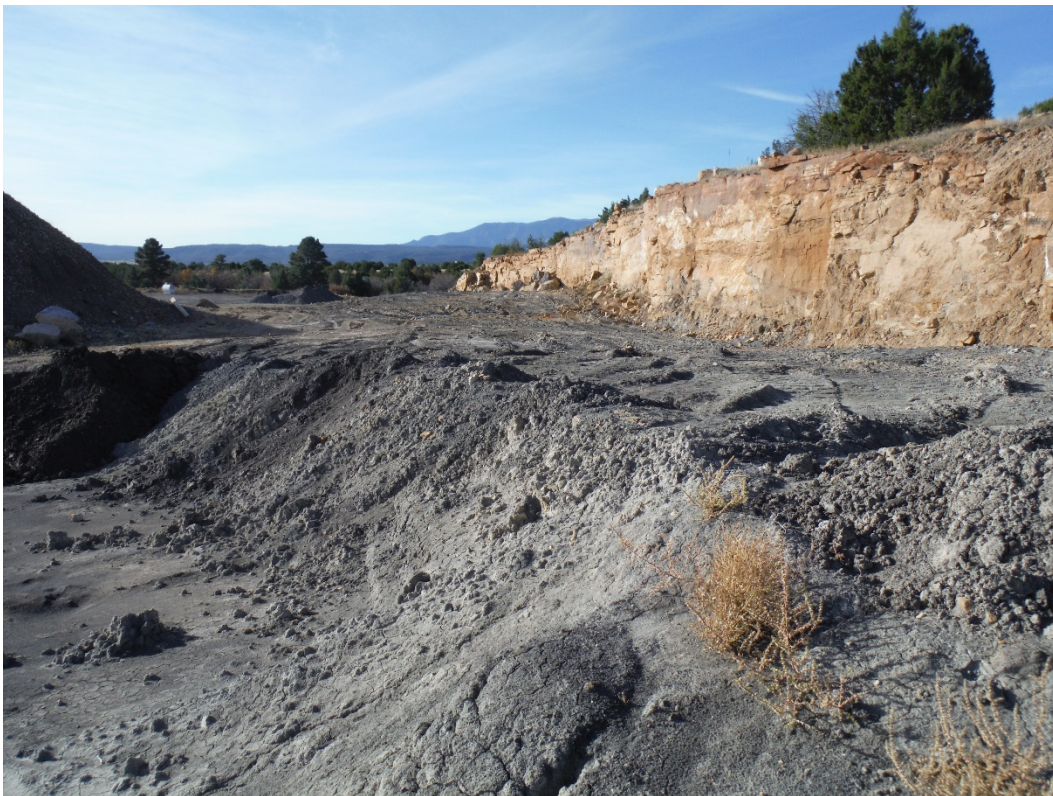
Photo 6. Sample photo of existing operations, clay currently being mined; looking south.

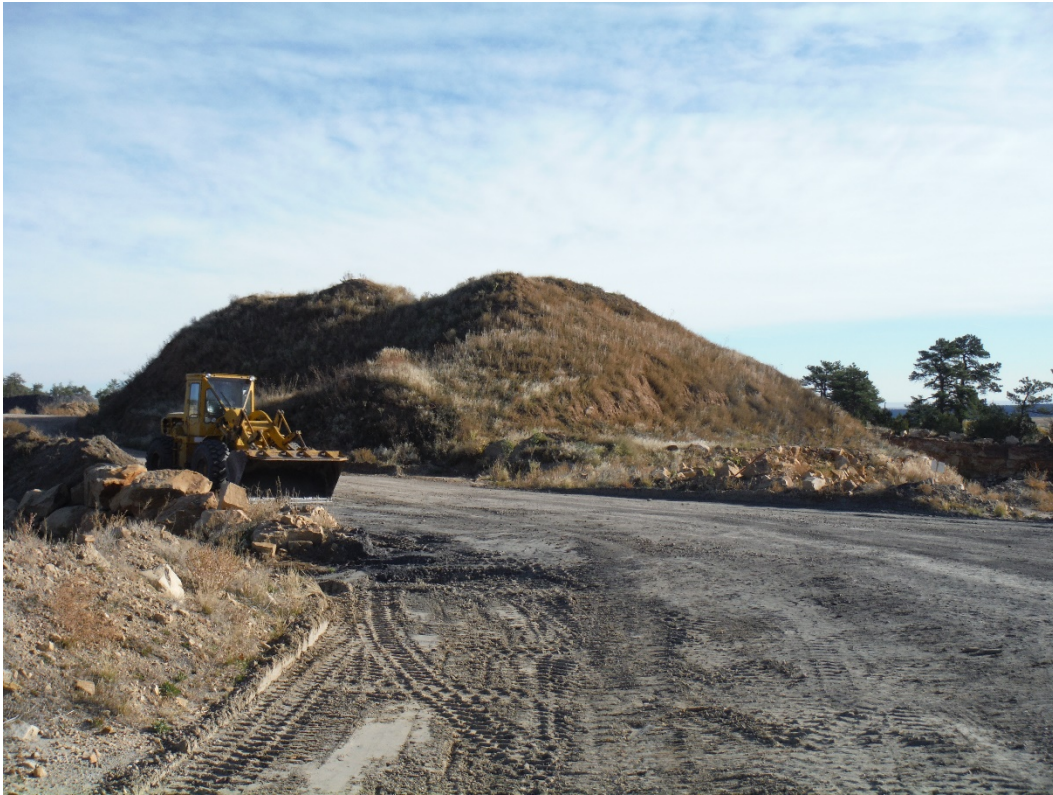
Photo 7. Sample photo of existing operations, vegetated topsoil stockpile; looking northeast.

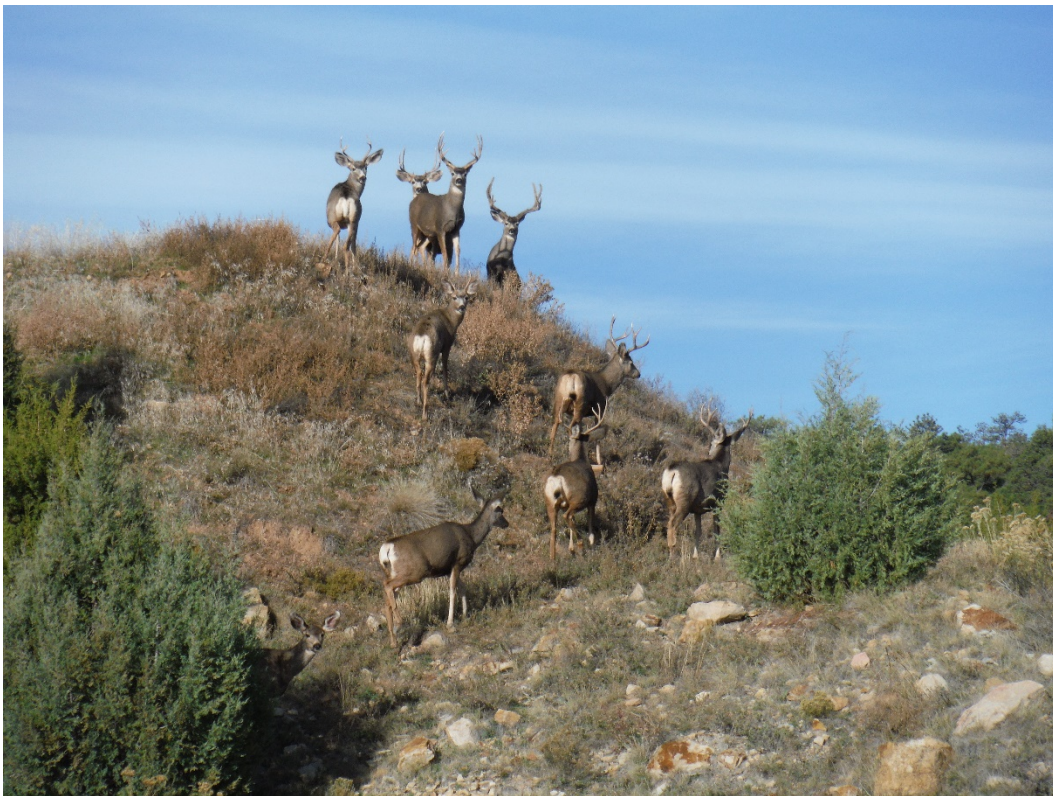
Photo 8. Mule deer observed on one of the site's topsoil stockpile; looking west.

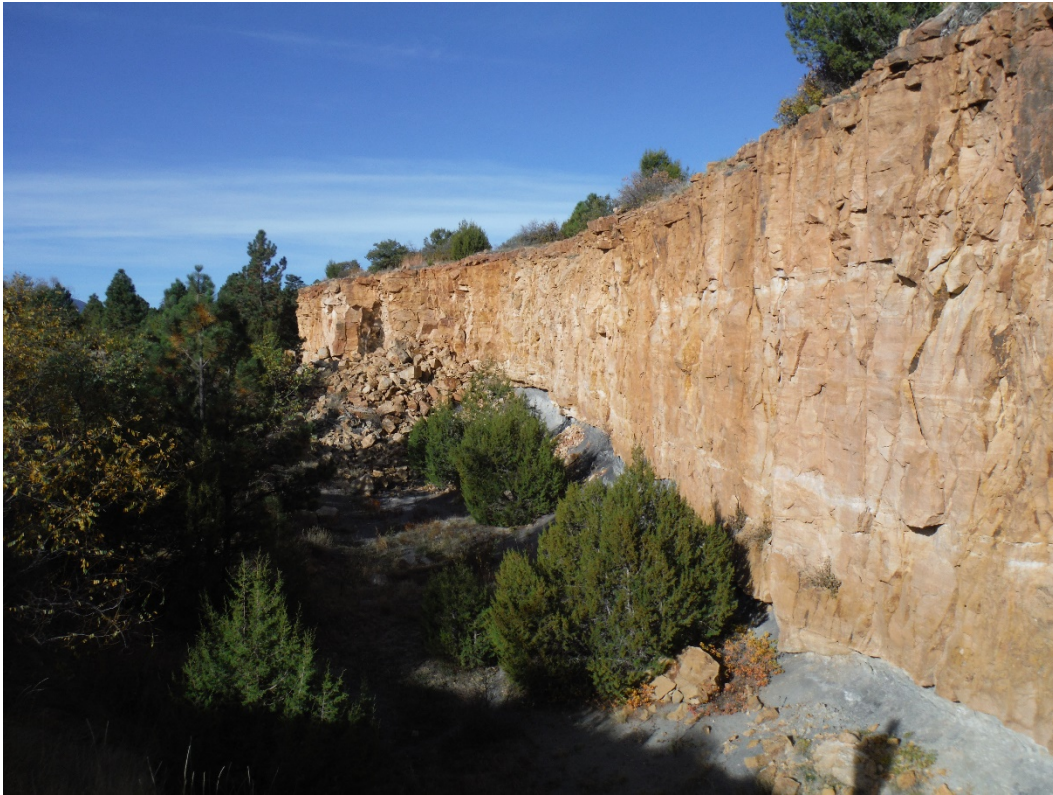
Photo 9. Historic (pre-permit) highwall located just north of the existing operation, located within the amendment area and proposed to be mined; looking west.

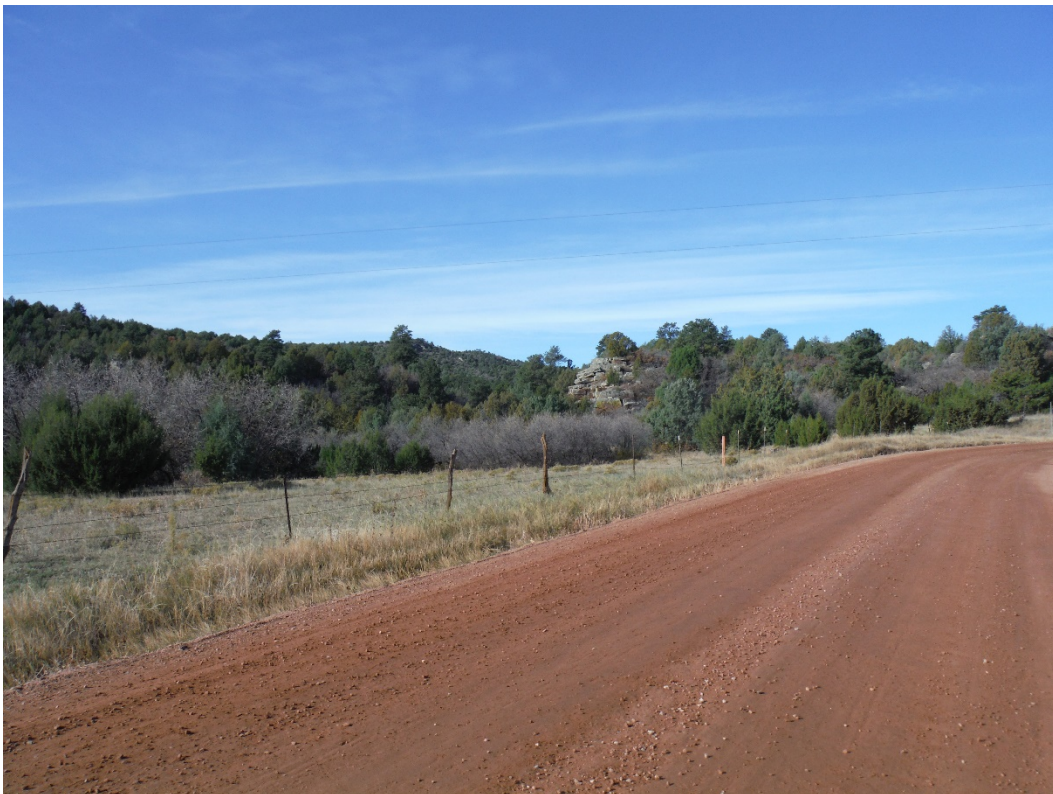
Photo 10. Sample photo of the northern portion of the amendment area; looking west from Siloam Road.

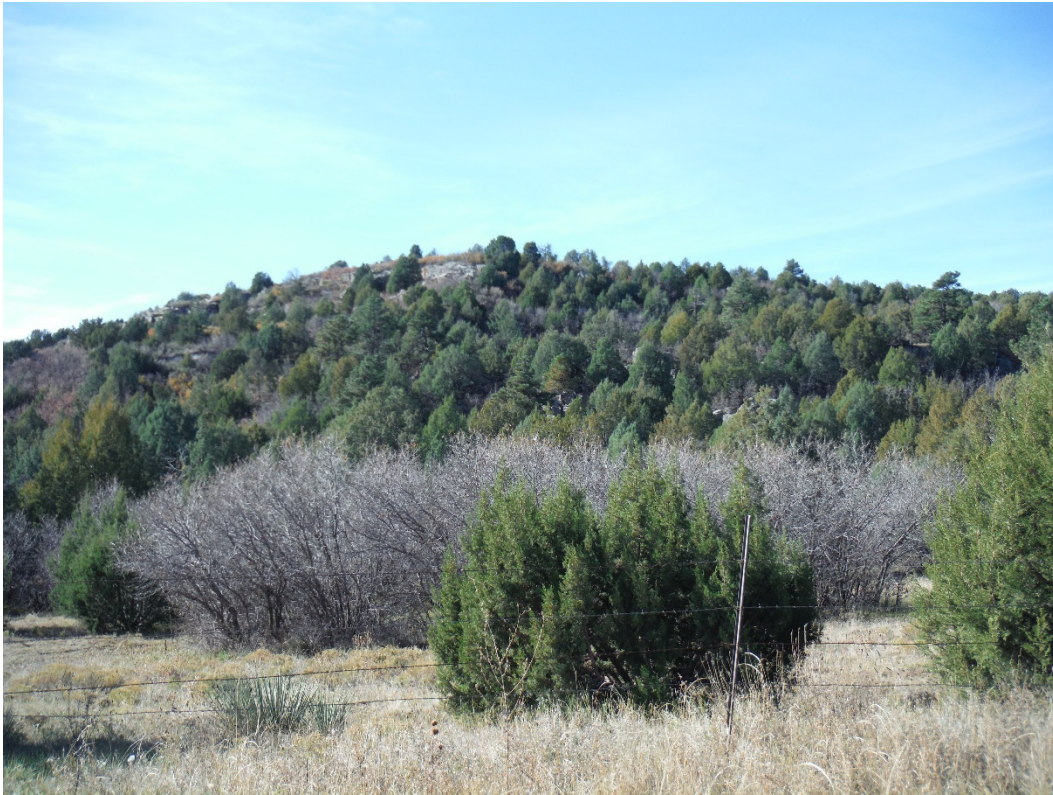
Photo 11. Sample photo of the northern portion of the amendment area; looking southwest from Siloam Road.

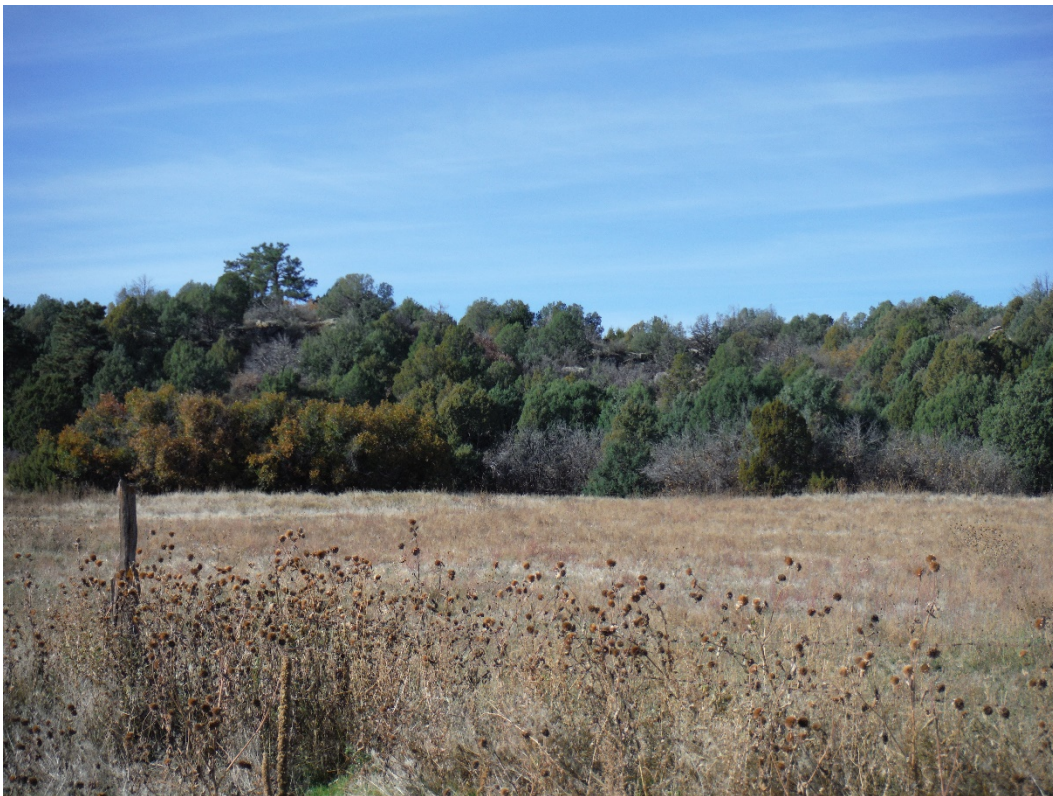
Photo 12. Sample photo of the central portion of the amendment area; looking west from Siloam Road.

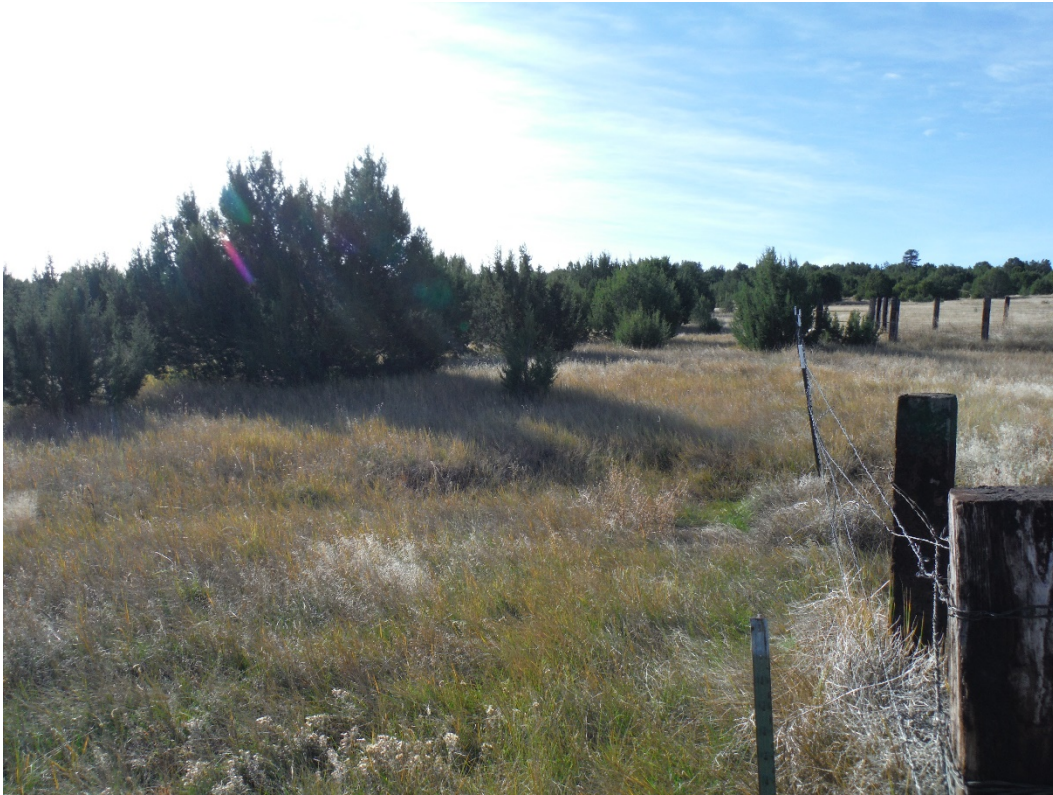
Photo 13. Sample photo of the northwest portion of the amendment area; looking south from Even Road.

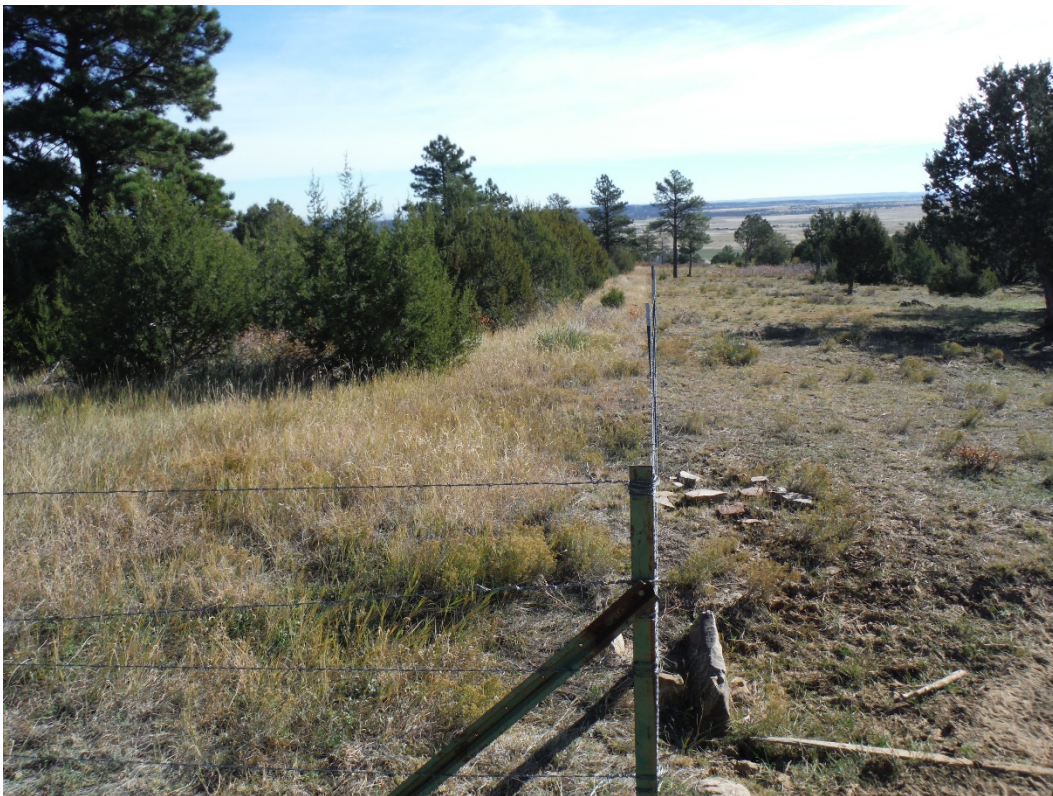
Photo 14. Sample photo of the western portion of the amendment area (right side of fence); looking.
